Home Inspection Report

811 Nelchina St

Anchorage, AK 99501

Inspected on Mon, Jul 27 2020 at 12:30 PM

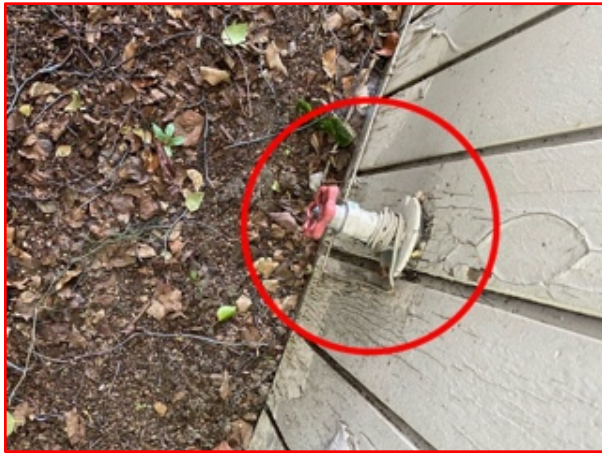
Figure 1-1

The hose bib (faucet) on the Northern side of the house is not anti-siphon hose bib. Also, the copper plumbing to the hose bib is not connected in the crawlspace. Recommend a qualified contractor replace hose bib with an anti-siphon/freeze proof hose bib to be muni code compliant and repair the copper piping to the hose bib in the crawlspace.

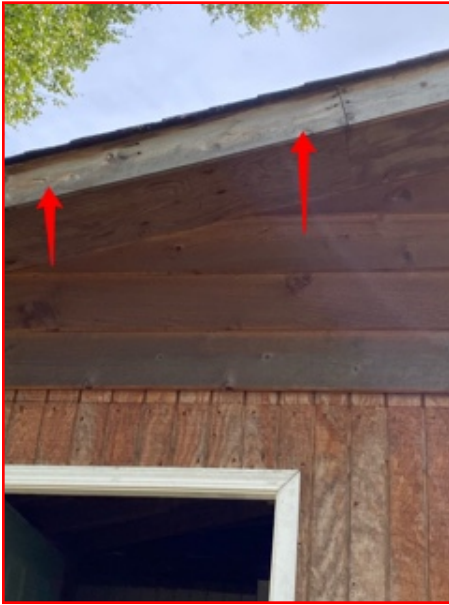
Figure 2-1

Several wood trim pieces rotted and the exterior of the house are weathered and missing paint. Recommend a qualified contractor assess and fix/repaint.

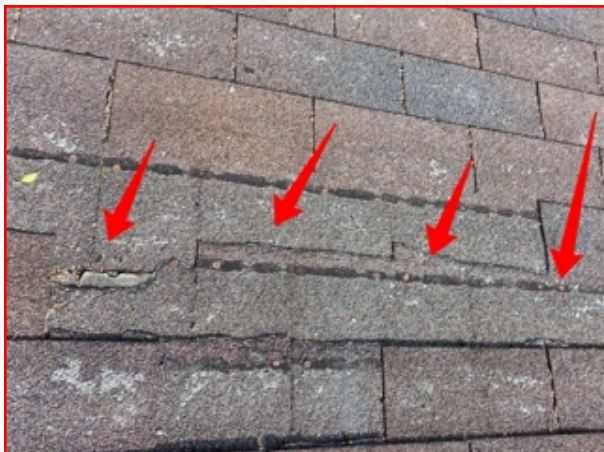
Figure 3-1

Several missing shingles, wind blown shingles, exposed sheathing, and nail heads visible. Several of the vent and flashing boots were cracked. Roof is near the end of its life. Recommend a qualified roofing contractor assess and re roof.

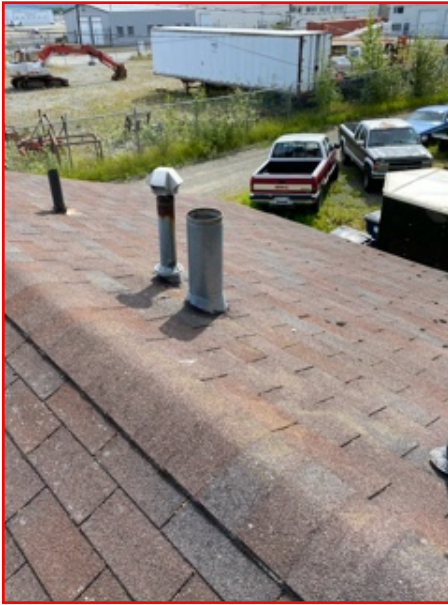
Figure 4-1

House heater furnaces rain cap is missing from the top of the flue. Recommend a qualified contractor install a rain cap at the top of the flue to keep the elements out of the flue and furnace.

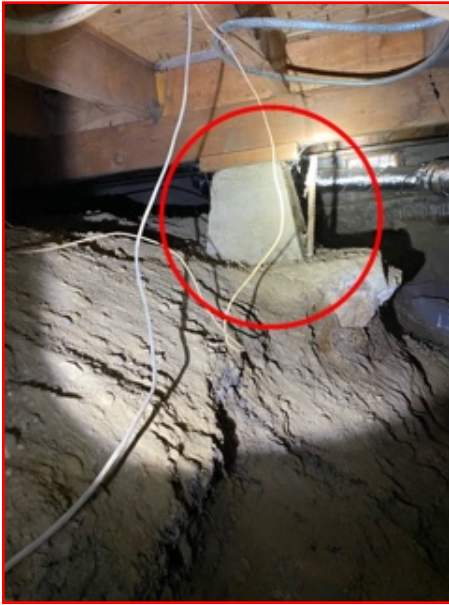
Figure 5-1

The concrete block (piers) aren't mortared together (dry stacked). They were loosely stacked under the girder main support beams under the house. Also, the block should be separated from the wood shim with a thin piece of metal and the girder support beam should be connected (strapped or nailed) to the floor joist. Could not verify that the blocks were built on an actual footer (concrete pad). Recommend a qualified structural contractor assess the concrete block piers, missing metal separation, missing tie points (strapping between girder and joist and footing).

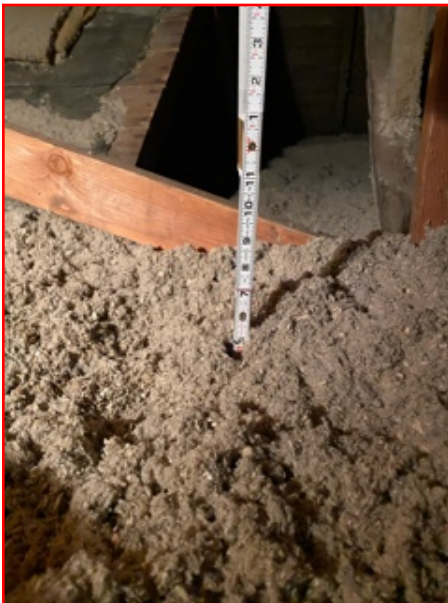
Figure 6-1

There were 6"-8" of blown in cellulose in the attic for an R value for around R21-R30. Recommend putting up to 16" in for a rating of R 50-R60 for this region.

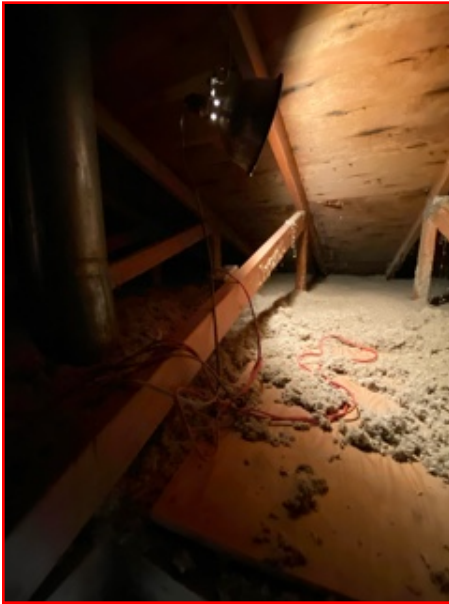
Figure 7-1

Extension cords used for lighting in the attic. This is unsafe and not permitted. Junction boxes with permanent wiring are permitted according to the NEC. Recommend a qualified electrical contractor assess and fix/repair.

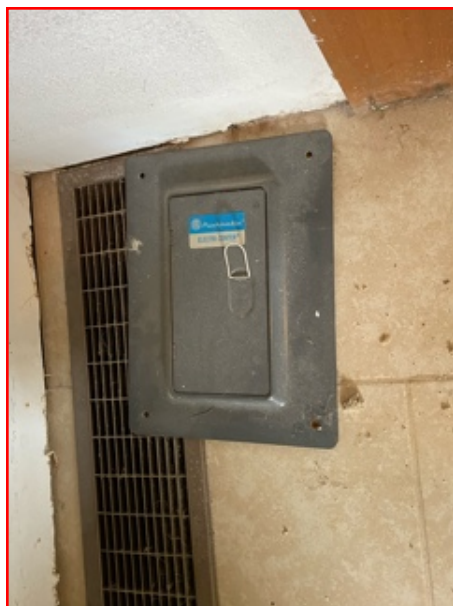
Figure 10-1

Dead front (front cover) was off the main service distribution panel and laying on the ground. This is unsafe and can a shock hazard. Recommend a qualified electrical contractor install the dead front cover back on with the appropriate flat backed screws.

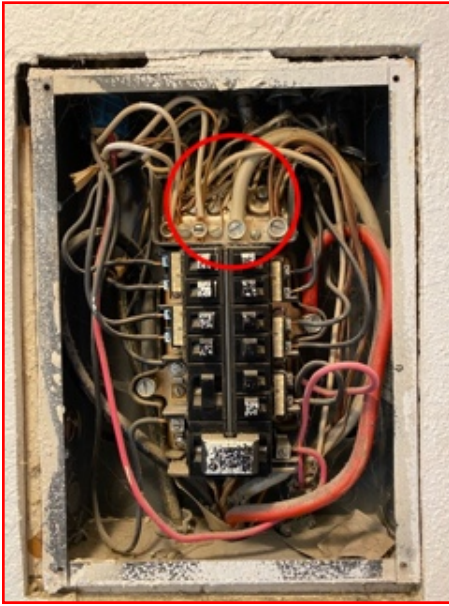
Figure 11-1

The service panel is a pushmatic and is very old. They have neutrals and grounds together and need to be separated on their own bus bars. Recommend a qualified electrical contractor assess and repair or replace service panel with updated version.

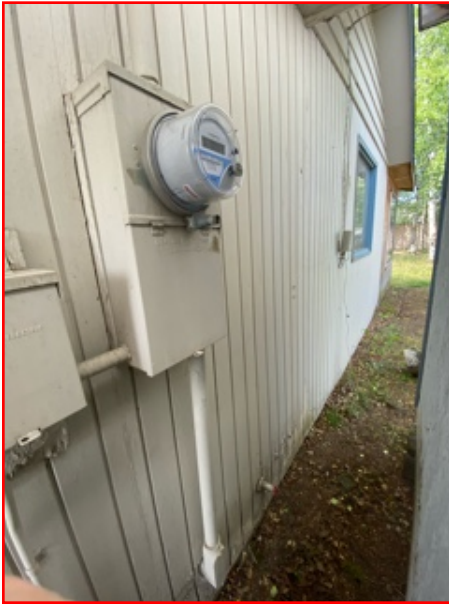
Figure 12-1

The metered service disconnect is missing the dead front (inside cover over the 100 amp breaker) cover. This poses a shock hazard and should be replaced. Recommend a qualified electrical contractor assess and replace the dead front on the metered service disconnect.

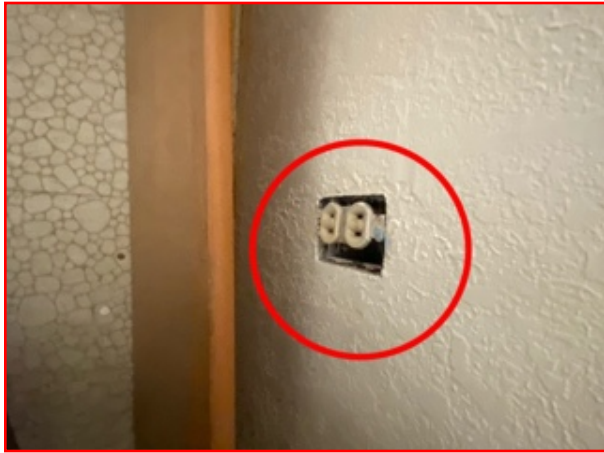
Figure 13-1

Several outlet and switch plates were missing through out the house . Recommend replacing outlet plates to keep from getting electrocuted.

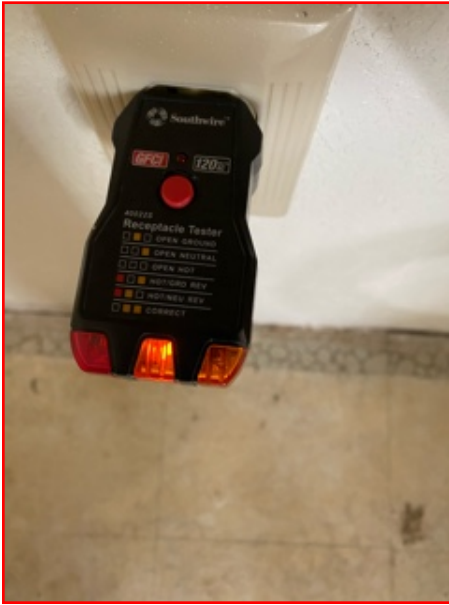
Figure 14-1

Several outlets in the living room/dining room are improperly wired and have open grounds. Also, the light in the front bedroom is hanging by the conductors and not properly supported by a box. Recommend a qualified electrical contractor assess and repair open grounds and install a light box for the front bedroom lights.

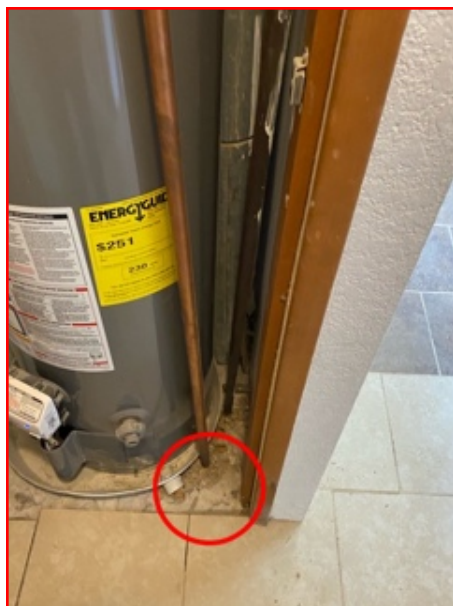
Figure 17-1

T & P valve with blow off Leg present for water heater. Water heater has a drain pan but the T&P valve blow off leg doesn't empty into pan. Also, the pan has no tube to drain into a suitable receptacle. The water heater can over flow onto the subfloor. Recommend a qualified contractor correct blow off leg to empty into drain pan and install drain pipe to a suitable receptacle or drain to the exterior between 6" - 24" above grade.

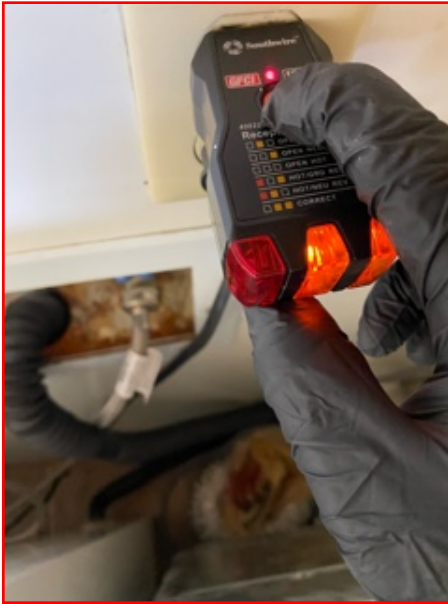
Figure 18-1

Regular outlet in laundry room for washer. Recommend replacing regular outlet with a GFCI outlet or install a GFCI breaker on that circuit to be GFCI protected.

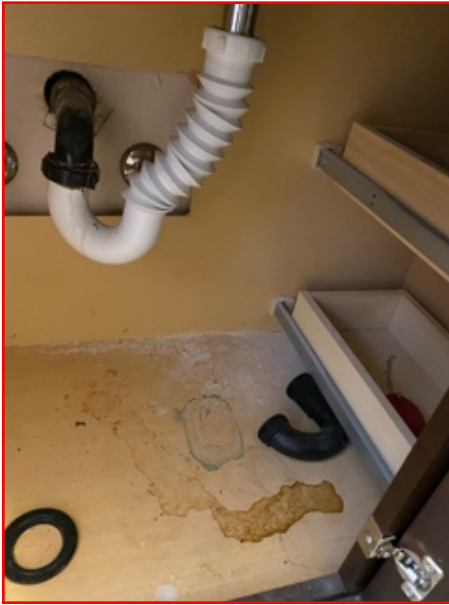
Figure 19-1

Bathroom sink has an unapproved corrugated waste pipe that can cause clogs. Suggest replacing with a smooth approved waste pipe.

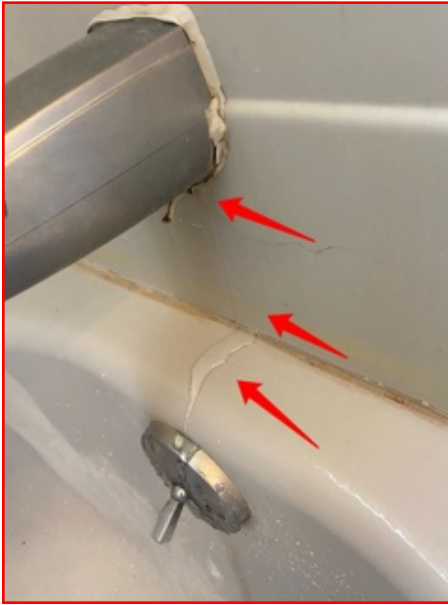
Figure 21-1

Tub faucet is leaking at the connection point. Possible water intrusion behind the vinyl tub surround. Recommend a qualified contractor assess and repair/replace.

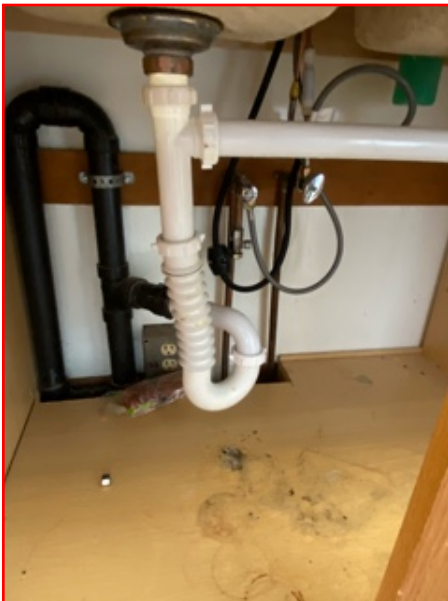
Figure 22-1

Kitchen sink has an unapproved corrugated waste pipe that can cause clogs. Recommend replacing with a smooth approved waste pipe.

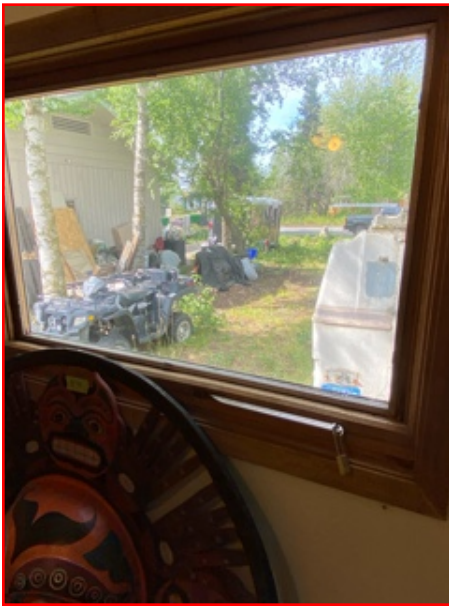
Figure 23-1

Front bedroom casement window is locked with a pad lock. This is a safety hazard due to it being able to quickly unlock and exit in case of fire or emergency. Recommend removing pad lock and placing a window locking mechanism or replacing window with a newer style with built in lock.

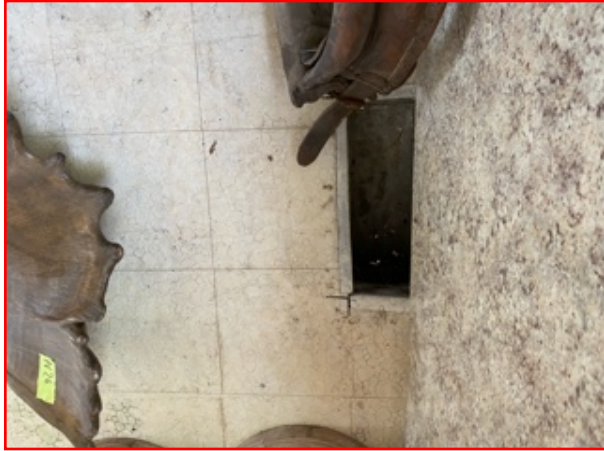
Figure 24-1

Some cosmetic damage possibly from earthquake and foundational movement with Sheetrock cracking at tape seems in various locations and also, holes in walls and some patching that was not done to standards. Also cracked tile and missing trim boards. Recommend a qualified contractor asses and repair Sheetrock areas.

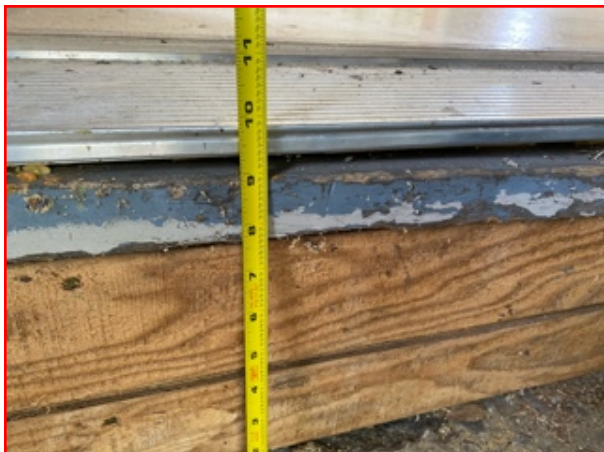
Figure 25-1

The step up/down from the arctic entry to the home is 11" to the threshold. The max rise on a step is 7 3/4". For safety purposes a single step should be put in place and secured to the wall. Recommend a qualified contractor add a single step that has a minimum rise of 4" and maximum rise of 7" and a tread depth of 11".

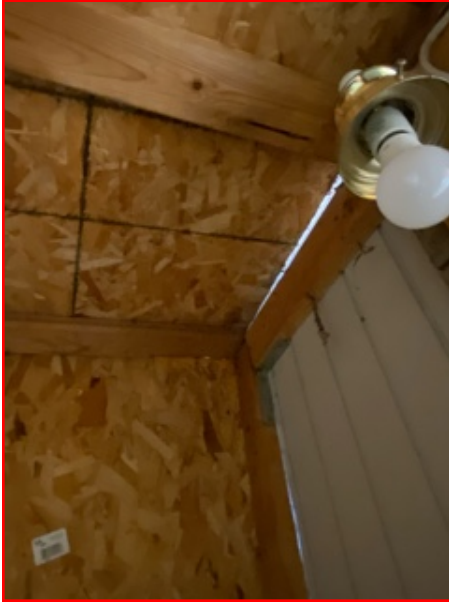
Figure 26-1

Rear arctic entry has gaps in between the house siding and the plywood. Recommend a qualified contractor seal with foam sealant to fill the gaps and keep out water.
