Wood Destroying Insect Inspection Report

04/16/2019

131 4th St
Schwenksville PA 19473

Single Family Home

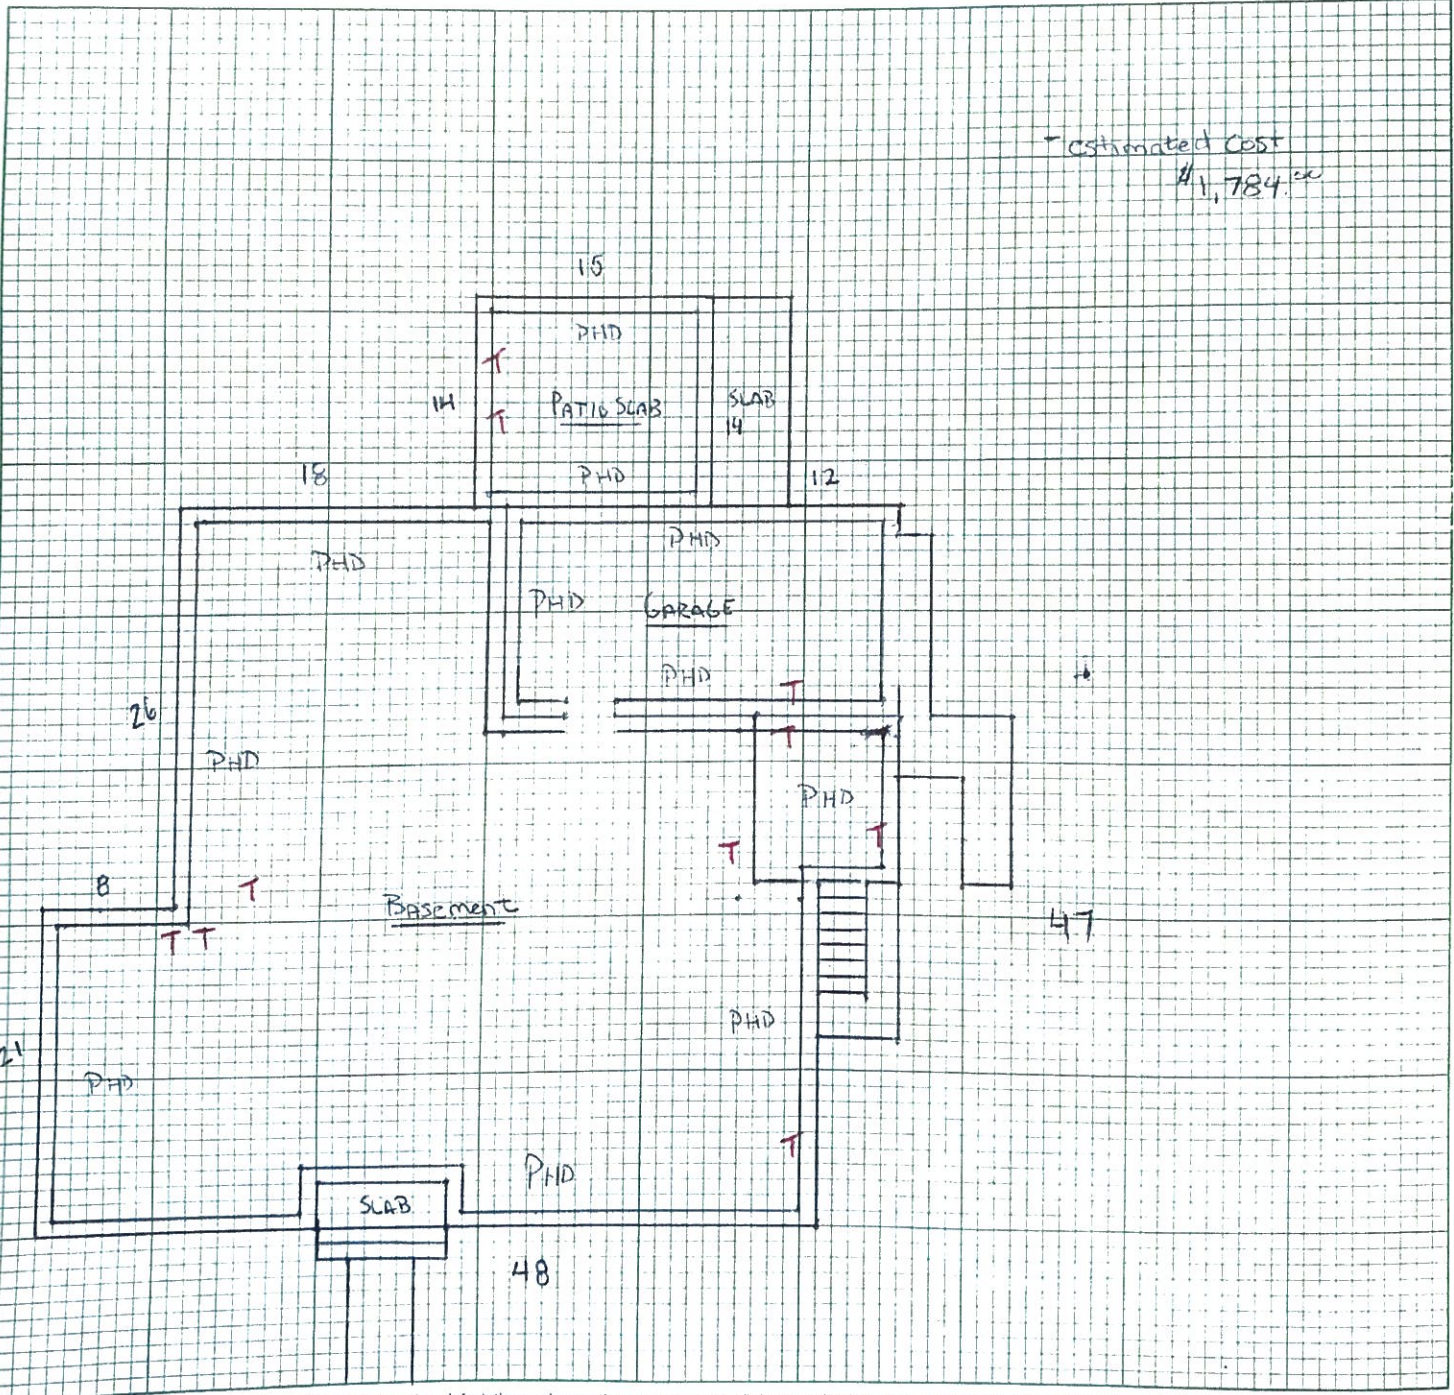
STRUCTURE DIAGRAM

Subterranean Termite mud tubes in multiple locations of basement and garage along block wall, studs, and joists

Subterranean Termite damage wood paneling and studs in porch area

STATEMENT OF DAMAGE & ACTIVITY
- Termite mud tubes in multiple locations

Recommend treatment for the control of: Subterranean Termites

Estimated cost for subterranean termite remediation is \$1,784.00 with a one year renewable warranty
