SPY Inspection Services, Inc.

Home Inspection Report

229 Lower Valley Rd
North Wales, PA 19454

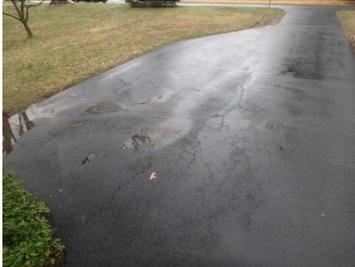
1. Driveway: Asphalt - Cracking/uneven settling noted in asphalt driveway, recommend repair by contractor to prevent further damage.

1. Driveway: Asphalt - Cracking/uneven settling noted in asphalt driveway, recommend repair by contractor to prevent further damage.
2. Steps/Stoops: Concrete - Missing graspable handrail at rear concrete stairs, recommend installation to reduce the risk of injury.
3. Patio: Concrete - Cracking noted on patio, recommend sealing cracks by contractor to prevent further damage.
4. Grading: Negative slope - Improper soil slope towards foundation, recommend the addition of fill dirt to improve grade to help reduce moisture/water pooling against foundation.
5. Retaining Walls: Block - Crack with no displacement of wall noted at rear retaining wall, recommend sealing by contractor crack to prevent further damage.

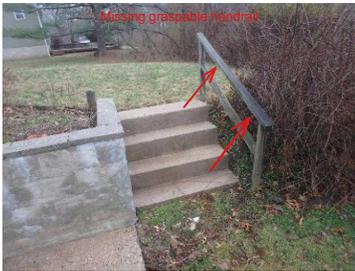
2. Walks: Concrete
3. Steps/Stoops: Concrete - Missing graspable handrail at rear concrete stairs, recommend installation to reduce the risk of injury.

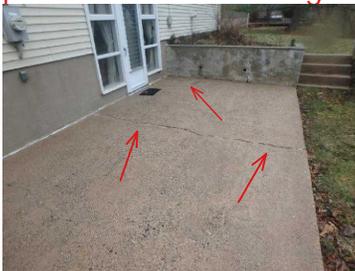
4. Porch: Concrete
5. Patio: Concrete - Cracking noted on patio, recommend sealing cracks by contractor to prevent further damage.

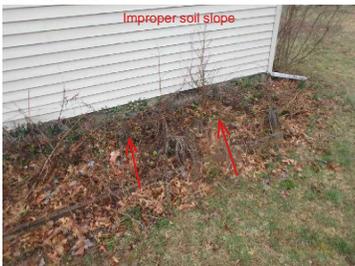
6. Grading: Negative slope - Improper soil slope towards foundation, recommend the addition of fill dirt to improve grade to help reduce moisture/water pooling against foundation.

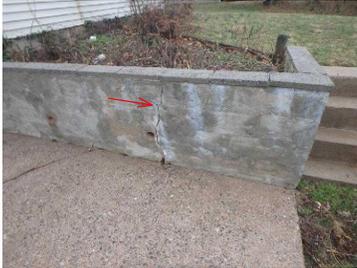
7. Vegetation: Trees, Shrubs
8. Retaining Walls: Block - Crack with no displacement of wall noted at rear retaining wall, recommend sealing by contractor crack to prevent further damage.

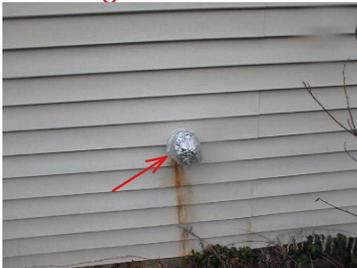
1. Type: Vinyl siding, Stone - Vent (possibly dryer vent) was covered at the exterior of the house, recommend evaluation and repair as needed to reduce the risk of critter entering the house.

6. Entire House Exterior Surface Type: Vinyl siding, Stone - Vent (possibly dryer vent) was covered at the exterior of the house, recommend evaluation and repair as needed to reduce the risk of critter entering the house.

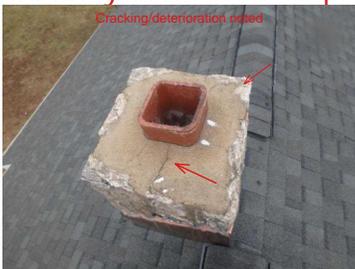
Middle Chimney

11. Chimney: Stone - Chimney crown has cracks, recommend repair/sealing cracks by chimney contractor to prevent further damage of chimney crown.

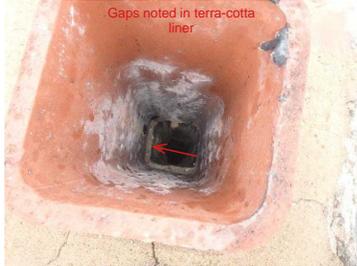
12. Flue/Flue Cap: Terra-cotta - Gaps and signs of deterioration in terra-cotta flue liner for gas furnace and water heater, recommend evaluation and installation of metal liner by chimney contractor to reduce the risk of blockage.

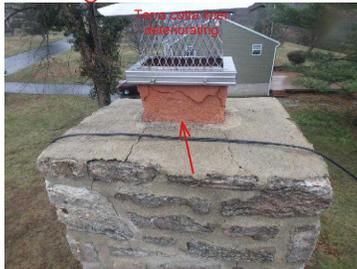
14. Chimney: Stone - Chimney crown has cracks, recommend repair/sealing cracks by chimney contractor to prevent further damage of chimney crown.

15. Flue/Flue Cap: Terra-cotta - Top tile of Terra cotta liner showing signs of deterioration, recommend evaluation and repair as needed by chimney specialist to prevent further damage.

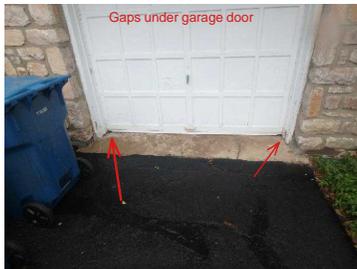
2. Garage Doors: Wood - Gaps noted underneath garage door, recommend repair to reduce the risk of critters entering the house.

9. Attached Garage Garage Doors: Wood - Gaps noted underneath garage door, recommend repair to reduce the risk of critters entering the house.
10. Attached Garage Electrical: 120 VAC - Non-GFCI receptacles in garage area, recommend installation to reduce the risk of shock.

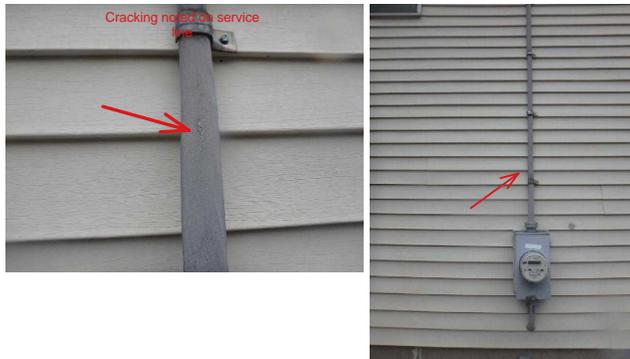
- 1. Service Size Amps: 200 Volts: 120-240 VAC
- 2. Service: Copper and aluminum - **Surface coating of service cable is cracked and may allow water to penetrate inside the cable, recommend repair/replacement by electrician to reduce the risk of water infiltration.**

3. Service: Copper and aluminum - Surface coating of service cable is cracked and may allow water to penetrate inside the cable, recommend repair/replacement by electrician to reduce the risk of water infiltration.

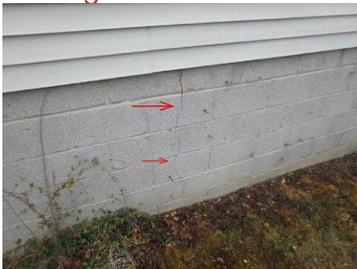
1. Structure Type: Wood frame
 2. Foundation: Block - Vertical cracks with no visible movement noted on block walls on garage side of house, does not appear to compromise structural integrity, recommend sealing cracks to reduce the risk insects/moisture entering the house.

13. Foundation: Block - Vertical cracks with no visible movement noted on block walls on garage side of house, does not appear to compromise structural integrity, recommend sealing cracks to reduce the risk insects/moisture entering the house.

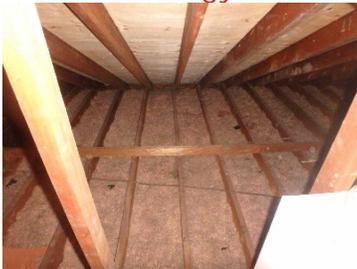
3. Roof Framing: Rafter
4. Sheathing: Plywood
5. Ventilation: Gable, Ridge and soffit vents
6. Insulation: Blown in - **Insulation compressed, recommend adding insulation to help conserve energy.**

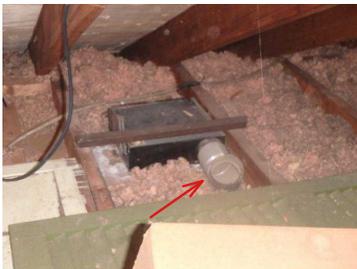
7. Insulation Depth: 6, 8
8. Wiring/Lighting: 110 VAC lighting circuit
9. Bathroom Fan Venting: Electric fan - **Bathroom improperly vents into attic and may cause moisture damage to the insulation/roof sheathing, recommend venting bathroom to the exterior of the house.**

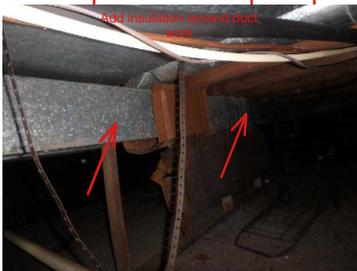
5. Moisture Location: None
6. Moisture Barrier: Gravel, Concrete
7. Ventilation: Vents
8. Insulation: None - **Recommend adding insulation to crawlspace to help improve energy costs.**
9. HVAC Source: Heating system register - **Recommend insulating metal ducts in crawlspace to help improve energy costs.**

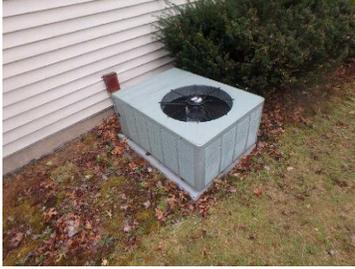
1. A/C System Operation: Appears serviceable - **To avoid possible compressor damage due to outside temperature below 60 degrees, the unit was not tested, Unit uses R-22 refrigerant which is no longer being produced, this may increase service costs, recommend evaluation and servicing by HVAC contractor.**

18. Main AC System A/C System Operation: Appears serviceable - To avoid possible compressor damage due to outside temperature below 60 degrees, the unit was not tested, Unit uses R-22 refrigerant which is no longer being produced, this may increase service costs, recommend evaluation and servicing by HVAC contractor.

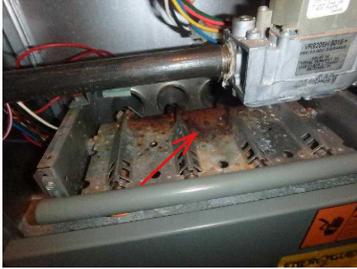
1. Heating System Operation: Adequate - **Rust noted on burner, this may be an indication past/present of exhaust leakage, recommend evaluation and servicing/repair as needed by HVAC contractor to prevent further damage to burners.**

20. Main Heating System Heating System Operation: Adequate - Rust noted on burner, this may be an indication past/present of exhaust leakage, recommend evaluation and servicing/repair as needed by HVAC contractor to prevent further damage to burners.

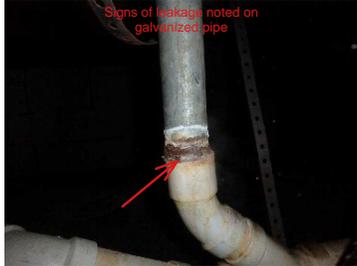
4. Drain Pipes: Cast iron, Copper, PVC, Galvanized - Signs of leakage on galvanized drain pipe, recommend repair/replacement of pipe by plumber to prevent further leakage.

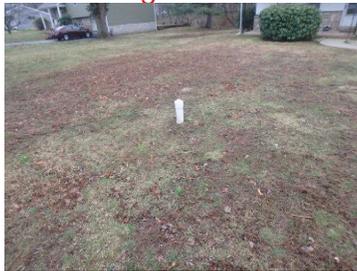
5. Service Caps: Accessible - Recommend sewage lateral inspection to ensure there are no blockages to main drain line.

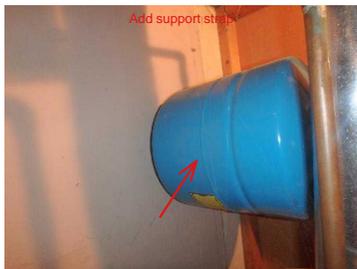
8. Water Heater Operation: Adequate - Recommend adding support strap to expansion tank to reduce the risk of water leaks.

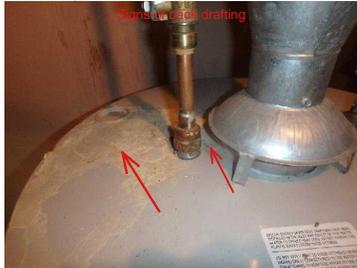
9. Manufacturer: Bradford-White
10. Model Number: RG240S6N Serial Number: NJ38275363
11. Type: Natural gas Capacity: 40 Gal.
12. Approximate Age: 6 years Area Served: Whole building
13. Flue Pipe: Single wall - Evidence of back-drafting on top of water heater, recommend evaluation and repair as needed by plumber

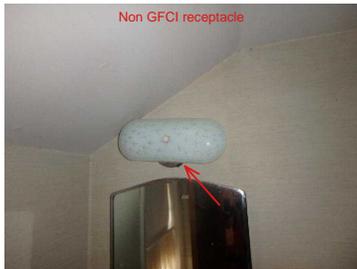
1. Ceiling: Paint
2. Walls: Paint and paneling
3. Floor: Tile
4. Doors: Hollow wood
5. Windows: Aluminum double hung
6. Electrical: 120 VAC - **Non GFCI receptacle installed in bathroom, recommend installation to reduce the risk of shock.**

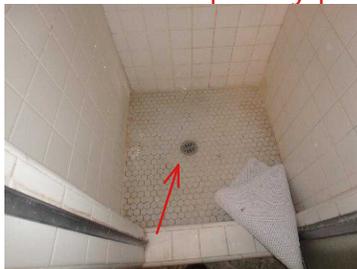
7. Counter/Cabinet: Laminate and wood
8. Sink/Basin: Molded single bowl
9. Faucets/Traps: Moen fixtures with a metal trap
10. Shower/Surround: Tile Pan and tile surround - **Slow drain noted noted in shower, recommend repair by plumber to reduce the risk of water damage.**

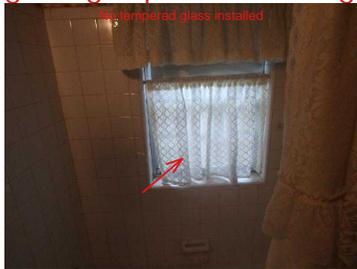
- 14. Ceiling: Paint
- 15. Walls: Wallpaper and tile
- 16. Floor: Tile
- 17. Doors: Hollow wood
- 18. Windows: Aluminum double hung - Window in shower does not have tempered glass installed, this is considered a safety hazard, recommend installation of safety glazing/replacement of glass by contractor to reduce the risk of injury.

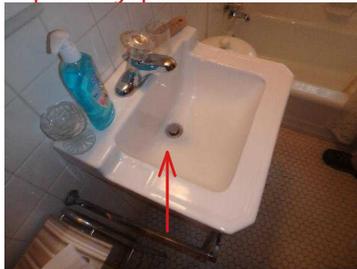
- 19. Electrical: 120 VAC - Non-GFCI receptacle in bathroom, recommend installation by electrician to reduce the risk of shock.
- 20. Sink/Basin: One piece sink/counter top
- 21. Faucets/Traps: Moen fixtures with a metal trap - Slow drain noted in sink, recommend repair by plumber to reduce the risk of water damage.

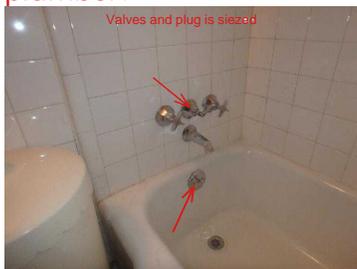
- 22. Tub/Surround: Porcelain tub and ceramic tile surround - Shower diverter valve and drain plug was seized, unable to operate, recommend repair/replacement of valves by plumber.

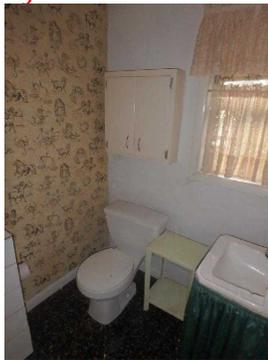
- 26. Ceiling: Paint
- 27. Walls: Wallpaper, Paint
- 28. Floor: Tile
- 29. Doors: Hollow wood
- 30. Windows: Aluminum double hung
- 31. Electrical: 120 VAC - No receptacles installed in powder room, recommend installation by electrician.

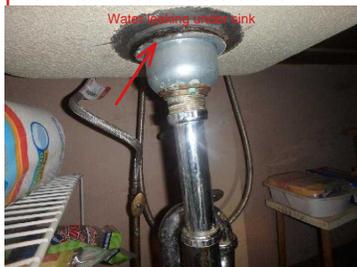
- 1. Cooking Appliances: Frigidaire, Tappen
- 2. Ventilator: Nautilus
- 3. Sink: Stainless Steel
- 4. Electrical: 120 VAC GFCI - Insufficient outlets for space, recommend adding outlets to kitchen area by electrician to avoid overloading circuits.
- 5. Plumbing/Fixtures: Metal - Water leak noted underneath sink, recommend repair by plumber to reduce the risk of water damage.

10. 1st Floor Kitchen Plumbing/Fixtures: Metal - Water leak noted underneath sink, recommend repair by plumber to reduce the risk of water damage.

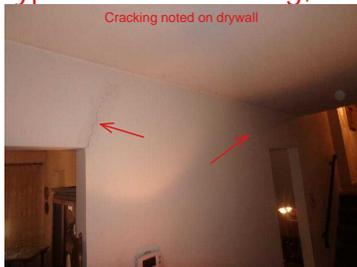
- 1. Closet: Single
- 2. Ceiling: Paint
- 3. Walls: Paint, Wallpaper - Cracking noted on drywall, this may be an indication of typical house settling, recommend repair of cracks by painter

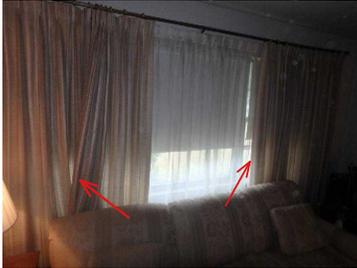
5. Doors: Hollow wood
6. Windows: Aluminum double hung - Unable to open front living room windows, recommend repair by contractor to allow for proper operation of windows.

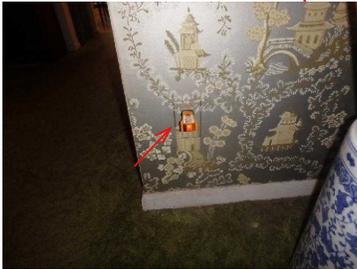
7. Electrical: 120 VAC - Open or missing ground noted on 3 prong receptacle in living room, recommend repair by electrician to reduce the risk of shock

11. Living Room, Dining Room Living Space Electrical: 120 VAC - Open or missing ground noted on 3 prong receptacle in living room, recommend repair by electrician to reduce the risk of shock

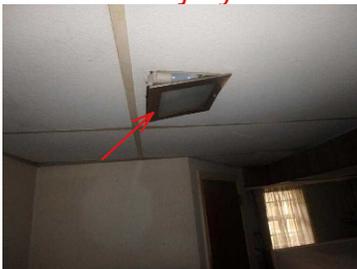
1. Ceiling: Paint - Loose light fixture in ceiling, recommend repair/replacement to reduce the risk of injury.

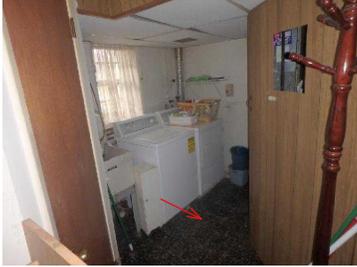
2. Walls: Paint
3. Floor: Tile - Floor tiles may contain asbestos, lab testing is needed to confirm, recommend evaluation by flooring specialist
