Prepared by: Nicholas Frey  
ASHI#: 262051 EDI#: PA-158

# **Home Inspection Report**

113 Mica Cir  
Bethlehem, PA 18017

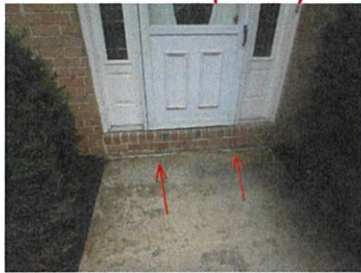
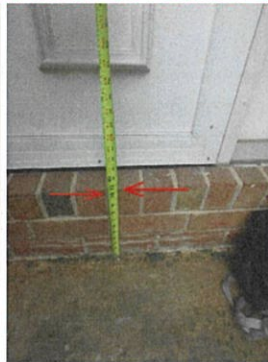
1.      Driveway: Concrete
2.      Walks: Concrete - **Concrete has settled making front step into house too high, recommend repair by contractor to reduce the risk of injury.**

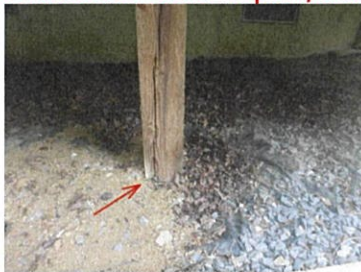
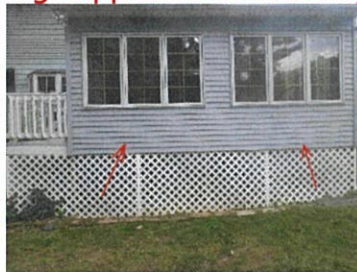
3.      Porch: Sun room - **Sun room/ porch was built over deck structure, there are no visible footers underneath posts, wood to soil may be prone to wood decay, recommend evaluation and repair/adding support as needed by contractor.**

1. Porch: Sun room - Sun room/ porch was built over deck structure, there are no visible footers underneath posts, wood to soil may be prone to wood decay, recommend evaluation and repair/adding support as needed by contractor.
2. Vegetation: Trees, Shrubs - Recommend keeping vegetation trimmed away from house to reduce the risk of insects/critters from entering the house.

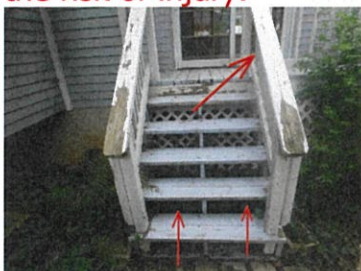
4.      Deck: Treated wood - **Missing graspable handrail on deck stairs, recommend installation to reduce the risk of injury.**

**Openings between stair risers is greater than 4 inches, recommend repair to reduce the risk of injury.**

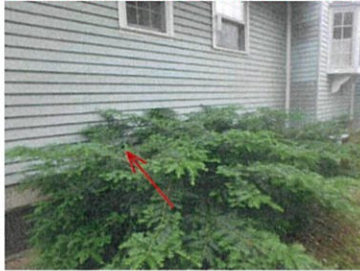
5.      Grading: Minor slope  
6.      Vegetation: Trees, Shrubs - **Recommend keeping vegetation trimmed away from house to reduce the risk of insects/critters from entering the house.**

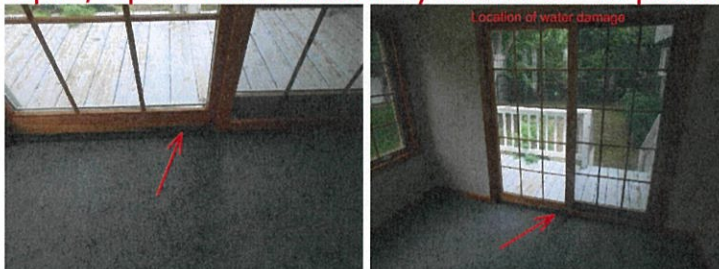
2.      Type: Vinyl siding, Aluminum siding  
3.      Trim: Aluminum  
4.      Fascia: Aluminum  
5.      Soffits: Aluminum  
6.      Entry Doors: Metal  
7.      Patio Door: Wood sliding - **Water damage note at rear wood slider, recommend repair/replacement of door by contractor to prevent further water damage.**

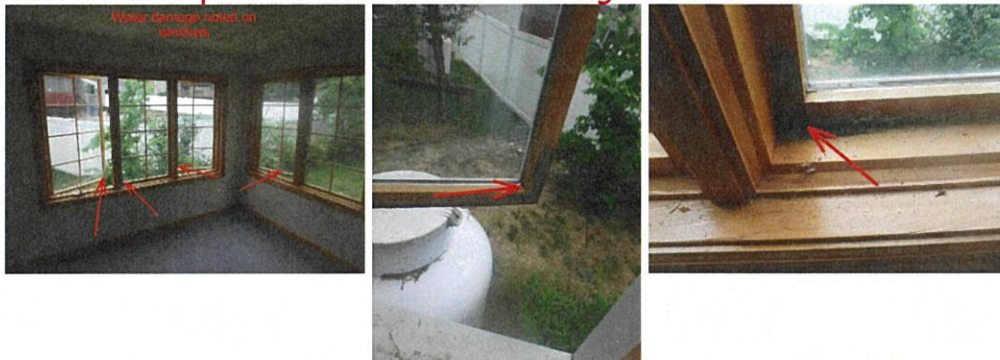
8.  Windows: Wood casement, Wood double hung - **Water damage noted on sunroom casement windows, recommend repair/replacement of all effected windows by contractor to prevent further water damage.**

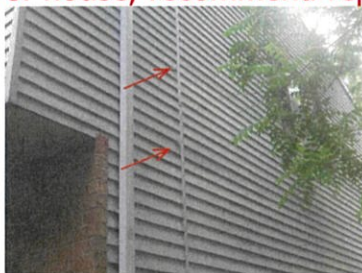
9.  Basement Windows: Steel casement  
10.  Exterior Lighting: Surface mount - **Broken support brackets for electric conduit at side of house, recommend repair to prevent further damage.**

3. Exterior Lighting: Surface mount - Broken support brackets for electric conduit at side of house, recommend repair to prevent further damage.

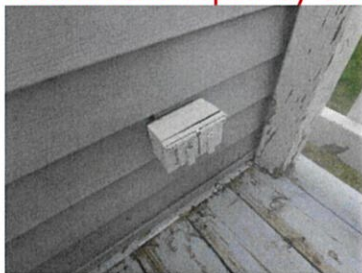
11.  Exterior Electric Outlets: 120 VAC - **Rear deck receptacle is not GFCI protected, recommend repair by electrician to reduce the risk of shock.**

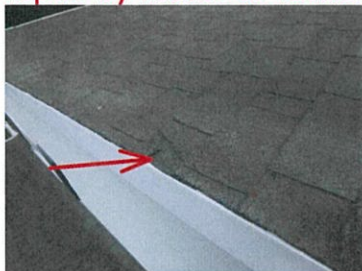
3.      Material: Asphalt shingle - **Damaged shingle noted on gable end of roof, recommend repair by roofer to reduce the risk of water infiltration.**

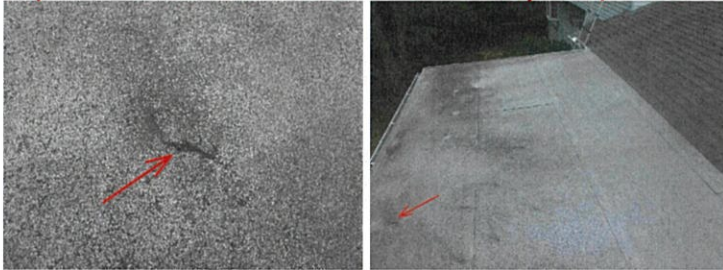
8.  Material: Rolled roof material - **Damaged roof material noted at end of roof line, recommend repair by roofer to reduce the risk of water infiltration.**

**Cracking noted in roof material which is an indication of age of roof, life span of asphalt rolled roof material is 10-15 years, recommend budgeting for replacement.**

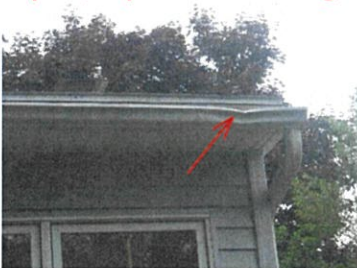
14.  Gutters: Aluminum - **Damaged section of gutter at rear of house, recommend repair/replacement of gutter to allow for proper drainage.**

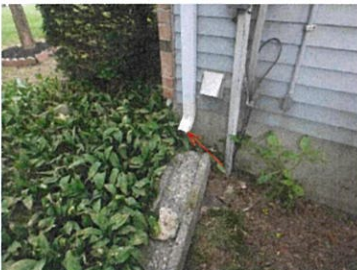
15.  Downspouts: Aluminum - **Improve downspouts discharge for better drainage away from house foundation.**

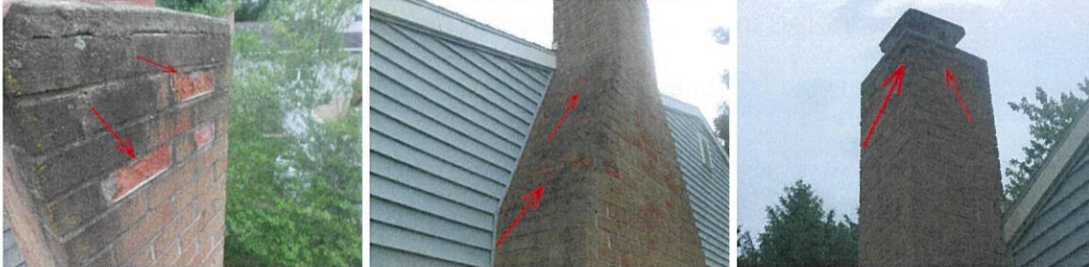
Left side Chimney

16.  Chimney: Brick - **Brick is spalling in few areas of chimney, recommend repair of brick by chimney specialist to prevent further damage.**

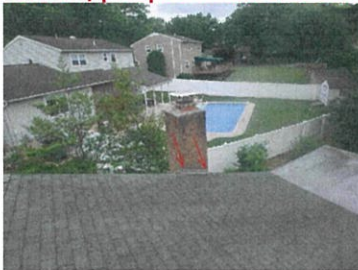
17.  Flue/Flue Cap: Terra-cotta  
 18.  Chimney Flashing: Aluminum - **Improper installation- counter flashing is not recessed into mortar joints, flashing was caulked, recommend regular maintenance by roofer/proper installation of counter flashing.**

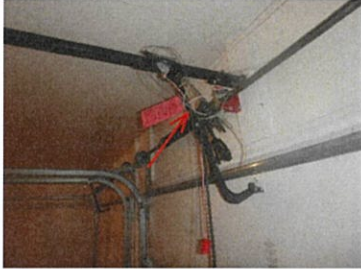
1. Type of Structure: Attached Car Spaces: 2  
 2.  Garage Doors: Insulated aluminum  
 3.  Door Operation: Mechanized  
 4.  Door Opener: Genie - **Chain is broken on right garage door, recommend repair by garage door contractor to allow for proper operation.**

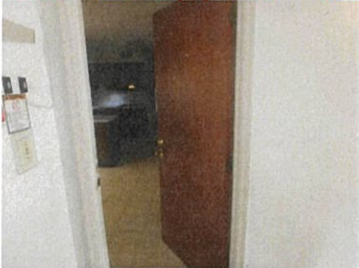
6.      Service Doors: Wood - Entry door not rated for fire, recommend repair/replacement of door to comply with fire separation requirements between garage and livable space.

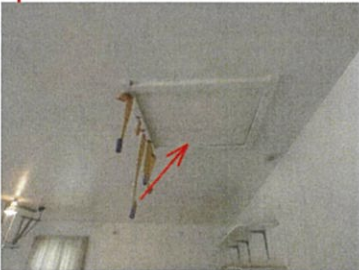
7.      Ceiling: Paint - Attic hatch not fire rated, recommend replacement of hatch with fire rated material to comply with fire separation requirements between garage and livable space.

9. Attached Garage Ceiling: Paint - Attic hatch not fire rated, recommend replacement of hatch with fire rated material to comply with fire separation requirements between garage and livable space.
10. Attached Garage Windows: Wood double hung - Water damage noted at end of sill at exterior of window, recommend repair of window to prevent further water damage.

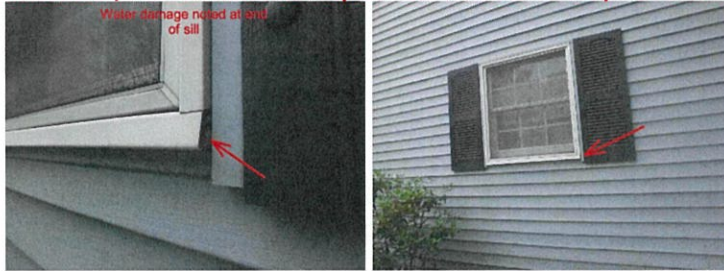
11.  Windows: Wood double hung - **Water damage noted at end of sill at exterior of window, recommend repair of window to prevent further water damage.**

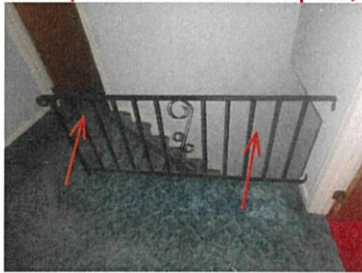
- 1.      Structure Type: Wood frame
- 2.      Foundation: Concrete
- 3.      Differential Movement: No movement or displacement noted
- 4.      Beams: Bonded wood
- 5.      Bearing Walls: Frame
- 6.      Joists/Trusses: 2x8
- 7.      Piers/Posts: Steel posts
- 8.      Floor/Slab: Poured slab
- 9.      Stairs/Handrails: Wood stairs with metal handrails - **Guardrail is too low on second floor, recommend repair/improvement to reduce the risk of injury.**

13. Stairs/Handrails: Wood stairs with metal handrails - Guardrail is too low on second floor, recommend repair/improvement to reduce the risk of injury.

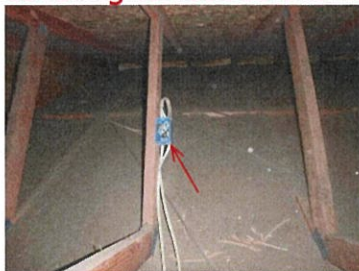
3.      Roof Framing: Truss
4.      Sheathing: Plywood
5.      Ventilation: Gable and soffit vents
6.      Insulation: Blown in
7.      Insulation Depth: 8
8.      Attic Fan: Thermostat controlled
9.      Wiring/Lighting: 110 VAC lighting circuit - **Open junction box noted, recommend covering to reduce the risk of shock.**

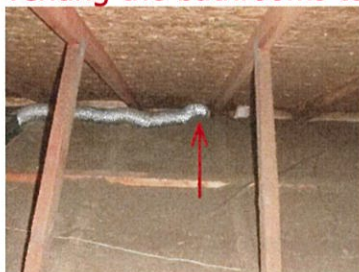
10.      Bathroom Fan Venting: Electric fan - **Bathrooms improperly vents into attic and may cause moisture damage to the insulation and roof sheathing, recommend properly venting the bathrooms to the exterior.**

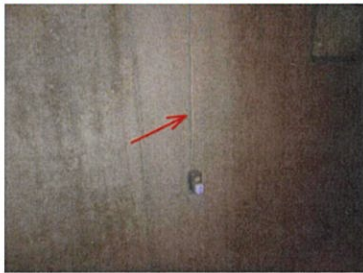
1.      Unable to Inspect: 10%
2.      Ceiling: Exposed framing
3.      Walls: Concrete
4.      Floor: Poured
5.      Doors: Hollow wood
6.      Windows: Steel frame
7.      Electrical: 120 VAC - Unsecured wires for receptacles in basement, recommend repair to reduce the risk of shock.

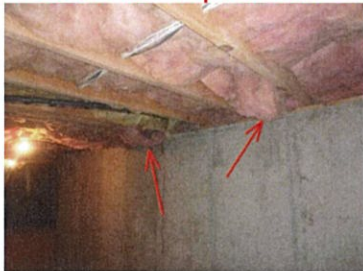
8.      Insulation: Fiberglass - Loose insulation noted in few areas, recommend repair as needed to help conserve energy.

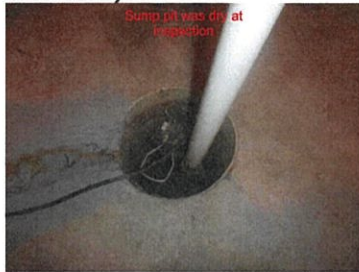
9.      Sump Pump: Submerged - Sump crock was completely dry/empty-unable to test pump operation/piping for leaks.

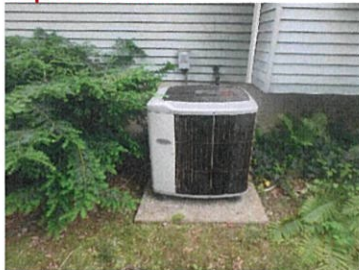
1.  A/C System Operation: Functional - The unit is currently in service beyond the manufactures stated design life, average life span of heat pumps are 10-15 years, unit uses R-22 refrigerant which is no longer being produced, recommend budgeting for replacement

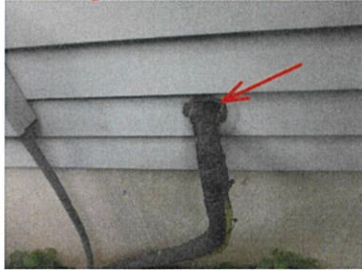
- 7. Fuel Type: 120-240 VAC Temperature Differential: 17 degrees
- 8. Type: Heat pump Capacity: 2.5 Ton
- 9.      Visible Coil: Copper core with aluminum fins
- 10.      Refrigerant Lines: Suction line and liquid line - **Entry point not sealed, recommend sealing area to reduce the risk of critters/moisture entering the house.**

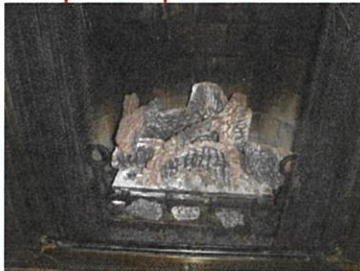
- 1.      Fireplace Construction: Brick
- 2. Type: Gas log
- 3.      Fireplace Insert: Standard - **Pilot light would not light for insert, recommend repair by fire place specialist to ensure proper operation.**

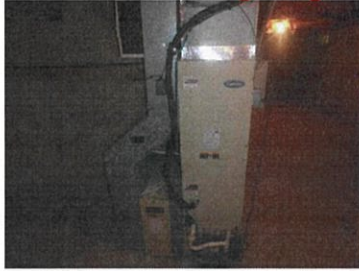
1.  Heating System Operation: Adequate - **Furnace nearing the end of it's design life, recommend budgeting for replacement**

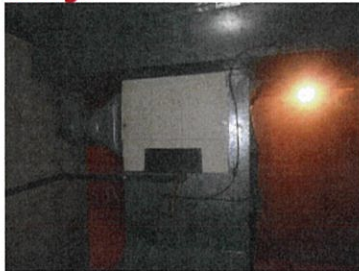
10.  Humidifier: April-Aire - **Recommend servicing humidifier by HVAC contractor prior to using.**

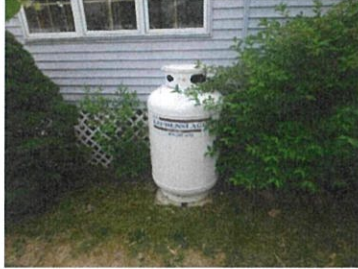
12.  Fuel Tank: Propane tank - Tank appears to be leased, recommend calling propane company on tank for service.

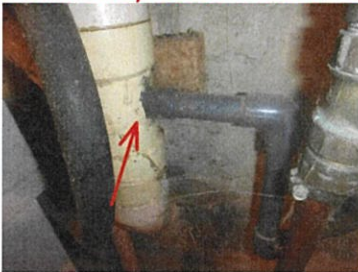
3.  Water Lines: Copper  
4.  Drain Pipes: PVC - **Missing backflow preventer on where humidifier drain connects to drain line, recommend installation to reduce the risk of sewage entering the house.**

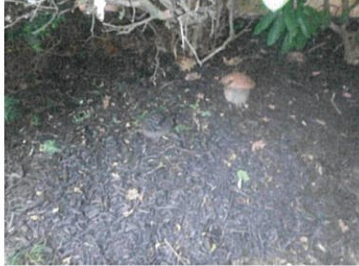
5.  Service Caps: Accessible - **Recommend having a sewage lateral inspection of main drain line to ensure there are no blockage to drain line.**

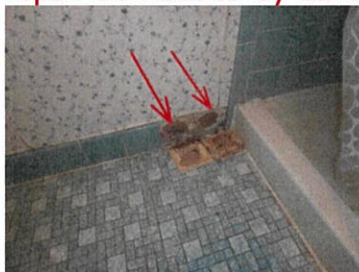
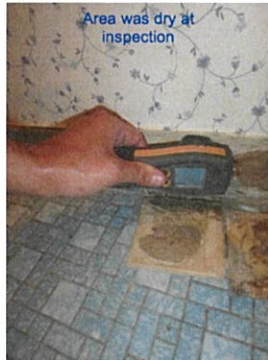
1.  Closet: Single
2.  Ceiling: Paint
3.  Walls: Wallpaper
4.  Floor: Tile - **Loose tile near shower, area was dry at time of inspection, recommend repair as needed by contractor.**

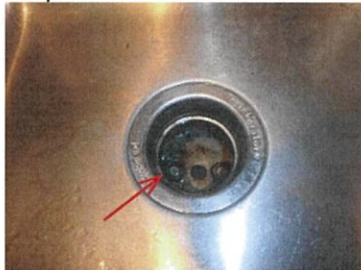
- 1.  Cooking Appliances: Maytag, Whirlpool
- 2.  Ventilator: Whirlpool
- 3.  Disposal: In-Sinkerator - **Missing cover for drain for disposal, recommend installation.**

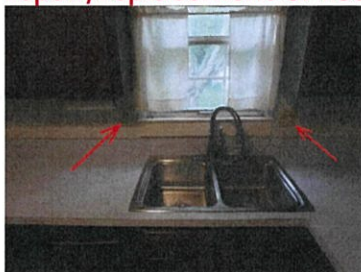
- 4.  Dishwasher: Bosch
- 5. Air Gap Present?  Yes  No
- 6.  Microwave: Whirlpool
- 7.  Sink: Stainless Steel
- 8.  Electrical: 120 VAC GFCI - **Faulty GFCI receptacles at right and left of sink, recommend repair/replacement of receptacles by electrician to reduce the risk of injury.**

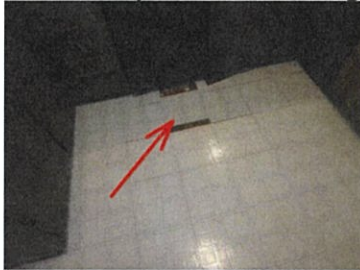
- 11.      Cabinets: Laminate and wood
- 12.      Pantry: Single
- 13.      Ceiling: Paint
- 14.      Walls: Wallpaper
- 15.      Floor: Vinyl floor covering - Loose flooring noted, recommend repair of loose floor tiles

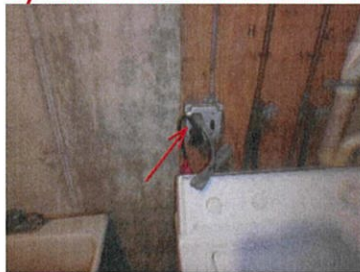
- 1.      Ceiling: Exposed framing
- 2.      Walls: Concrete
- 3.      Floor: Poured
- 4.      Electrical: 120 VAC - **Non-GFCI outlet next to laundry tub sink, recommend installation by electrician to reduce the risk of shock.**

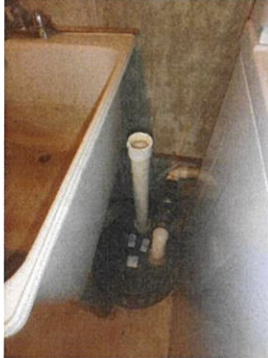
6.  Laundry Tub Drain: Electric pump - Pump is operated by switch next to laundry tub, make sure switch is turned on to allow for drain pump to operate.

Recommend adding AAV to vent opening to reduce the risk of sewage gases entering the house.
