SPY Inspection Services, Inc.

Home Inspection Report

651 New Galena Rd.
Chalfont , PA 18914

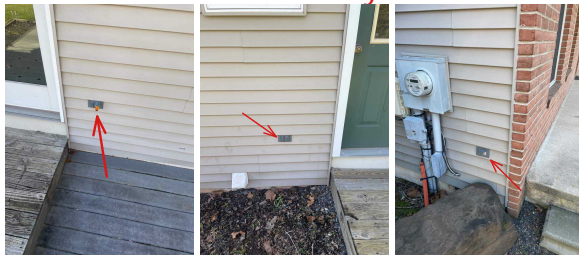
5. Entry Doors: Metal
6. Patio Door: Wood sliding
7. Windows: Wood double hung, Wood casement
8. Basement Windows: Wood casement
9. Exterior Lighting: Surface mount, Pole light
10. Exterior Electric Outlets: 120 VAC - Exterior receptacles are not GFCI protected, recommend installation by electrician to reduce the risk of shock.

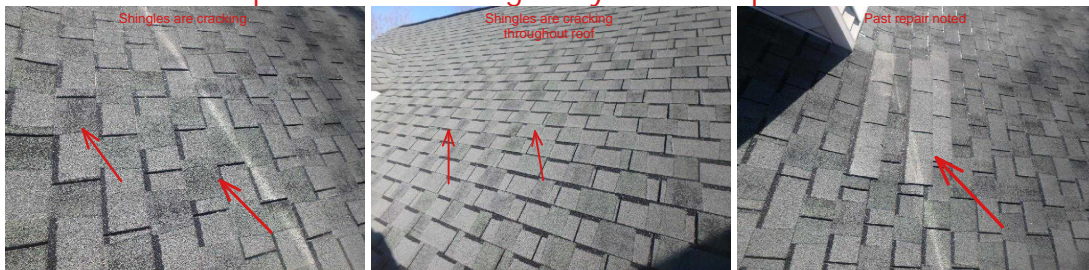
3. Material: Asphalt shingle - **Shingles are showing signs of deterioration, Signs of cracking noted on shingles, evidence of patching/repairs, water stains and active moisture detected on roof sheathing in attic (see photos in attic section), recommend evaluation and replacement of shingles by roofer to prevent further water infiltration.**

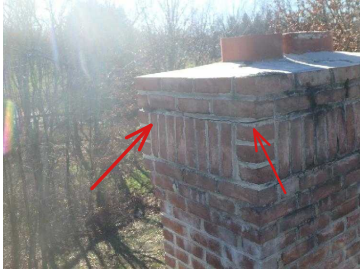
13. Chimney: Brick - **Mortar cracking/deteriorating between brick, recommend further evaluation and repair as needed by chimney specialist to prevent further damage.**

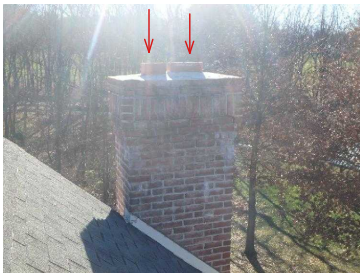
14. Flue/Flue Cap: Clay - **Recommend cleaning and inspecting flue liners by chimney special prior to using wood fire place and coal furnace to ensure there is no damage/blockage.**

Recommend adding rain/snow caps on flue liners to keep critters/debris from entering the house.

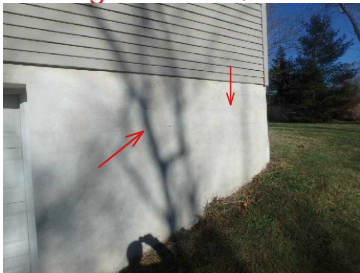
1. Structure Type: Wood frame
2. Foundation: Block - **Stair step and horizontal Cracking noted foundation wall along mortar lines of block at right rear corner of house, cracks appear to be from typical settling of house, recommend sealing cracks/evaluation by structural engineer.**

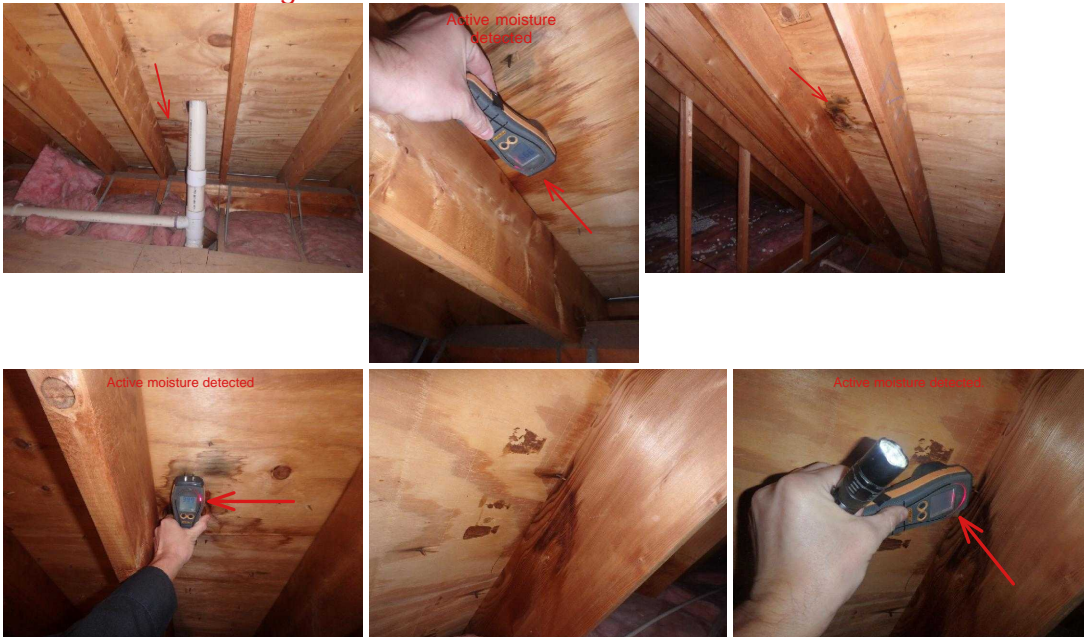
3. Roof Framing: Rafter
4. Sheathing: Plywood - Water stains present, active moisture detected on sheathing at rear attic, recommend further evaluation and repair as needed by roofer to prevent further water damage.

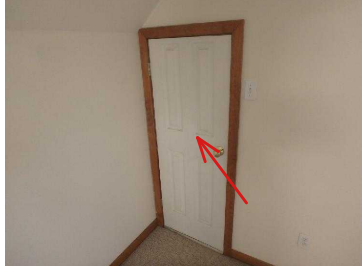
6. Insulation: Batts - Hollow core door used for attic space, recommend adding insulation/replacement with insulated door to help improve energy costs.

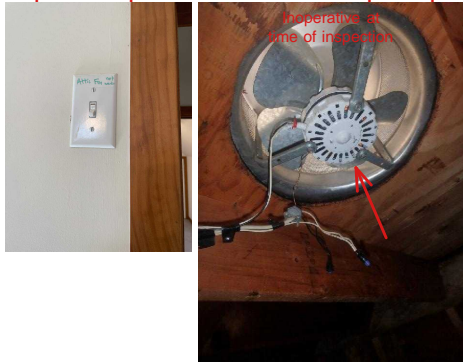
8. Attic Fan: Thermostat controlled - Inoperative at time of inspection, recommend repair/replacement to help improve attic ventilation.

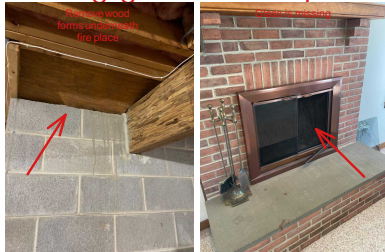
- Fireplace Construction: Brick - **Remove wood forms from underneath fireplace to reduce the risk of fire.**

Missing glass on fire place surround cover, recommend repair/replacement.

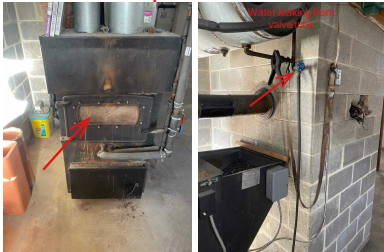
1. Heating System Operation: Adequate - Cracked glass noted on door for coal furnace and water leaking from valve/ tube, recommend evaluation and repair as needed by HVAC/fire place contractor prior to using coal furnace.

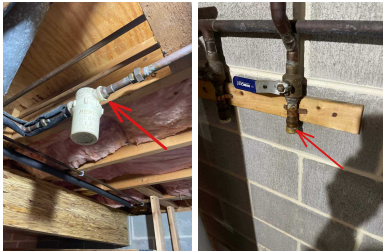
3. Water Lines: Copper - Water leak noted on connection of supply line, at sediment trap and where past water softener was installed, recommend evaluation and repair as needed by plumber to reduce the risk of water damage.

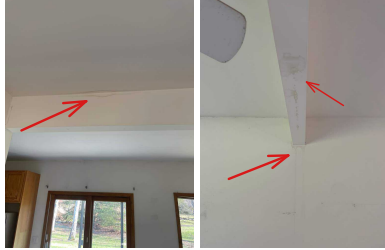
2. Ceiling: Paint - Water stain noted on ceiling in living room, area was dry at time of inspection, recommend repair/replacement as needed of damaged drywall.
