SPY Inspection Services, Inc.

Home Inspection Report

6254 Greenhill Rd
New Hope, PA 18938

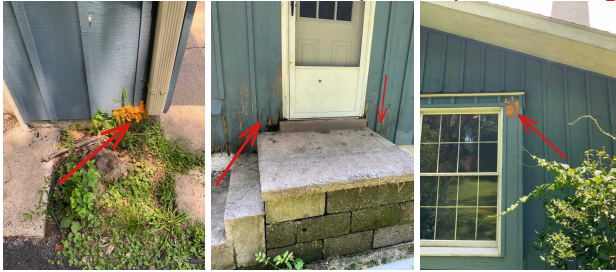
1. Type: Wood panels and brick - Water damage noted on wood siding in numerous area around house, spray foam is not the proper repair for water damage, recommend further evaluation and repair/replace siding as needed by siding contractor.

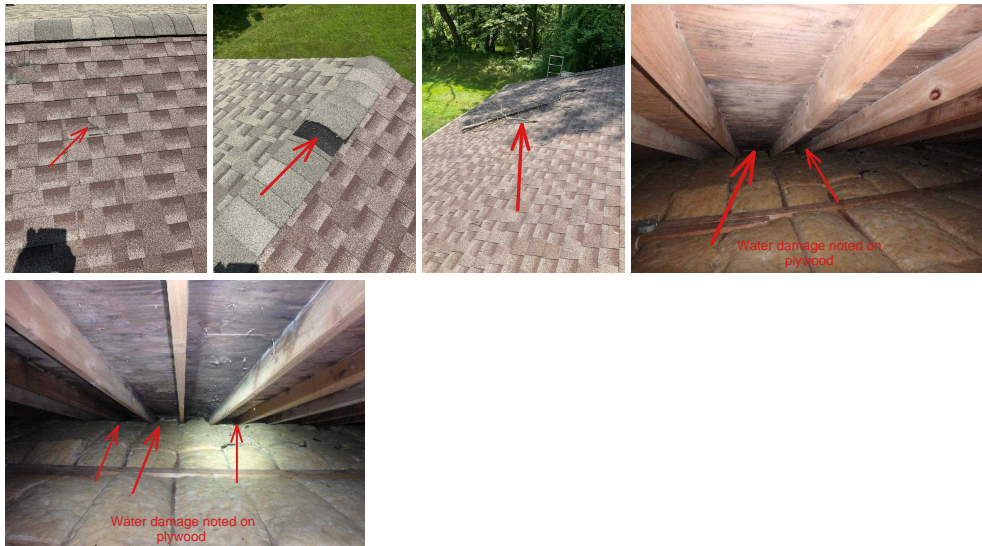
Branches and moss growth noted on roof, recommend removal of debris by contractor to reduce the risk of damaging shingles.

Shingles appear to be newer on left side of house, water damage was noted on plywood in attic underneath newer shingles, typically when newer shingles are installed damaged roof sheathing is replaced as needed, recommend further evaluation and repair/replace shingles/water damaged plywood as needed by roofing contractor.

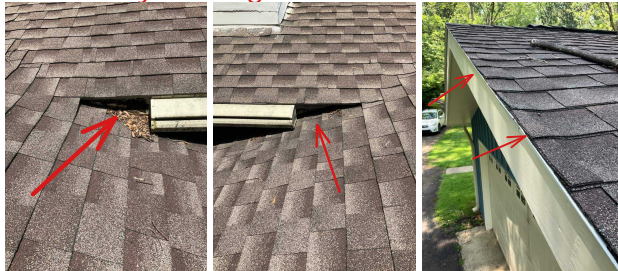
6. Flashing: Aluminum - Wood rot/ water damage noted at trim board at bottom of valleys, recommend repair by roofing contractor to prevent further water damage/water infiltration.

Drip edge flashing was not installed on left side of roof where newer shingles were installed, shingles do not properly overhang drip edge on older shingles, this may increase the risk of water infiltration, recommend further evaluation and repair as needed by roofing contractor.

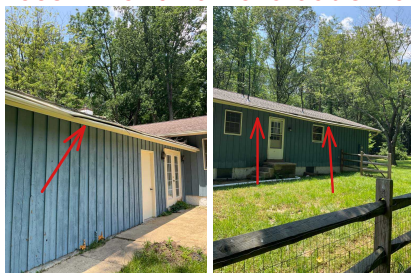
8. Plumbing Vents: ABS
9. Electrical Mast: Underground utilities
10. Gutters: Aluminum - Damaged / loose gutter noted in a few areas of the house, recommend full evaluation and repair/replace gutters as needed by gutter contractor.

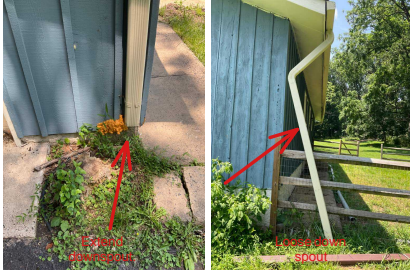
11. Downspouts: Aluminum - Recommend adding extension to all downspout discharges around house to help keep water away from foundation.

Loose downspout noted at the rear of house, recommend repair by gutter contractor.

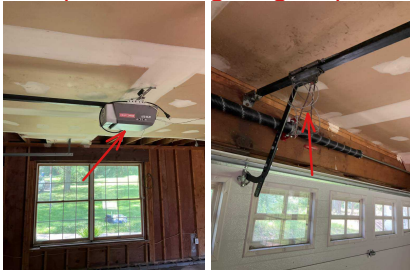
3. Door Operation: Mechanized - Broken cable to garage door to garage opener, recommend repair by garage door contractor to ensure proper operation.

Garage opener was not plugged in at time of inspection, there was no dedicated receptacle for garage opener, recommend repair by electrician.

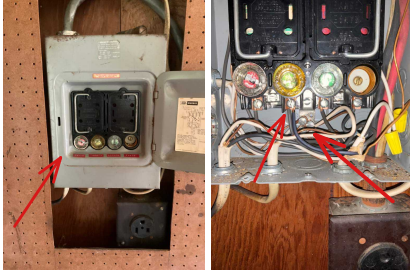
9. Manufacturer: Murray - Double tap wiring noted in fuse box, recommend further evaluation and repair as needed by electrician.

Grounds and neutral wires are mixed on terminal bar in sub panel, these wires should be separated, recommend repair by electrician.

Missing fuse, recommend installation by electrician to ensure proper protection.

Recommend updating fuse box by electrician

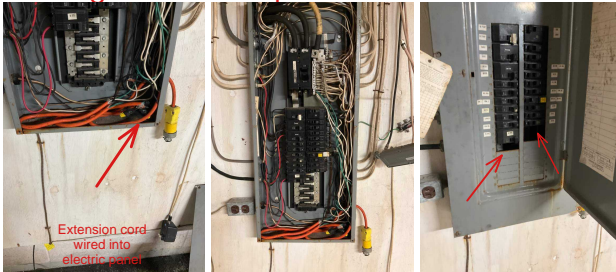
14. Manufacturer: Square D - Extension cord wired into breaker box, recommend further evaluation and repair by electrician to reduce the risk of shock.

Open "knock-out" holes recommend inserting "blank-out" cap to close off opening to reduce the risk of shock.

Missing screws for panel cover, recommend installation.

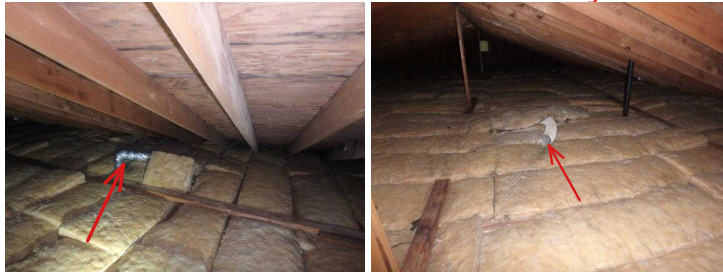
3. Roof Framing: Rafter - Some 2x6 roof rafters appear to be sagging, recommend adding support by roofing contractor to prevent further damage.
4. Sheathing: Plywood - Water damage present on roof sheathing in attic, recommend further evaluation and repair/replace as needed by roofing contractor.
5. Ventilation: Ridge and Gable vents

6. Insulation: Batts - Evidence of rodents noted in insulation, recommend further evaluation by pest control contractor and repair/replace damaged insulation as needed by insulation contractor.
7. Insulation Depth: 8
8. Wiring/Lighting: 110 VAC
9. Bathroom Fan Venting: Electric fan - Bathrooms improperly vents into attic and may cause moisture damage to the insulation and roof sheathing, recommend venting bathrooms to the exterior of the house by contractor.

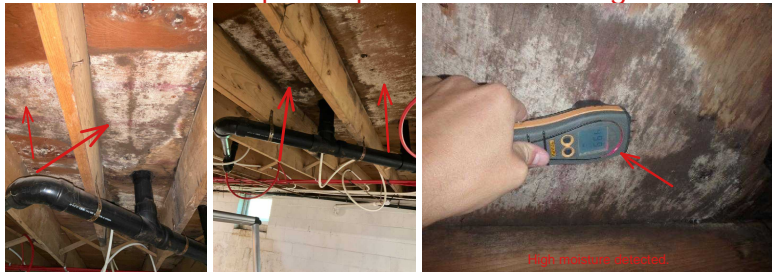
1. Unable to Inspect: 10%
2. Ceiling: Exposed framing - Water damage/ high moisture readings noted on sub-floor around plumbing drain lines, this may be an indication of possible leaks in first floor bathroom, recommend further evaluation and repair of water leaks by plumbing contractor, and repair/replace water damaged subfloor and flooring by contractor

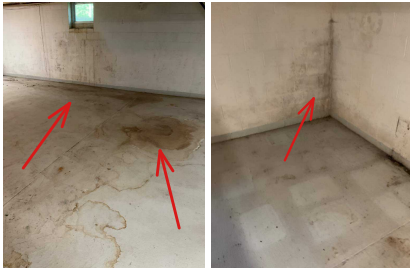
11. Moisture Location: Under the entire home - Water stains noted on basement floor and walls, this may be an indication of past/present water infiltration in basement, recommend improving/repairing exterior grading and drainage, running a dehumidifier, and evaluation and repair as needed by basement specialist.

Possible mold growth noted on sub floor/plywood in basement, recommend further evaluation and re-mediate as needed by mold specialist.

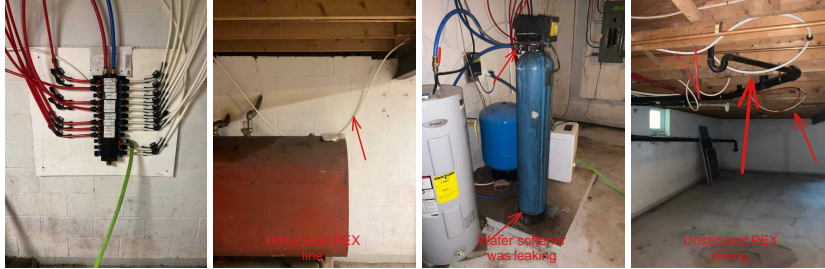
3. Water Lines: PEX - Unsecured PEX lines noted on basement ceiling, recommend repair to reduce the risk of leaks.

Water softener tank leaking was leaking water at the bottom of tank and at water line connection at time of inspection, recommend evaluation and repair/replacement as needed by plumbing contractor.

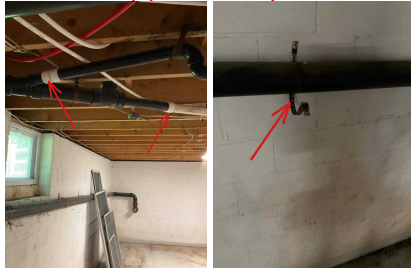
4. Drain Pipes: ABS, Cast iron - ABS and PVC glued together, these materials react differently to glue and may be prone to leaks, there were no leaks detected at time of inspection, recommend repair by plumber.

Loose support strap on drain line, recommend repair.

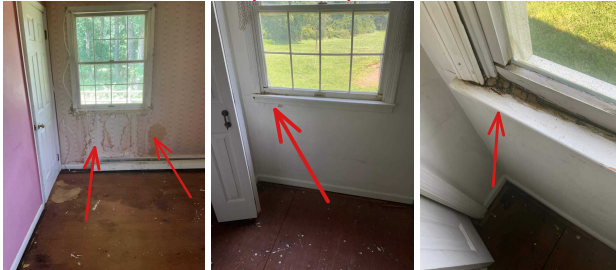
1. Closet: Large
2. Ceiling: Paint
3. Walls: Wallpaper - Water staining/damage noted under windows in primary bedroom and rear bedroom, areas were dry at time of inspection, recommend further evaluation and repair/replace windows/water damaged material by contractor.
