SPY Inspection Services, Inc.

Home Inspection Report

1925 Foster Rd.
Hatfield, PA 19440

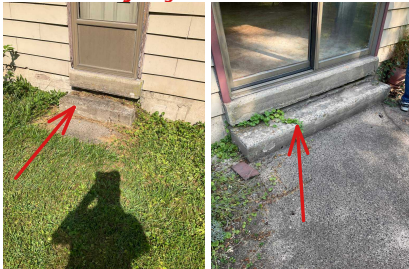
3. Steps/Stoops: Concrete - Rear concrete steps have settled away from house and has created a high/uneven step, recommend repair by concrete contractor to reduce the risk of injury.

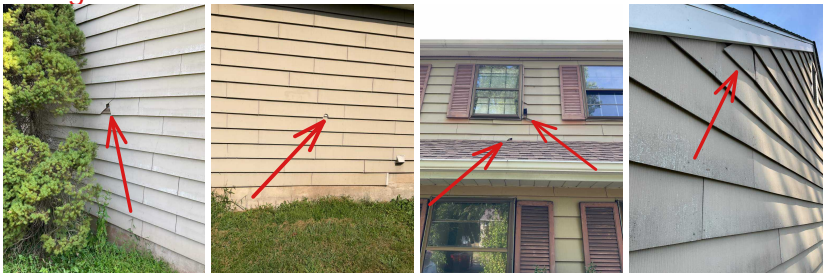
1. Type: Fibrous Cement Siding - Damage/ loose/ cracked cement siding noted in numerous areas of the house, due to the age of the house cement siding may contain asbestos, recommend further evaluation and repair/replaces siding as needed by siding contractor.

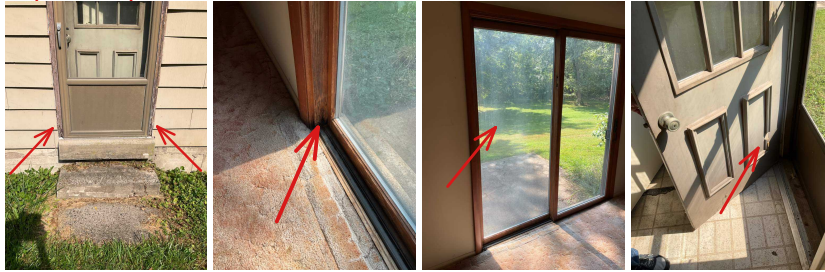
6. Patio Door: Metal glass entry door, wood sliding - Water damage noted on exterior trim of laundry room entry door, recommend repair/replacement of damaged trim as needed by contractor to prevent further water damage.

Water damage noted on the interior jamb of wood sliding door, area was dry at time of inspection, recommend repair/replacement of water damage wood/ there may be the need for possible replacement of door.

Seal failure noted in glass in sliding door, recommend replacement of glass by glass contractor.

Trim on exterior laundry room door is broken, pulling away from door, recommend repair/replacement of door as needed.

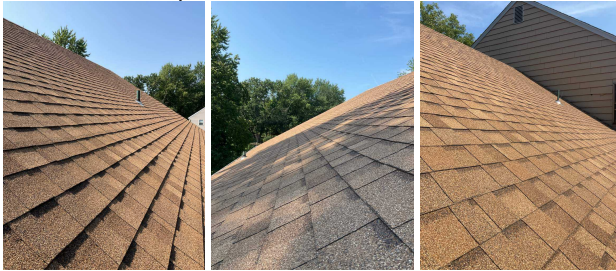
3. Material: Asphalt shingle - **Newer shingles were installed on roof, there was no ridge vent installed on roof, most shingle manufacturer's specifications require a ridge vent to be installed, this may void the shingle manufacturer's warranty, recommend further evaluation of ventilation of attic and improve ventilation as needed by roofing contractor**

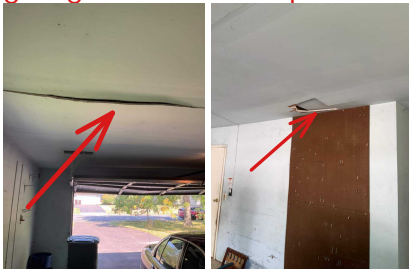
6. Service Doors: Metal
7. Ceiling: Paint - Damaged drywall noted on ceiling, recommend repair/replacement of damaged drywall by contractor to comply with fire separation requirements between garage and livable space.

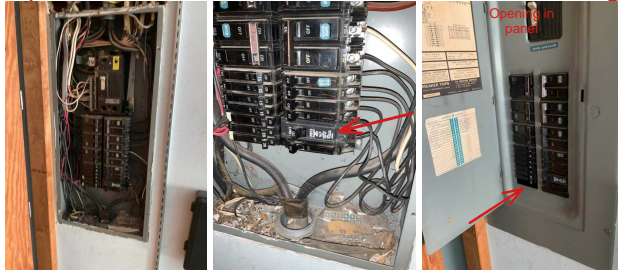
8. Manufacturer: General Electric - Different manufacturer's breaker noted in GE electrical panel, per GE specifications only GE breakers are permitted in panel, recommend replacement of breaker by electrician.

Open knock-out hole, recommend inserting blank-out cap to close off opening

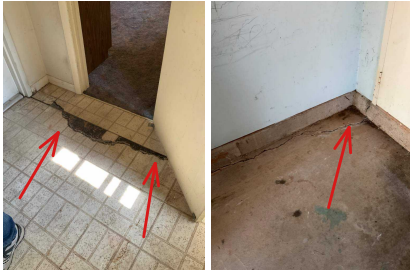
3. Floor/Slab: Poured slab - Uneven settling noted on concrete slab in laundry room and garage, there was no evidence of cracks/ separation on walls or ceiling in that area at the time of inspection, this may be an indication that there is no current movement of concrete slab, recommend further evaluation and repair/sealing cracks as needed by concrete contractor.

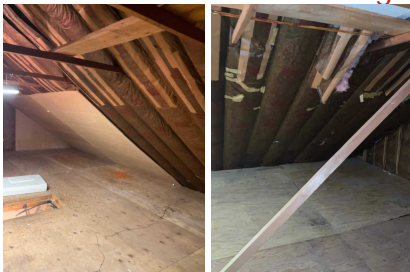
1. Method of Inspection: In the attic
2. Unable to Inspect: 70% - Insulation was installed between rafters of roof, unable to view roof structure/decking.

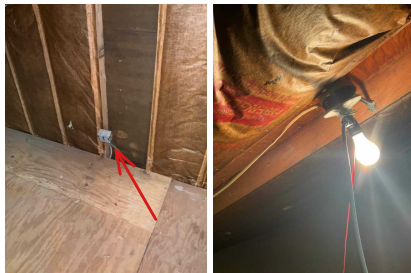
- 4. Sheathing: Plywood
- 5. Ventilation: Gable vents
- 6. Insulation: Batts, Blown in - Insulation was installed between the rafters on roof, this may compromise attic ventilation, recommend further evaluation and improve insulation configuration in attic area by insulation contractor.
- 7. Insulation Depth: 6, 10
- 8. Wiring/Lighting: 120 VAC - Loose receptacle and light fixture, recommend repair by electrician to reduce the risk of shock.

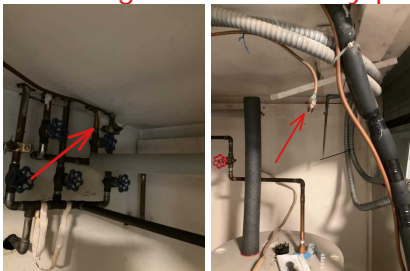
3. Water Lines: Copper - **Water line was disconnected from saddle valve, recommend removing saddle valve by plumbing contractor to reduce the risk of leaks.**

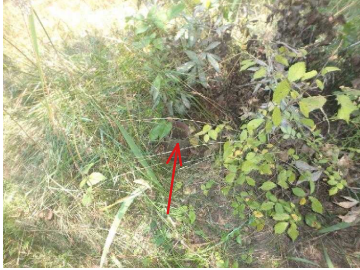
5. Service Caps: Accessible - Missing cap for exterior vent/trap, recommend installation of cap to reduce the risk of debris entering drain line.

Due to the age of the house, recommend having a sewage lateral inspection performed to determine if there are any blockage/damage to main drain line

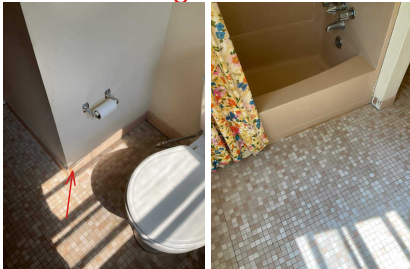
3. Floor: Tile - **Loose tile noted, recommend repair to prevent further damage.**

Recommend Sealing/caulking between floor and tub surround to reduce the risk of water damage.

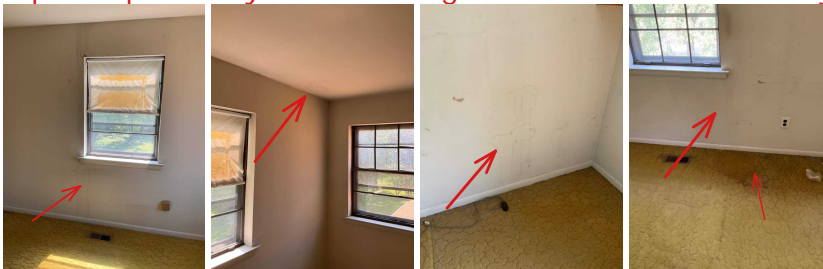
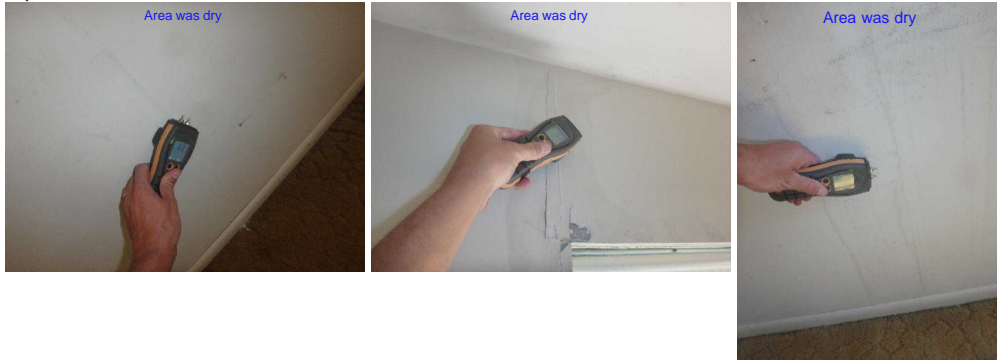
1. Closet: Walk In and Large
 2. Ceiling: Paint
 3. Walls: Paint - **Water staining noted in primary and rear bedrooms, underneath windows and ceiling, all water stains were dry at time of inspection, recommend further evaluation/monitoring water stains to determine if areas are still leaking and repair/replace any water damaged materials as needed by contractor.**

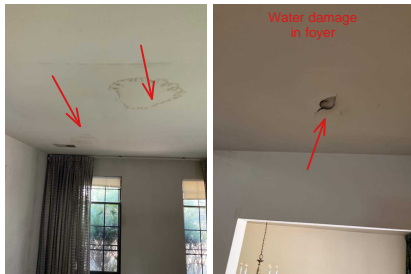
2. Ceiling: Paint - Water staining/water damage noted in living room and foyer area, all areas were dry at time of inspection, water damage in foyer the area above is the primary bathroom, recommend further evaluation to determine if plumbing leaks were properly repaired and repair/replacement of water damaged materials by contractor.

Recommend repair/replacement of water damaged material in living room by contractor.

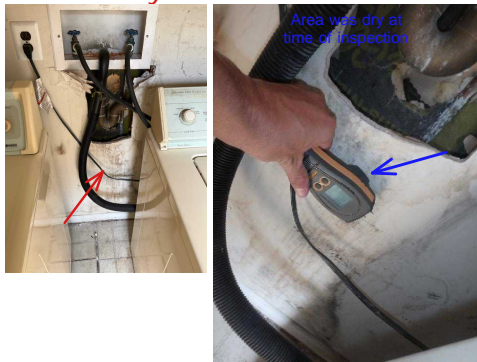
8. Washer Hose Bib: Rotary - Signs of past water leaks near washing machine drain line, area was dry at time of inspection, recommend repair/replacement of water damaged material by contractor.
