SPY Inspection Services, Inc.

Home Inspection Report

170 N Main St.
New Hope, PA 18938

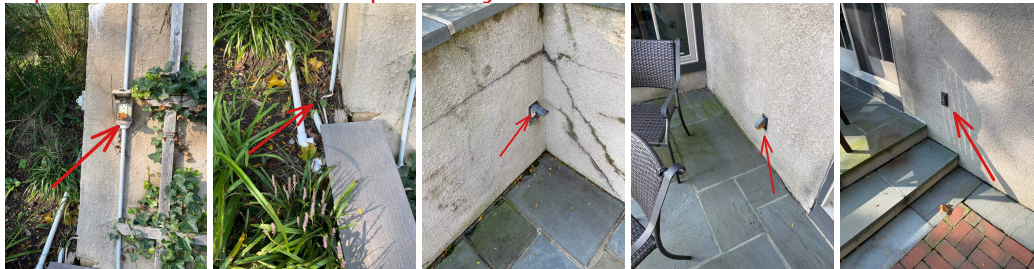
- 1. Type: Stucco
- 2. Trim: Composite material, Aluminum
- 3. Fascia: Wood, Aluminum
- 4. Soffits: Aluminum
- 5. Entry Doors: Metal
- 6. Patio Door: Vinyl sliding
- 7. Windows: Vinyl casement, Vinyl double hung
- 8. Basement Windows: Wood hopper
- 9. Exterior Lighting: Surface mount
- 10. Exterior Electric Outlets: 120 - Rear dock receptacle not GFCI protected, recommend installation by electrician to reduce the risk of shock.

Wires for flood light at rear dock may be subject to damage, recommend covering/protecting wires by electrician to reduce the risk of shock.

No power to receptacle on lower patio area, recommend further evaluation and repair as needed by electrician.

Upper Patio receptacles did not trip when tested, recommend further evaluation and replacement of GFCI receptacle by electrician.

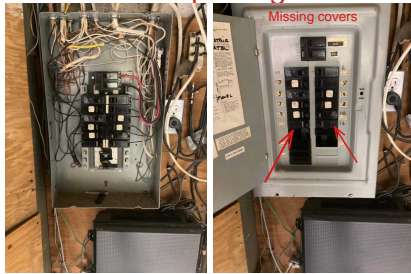
Basement Subpanel Electric Panel

9. Manufacturer: Crouse-Hinds - **Open knock-out hole recommend inserting blank-out cap to close off opening to reduce the risk of shock.**

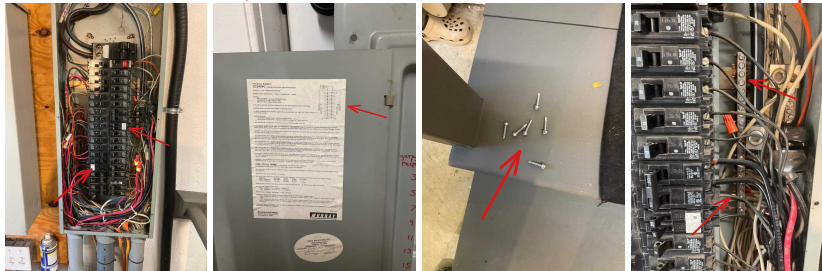
Garage Main Panel Electric Panel

14. Manufacturer: Murray - **Mini/tandem breakers noted in electrical panel, per manufacturer's specifications mini breakers are not permitted in electric panel, recommend further evaluation and repair as needed by electrician.**

Improper screws used for panel cover, screws used for panel cover should be blunt tipped screws to reduce the risk of damaging wires, recommend replacement of cover screws.

Neutral wires are double/ triple tapped on neutral bus bar, this can increase the risk of loose connection, recommend further evaluation and repair as needed by electrician.

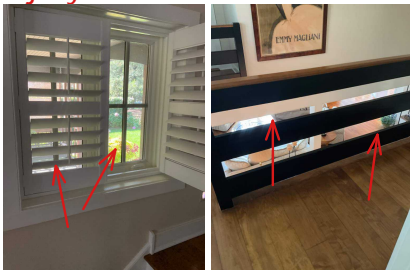
1. Structure Type: Wood frame
2. Foundation: Block
3. Beams: Steel I-Beam, Bonded wood
4. Bearing Walls: Frame
5. Joists/Trusses: 2x8
6. Piers/Posts: Steel posts, Block piers and posts
7. Floor/Slab: Poured slab
8. Stairs/Handrails: Wood stairs with wood handrails - Windows on stairway does not appear have tempered glass installed, recommend installation of safety glazing by contractor to reduce the risk of injury.

Space between guardrails does not comply to current safety standards, there should be no more than 4" space between rails, recommend repair to reduce the risk of injury.

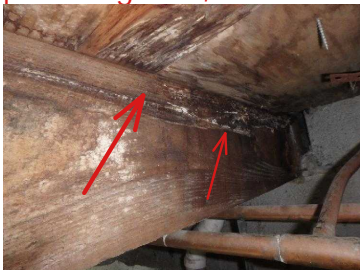
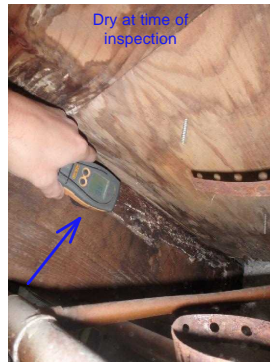
9. Subfloor: Plywood, Dimensional wood - Water stain noted on subfloor/floor joists at front crawlspace section, area was dry at time of inspection, this may be due to past plumbing leak, recommend monitoring area

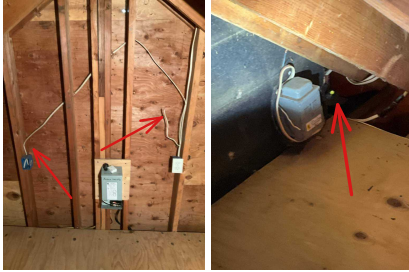
5. Ventilation: Ridge and soffit vents
6. Wiring/Lighting: 120 VAC - **Disconnected wires noted on front gable walls, recommend further evaluation and repair as needed by electrician.**

Exposed wires noted in attic, recommend installing wires in junction box by electrician to reduce the risk of shock.

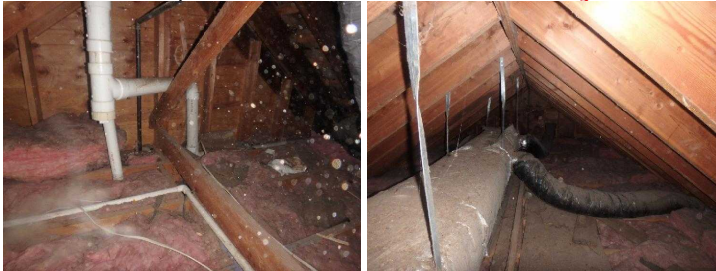
9. Unable to Inspect: 25% - **Roof line, Safety and footing**

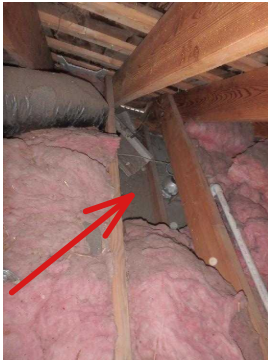
13. Insulation: Batts - **Missing area of insulation noted, recommend adding insulation to section to help conserve energy.**

Recommend adding insulation to attic area to help conserve energy.

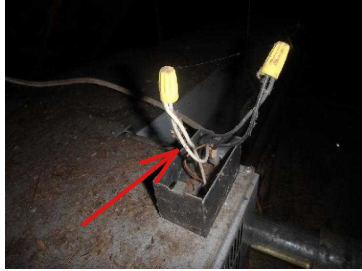
15. Wiring/Lighting: 120 VAC I - Exposed wires noted on top or furnace, recommend covering/repair to reduce the risk of shock.

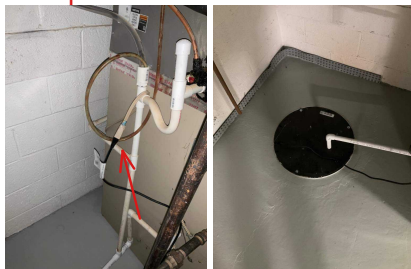
1. Unable to Inspect: 20%
2. Ceiling: Exposed framing
3. Walls: Paint
4. Floor: Poured
5. Floor Drain: Covered
6. Doors: Hollow wood
7. Windows: Wood hopper
8. Electrical: 120 VAC
9. HVAC Source: Heating system register
10. Sump Pump: Submerged - Extension cord used for sump pump, sump pump should be installed on separate circuit, recommend repair by electrician.

Sump lid was sealed at time of inspection, unable to test sump pump.

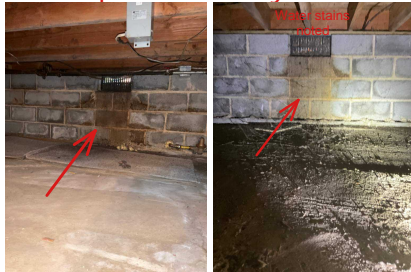
- 1. Method of Inspection: In the crawl space
- 2. Unable to Inspect: 10%
- 3. Access: Open
- 4. Moisture Penetration: Water stains - Evidence of past water/moisture infiltration at crawlspace vents and block walls, recommend improving exterior grading and drainage by landscaping contractor, running a dehumidifier, and further evaluation as needed by basement specialist.

Crawlspace was dry at time of inspection.

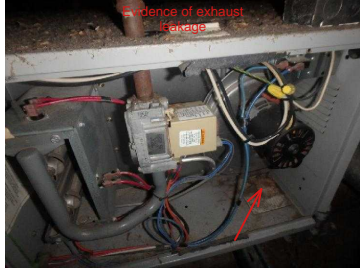
15. Heating System Operation: Adequate - Per seller HVAC interior was replaced and exterior is original, service tag by JA Smith states replacement, recommend regular servicing by HVAC contractor.

Signs of past exhaust leakage noted in furnace, recommend further evaluation and repair as needed by HVAC contractor.

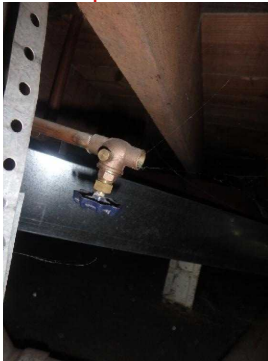
3. Water Lines: Copper - Recommend capping disconnected rotary valve in front crawlspace to reduce the risk of water leaks.

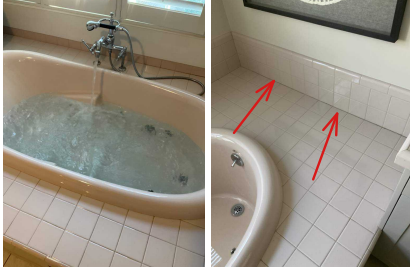
25. Spa Tub/Surround: Porcelain tub and ceramic tile surround - **Cracking mortar noted on surround near spa tub, recommend sealing cracks**
