SPY Inspection Services, Inc.

Home Inspection Report

1111 Sandy Ridge Rd
Doylestown, PA 18901

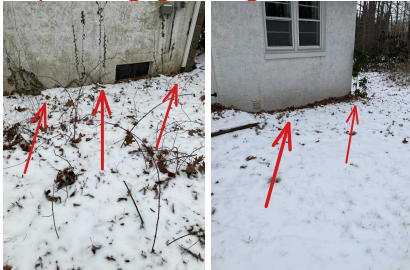
- 4. Patio: Brick - **Snow covered at time of inspection, unable to inspect**
- 5. Grading: Negative slope - **Improper soil slope towards foundation, recommend improving grading around the house by landscaping contractor.**

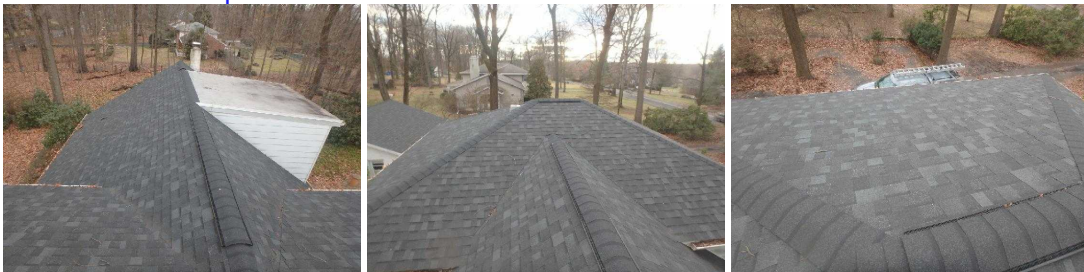
1. Method of Inspection: On roof
2. Unable to Inspect: 95% - Roof was covered with snow at time of inspection, unable to view roof material and flashings, recommend full evaluation of roof by roofing contractor.

Roof was re-inspected on 1/29/2024 when the snow melted off of the roof.

3. Material: Asphalt shingle - Damaged ridge cap shingle noted on roof, recommend replacement of damaged shingle by roofing contractor to reduce the risk of water infiltration.

Exposed nail heads noted on ridge, recommend sealing nail heads by roofing contractor to reduce the risk of water infiltration.

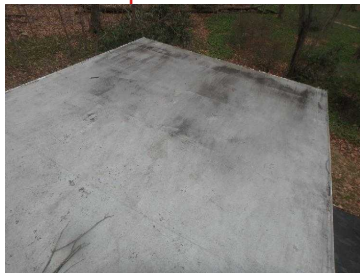
Rear Dormer Roof Surface

- 6. Method of Inspection: On roof
- 7. Unable to Inspect: 10%
- 8. Material: Built-up - Recommend maintaining roof coating on built up roof to prolong the life span of roof material.

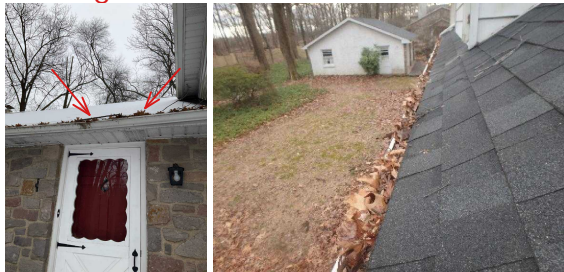
- 10. Approximate Age: 10-12 years
- 11. Flashing: Aluminum
- 12. Valleys: Asphalt shingle
- 13. Plumbing Vents: Copper
- 14. Electrical Mast: Surface mount
- 15. Gutters: Aluminum - Gutters are filled with leaves and debris, recommend cleaning/realigning gutters as needed by gutter contractor to allow for proper exterior drainage.

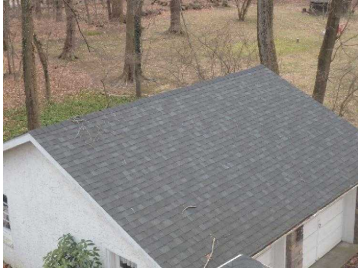
6. Roof: Asphalt shingle - Roof was covered with snow at time of inspection, unable to view roof material and flashings, recommend full evaluation of roof by roofing contractor.

Roof was re-inspected on 1/29/2024 when the snow melted off of the roof.

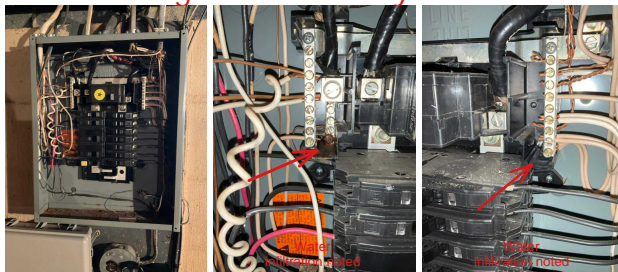
Basement Electric Panel

2. Service: Aluminum - Surface coating of service cable is cracked and deteriorated and may allow water to penetrate inside the cable, recommend replacing service cable by electrician.

Water infiltration was noted inside electrical panel at time of inspection.

9. Manufacturer: Square D - Water infiltration noted in electrical panel, possibly due to deteriorated service cable, recommend replacing cable and full evaluation and repair water damage as needed by electrician.

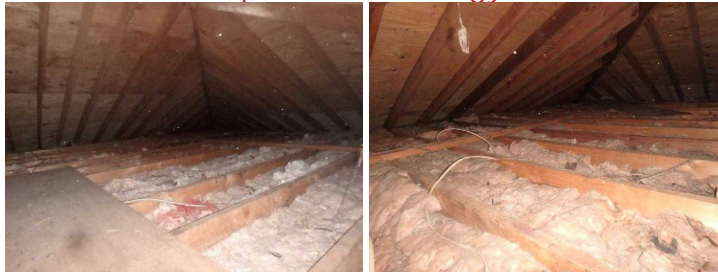
Main Attic

1. Method of Inspection: In the attic
2. Unable to Inspect: 60% - Finished attic
3. Roof Framing: Rafter
4. Sheathing: Plywood
5. Ventilation: Ridge and soffit vents
6. Insulation: Batts - Insulation compressed, recommend adding insulation by insulation contractor to help conserve energy.

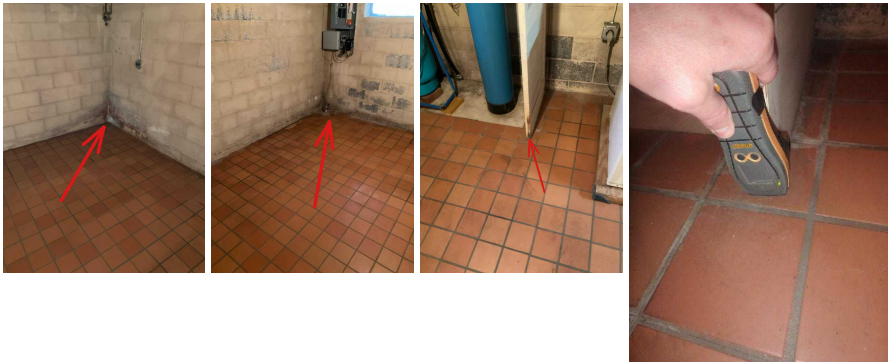
10. Moisture Location: Block walls and door - **Water stains noted on block walls and door, this may be due to past water/moisture infiltration, basement was dry at time of inspection, recommend improving exterior grading and drainage and running a dehumidifier.**

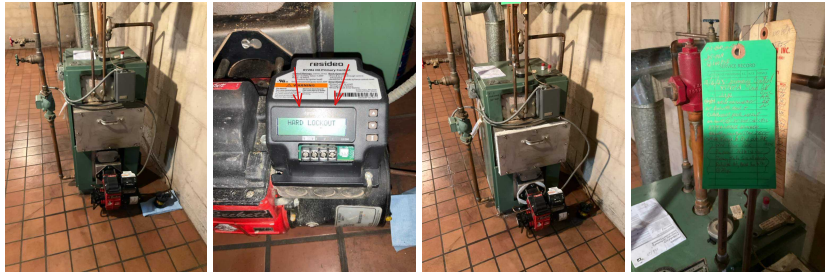
1. Heating System Operation: Adequate - Oil burner on boiler kept short cycling, oil burner kept tripping off while trying to operate, recommend further evaluation and repair by HVAC contractor.

Boiler was re-inspected on 1/29/2024, the boiler was operating properly at the time of re-inspect. Per HVAC service tag, repairs were performed/completed on 1/24/2024

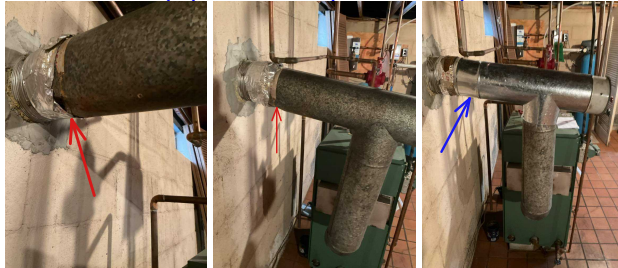
2. Manufacturer: New Yorker
3. Model Number: FR-122-W Serial Number: N/A
4. Type: Boiler system Capacity: 122,000 BTU
5. Area Served: Whole building Approximate Age: 20 years
6. Fuel Type: Oil
7. Heat Exchanger: 1 Burner
8. Unable to Inspect: 95%
9. Distribution: Hot water
10. Circulator: Pump
11. Draft Control: Manual
12. Flue Pipe: Single wall - Rust holes/ gaps noted on flue pipe, recommend replacing flue pipe by HVAC contractor to reduce the risk of carbon monoxide poisoning.

Boiler Flue pipe was repaired/replaced at the time of re-inspection 1/29/2024.

19. Main Heating System Flue Pipe: Single wall - **Rust holes/ gaps noted on flue pipe, recommend replacing flue pipe by HVAC contractor to reduce the risk of carbon monoxide poisoning.**

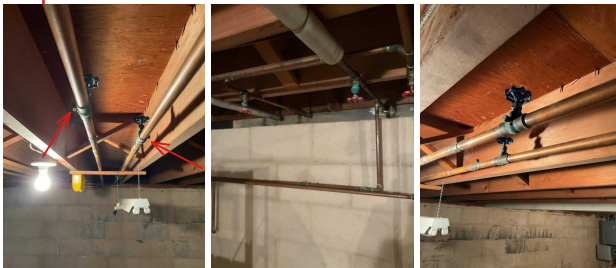
3. Water Lines: Copper - **Valves are leaking water in basement ceiling, recommend repair/replacement of valve by plumbing contractor to reduce the risk of water damage.**

Repaired

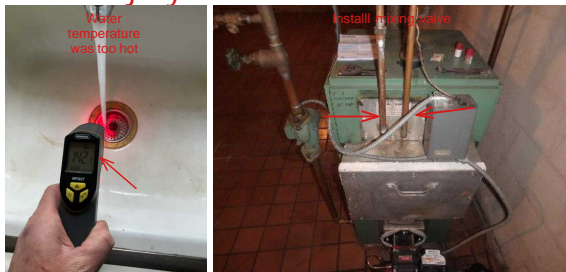
7. Water Heater Operation: Inadequate - Summer winter hook up was inoperative due to oil burner short cycling (refer to heating section in inspection report) unable to test hot water at fixtures throughout the house, recommend repair by plumbing contractor/HVAC contractor.

At the time of re-inspection, the water temperature was too hot, water temperature should range between 120-125 to reduce the risk of injury, recommend installing mixing valve on summer winter hookup by plumbing/HVAC contractor to reduce the risk of injury.

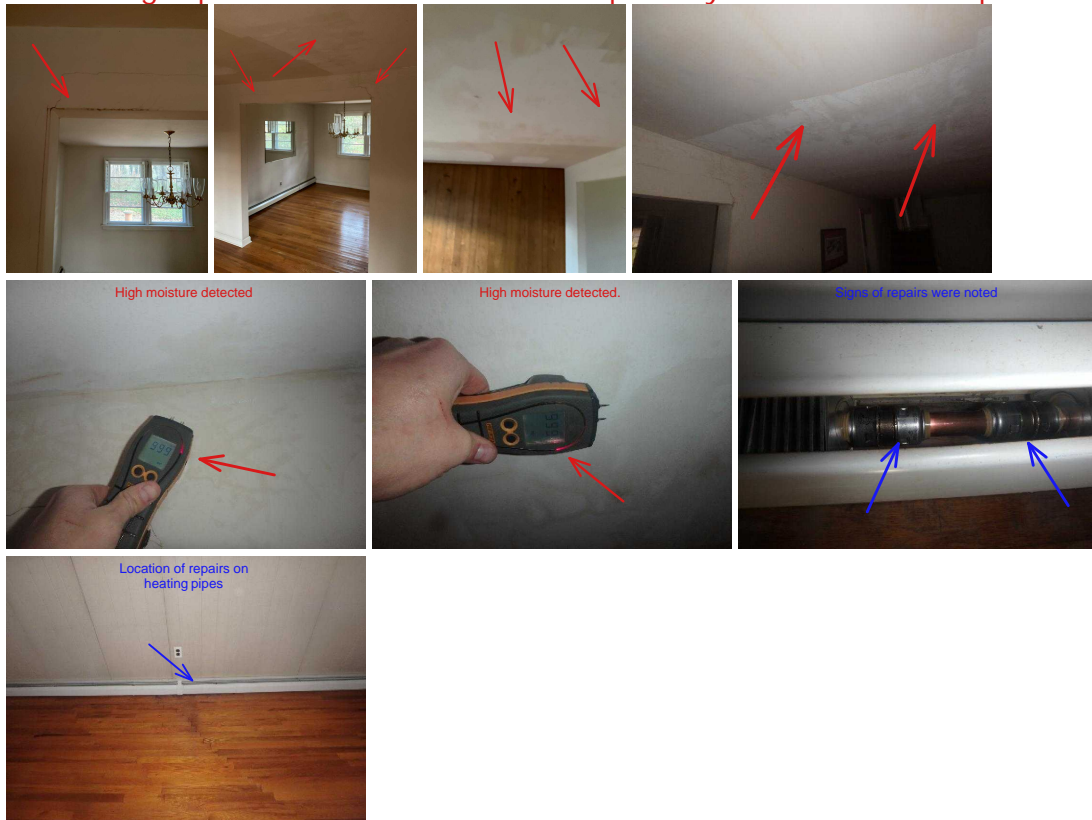
1. Closet: Single
2. Ceiling: Paint
3. Walls: Paint - At the time of re-inspection of the house 1/29/2024, there was notable water damage/staining on the living room/dining room ceiling and walls, high moisture was detected at time of re-inspection, recommend replacing all water damaged material by contractor to reduce the risk of mold growth.

Water damage appears to have come from the attic heating baseboard, possibly due to damaged heating pipes, it appears that repairs were performed on heating pipes and there was no active water leaks noted at time of re-inspection, recommend monitoring repairs/further evaluation of repairs by HVAC contractor/plumber.

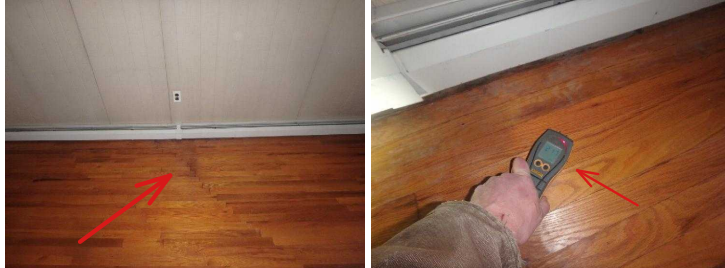
4. Floor: Carpet, Hardwood - Attic/Upper Loft hardwood floor was buckling and high moisture was detected this may be due to water leak from heating pipes, recommend replacing water damaged flooring by floor contractor to prevent further damage.
