May 16th, 2024

1032 Park Ave, Wycombe, PA, 18980

Right Way Home Inspection Plus

Alderfer Auction

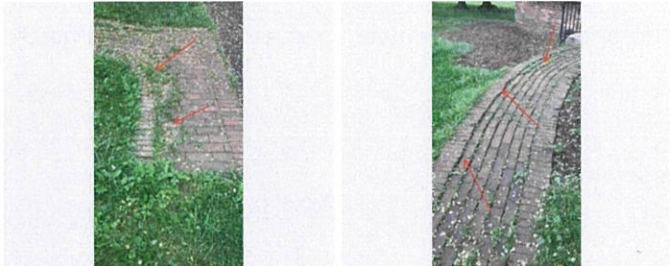
Defective

Uneven surface, possible trip hazard, recommend resetting, recommend further evaluation from a qualified landscape contractor

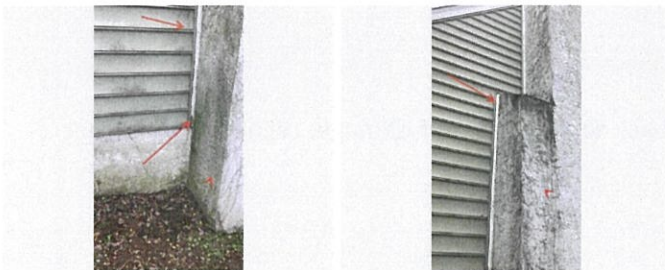
Defective

Evidence of rotting Wood, Recommend further evaluation from a qualified contractor

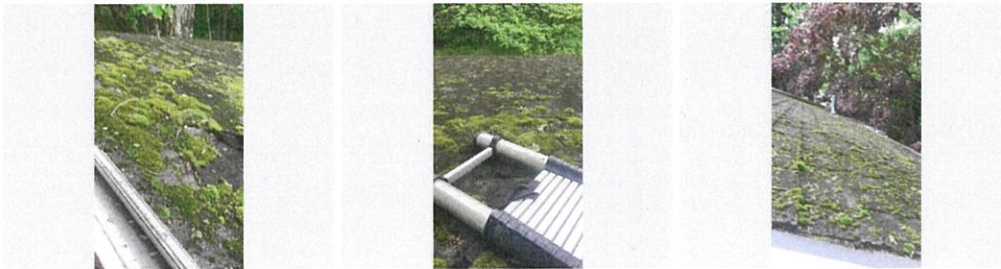
Defective

Moss is present

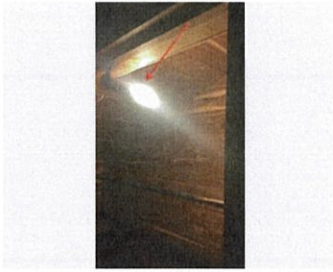
Defective

Exposed Bulb, possible fire hazard, it is recommended that a closet light be covered, recommend further evaluation from a qualified Electrician

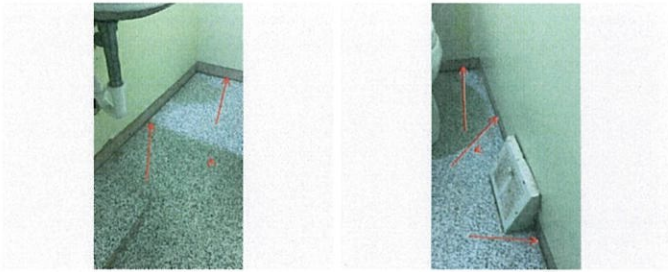
Location - Bathroom, 1st Floor

Defective

Missing Baseboard, recmmend installing to prevent watr penetration, Recommend further evaluation from a qualified contractor

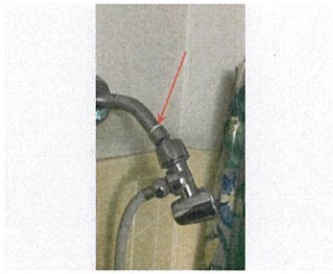
Defective

Shower Connection is leaking, Recommend further evaluation from a qualified handyman

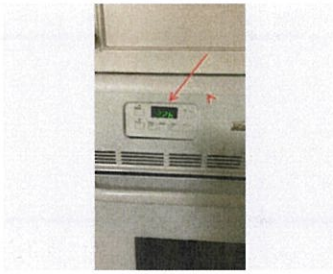
Defective

Oven control panel appears not installed correctly, Recommend further evaluation from a qualified appliance repair technician

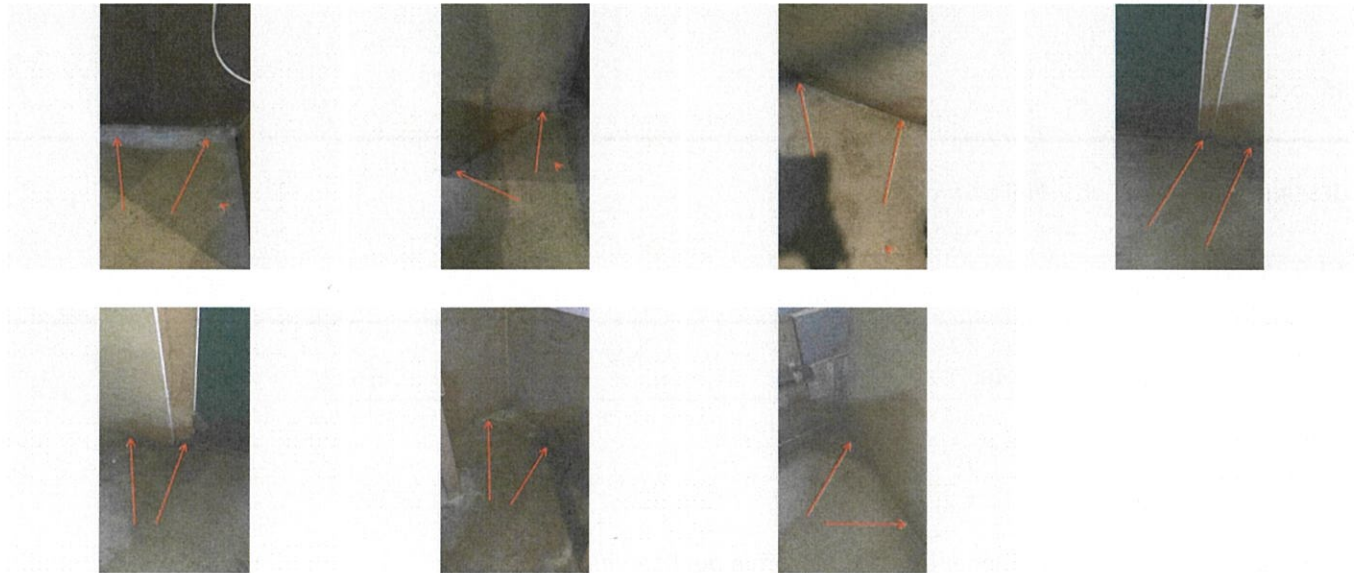
Defective

Evidence of possible wood rot, moisture present at bottom of paneling, Recommend further evaluation from a qualified contractor

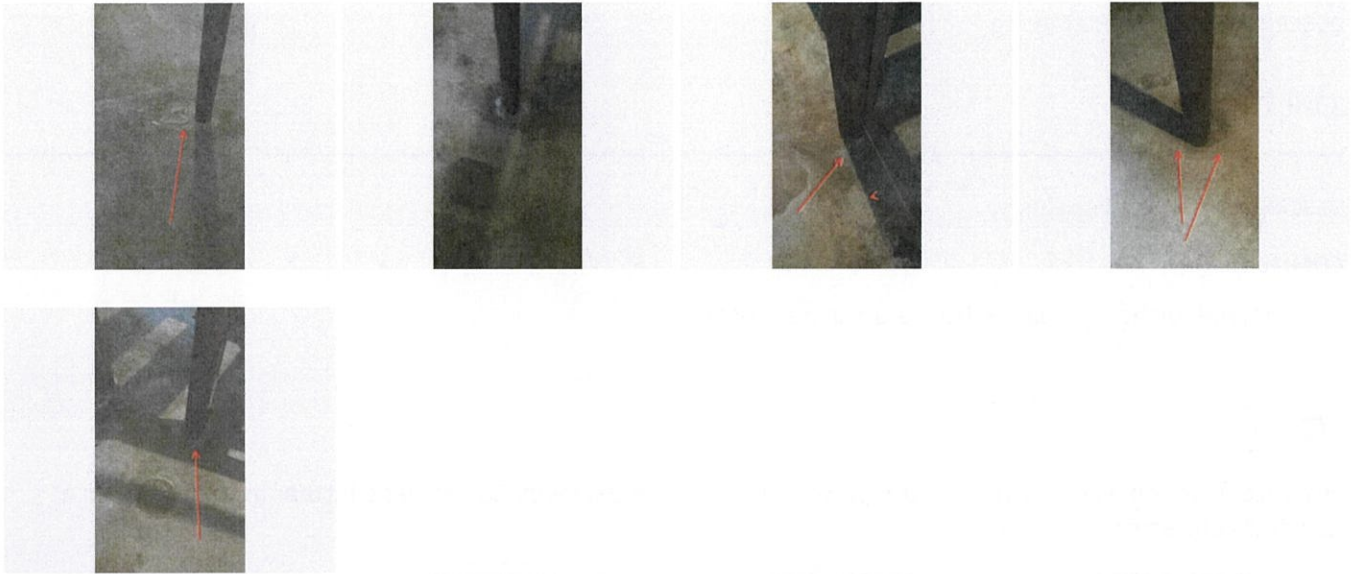
Defective

Efflorescence is present on the floor, this is caused by a moisture issue, recommend further evaluation from a basement water proofing contractor

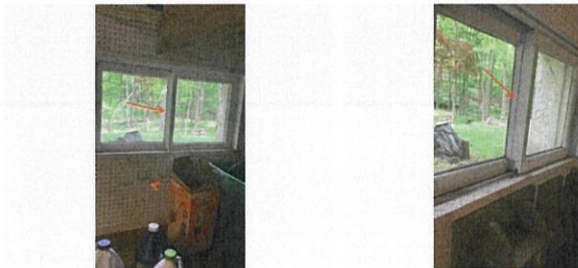
Defective

Missing Latch, Recommend further evaluation from a qualified handyman

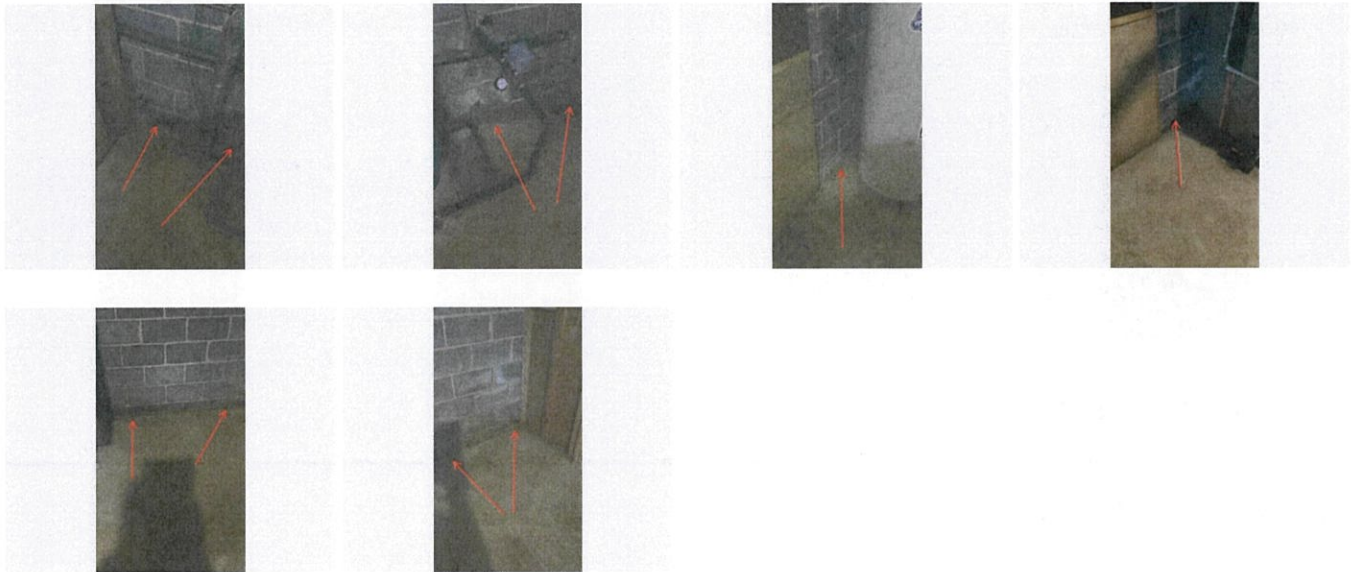
Defective

Moisture present around perimeter, Efflorescence is also present, A qualified basement water proofing contractor is recommended to evaluate and estimate repairs

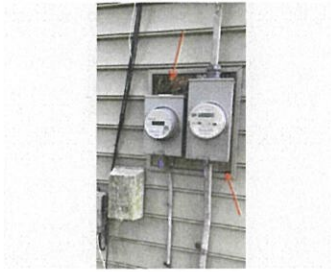
Defective

Exposed Plywood starting to rot, Recommend further evaluation from a qualified Electrician

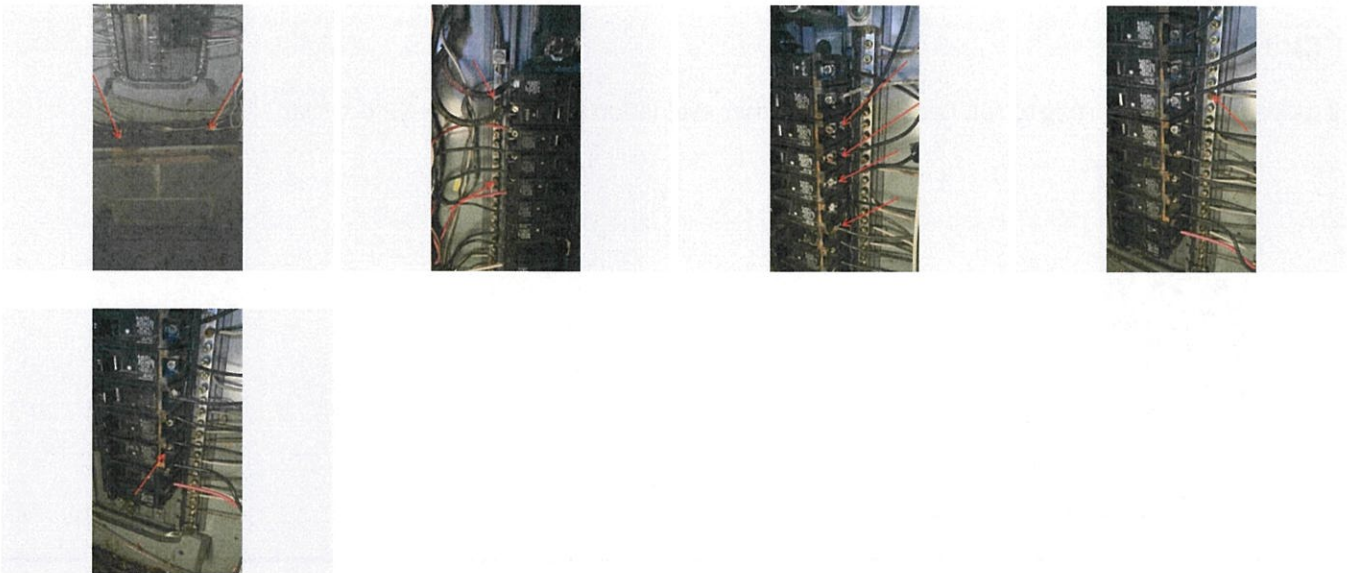
Defective

Panel is rusted inside, Neutral screws rusted, breakers are showing rust, Recommend further evaluation from a qualified Electrician

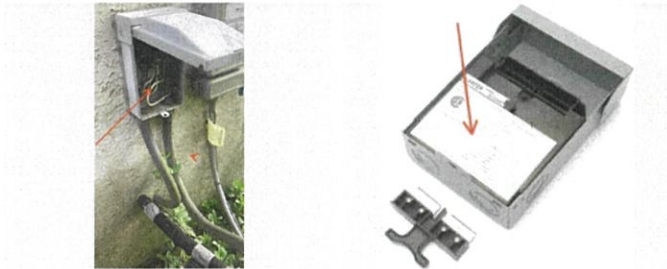
Defective

Exposed Wires in Disconnect, Missing plastic cover over live wires, recommend further evaluation from a qualified Electrician

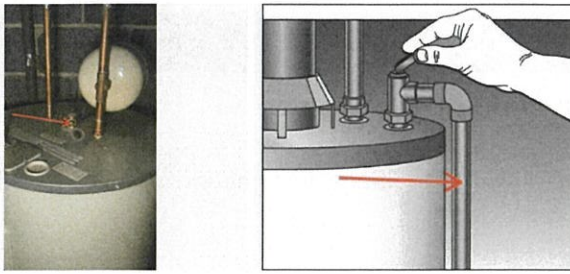
Defective

Missing drain tube, It is recommended that the Drain Tube extend to 6" above the floor, Recommend further evaluation from a qualified plumbing contractor

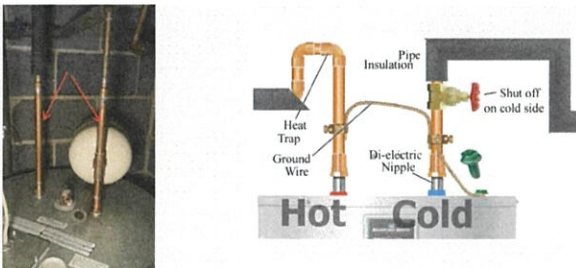
Defective

It is recommended that a bonding wire be attached across the hot and cold pipe, recommend further evaluation from a qualified Electrician

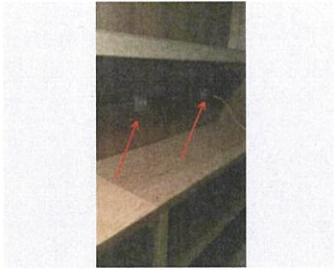
Not installed correctly
