May 30th, 2024

157 Upper Church Road, Chalfont, PA, 18914

Right Way Home Inspection Plus

RIGHT WAY HOME INSPECTION PLUS

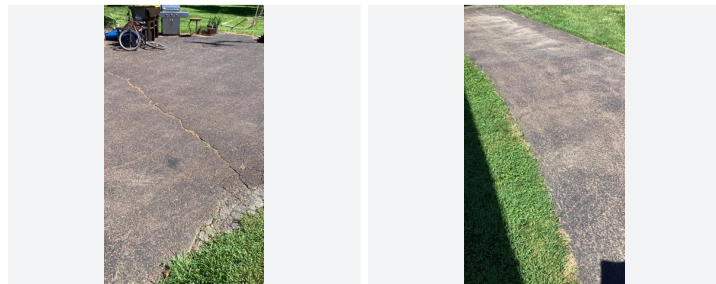
1.1 DRIVEWAY

Marginal

Recommend Sealing Asphalt to Preserve Surface

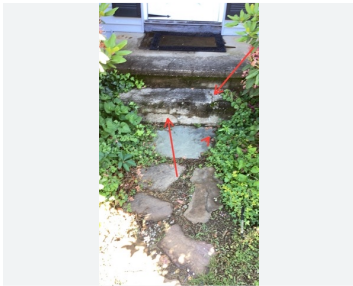
Defective

Damaged or deteriorated, recommend estimate for repair or replacement by a concrete contractor

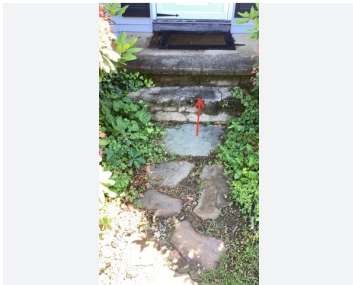
Defective

Not the correct step height, average step height is 7.5 ', recommend estimate for repair or replacement by a concrete contractor

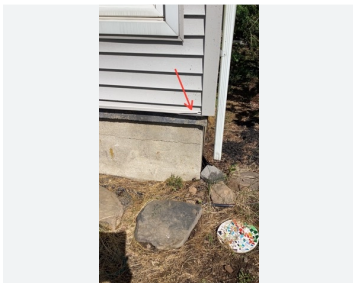
Location - 3 Season Room

Marginal

Damaged Siding

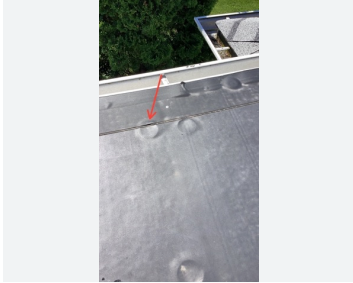
3.3 MATERIAL

Recommend re sealing to prevent possible water intrusion, Recommend further evaluation from a qualified roofing contractor

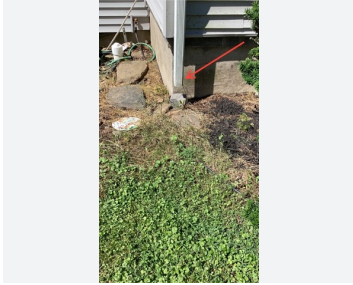
3.11 LEADER/EXTENSION

Marginal

Leaders do not extend 6 feet beyond the foundation perimeter

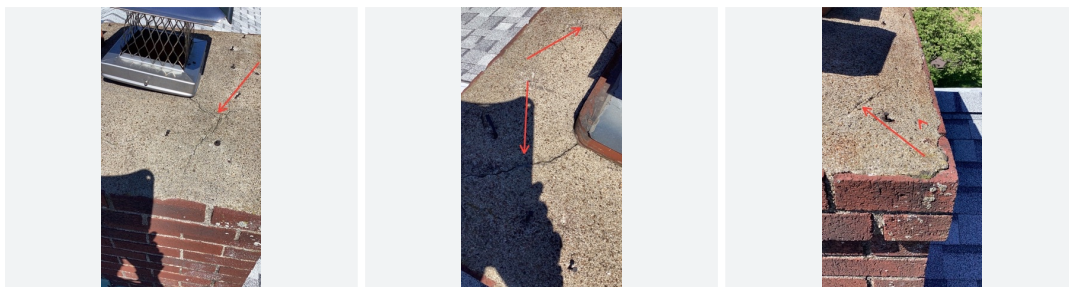
Defective

Crown cracked, recommend Repairing chimney mortar crown to prevent water penetration, recommend further evaluation from a qualified chimney sweep

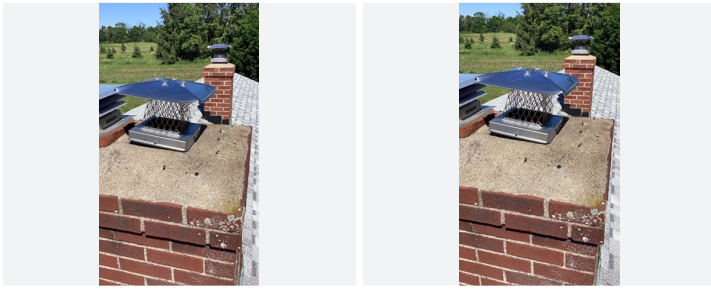
Chimney lining could not be inspected due to rain cap

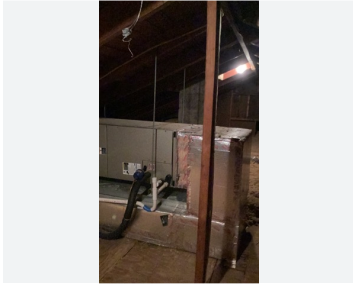
4.9 WIRING/LIGHTING

Defective

110 volt Receptacle is required in the attic no further than 8ft away from the HVAC system for repair, recommend further evaluation from a qualified Electrician

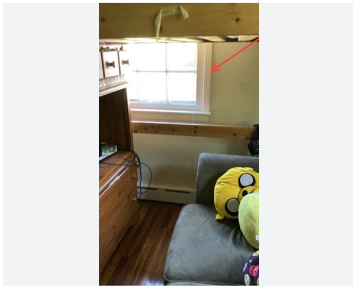
Location - Bedroom Rear

Defective

Hard operation-needs improvements for ease of operation, A qualified glazier is recommended to evaluate and estimate repairs

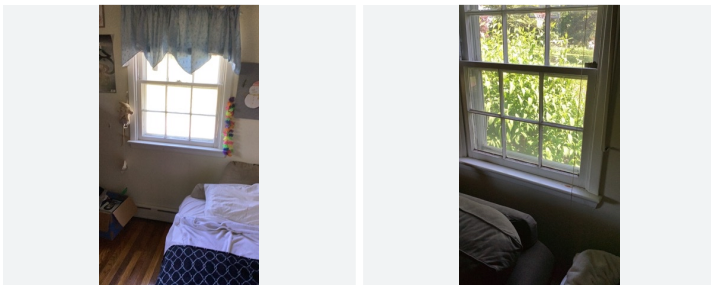
Location - Bedroom Both

Defective

Window does not stay up, A qualified glazier is recommended to evaluate and estimate repairs

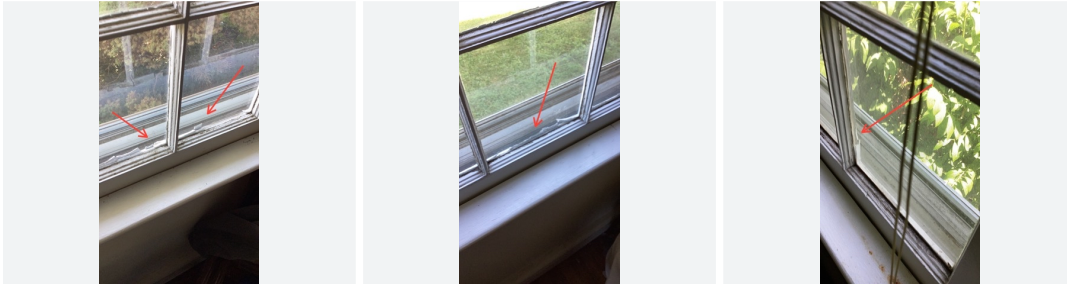
Location - Bedroom Both

Defective

Glazing is peeling off, A qualified glazier is recommended to evaluate and estimate repairs

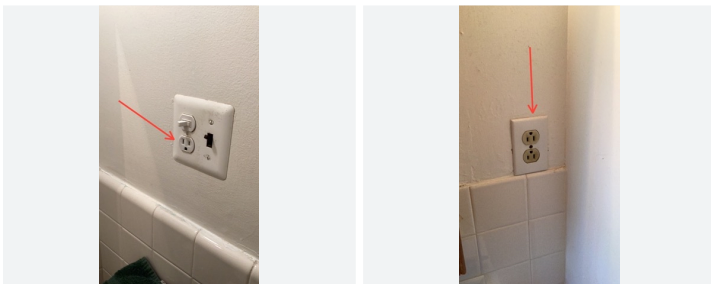
Location - Bathrooms Both

Defective

It is recommended that all bathrooms have a GFCI Receptacle, recommend further evaluation from a qualified Electrician

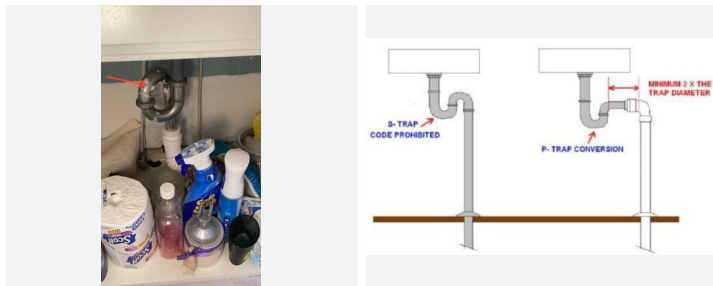
Location - Hall Bath

Marginal

An 'S' trap has been used. S traps should be replaced during any new plumbing work as they are subject to siphoning problems. Replacement is sometimes difficult and thus the S traps are usually tolerated. Care should be taken to keep the trap 'primed.' Fixtures should be monitored for sewer odor.

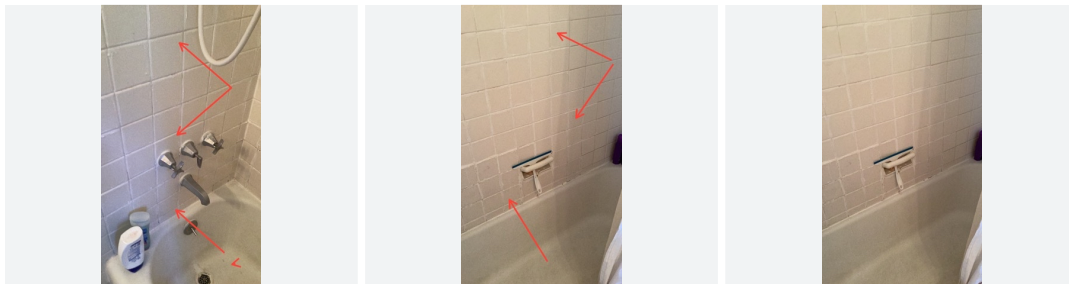
Location - Main Bathroom

Defective

Tile grout has been repaired with caulk, possible wall Damage, Recommend further evaluation from a qualified contractor

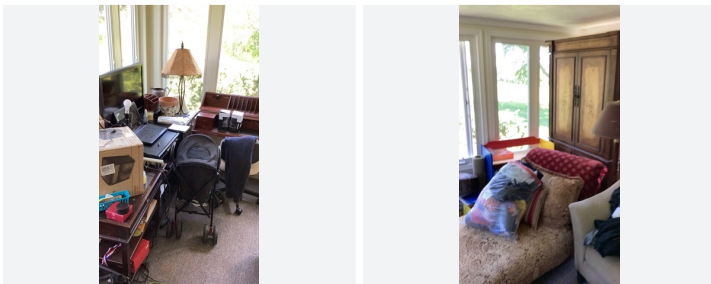
Marginal

Could not Test all windows

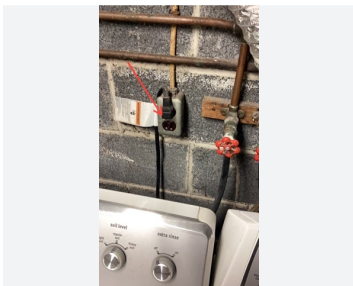
Defective

Non-GFCI circuit, It is recommended that all Receptacles in a Laundry Room be GFCI Protected

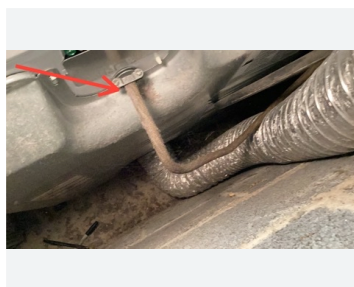
Defective

Dryer is direct wired, it is required that a Receptacle be installed for Dryer, recommend further evaluation from a qualified Electrician

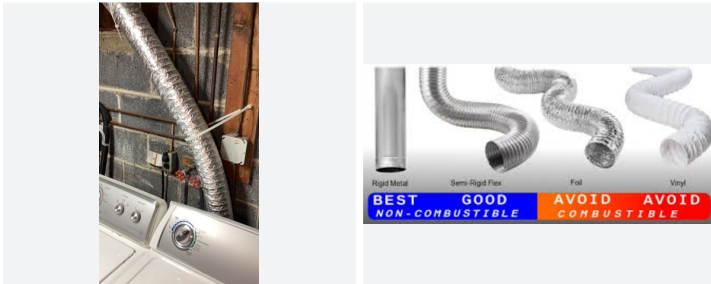
Marginal

Aluminum Foil Flex has been known as a Fire Hazard, Recommend a Ridged Flex Hose be Installed

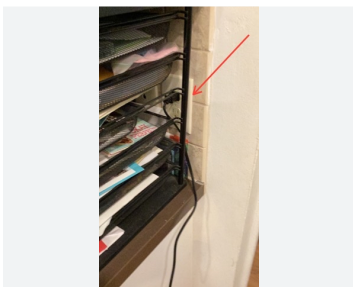
Defective

Non GFCI Receptacles present, it is recommended that all Receptacles on a kitchen counter be GFCI Protected, recommend further evaluation from a qualified Electrician

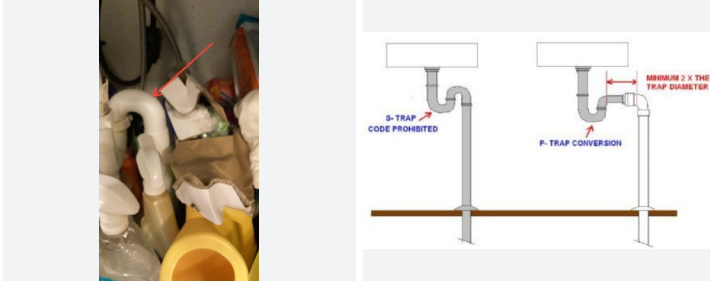
Marginal

An 'S' trap has been used. S traps should be replaced during any new plumbing work as they are subject to siphoning problems. Replacement is sometimes difficult and thus the S traps are usually tolerated. Care should be taken to keep the trap 'primed.' Fixtures should be monitored for sewer odor.

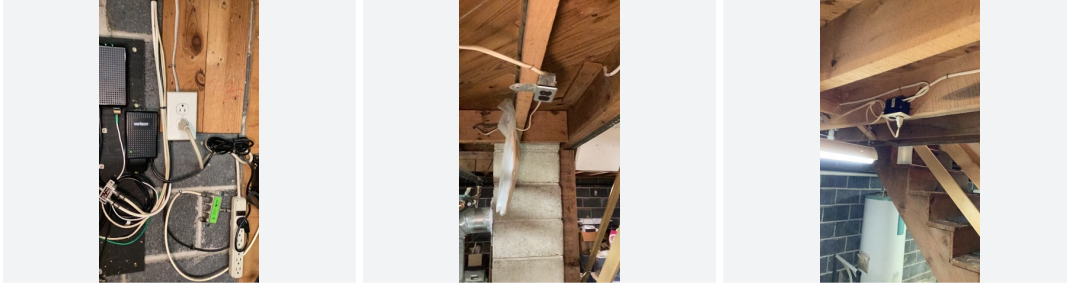
Defective

It is recommended that all Receptacles in an unfinished basement be GFCI Protected, recommend further evaluation from a qualified Electrician

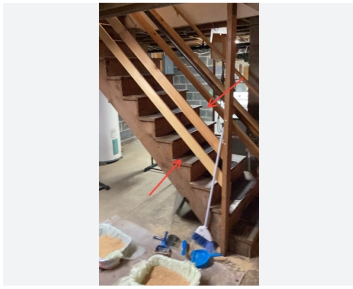
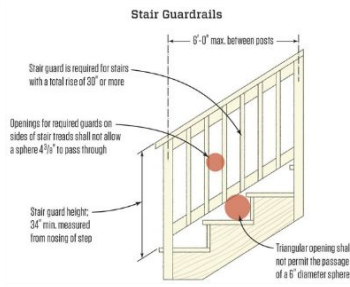
Defective

Improper baluster spacing, A qualified contractor is recommended to evaluate and estimate repairs

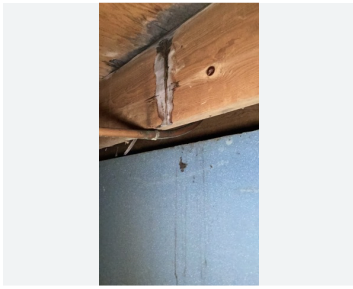
Previous Water Stains

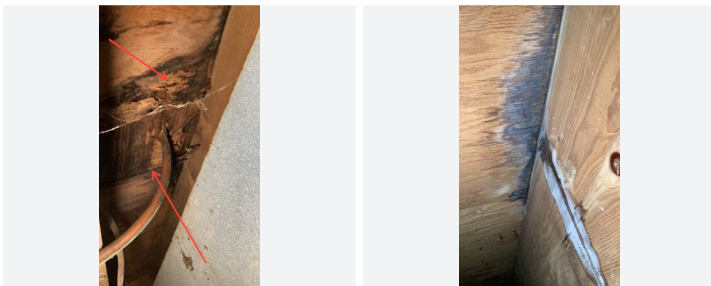
Defective

evidence of previous water stains, evidence of rotted wood, possible mold present

Evidence of previous water stains, evidence of rotted wood, possible mold present, Recommend further evaluation from a qualified contractor/and a qualified mold remediation specialist

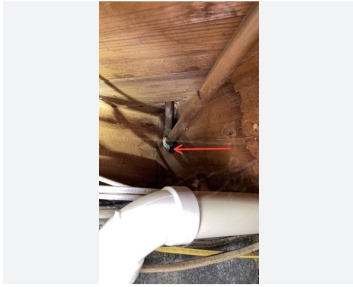
Defective

Leaking Fitting, Recommend further evaluation from a qualified plumber

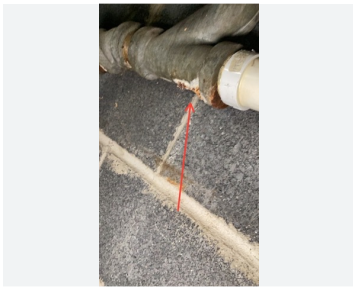
17.4 DRAIN PIPES

Marginal

Galvanized drain pipe showing signs of corrosion, no leak observed at time of inspection

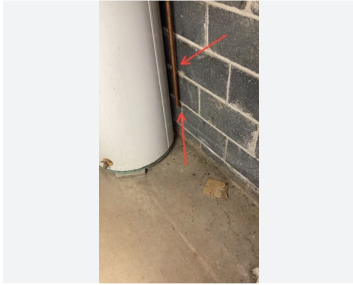
Defective

Drain tube opening is not within six inches of the floor, Recommend further evaluation from a qualified plumber

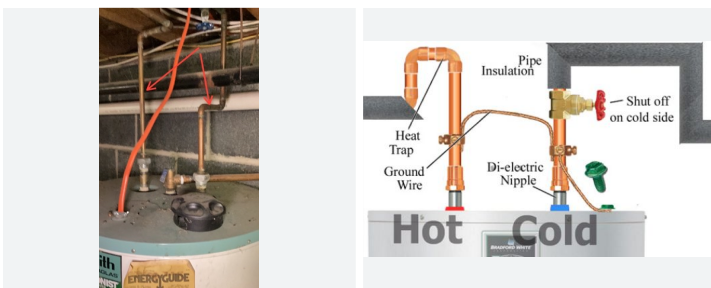
17.14 HOT AND COLD LINE BONDED

Defective

It is recommended that a bonding wire be attached across the hot and cold pipe, recommend further evaluation from a qualified Electrician

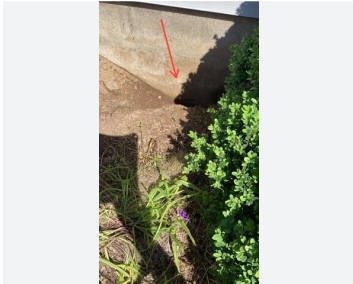
Location - Right Side of House

Evidence of Possible Rodent Activity, Recommend further evaluation from a qualified pest control Technician
