Jun 18th, 2024

146 Schultz Road, Telford, PA, 18969

# Right Way Home Inspection Plus

Alderfer Auction

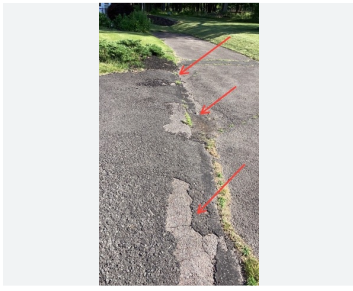
Marginal

Damaged or deteriorated, recommend estimate for repair or replacement by a qualified Asphalt contractor

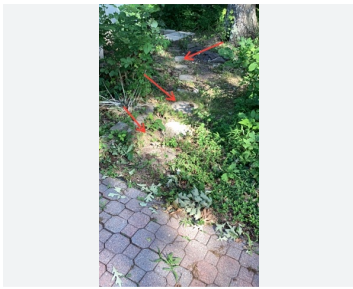
Location - Back of House

Defective

Possible Trip hazard, Recommend further evaluation from a qualified landscape contractor

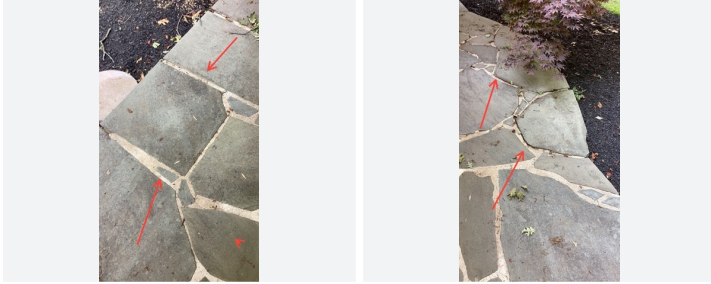
Defective

Loose flag stone, Recommend further evaluation from a qualified landscape contractor

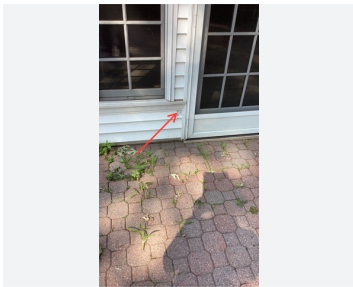
Defective

Improper siding, Recommend further evaluation from a qualified siding contractor

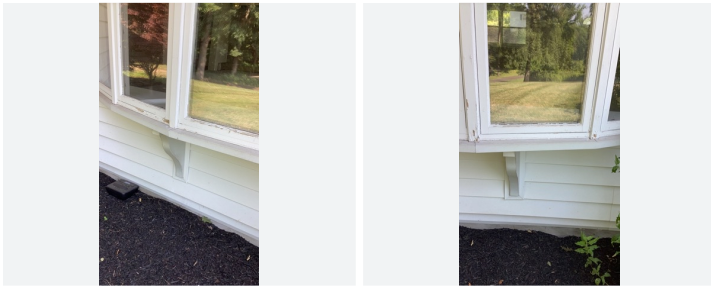
Defective

Peeling paint, recommend repairing to prevent wood rot, Recommend further evaluation from a qualified painting contractor

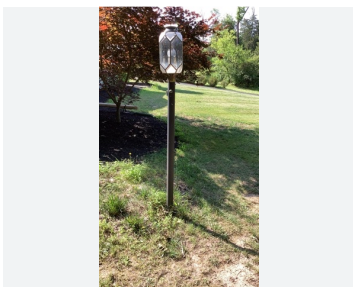
Defective

Pole is Loose, Recommend further evaluation from a qualified handyman

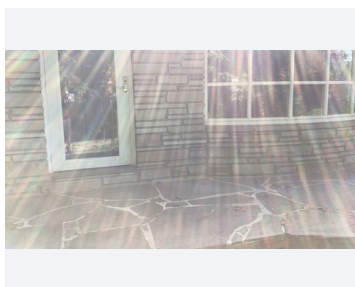
**Defective**

It is Recommended that a GFCI receptacle be installed at the Front of House, Recommend further evaluation from a qualified electrical contractor

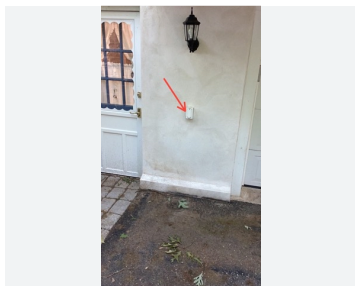
**Defective**

Faulty GFCI Receptacle, Recommend further evaluation from a qualified electrical contractor

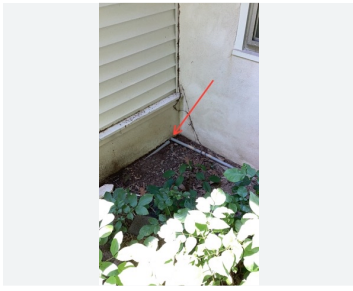
**Defective**

Open conduit, Recommend further evaluation from a qualified electrical contractor

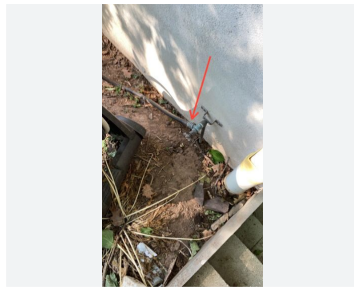
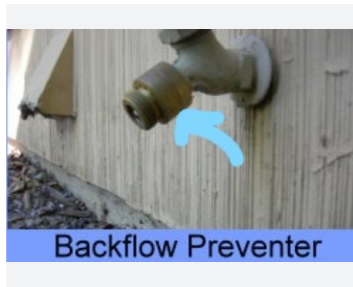
Defective

Recommend a Backflow preventer, to prevent cross contamination, these can be purchased at Home Depot or Lowes

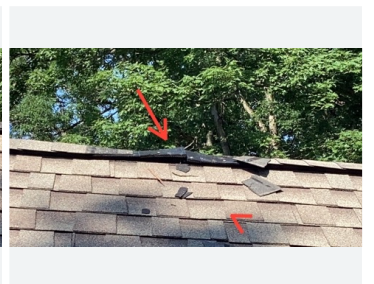
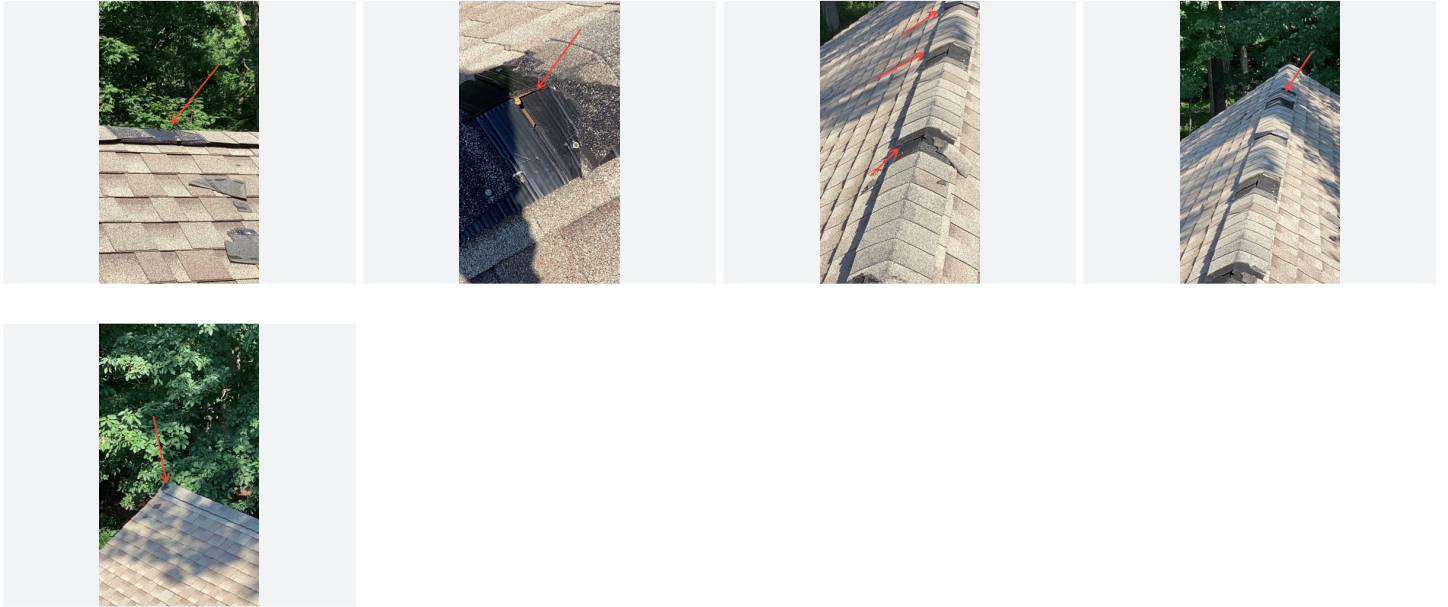
Defective

Loose missing or damaged shingles, Recommend further evaluation from a qualified roofing contractor

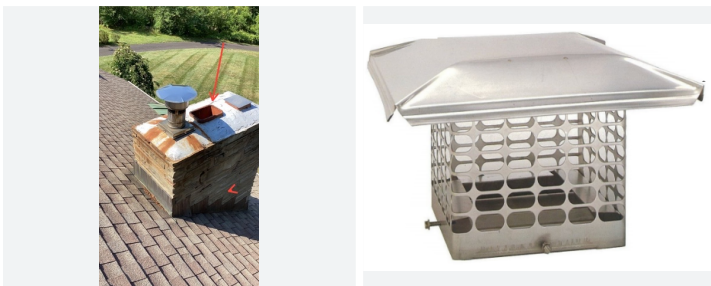
Defective

Recommend adding rain/snow cap to prevent water penetration, recommend further evaluation from a qualified chimney sweep

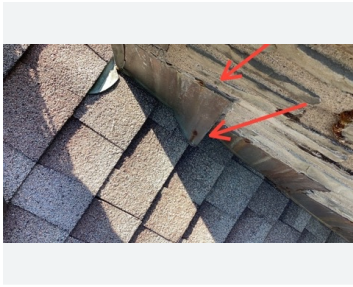
Defective

Loose counter flashing, Recommend further evaluation from a qualified roofing contractor

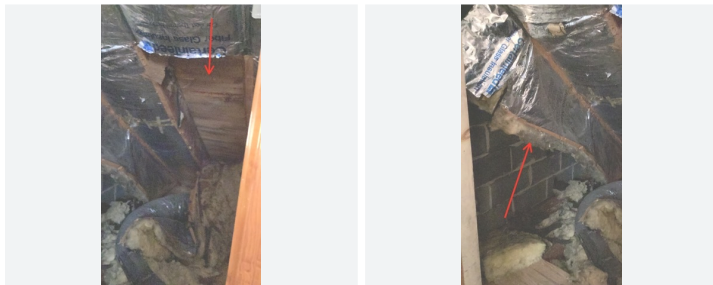
Defective

Insulation batts have fallen out of position-properly reinstall, Recommend further evaluation from a qualified handyman

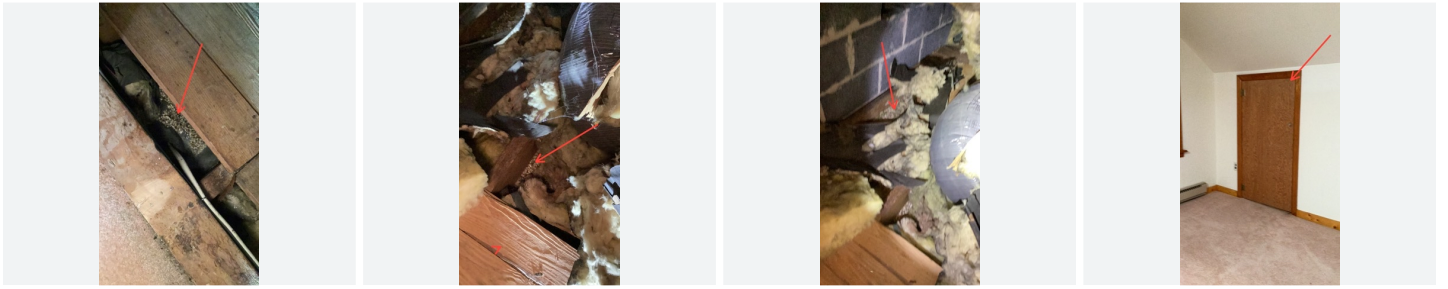
Location - Right Side of House, Front

Defective

Vermiculite Present, only found a small amount most of the attic has plywood over it, the other areas that I was able to check there was no evidence of it. Vermiculite can have asbestos the Zonolite brand did contain traces of asbestos. (please see [www.zonoliteatticinsulation.com](http://www.zonoliteatticinsulation.com) for more details) recommend further evaluation from a asbestos remediation contractor

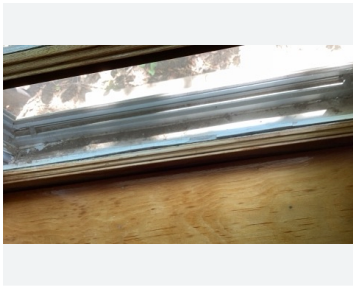
Location - Bedroom Rear

Defective

Exterior glazing repairs required, Recommend further evaluation from a qualified handyman

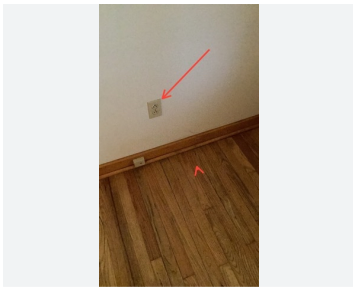
Location - Front Center

Defective

Reversed polarity, Recommend further evaluation from a qualified Electrician

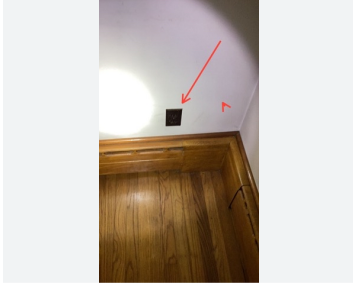
Location - Back of House

Defective

Receptacle not working, Recommend further evaluation from a qualified Electrician

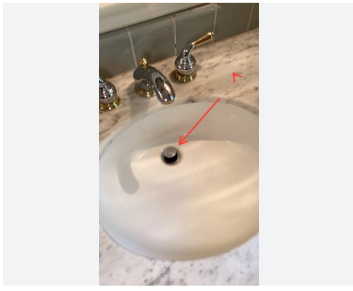
Location - 1st Floor Main

Defective

Stopper not operating, Recommend further evaluation from a qualified handyman

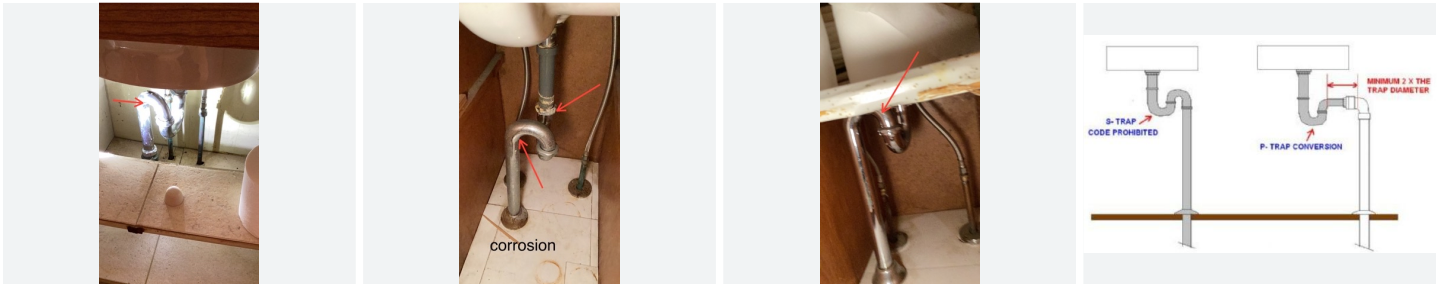
**Location -** Master, Main

An 'S' trap has been used. S traps should be replaced during any new plumbing work as they are subject to siphoning problems. Replacement is sometimes difficult and thus the S traps are usually tolerated. Care should be taken to keep the trap 'primed.' Fixtures should be monitored for sewer odor.

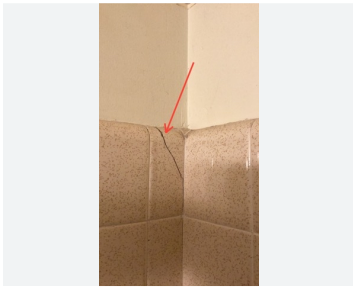
Marginal

Cracked tile

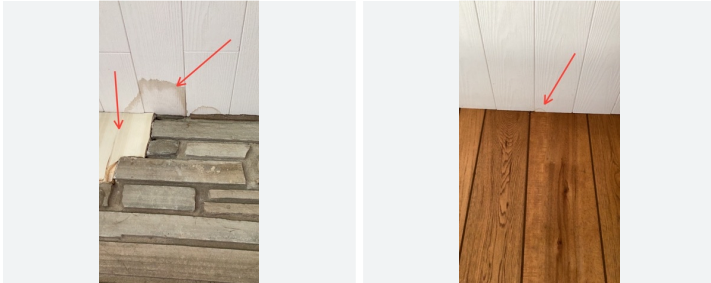
Marginal

Water stains present, no moisture at time of inspection

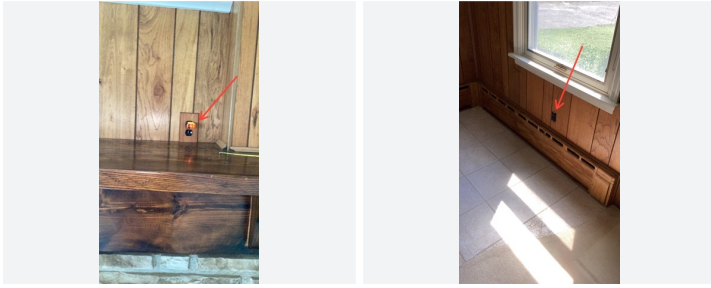
Location - Family Room

Defective

Reversed polarity, Recommend further evaluation from a qualified electrician

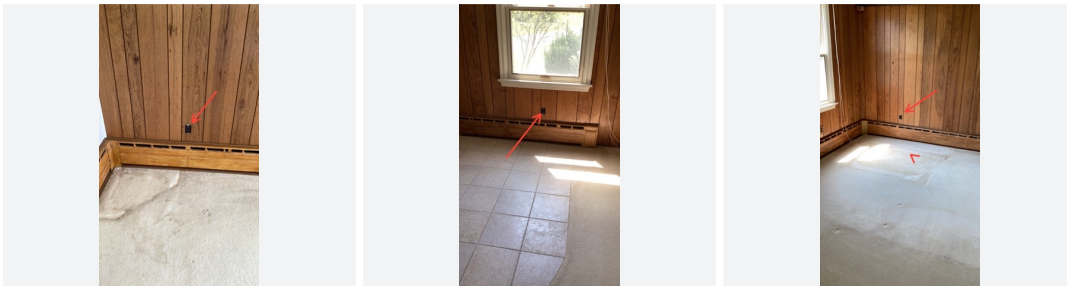
Location - Family Room

Defective

Missing Receptacle cover plates

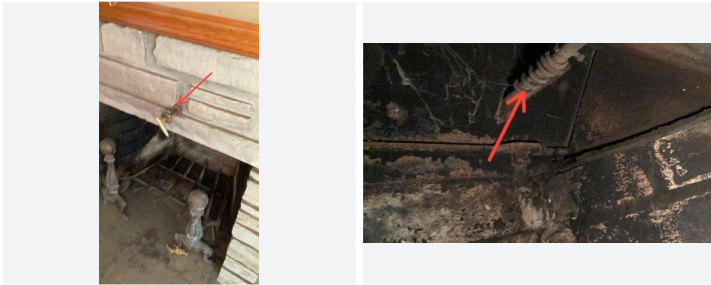
Defective

Defective, not opening, Recommend further evaluation from a qualified chimney sweep

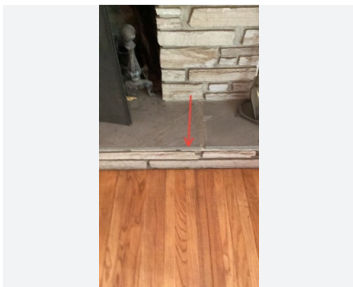
Defective

It is recommended that the hearth extend 16' from front of fire box and 8' beyond each side, this hearth is only 13.5", recommend further evaluation from a qualified contractor

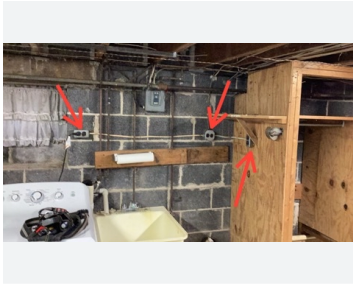
Defective

Non-GFCI circuit, It is recommended that all Receptacles in a Laundry Room be GFCI Protected, Recommend further evaluation from a qualified Electrician

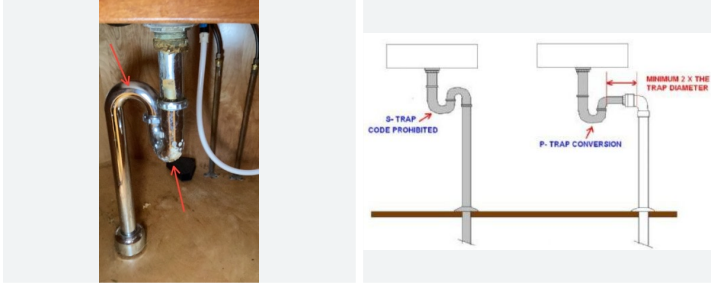
An 'S' trap has been used. S traps should be replaced during any new plumbing work as they are subject to siphoning problems. Replacement is sometimes difficult and thus the S traps are usually tolerated. Care should be taken to keep the trap 'primed.' Fixtures should be monitored for sewer odor.

Trap showing signs of corrosion, no leaks at time of inspection

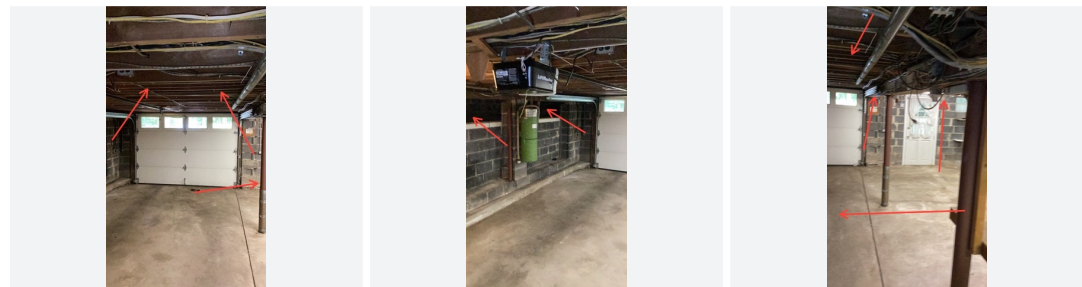
Defective

Cannot be used as a garage it is not fire rated, it is required that fire rated materials be installed to separate any living space from the garage, Recommend further evaluation from a qualified contractor

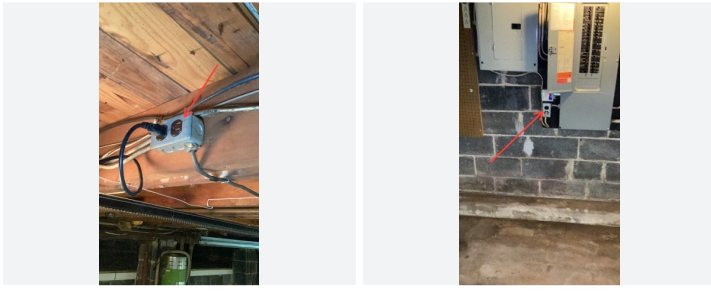
Defective

Non GFCI Receptacle, it is recommended that all Receptacles in a garage be GFCI Protected, recommend further evaluation from a qualified Electrician

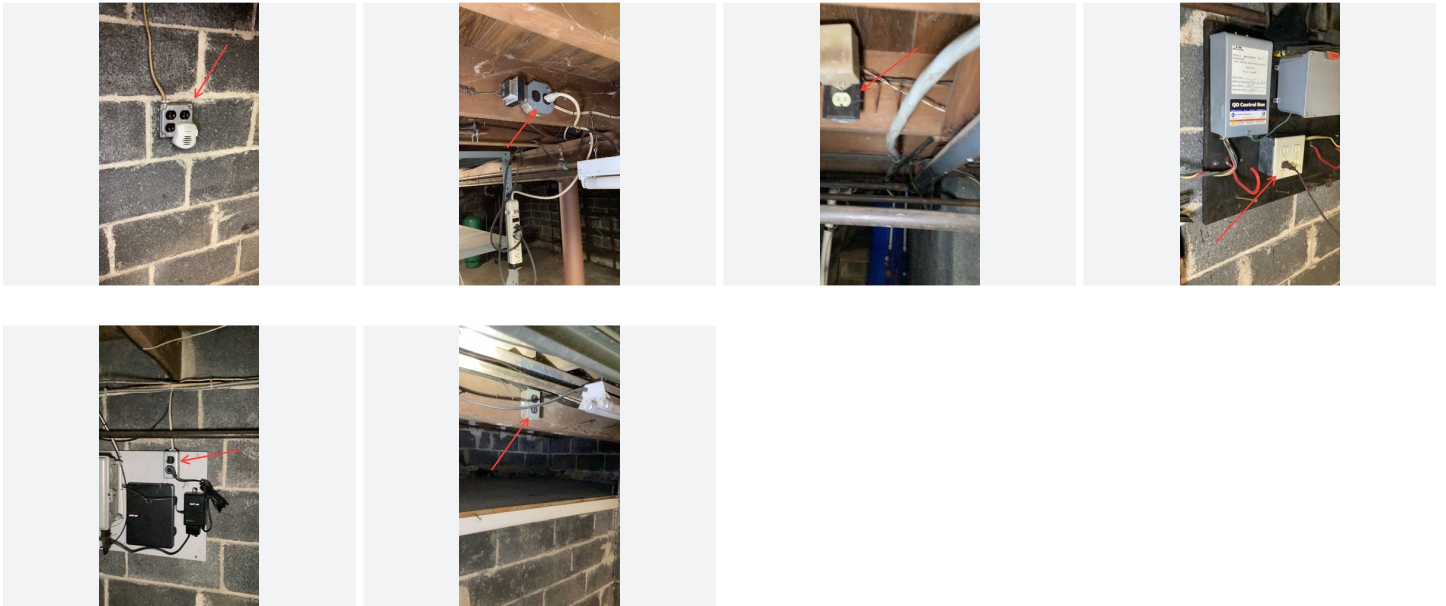
Defective

It is recommended that all Receptacles in an unfinished basement be GFCI Protected, recommend further evaluation from a qualified Electrician

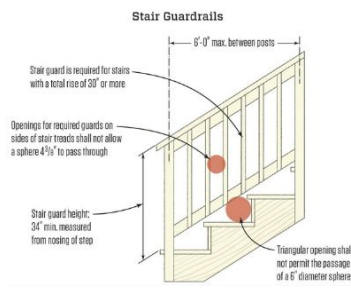
Defective

Missing Stair Guard, recommend further evaluation from a qualified contractor

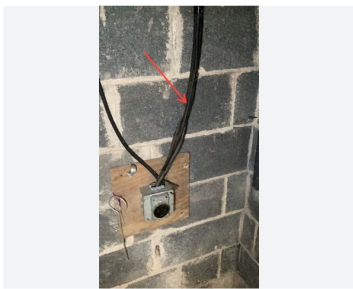
Defective

This cable may not be the the correct wire for this application, Recommend further evaluation from a qualified Electrician

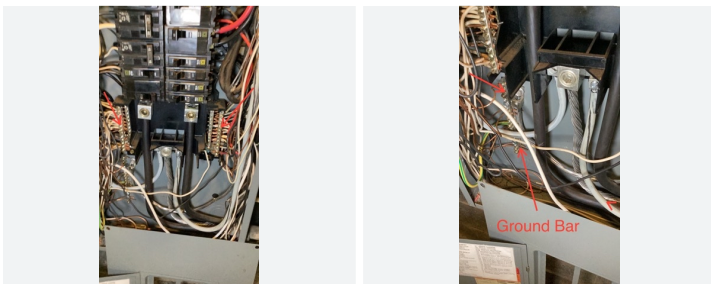
Defective

Neutrals and Grounds are not separated, it is required that the Neutral and Ground wires be separated in a sub panel, Recommend further evaluation from a qualified Electrician

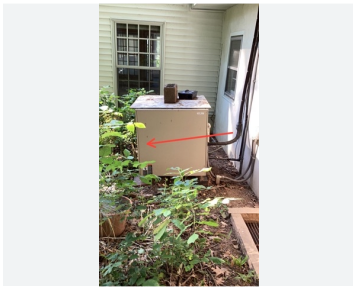
Defective

Unit is not level, to maximize efficiency it is recommended that the unit be Level, recommend further evaluation from a qualified hvac contractor

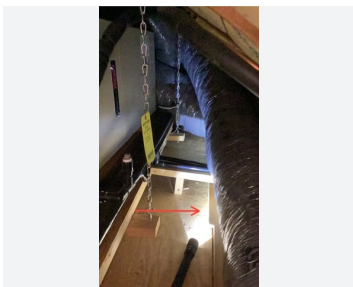
Defective

Not the proper clearance for maintenance, it is required to have a 30" clearance, recommend further evaluation from a qualified hvac contractor

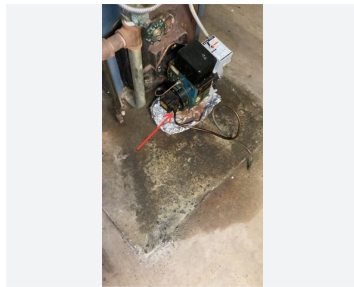
Defective

It is recommended that fire valves be installed at the Furnace and the Tank, according to NFPA regulations, recommend further evaluation from a qualified hvac contractor

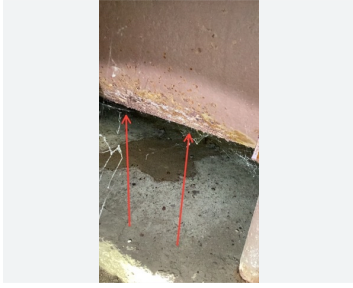
Defective

Tank is showing signs of rust, No leaks noted at time of inspection, recommend further evaluation from a heating contractor
