Home Inspection Report

Prepared for: Sherry Russell Alderfer Auction

244 Larkspur Lane
Hatfield, Pa. 19440

Inspected by:
Mike Bilyk
Cornerstone Home Inspection Services Inc

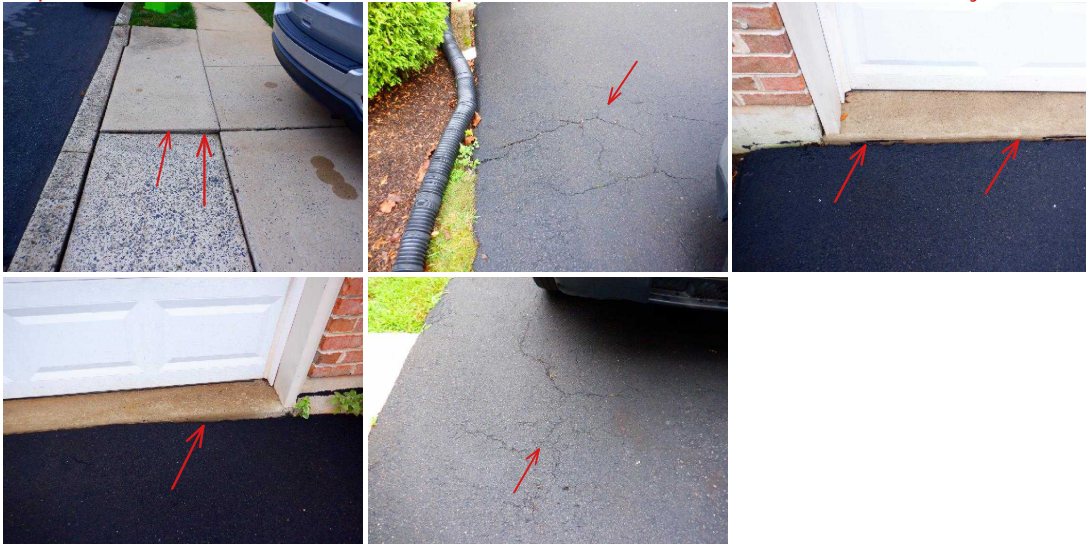
1. Driveway: Asphalt and Concrete Seal cracks and top surface as needed to prevent water damage, Repair uneven areas to prevent a trip hazard. Fill low area where the driveway meets the garage.

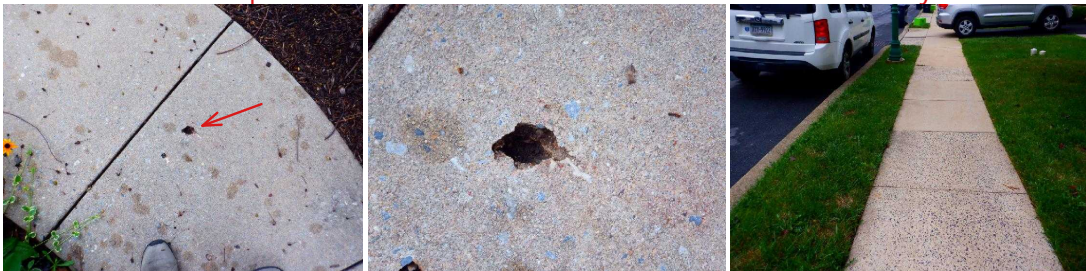
2. Walks: Concrete Repair hole and uneven areas to maintain safe walk ways.

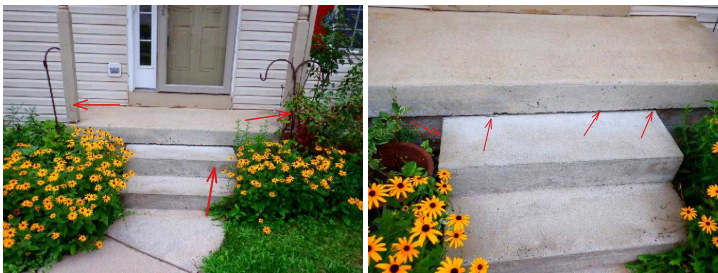
3. Steps/Stoops: Concrete Seal the open gap where the steps meet the structure to prevent water damage. Install a grip type hand rail with openings in the railings no more than 4 inches to prevent a fall.

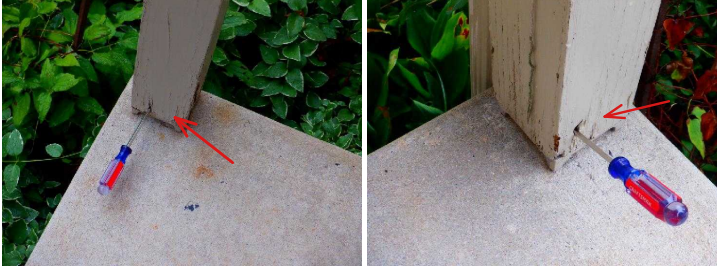
4. Porch: Concrete **Water damage noted to the front porch roof support post, repair to maintain support.**

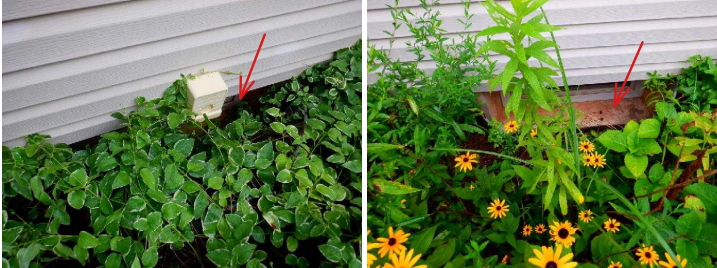
8. Window Wells: Metal **Install a window well cover to help prevent basement moisture.**

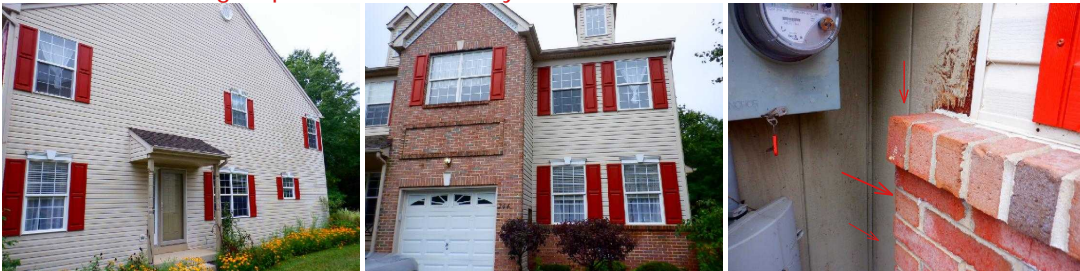
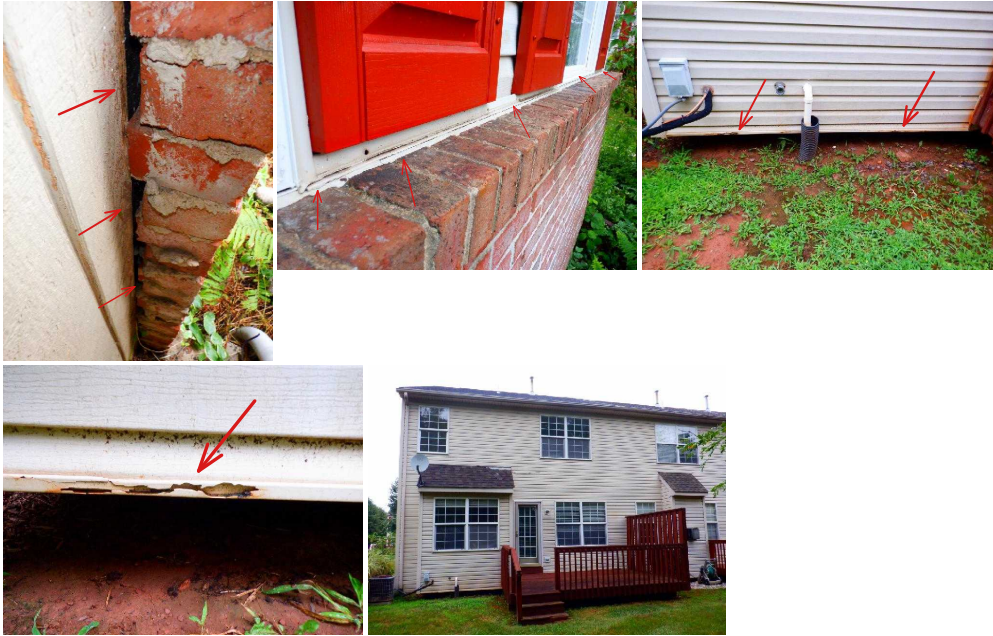
1. Type: Brick and vinyl siding **Gaps not properly sealed at front left side , repair to prevent water damage. Caulk where the brick wall meets the siding to prevent water related damage. Repair the holes in the siding to prevent water entry.**

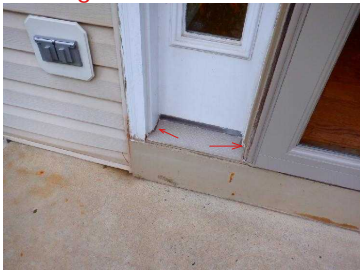
- 2. Fascia: Aluminum
- 3. Soffits: Vented
- 4. Door Bell: Present
- 5. Entry Doors: Fiberglass entry door **Caulk the open gaps at the lower frame to prevent water related damage.**

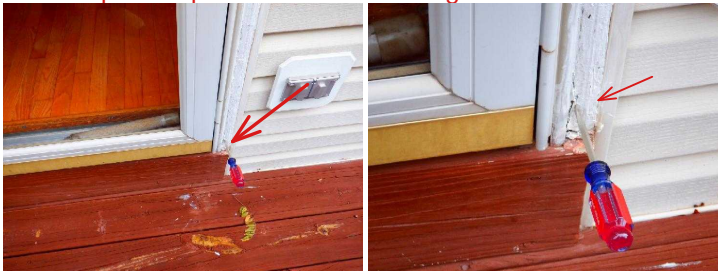
- 6. Patio Door: Metal entry door **Water damage noted to the exterior wood trim of the deck sliding glass door. Repair to prevent water damage.**

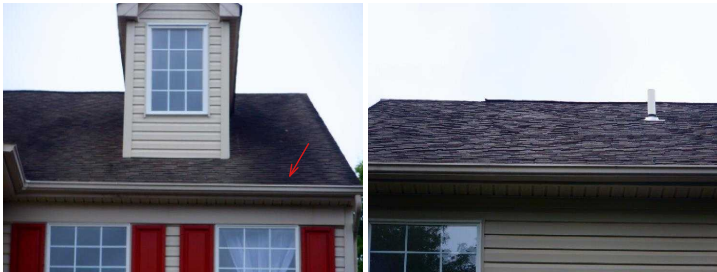
- 1. Method of Inspection: Compact Zoom
- 2. Material: Dimensional Shingles, Average life cycle 30-35 Years **A qualified roofing contractor is recommended to evaluate and estimate repairs, water stains noted above window at the master bedroom. Recommend a roof certification.**

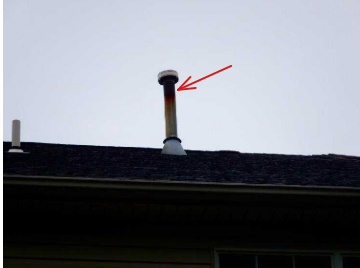
11. Chimney: Metal pipe **Rust noted,repair or replace to prevent deterioration/water damage. Consult a heating contractor.**

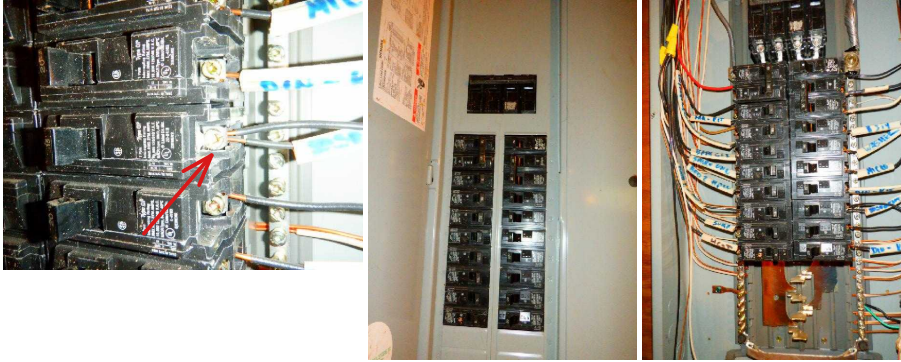
8. Manufacturer: Seimens **Double taps are present at breakers. These circuits need to be moved to their own circuit breaker and cannot share a breaker. It is recommended that a qualified electrician inspect the new circuits and properly connect the new circuits to an individual breaker for each circuit.**

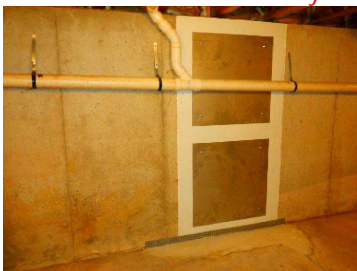
1. Structure Type: Wood frame
2. Foundation: Poured concrete **Obtain documentation for the foundation repairs and monitor for wall movement or water entry.**

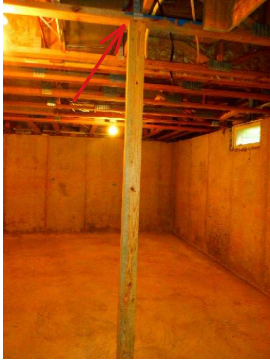
5. Piers/Posts: Wood **Attach the supporting post to prevent movement.**

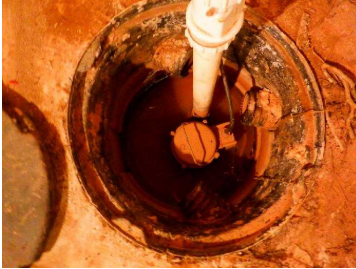
1. Doors: PVC
2. Windows: Awning
3. Electrical: 110 VAC GFCI outlets and lighting circuit
4. Smoke Detector: Present
5. Ventilation: Windows
6. Sump Pump: Submerged **Recommend install the sump pump on a dedicated GFCI protected outlet. Recommend installation of water-powered back-up sump pump to protect basement finishes if the electrical power was were off. Diaphragm type pump switch,no water in the crock,fill crock and verify operation.**

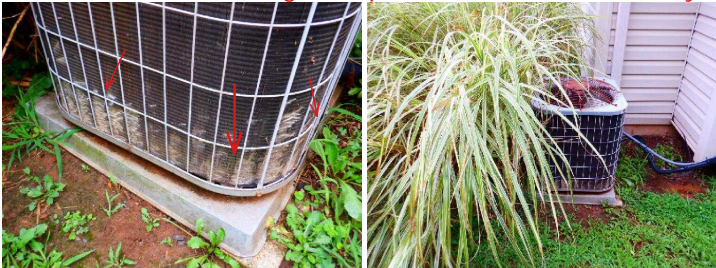
- 1. A/C System Operation: Functional **Clean and service yearly to maintain efficiency , The unit is currently in service beyond the manufactures stated design life,budget for replacement , No recent service tags noted,Recommend servicing by a qualified contractor.**
- 2. Condensate Removal: Electric pump
- 3. Exterior Unit: Pad mounted
- 4. Manufacturer: Carrier
- 5. Area Served: Whole building,unless stated on the sellers discloser Approximate Age: 24
- 6. Fuel Type: 120-240 VAC Temperature Differential: 18 Degrees
- 7. Type: Central A/C Capacity: 3 Ton
- 8. Visible Coil: Copper core with aluminum fins **Cut back bushes to maintain air flow 1 foot at sides 6 feet above. Fins damaged, repair to maintain efficiency.**

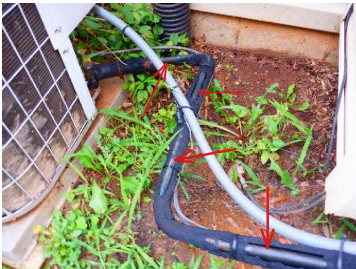
- 9. Refrigerant Lines: Suction line and liquid line **Replace missing or damaged insulation to prevent heat transfer/condensation/water damage.**

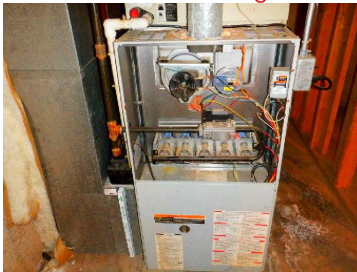
1. Heating System Operation: Functional Furnace existing beyond design life, budget for replacement.
No recent service tag noted, recommend cleaning and servicing needed

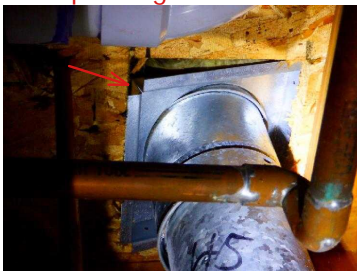
9. Flue Pipe: Double wall Repair loose fire space blocker to close off the open chase to prevent a fire from passing into the attic.

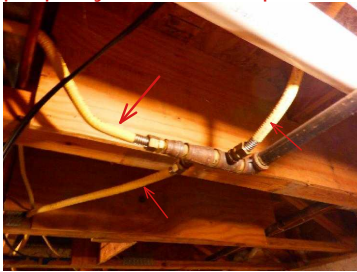
7. Gas Service Lines: Steel and flex **Ground gas lines as per local codes , consult a Electrical contractor for safety, Csst yellow flex gas lines have been experienced pin holes if a lightning strikes the property , consult a qualified contractor for safety.**

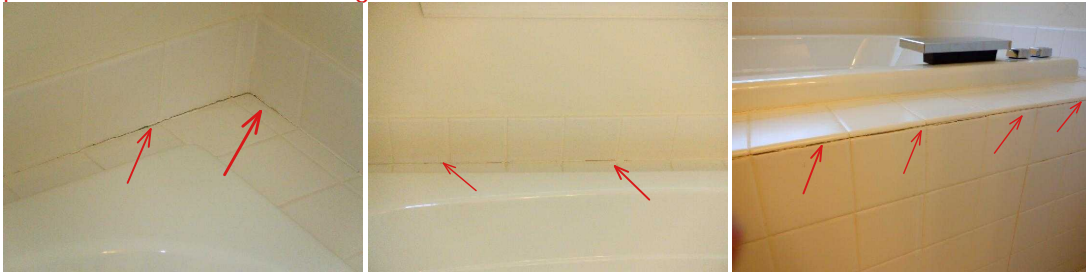
1. Closet: Single small
2. Ceiling: Painted Drywall
3. Walls: Painted Drywall
4. Floor: Ceramic tile
5. Doors: PVC **Lockset(s) not latching-requires adjustment**
6. Windows: Single hung
7. Electrical: 110 VAC GFCI outlets and lighting circuit
8. Counter/Cabinet: Acrylic and wood
9. Sink/Basin: Molded single bowl
10. Faucets/Traps: Moen fixtures with a PVC trap
11. Tub/Surround: Fiberglass tub with ceramic surround **Caulk where the wall tiles meet the tub to prevent water related damage**

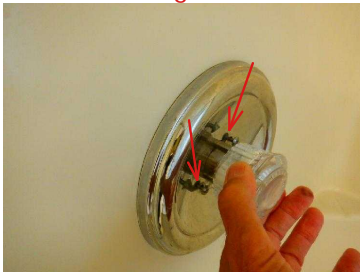
12. Shower/Surround: Fiberglass pan and fiberglass surround **Repair loose faucets to prevent water related damage.**

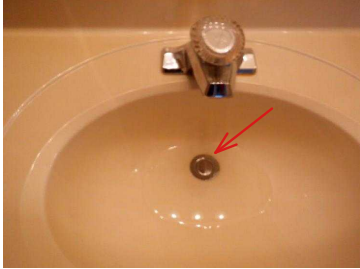
23. Faucets/Traps: Moen fixtures with a PVC trap **Sink stopper not operating, repair**

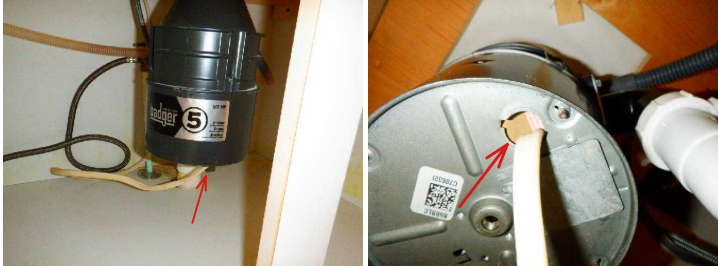
3. Disposal: In-Sinkerator **Install a wire connector to protect the wire from damage or be pulled out ,or causing electrical shock.**

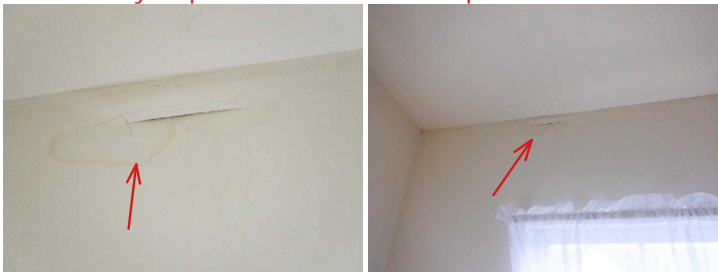
29. Ceiling: Painted Drywall **Water stains present , Checked with a moisture meter,no high level of moisture noted , Consult the home owner for details of the staining,if no explanation is given further evaluate by a qualified contractor to prevent water related damage.**

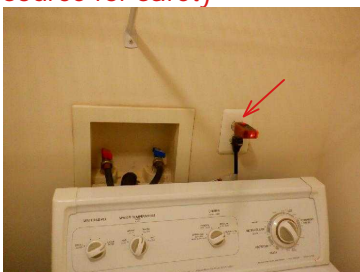
1. Ceiling: Painted Drywall
2. Walls: Painted Drywall
3. Floor: Vinyl floor covering
4. Doors: PVC
5. Electrical: 110 VAC outlets and lighting circuits **Non-GFCI circuit ,install within 6 feet of a water source for safety**

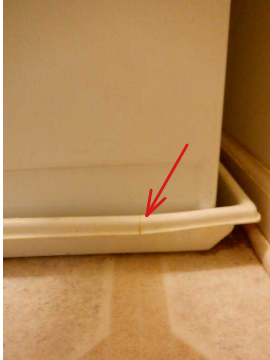
- 6. Smoke Detector:
- 7. HVAC Source: Forced air registers
- 8. Washer Hose Bib: Ball valves **Install metal braided hoses to prevent rubber failure.**
- 9. Washer and Dryer Electrical: 110-240 VAC **Washer and dryer are as is condition. Not tested.**
- 10. Dryer Vent: Metal flex **The clothes dryer vent and piping needs cleaning now and yearly for fire safety.**
- 11. Washer Drain: Wall mounted drain
- 12. Floor Drain: Pan under washer **Pan is cracked,replace to prevent water related damage.**
