Home Inspection Report

323 Applebrook Drive
Malvern, Pa. 19355

Inspected by:
Mike Bilyk
Cornerstone Home Inspection Services Inc

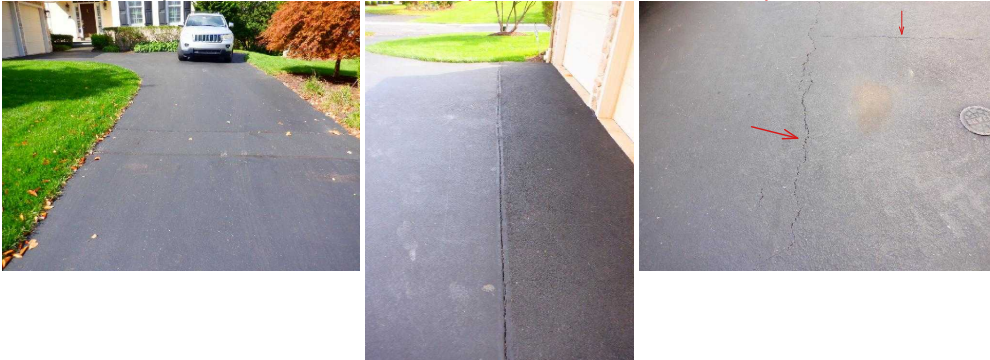
1. Driveway: Asphalt Seal cracks and top surface as needed to prevent water damage

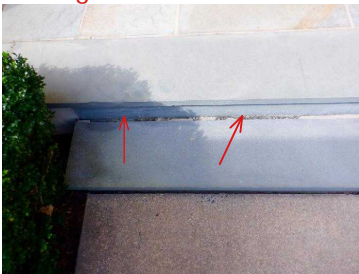
2. Steps/Stoops: Flagstone Seal the open gap where the steps meet the structure to prevent water damage or a fall

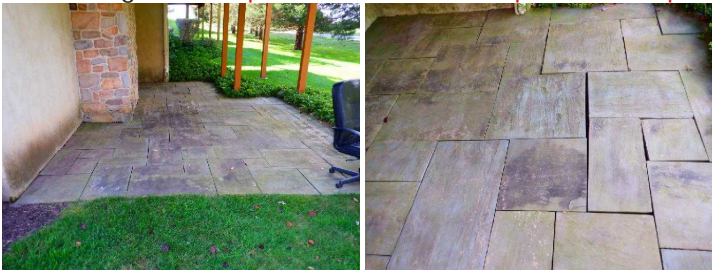
4. Patio: Flagstone Repair uneven areas to prevent a trip hazard

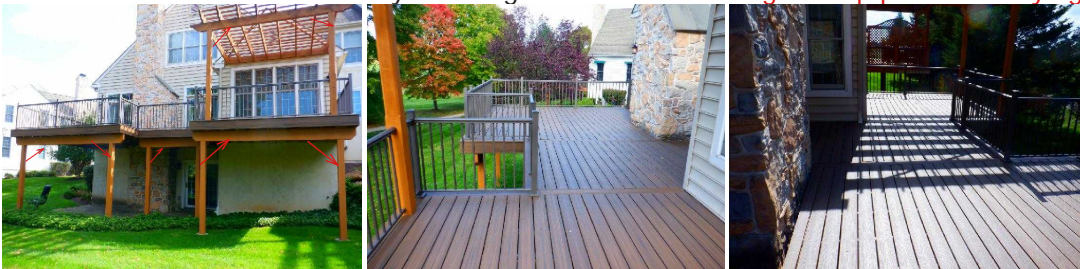
5. Deck: Pressure treated and Vinyl decking Install cross bracing to help prevent swaying.

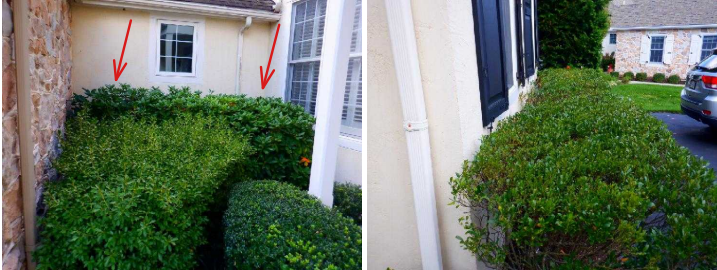
6. Grading: Minor slope
7. Vegetation: Shrubs and trees **Cut back trees and bushes to 12 inches of the structure to prevent water or insect damage.**

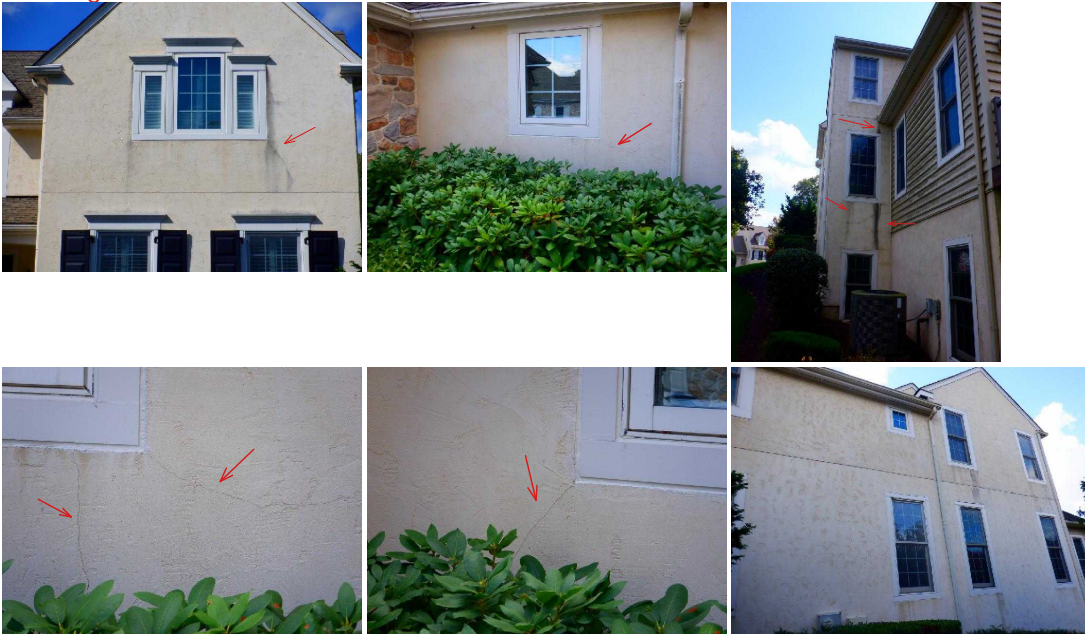
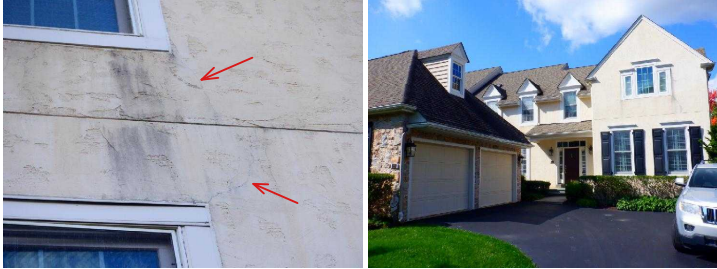
1. Type: Stucco, ornamental stone and vinyl siding **Stucco exterior finishes are prone to water infiltration and may cause hidden damage to the structure. There is usually no visible evidence of such damage. We recommend a detailed inspection by a qualified specialist prior to settlement. Cracks and staining noted.**

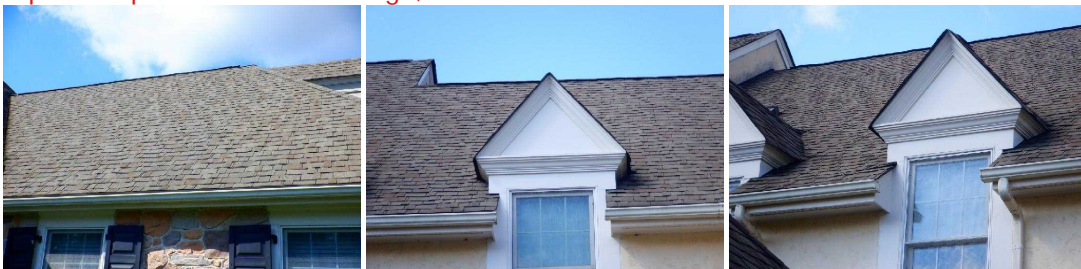
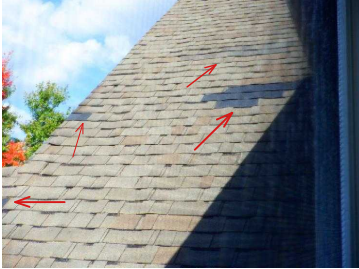
- 1. Method of Inspection: Compack Zoom
- 2. Unable to Inspect: 10% **Roof pitch**
- 3. Material: Dimensional Shingles, Average life cycle 30-35 Years **A qualified roofing contractor is recommended to evaluate and estimate repairs, Several missing/damaged shingles,, recommend repairs to prevent water damage, rear roof.**

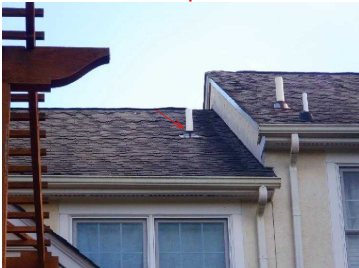
- 8. Plumbing Vents: PVC **The sanitary sewer vent pipe storm collars have a average life of 15 years , recommend replacement to prevent the risk of water damage.**

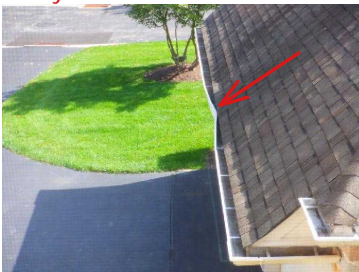
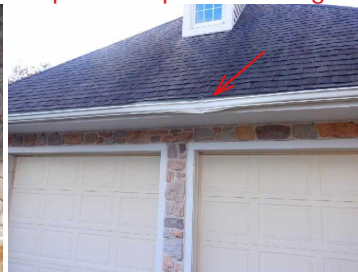
- 9. Electrical Mast: Underground utilities
- 10. Gutters: Aluminum **Need cleaning and maintenance to prevent water damage to the home or water entry to the basement or crawl space. Replace damaged gutters at the garage.**

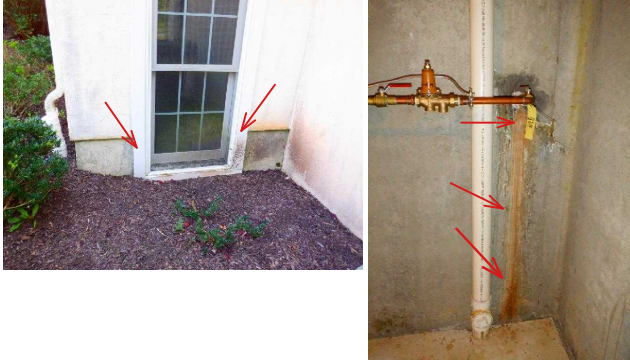
9. Moisture Location: Window and by the water entry pipe. **Improve grading, maintain gutter systems , rear window by the outdoor a/c condensing unit. Consult the homeowner and monitor water stains at front basement water supply entry pipe.**

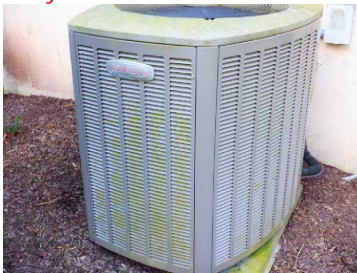
1. A/C System Operation: Functional **Clean and service yearly to maintain efficiency, Average life cycle 15 years.**

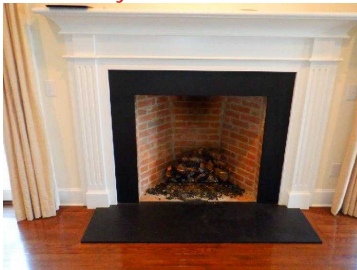
5. Fireplace Construction: Prefab **Did not light when tested,verify operation , install a spark screen for fire safety.**

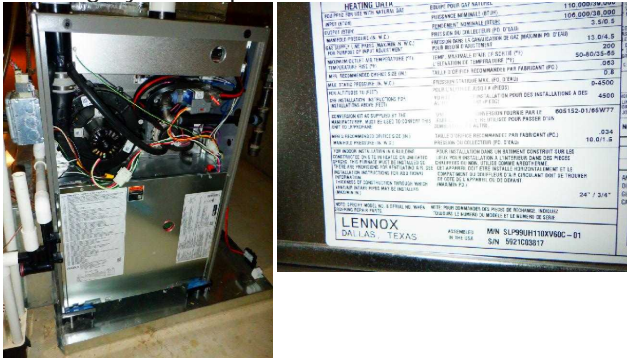
1. Heating System Operation: Functional **Clean and service yearly,average life cycle is 15 years**

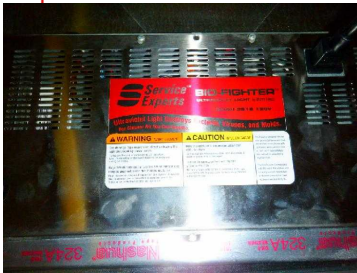
2. Manufacturer: Lennox
3. Type: Gas fired forced draft warm air condensing unit Capacity: 109,000BTU
4. Area Served: Whole building,unless stated on the sellers discloser Approximate Age: 4
5. Fuel Type: Natural gas
6. Blower Fan/Filter: Direct drive with disposable filter **Clean or replace the air filter monthly to maintain efficiency.**
7. Distribution: Metal duct
8. Draft Control: Forced
9. Flue Pipe: PVC
10. Devices: UVLight **Consult your HVAC contractor for repair or service , unplugged at the time of the inspection.**

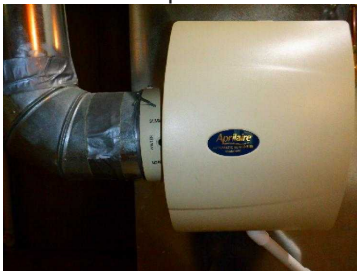
11. Humidifier: April-Aire 600 **Requires Yearly service,Not tested**

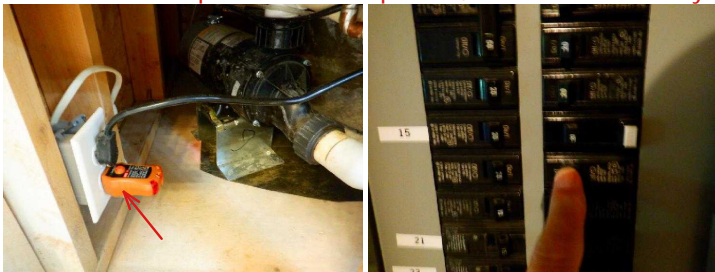
1. Ceiling: Painted Drywall
2. Walls: Painted Drywall
3. Floor: Ceramic tile
4. Doors: Wood
5. Windows: Casement
6. Electrical: 110 VAC GFCI outlets and lighting circuit
7. Counter/Cabinet: Acrylic and wood
8. Sink/Basin: Molded dual bowl
9. Faucets/Traps: Unknown faucets with a metal trap
10. Shower/Surround: Ceramic pan and ceramic surround
11. Spa Tub/Surround: Fiberglass tub with ceramic surround **No power to the outlet , gfcı tripped in the main electrical panel for the spa tub, further evaluate by a qualified contractor and repair .**

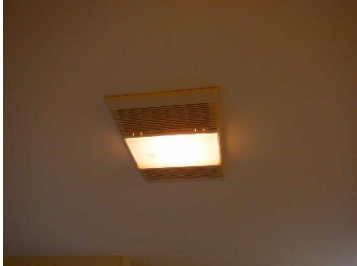
14. Ventilation: Electric ventilation fan with heater **Fan is very loud and faulty operation,replace the bath room main exhaust fan for safety.**

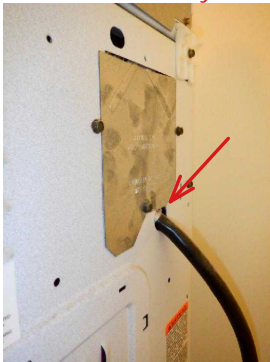
- 1. Ceiling: Painted Drywall
- 2. Walls: Painted Drywall
- 3. Floor: Vinyl floor covering
- 4. Doors: Wood
- 5. Windows: Casement
- 6. Electrical: 110 VAC outlets and lighting circuits **Non-GFCI circuit ,install within 6 feet of a water source for safety**

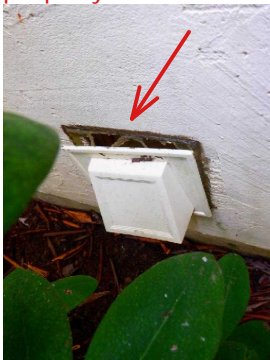
- 7. Smoke Detector:
- 8. HVAC Source: Forced air registers
- 9. Laundry Tub: PVC
- 10. Laundry Tub Drain: Metal
- 11. Washer Hose Bib: Multi-port **Install metal braided hoses to prevent rubber failure.**
- 12. Washer and Dryer Electrical: 110-240 VAC **Install a wire connector at the service wire to protect the wire from damage or be pulled out.Repair to prevent electrical shock. Washer and dryer are as is condition. Not tested.**
- 13. Dryer Vent: Metal flex **The exterior dryer vent cover is loose or damaged, The dryer vent piping is not properly attached to the dryer , repair.**

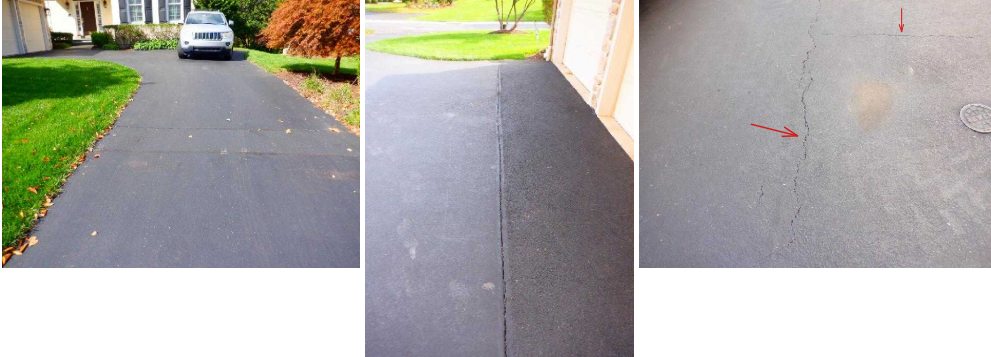
1. Driveway: Asphalt Seal cracks and top surface as needed to prevent water damage

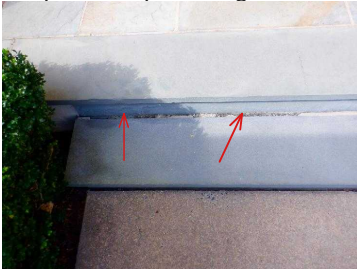
2. Steps/Stoops: Flagstone Seal the open gap where the steps meet the structure to prevent water damage or a fall

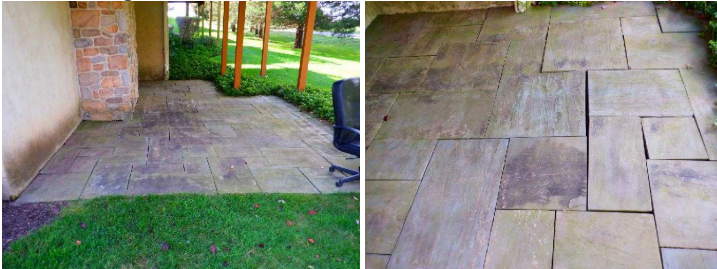
3. Patio: Flagstone Repair uneven areas to prevent a trip hazard

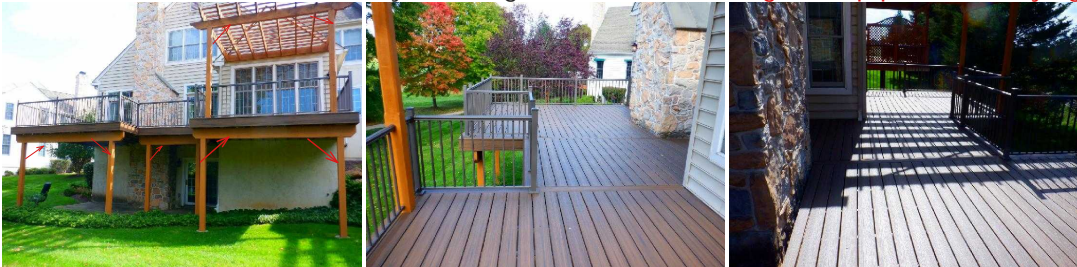
4. Deck: Pressure treated and Vinyl decking Install cross bracing to help prevent swaying.

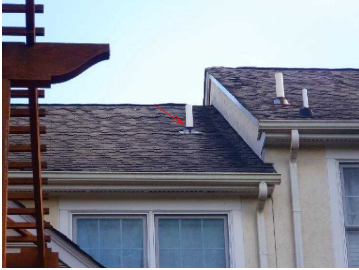
5. Plumbing Vents: PVC The sanitary sewer vent pipe storm collars have a average life of 15 years , recommend replacement to prevent the risk of water damage.

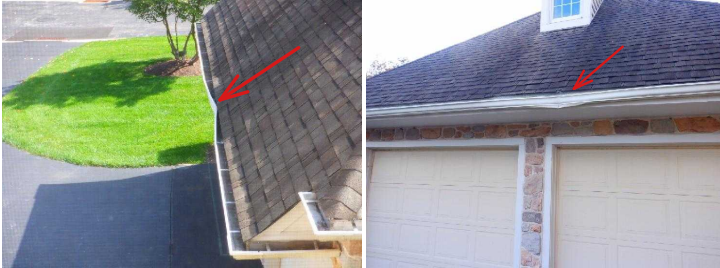
6. Gutters: Aluminum Need cleaning and maintenance to prevent water damage to the home or water entry to the basement or crawl space. Replace damaged gutters at the garage.

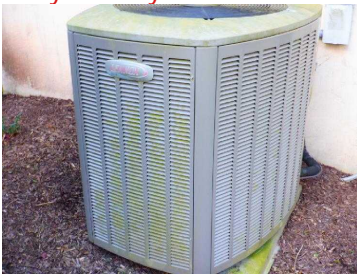
10. Side Yard AC System A/C System Operation: Functional Clean and service yearly to maintain efficiency, Average life cycle 15 years.

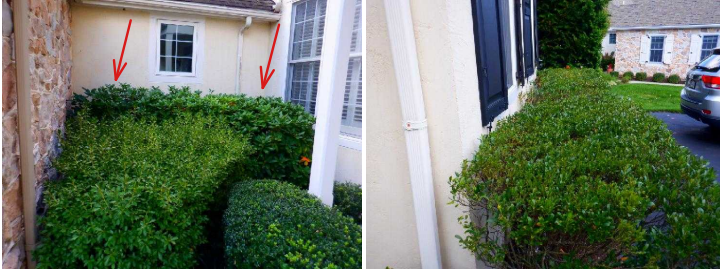
1. Vegetation: Shrubs and trees **Cut back trees and bushes to 12 inches of the structure to prevent water or insect damage.**

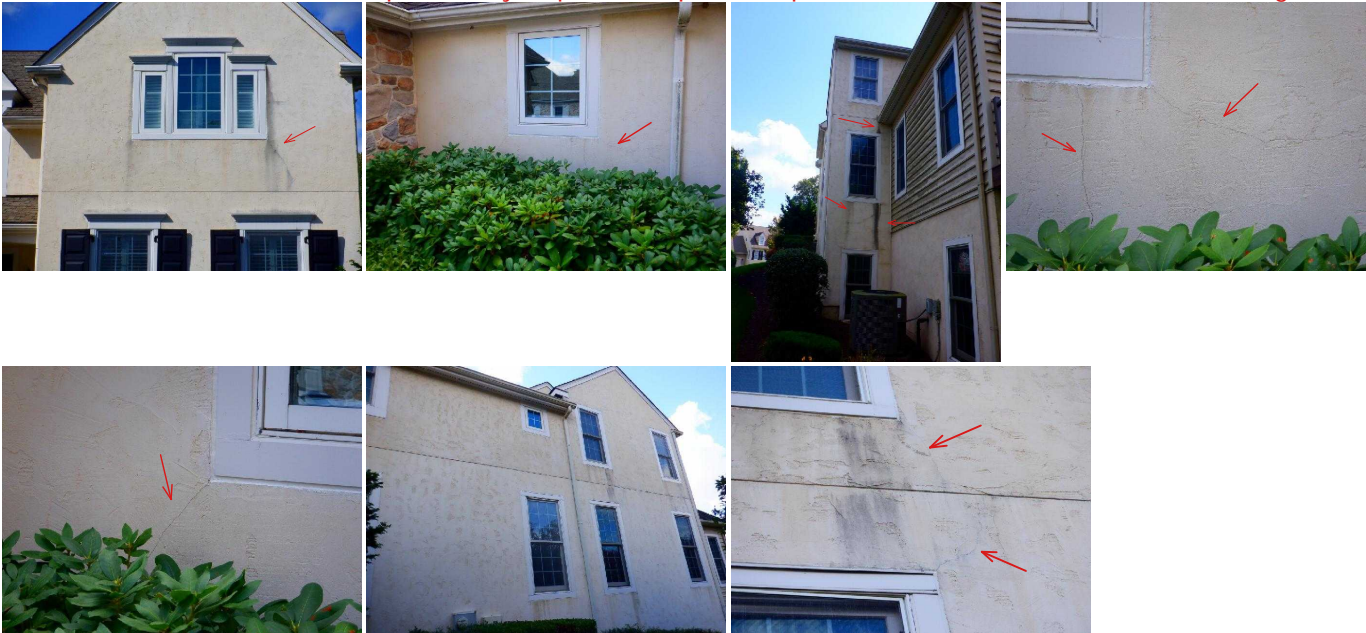
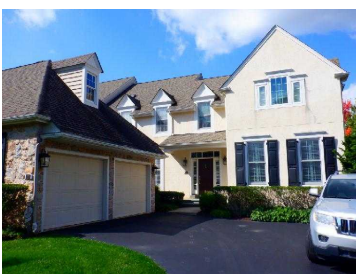
2. All Exterior Surface Type: Stucco, ornamental stone and vinyl siding **Stucco exterior finishes are prone to water infiltration and may cause hidden damage to the structure. There is usually no visible evidence of such damage. We recommend a detailed inspection by a qualified specialist prior to settlement. Cracks and staining noted.**

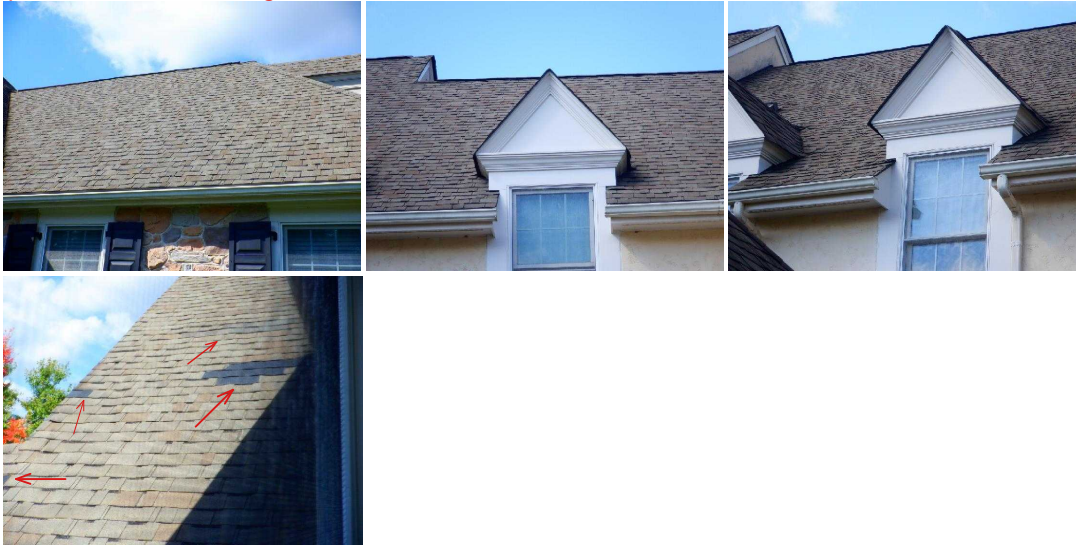
3. Main Roof Surface Material: Dimensional Shingles, Average life cycle 30-35 Years **A qualified roofing contractor is recommended to evaluate and estimate repairs, Several missing/damaged shingles,, recommend repairs to prevent water damage, rear roof.**

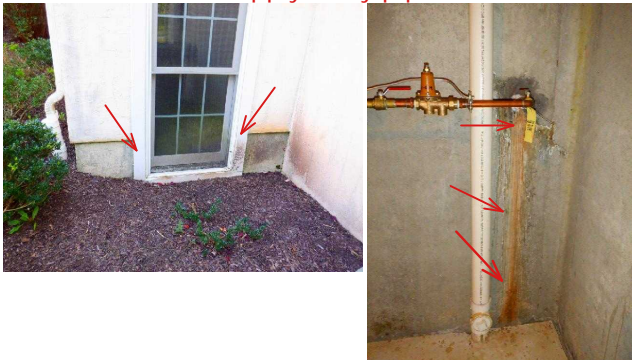
4. Main Basement Moisture Location: Window and by the water entry pipe. **Improve grading, maintain gutter systems , rear window by the outdoor a/c condensing unit. Consult the homeowner and monitor water stains at front basement water supply entry pipe.**

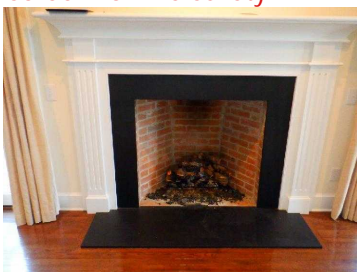
5. Family Room Fireplace Fireplace Construction: Prefab **Did not light when tested, verify operation , install a spark screen for fire safety.**

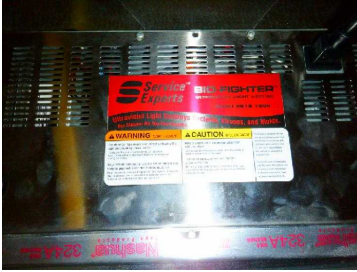
6. Basement Heating System Devices: UVLight Consult your HVAC contractor for repair or service , unplugged at the time of the inspection.

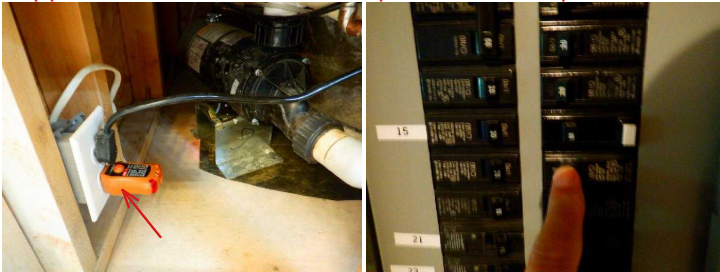
7. 2nd Floor Master Bathroom Spa Tub/Surround: Fiberglass tub with ceramic surround No power to the outlet , gfci tripped in the main electrical panel for the spa tub,further evaluate by a qualified contractor and repair .

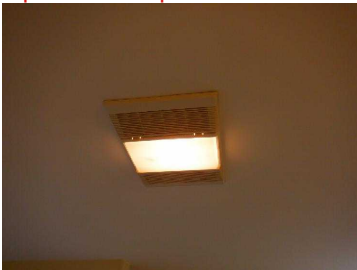
8. 2nd Floor Master Bathroom Ventilation: Electric ventilation fan with heater Fan is very loud and faulty operation,replace the bath room main exhaust fan for safety.

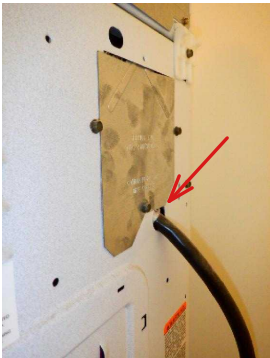
9. 1st Floor Laundry Room/Area Electrical: 110 VAC outlets and lighting circuits Non-GFCI circuit ,install within 6 feet of a water source for safety

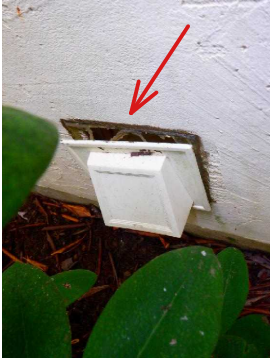
10. 1st Floor Laundry Room/Area Washer and Dryer Electrical: 110-240 VAC Install a wire connector at the service wire to protect the wire from damage or be pulled out. Repair to prevent electrical shock. Washer and dryer are as is condition. Not tested.
11. 1st Floor Laundry Room/Area Dryer Vent: Metal flex The exterior dryer vent cover is loose or damaged, The dryer vent piping is not properly attached to the dryer , repair.
