# Drainage Plane Remediation

Applebrook Carriage Homes

Lot 28

323 Applebrook Drive

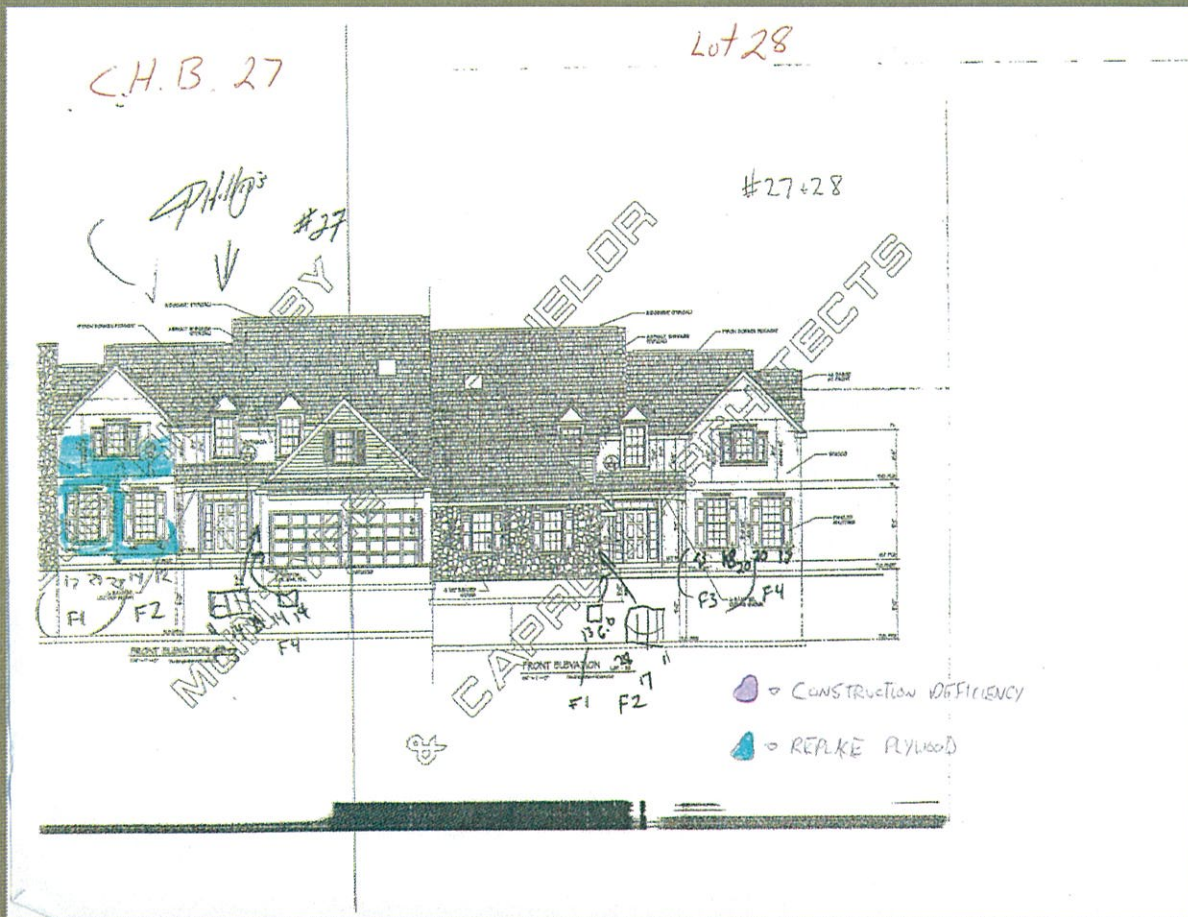
## 323 Applebrook Drive

# Test Results

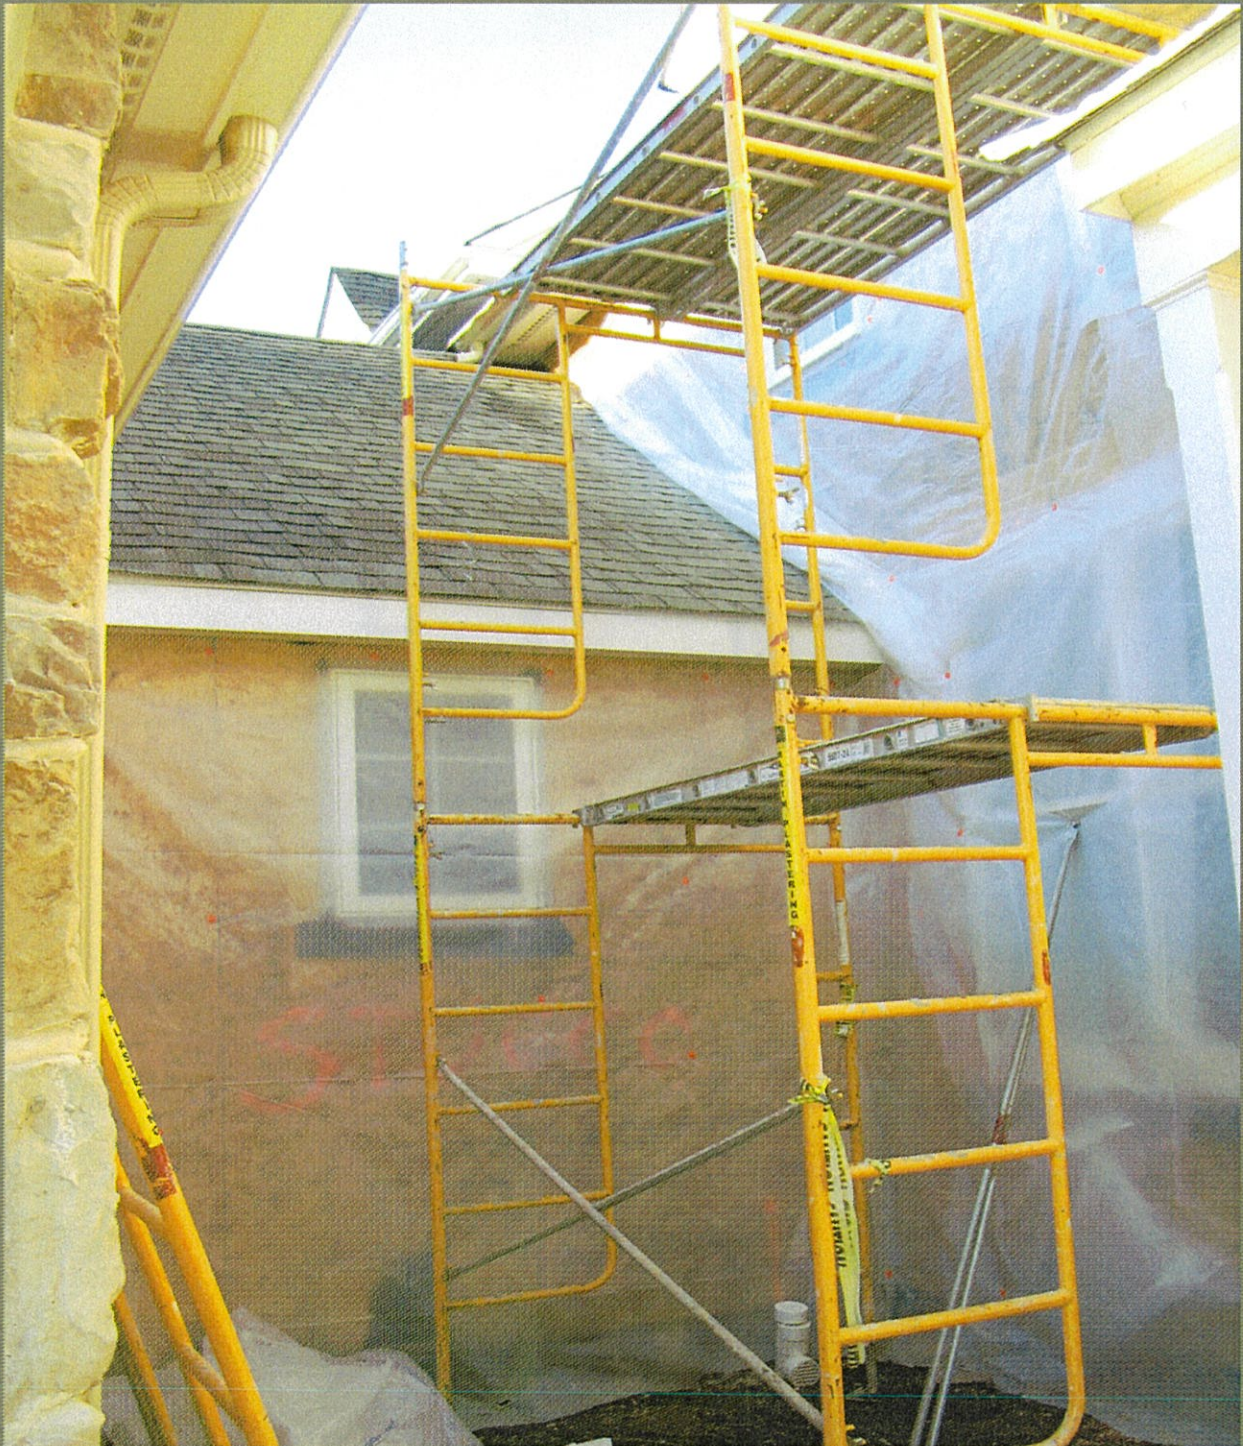
323 Applebrook Drive  
Stucco Removal

# Remediation In-Progress

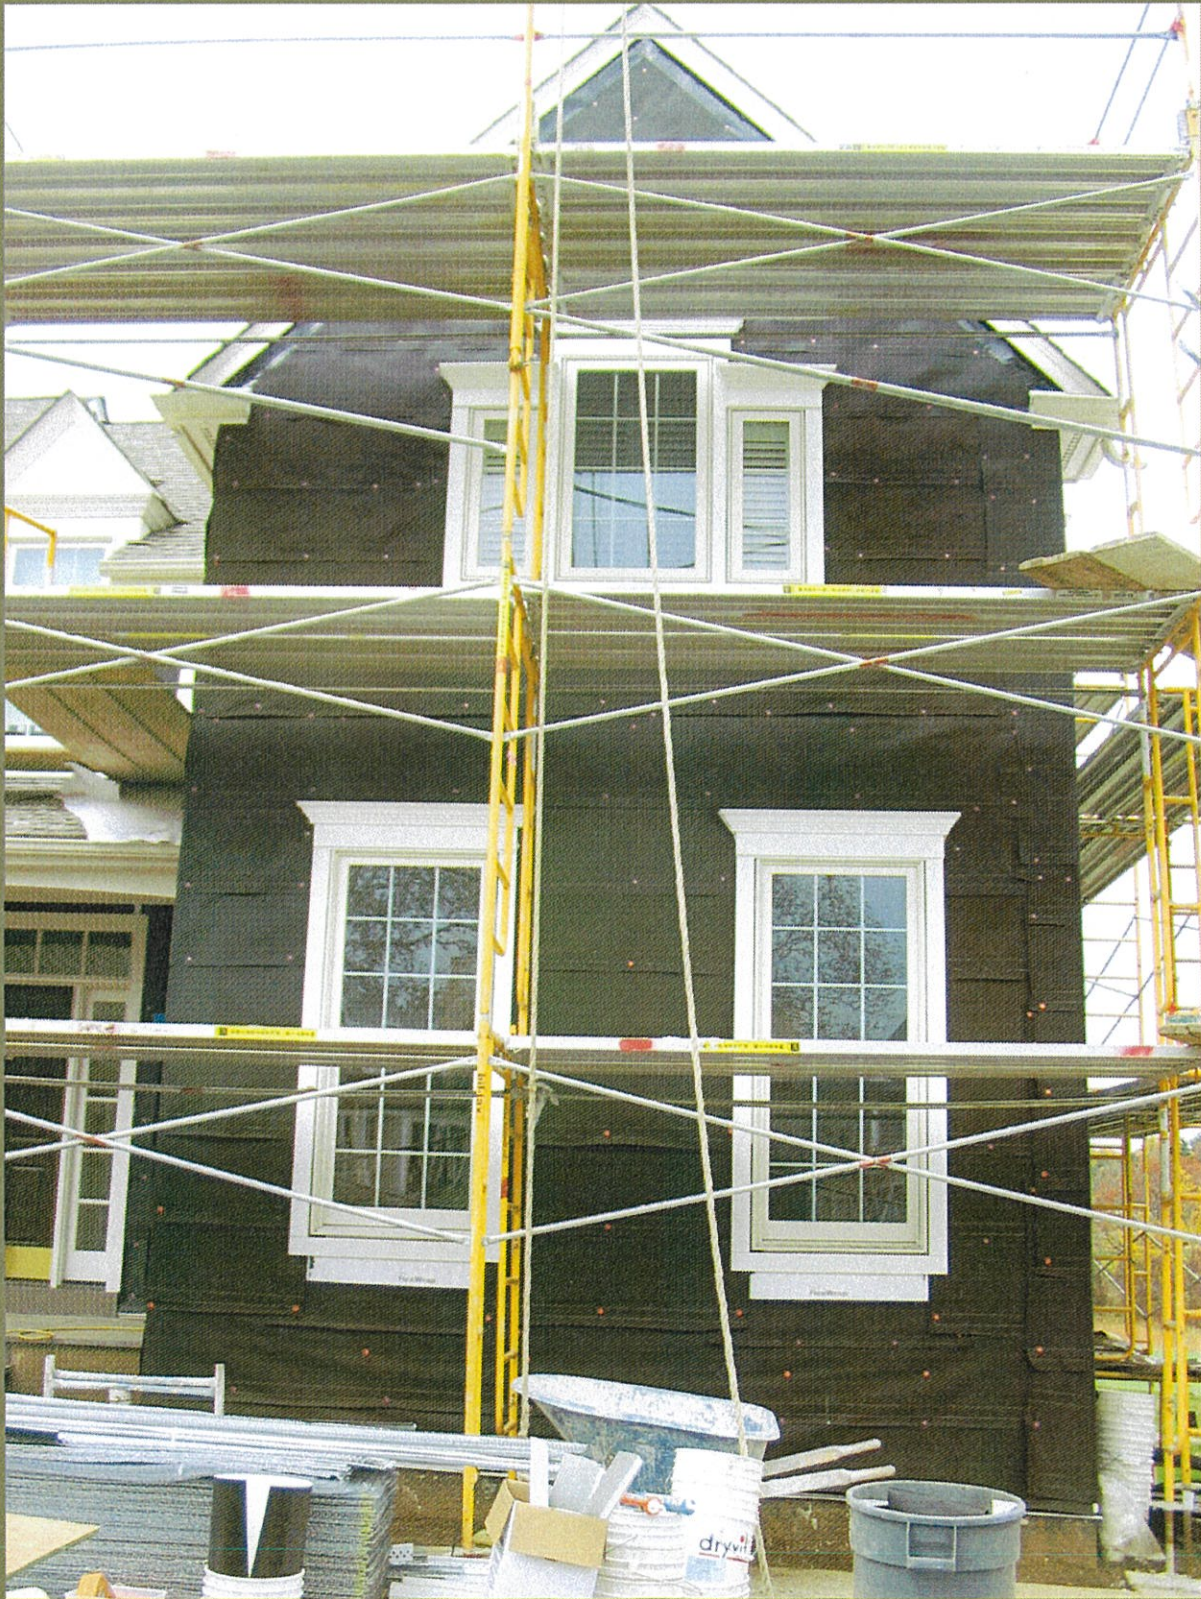
# New Drainage Plane

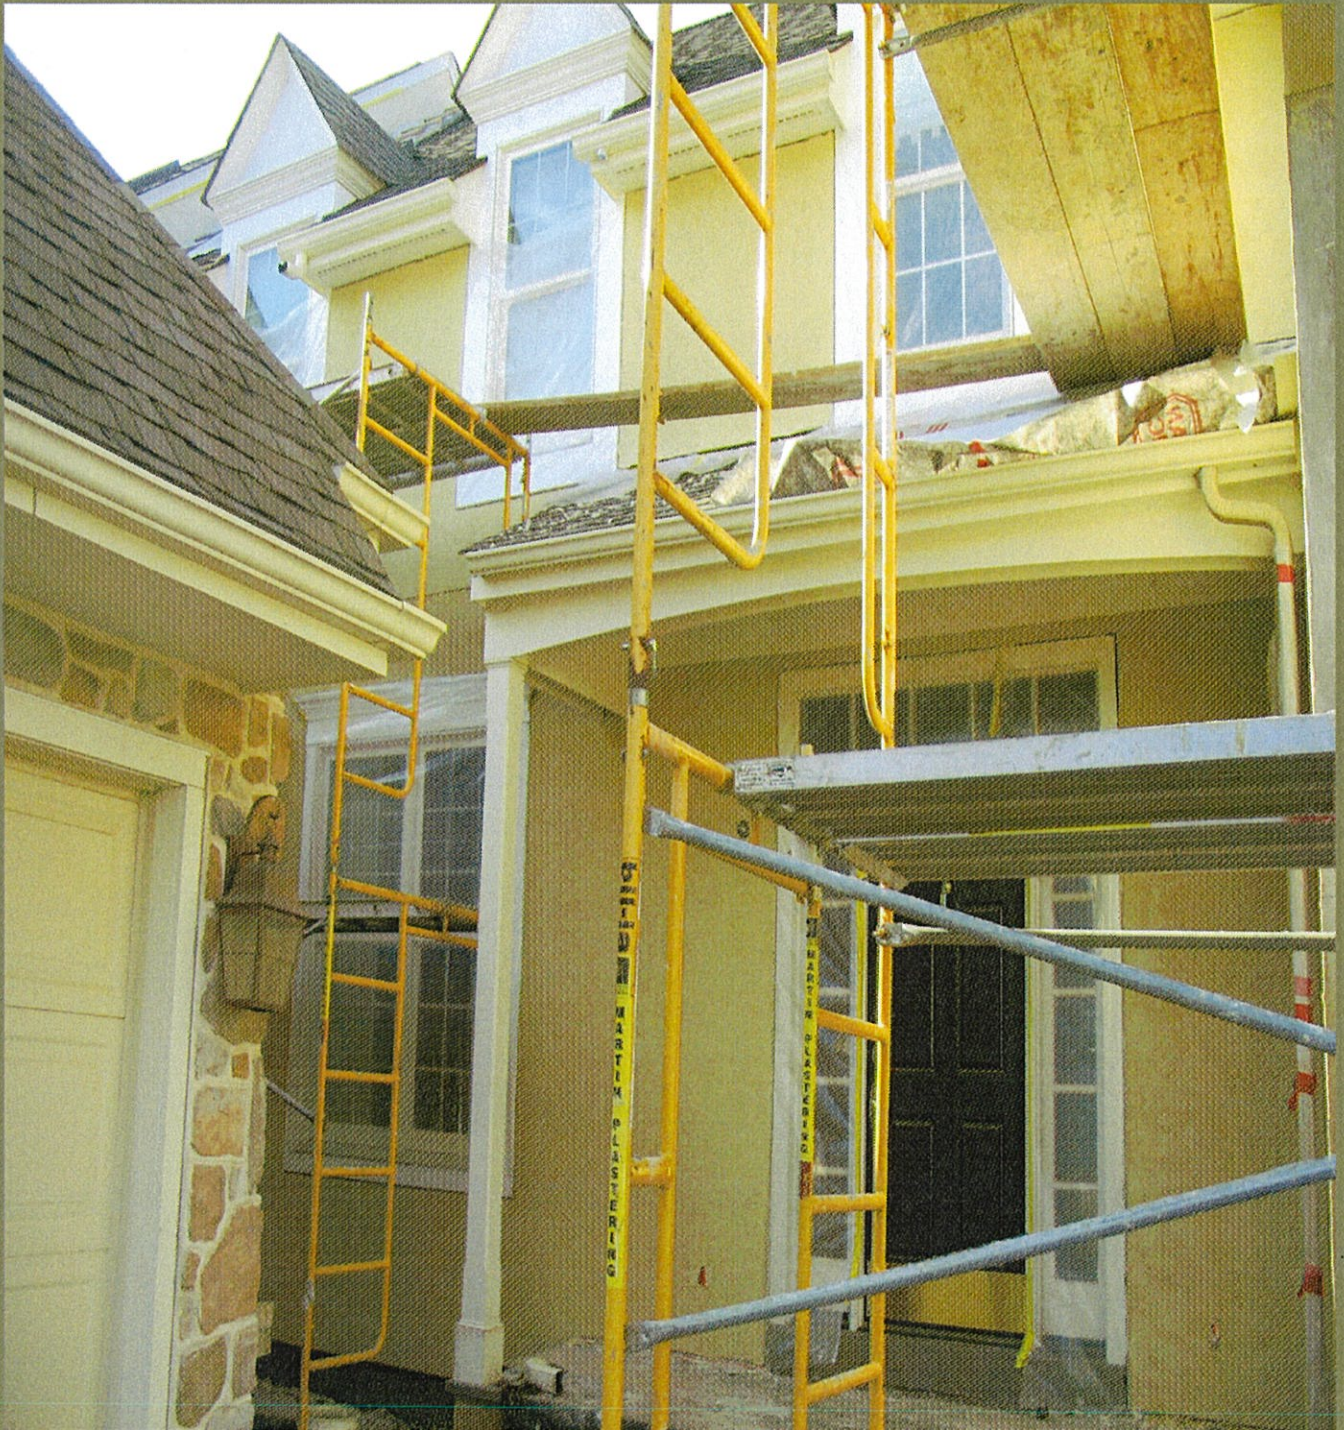
# New Stucco Finish Coat

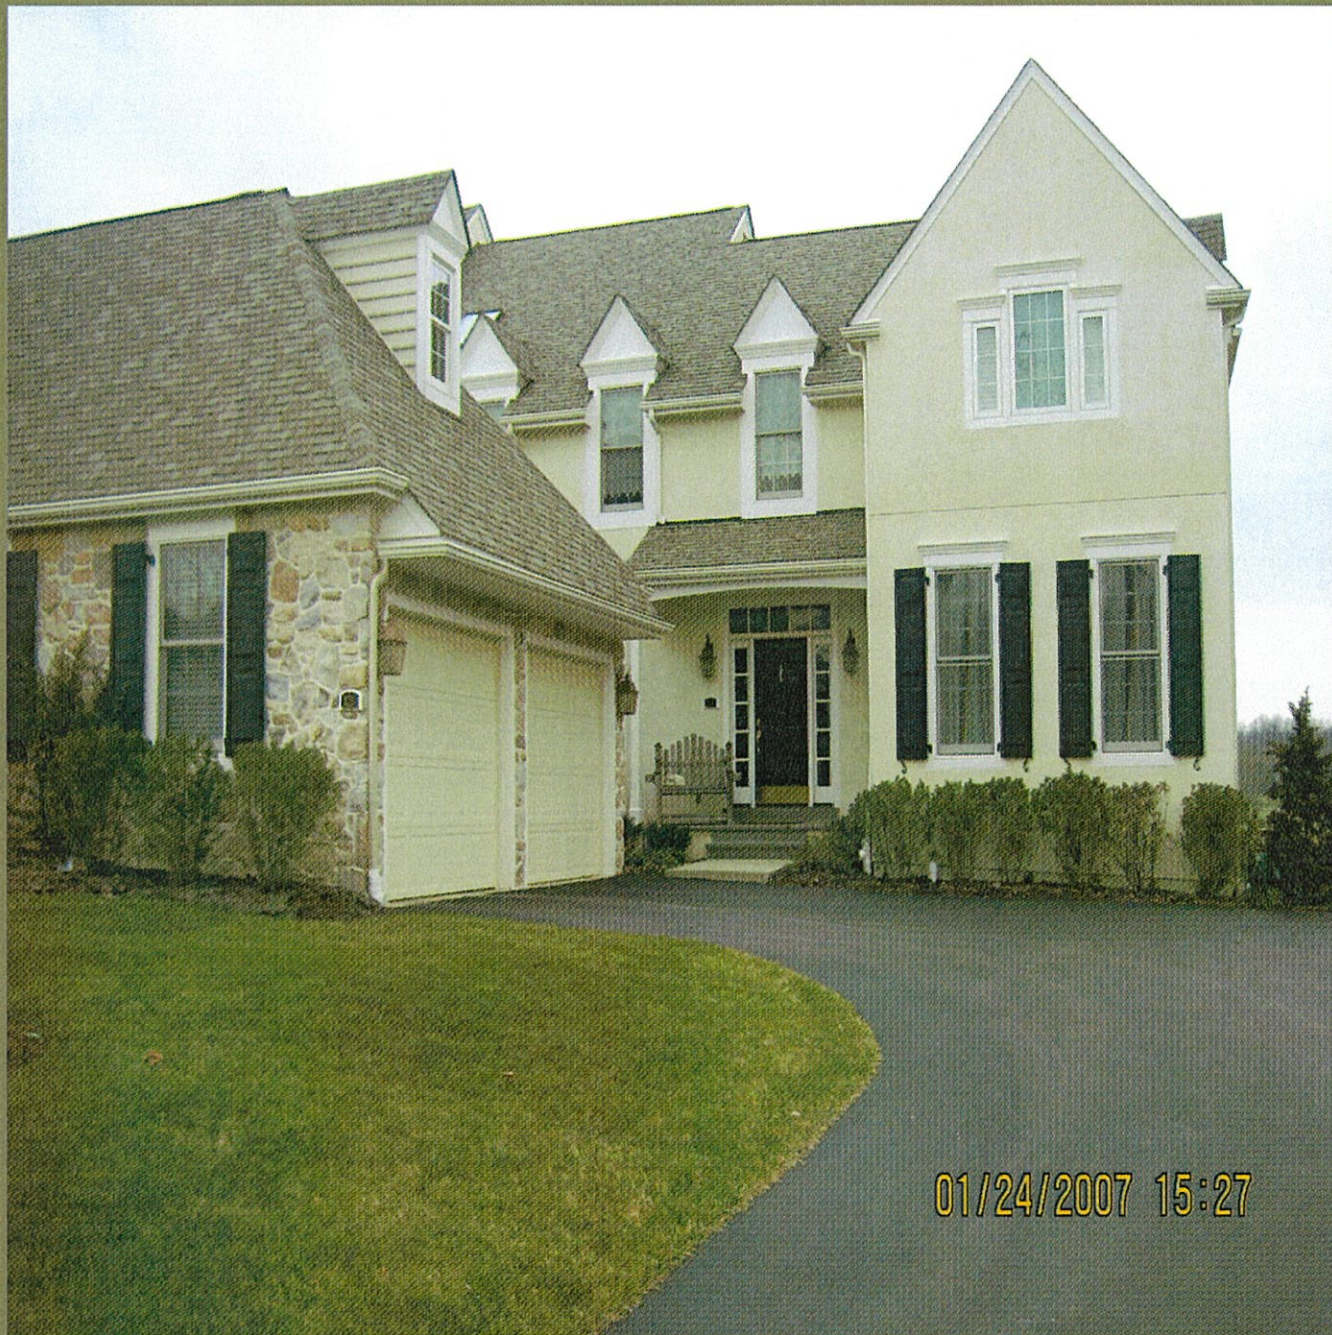
# Completed Remediation
