Job #39006485

Level 2 Chimney Inspection

890 Eichele Road, Perkiomenville, PA 18074 USA

2024-08-07

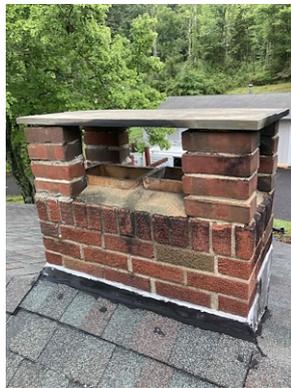
Picture of Chimney from the roof

No

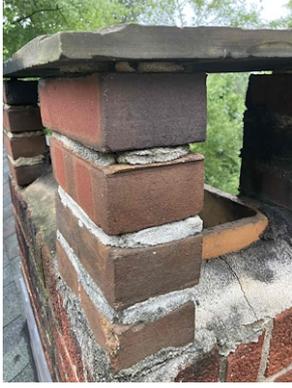
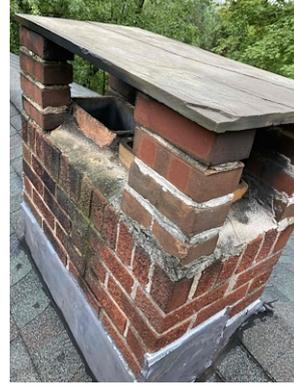
Picture of the Cap

There is a masonry cap covering the top of the chimney.

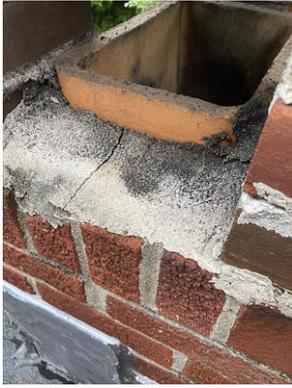
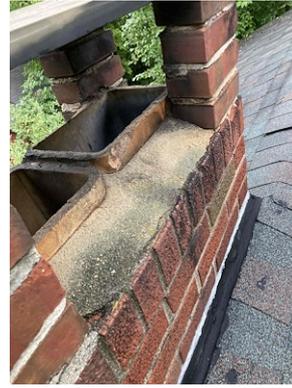
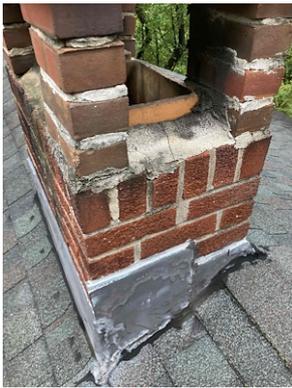
Picture of the Crown

Poured Concrete

32"x16.5"

No

Defective

Pillars are missing mortar
Chimney is not to height required by code
Crown is lifting off of brick and cracked

Pour new crown
Raise chimney to height required by code
Grind out and repoint bad joints

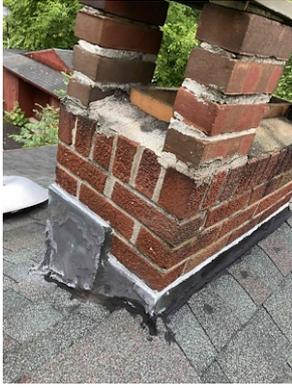
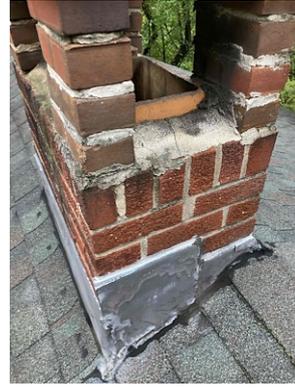
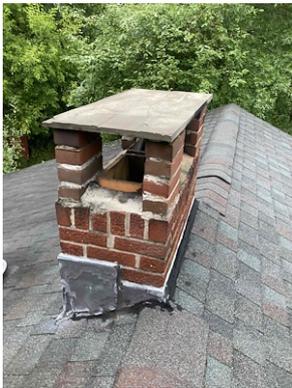
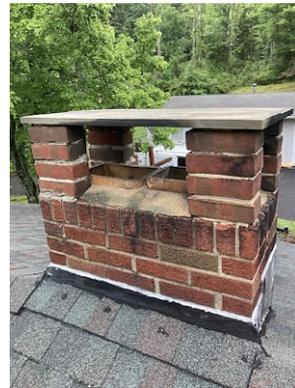
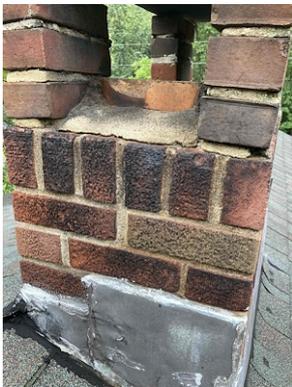
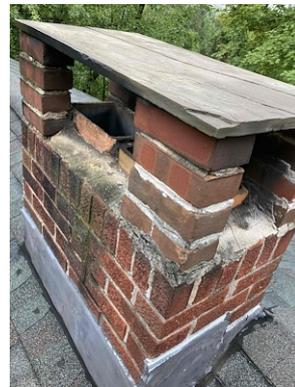
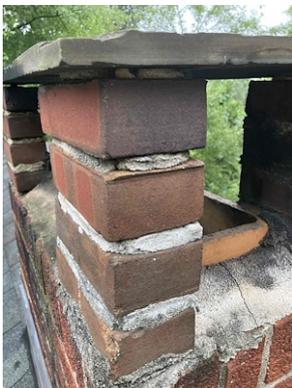
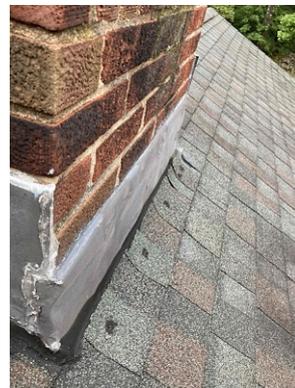
Pictures of the Chimney Body

Defective

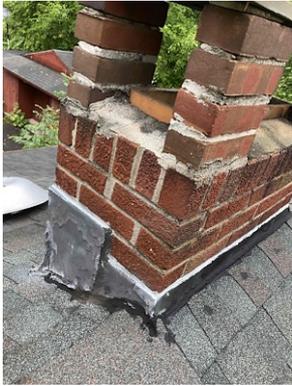
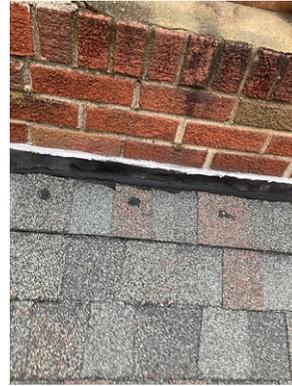
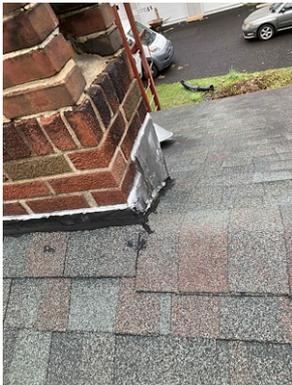
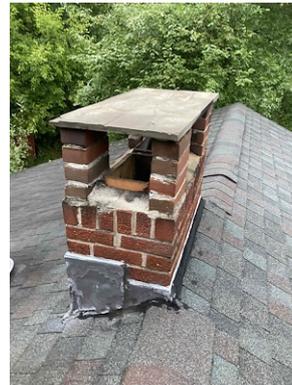
Picture of the Flashing

No Defect Detected

No

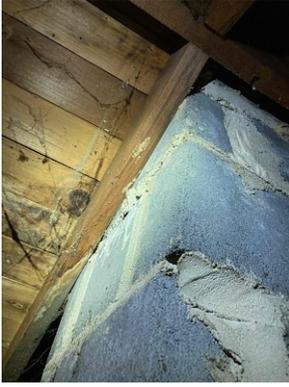
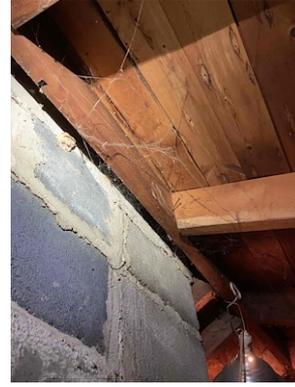
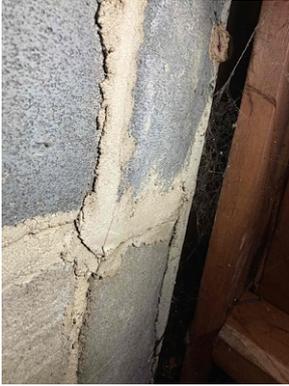
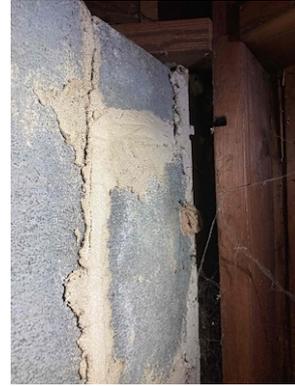
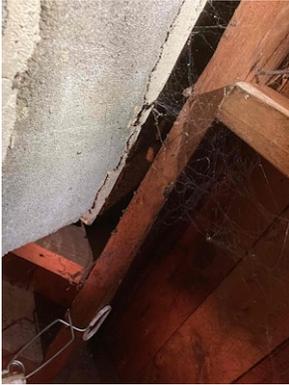
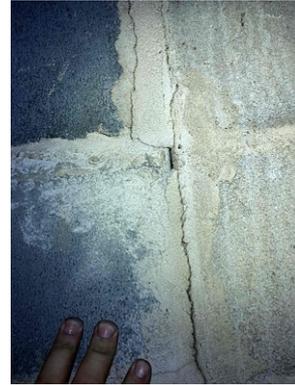
No Defect Detected
