HOME INSPECTION

12/29/25

3795 Route 202
Doylestown, PA 18902

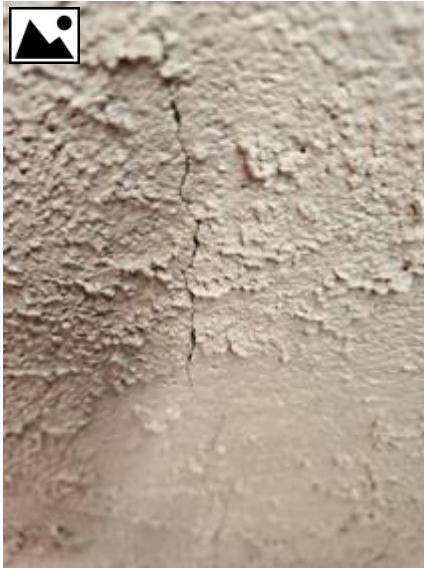
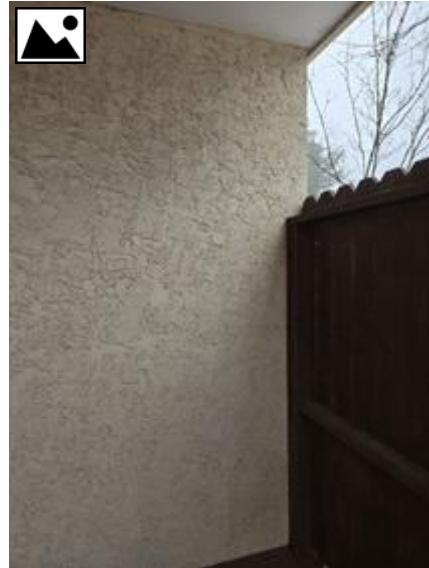
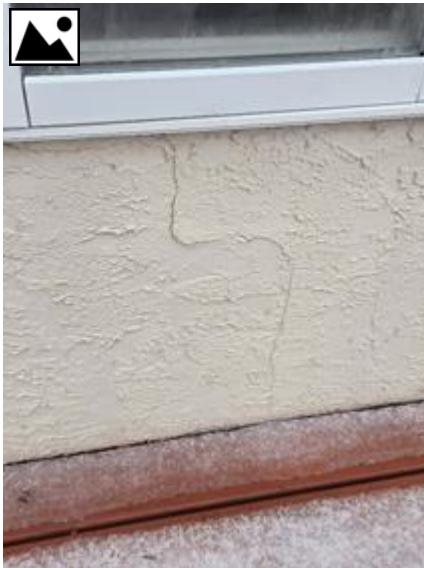
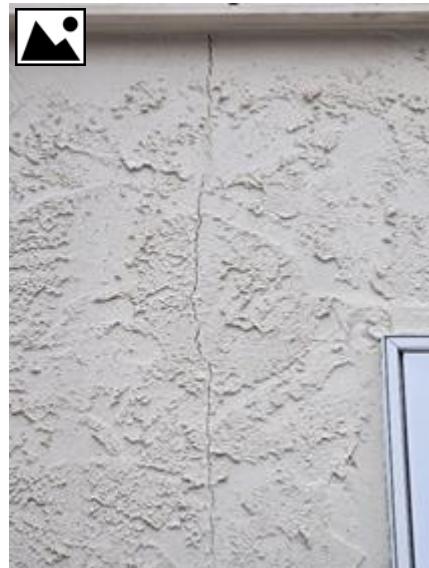
Exterior - Siding 1

☒ Issue There are cracks in the siding. This permits moisture penetration and may cause further damage.
Location Multiple locations
Action *Repair the cracks.*
Cost \$100 - \$300

☒ Issue A stucco siding system is present. Some of these stucco systems have had concerns because of concealed water penetration issues that are not readily apparent. We cannot identify latent problems during the course of this visual Home Inspection, which is non-intrusive. Due to concerns surrounding this material, a specialized inspection of the siding is recommended. The specialist performing this inspection should address the integrity of the installation according to the manufacturer's standards, and should perform intrusive (inside the wall) moisture readings. Furthermore, it is suggested to have a certified professional perform annual inspections.
Location
Action *Hire a specialist for further evaluation.*

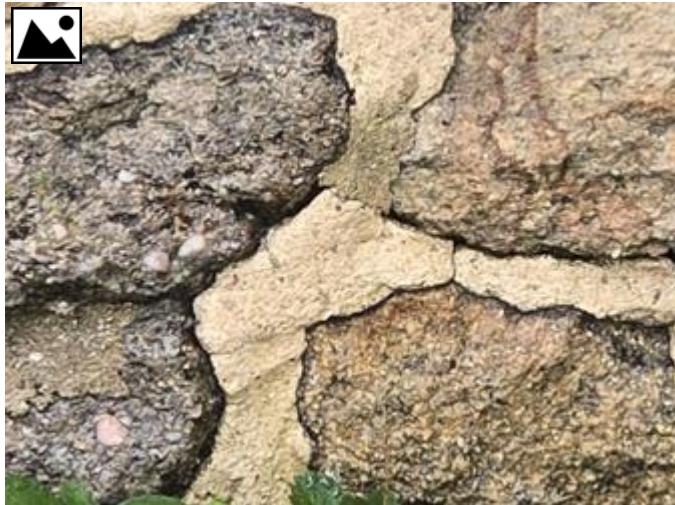
Exterior - Siding 2

☒ Issue There are deteriorated mortar joints in the siding. This permits moisture penetration and may cause further damage.
Location Multiple locations
Action *Repair the mortar joints.*
Cost \$2000 - \$10000

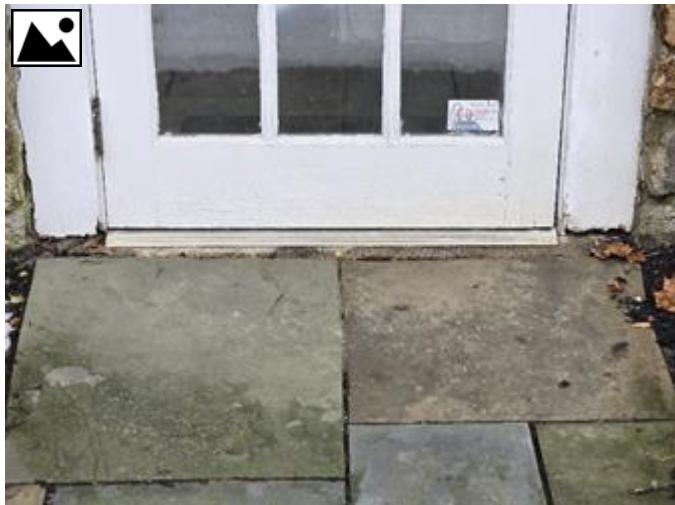
Exterior - Trim

☒ Issue The trim is deteriorated. This permits moisture to enter and may cause further deterioration. There may be hidden damage behind the trim.
Location Left Side
Action *Replace the trim and repair any damage which may be revealed. Caulk, one-part putty fillers, and paint are not acceptable substitutes for solid material.*
Cost \$200 - \$500

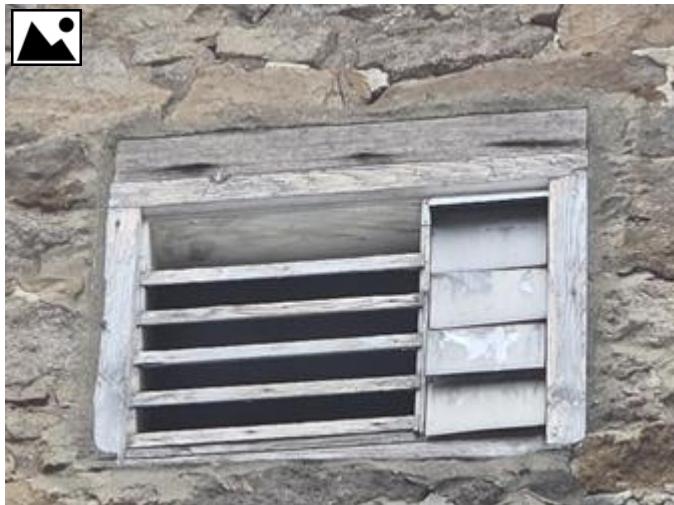
☒ Issue The paint on the trim is peeling or blistering. This implies that moisture has penetrated behind the finishes.
Location Gable vents
Action *Repair or replace the trim and repair any damage which may be revealed.*
Cost \$200 - \$300

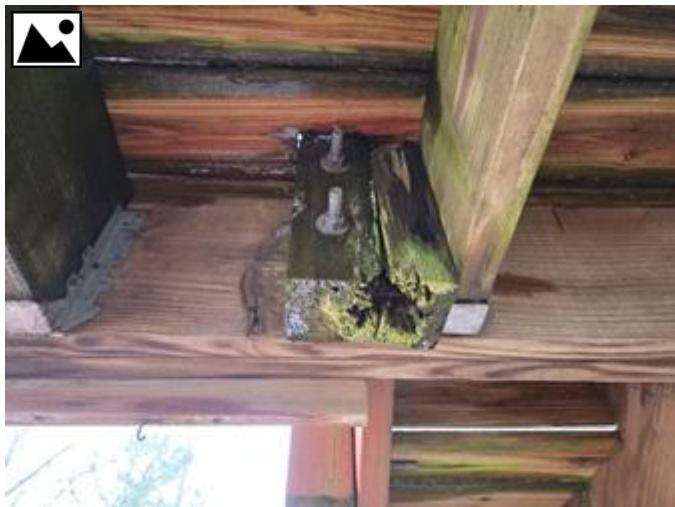
02 The deck has deteriorated support posts. This is a safety hazard. **Location:** Rear. *Repair or replace the supports.* Estimated cost: \$300 - \$500 [27](#)

Action *Repair or replace the supports.*

Cost \$300 - \$500

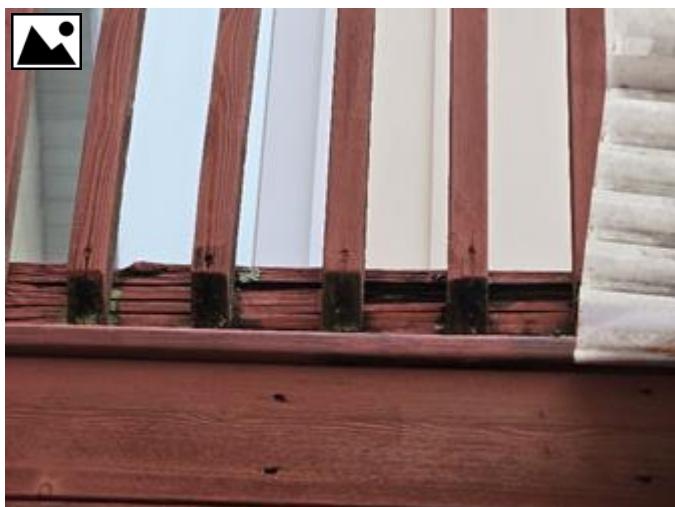
Issue The guardrail is damaged or deteriorated. This is a safety concern.

Action *Repair or replace the guardrail.*

Cost \$500 - \$800

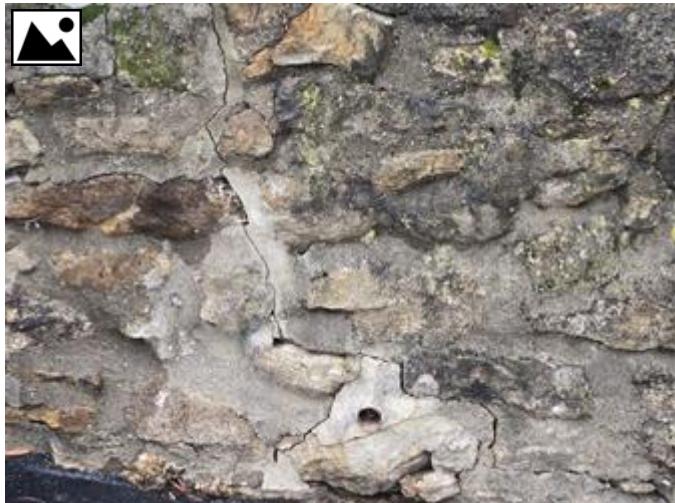
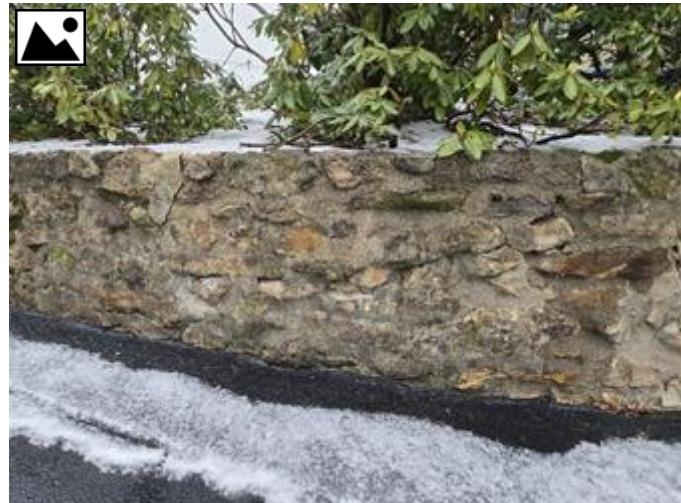
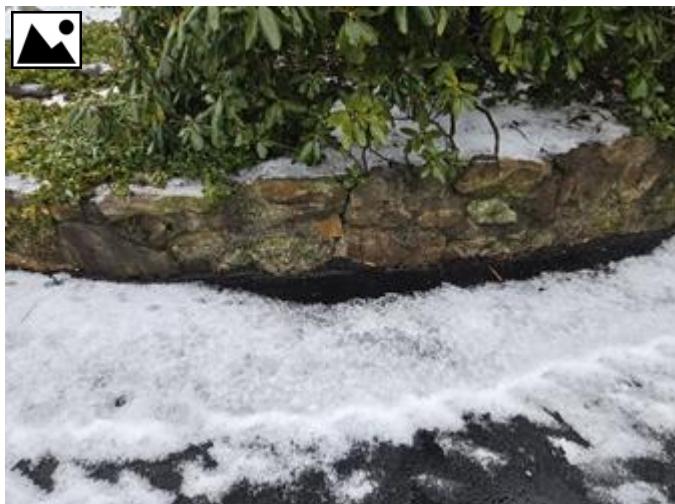
Exterior - Retaining Wall

(X) Issue There are cracks in the retaining wall. This may permit moisture penetration and cause further damage.
Location Multiple Locations
Action *Repair and seal the cracks.*
Cost \$1000 - \$10000

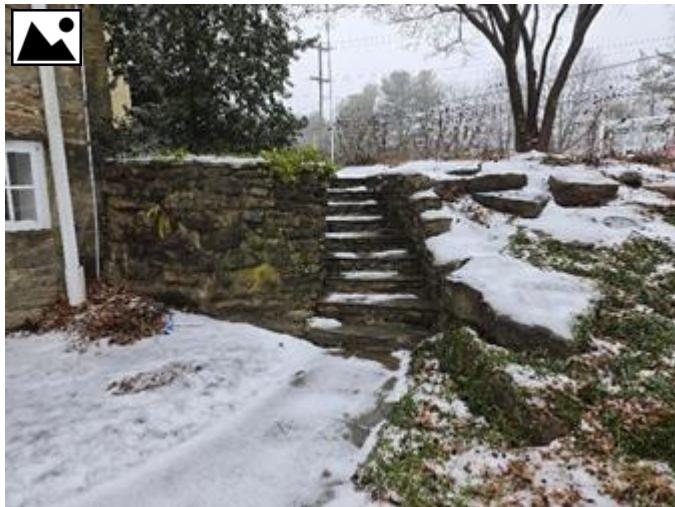
X Issue The retaining wall has no weep holes. Weep holes are designed to alleviate water pressure from behind the wall that might otherwise cause the wall to shift and fail.
Location Left Side
Action *Add weep holes as needed to the retaining wall.*
Cost \$200 - \$500

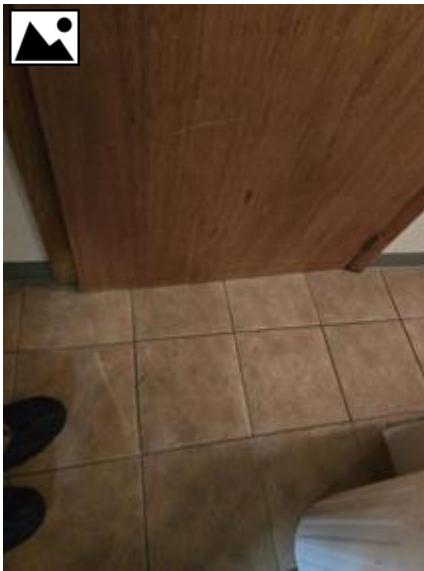
Interior - Doors

✗ Issue The door rubs on the floor. This may cause damage.
Location Basement
Action *Adjust or replace the door.*
Cost \$100 - \$300

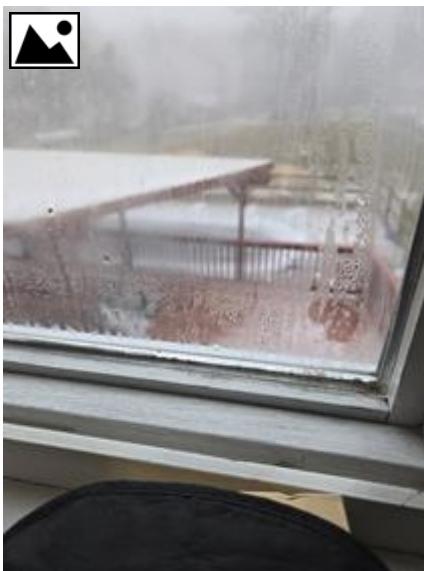
Interior - Windows

✗ Issue The window has a failed insulated glass seal. This permits condensation stains to develop between the glass panes, and may increasingly compromise the visibility, appearance, and insulation value. Other unidentified windows with the same issue may exist since certain atmospheric conditions must be present to identify them. Replacement of the insulated glass unit, the sash, or the entire window assembly is necessary to correct the problem.
Location Primary Bedroom
Action *Replace the insulated glass unit or the window as needed.*
Cost \$300 - \$700

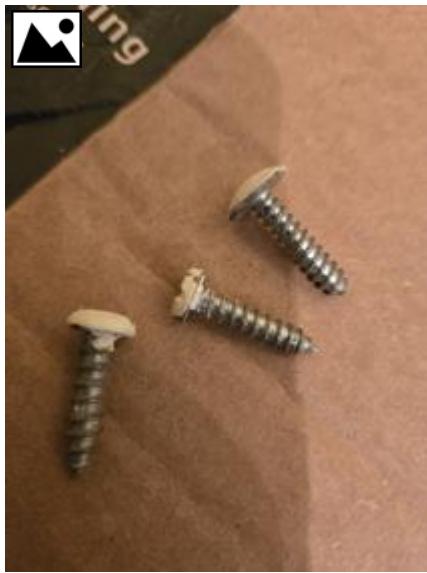
Issue There are pointed screws securing the electrical panel's cover. These may penetrate a conductor and cause a shock. This is a safety concern.
Location Basement
Action *Hire an electrician to replace the screws.*
Cost \$20 - \$100

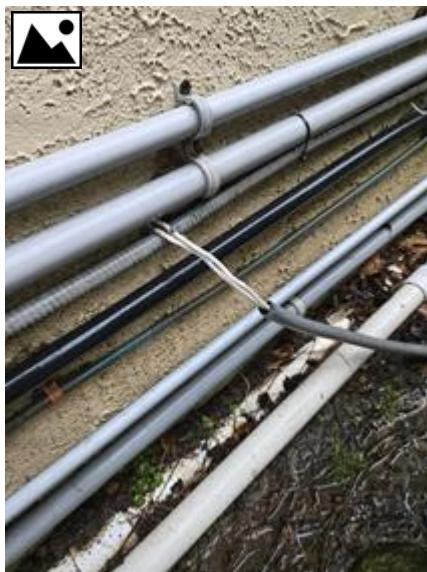
Electrical - Branch Circuits

Issue There is exposed and unprotected wiring. This is a safety concern.
Location Left side
Action *Hire an electrician to make required repairs.*
Cost \$100 - \$200

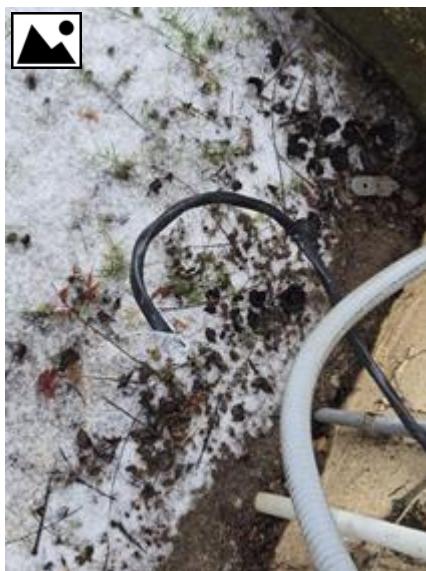
Issue There are exposed wire splices. All wiring splices must be in an approved junction box with a proper cover and permanently accessible. This is a safety concern.
Location Left side
Action *Hire an electrician to make required repairs.*
Cost \$100 - \$200

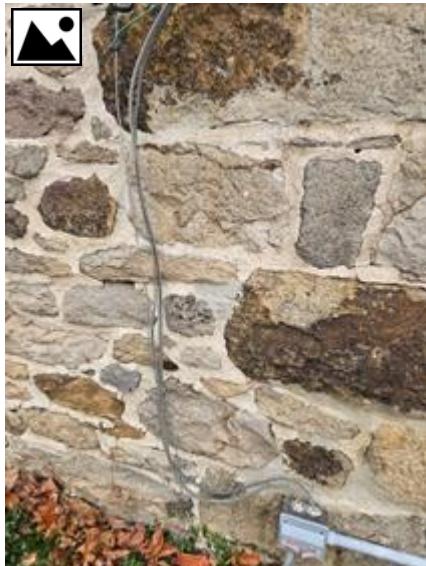
Issue There are loose or hanging wires. This is a safety concern.
Location Right side
Action *Hire an electrician to make required repairs.*
Cost \$100 - \$150

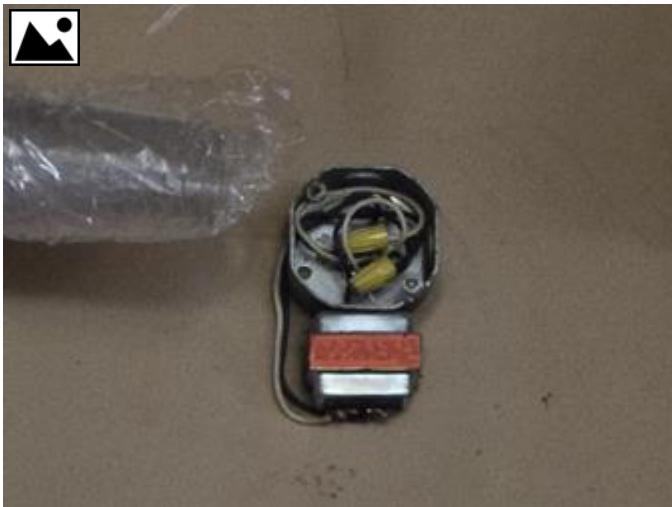
Issue There are missing cover plates, which defeats the enclosure's fire rating and permits contact with energized components. This is a safety concern.
Location Garage
Action *Secure or replace the cover plates.*
Cost \$50 - \$100

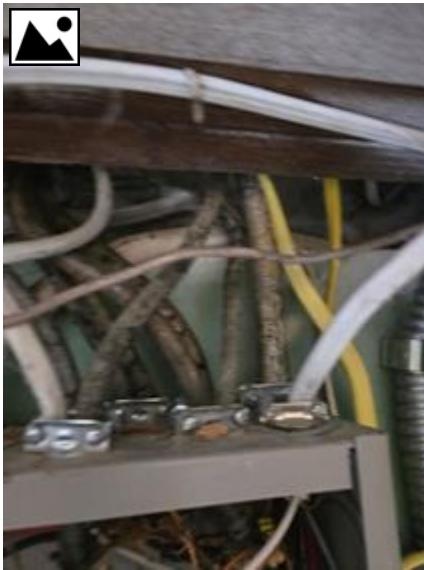
Issue There is cloth sheathed wiring present. Cloth wrapped wiring is one of the early forms of branch circuit wiring methods. If the insulation degrades or breaks, areas of wiring may be exposed. This is a safety hazard.
Location Basement
Action *Hire an electrician for an evaluation and to make repairs as needed.*

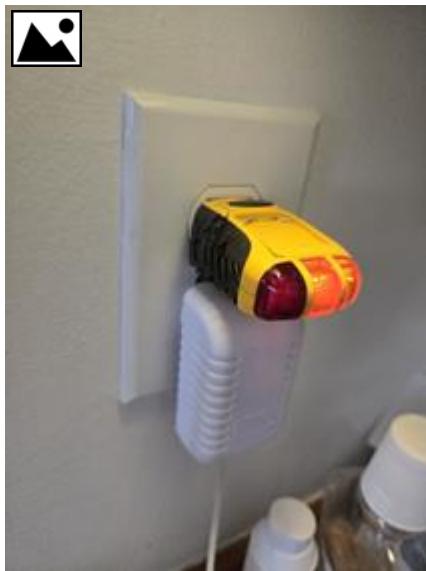
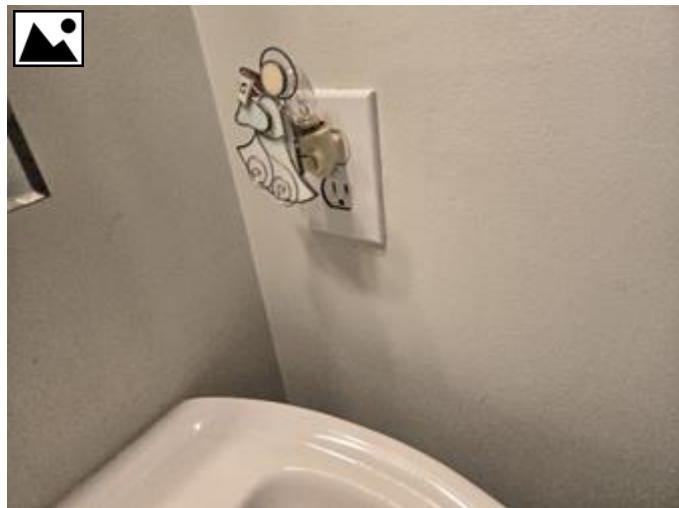
Electrical - Receptacles

Issue There is a standard receptacle installed in a location that currently mandates a GFCI device. While this may not have been required at installation, it is a safety concern.
Location Multiple Locations
Action *Hire an electrician to replace the receptacle.*
Cost \$100 - \$300

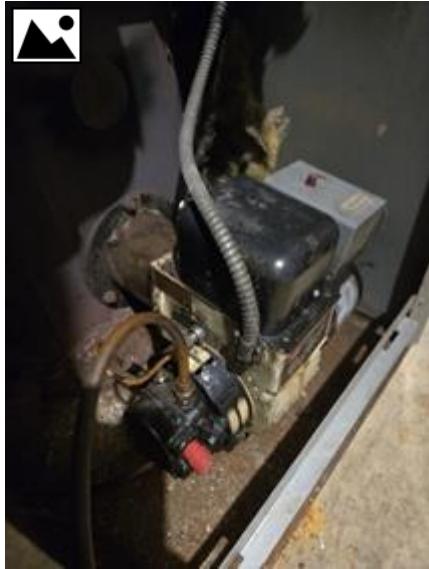
23 The fan vibrates or is excessively noisy. This indicates a failing or unreliable blower assembly. **Location:** Basement. *Hire an HVAC contractor to repair or replace the fan.* Estimated cost: \$500 - \$1000 55

Action *Hire an HVAC contractor to repair or replace the fan.*

Cost \$500 - \$1000

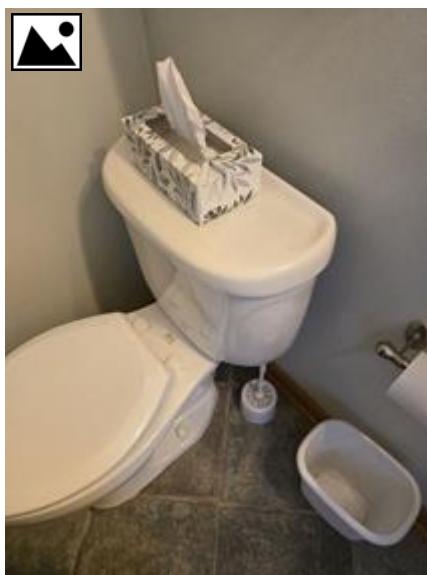
Plumbing - Toilet

☒ Issue The toilet tank is loose. This may permit water damage to surrounding areas.
Location Half Bathroom
Action *Secure the toilet tank to the base.*
Cost \$50 - \$150

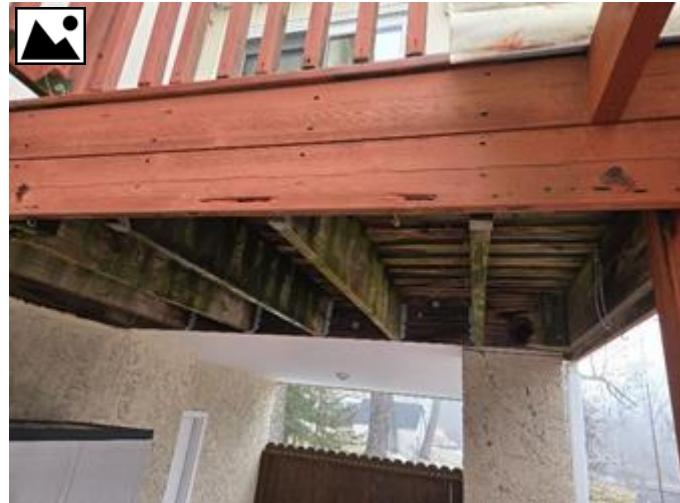
26 There is evidence of possible wood-destroying insect activity and damage. We do not determine the extent of the activity or any damage during a home inspection. **Location:** Deck. *Hire a pest specialist for further evaluation and required action.* Estimated cost: \$300 - \$800 64

Action *Hire a pest specialist for further evaluation and required action.*

Cost \$300 - \$800
