379 Sweetbriar Road
Perkasie, PA 18944
Bedminster Township
Bucks County

Report # TP083018001

BACKGROUND:

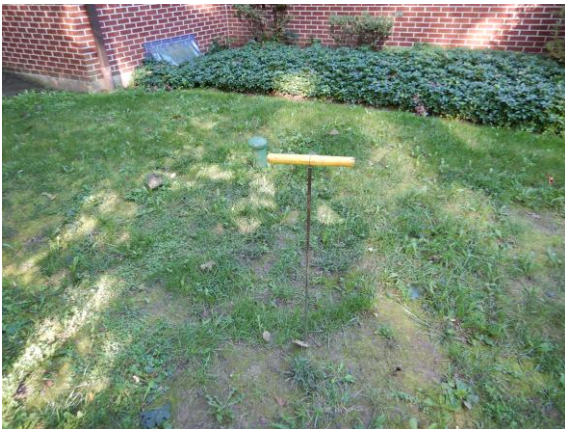
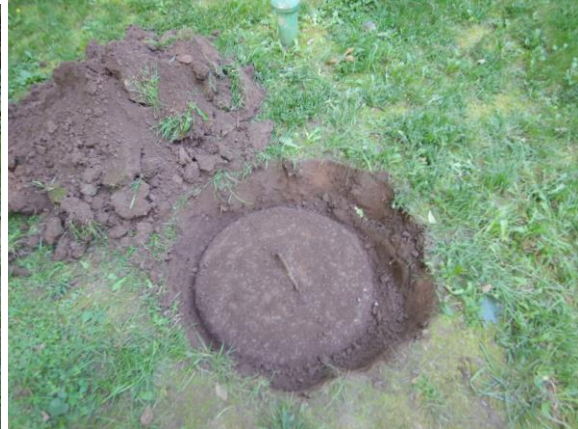
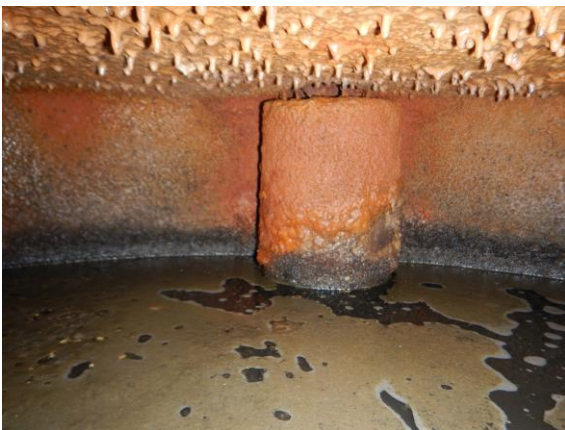
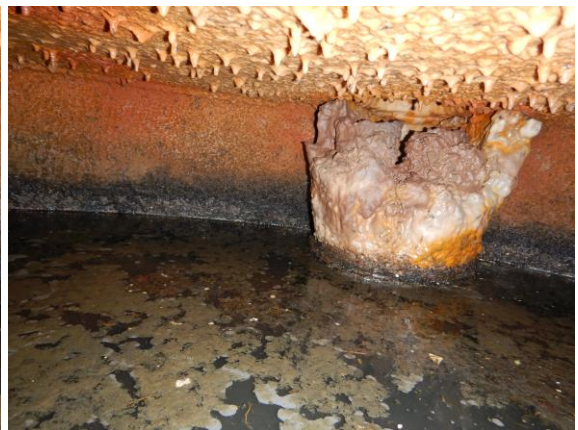
The septic tank was located to the rear of the home, 13' off the back wall. The main access was found to be 10", below grade and consisted of a concrete lid. The tank is a 1,000-gallon, concrete tank. The opening was found to be in the center of the tank. The concrete lid was opened to investigate the interior of the tank. The water level of the tank was viewed through this main access. The water level was found to be equal to the bottom of the outlet pipe, indicating a normal operating level. There were no signs of overfull conditions or back-ups from the past. The area of the tank above the water level, was found to be clean, and structurally sound. The inlet and outlet

baffles were present, and structurally sound, above the water level. The outlet baffle appears to be disforming, and may require a repair in the future. That being stated, the outlet baffle is presently performing its required duties of preventing solids from escaping the tank. Baffles assist in the proper breakdown of solids in the tank. Without baffles, floating solids can be “churned” by incoming water, causing solids to pass through the tank, out into the absorption area, leading to premature failure of the absorption field. The solids level of the tank was found to be minimal and consistent with a tank that is maintained. No information was available, as to the date of the last pumping.

1. It is recommended to repair the outlet baffle prior to it needing to be repaired. The baffle could be repaired once the tank is empty. If the outlet baffle is not repaired, it should be monitored closely, and repaired at the time it is an issue.
2. It is recommended that this septic system be pumped out every two to three years, through the main access, as suggested by PA State Code, Act 537.

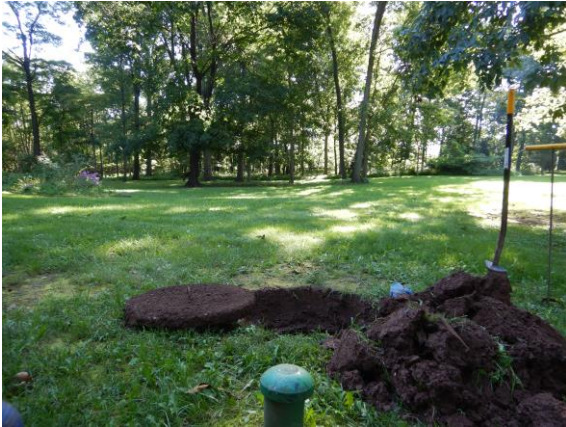
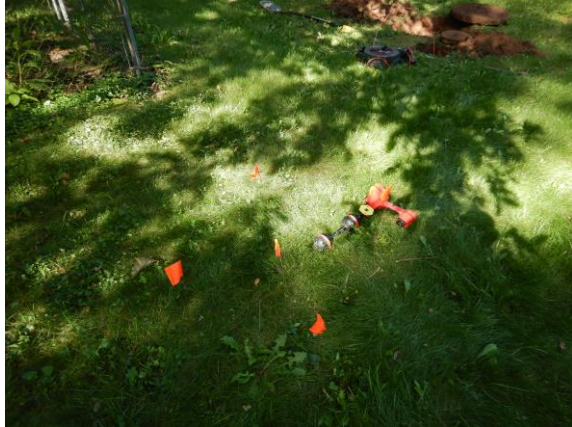
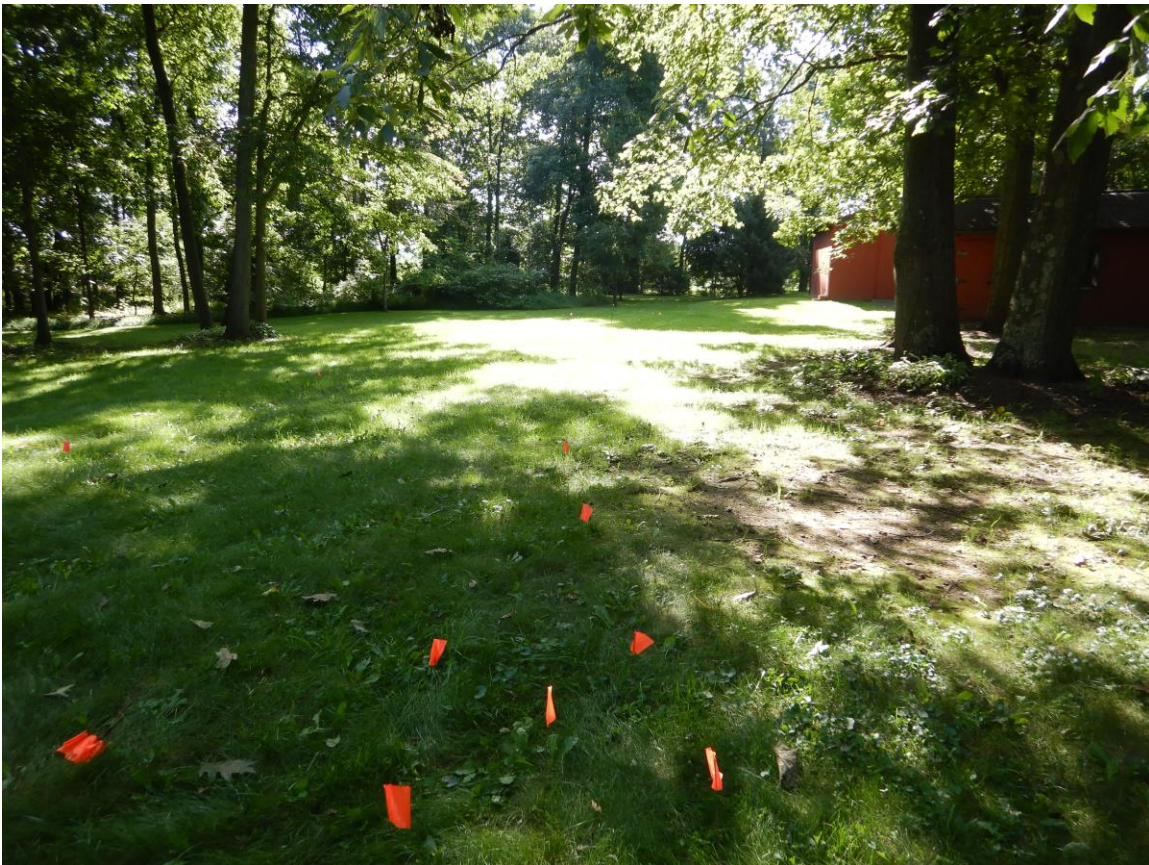
The outlet pipe heads straight out of the tank for 10' to the distribution box, where it distributes out to two trenches. The trenches are located in a cleared area of the rear yard. The area was inspected using the “probing” technique. The area was probed to

determine the size, type and condition of the existing absorption area. The absorption area was determined to be two, individual, 100' long, by 4' wide, trenches, with approximately 6' of undisturbed soil between them.

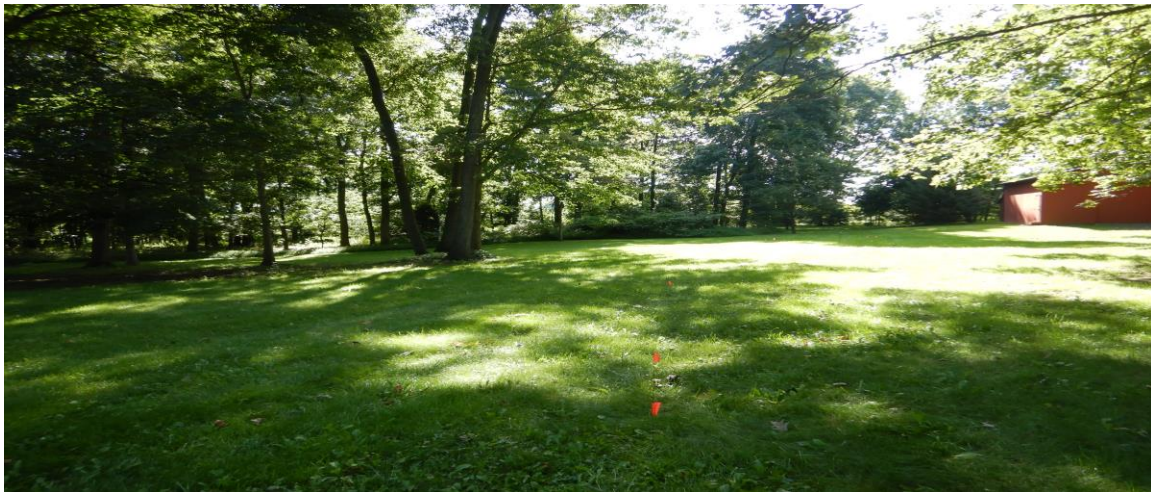
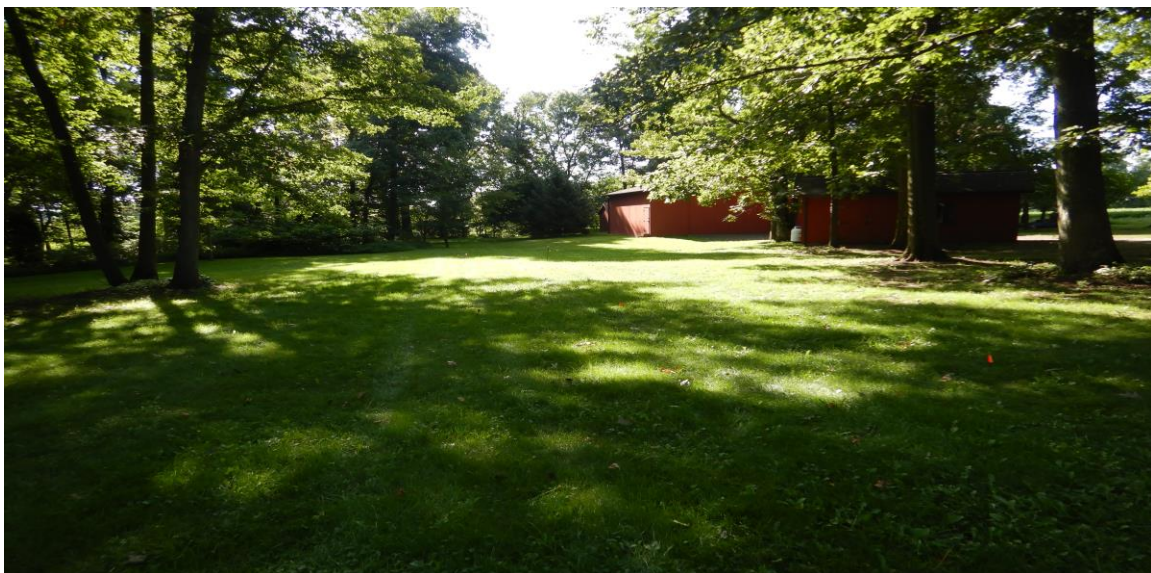
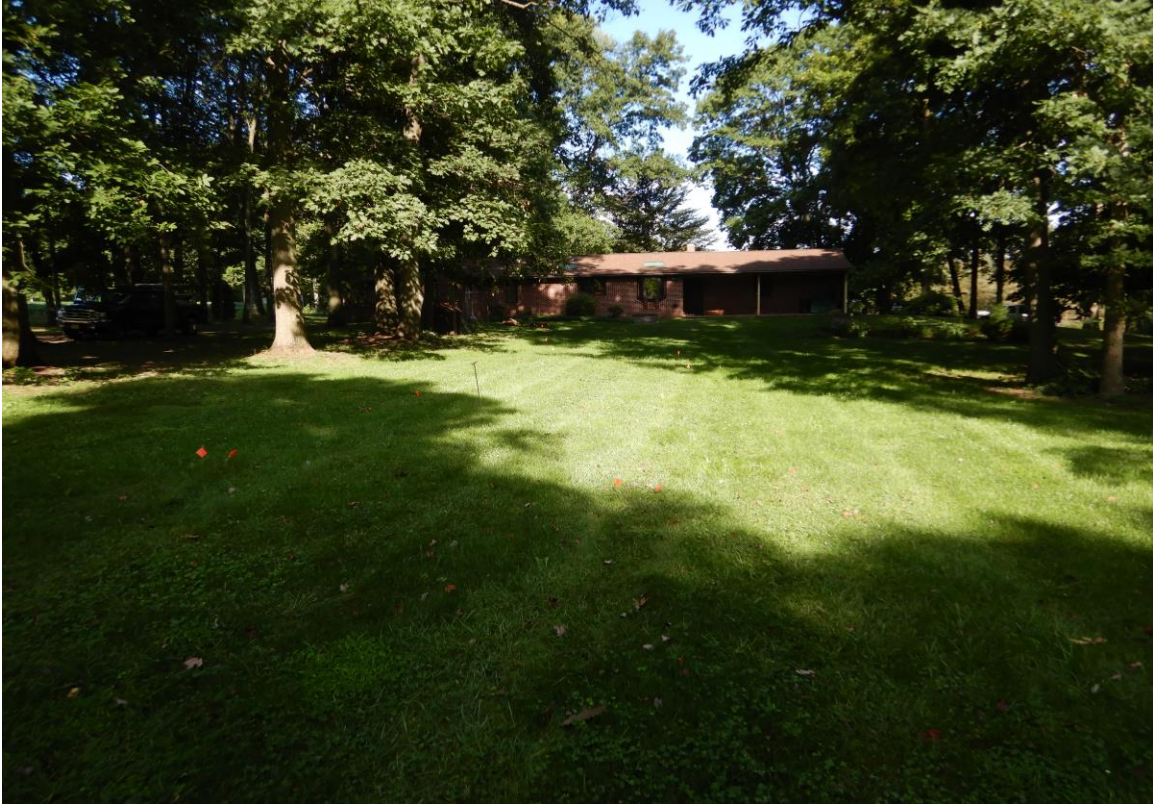
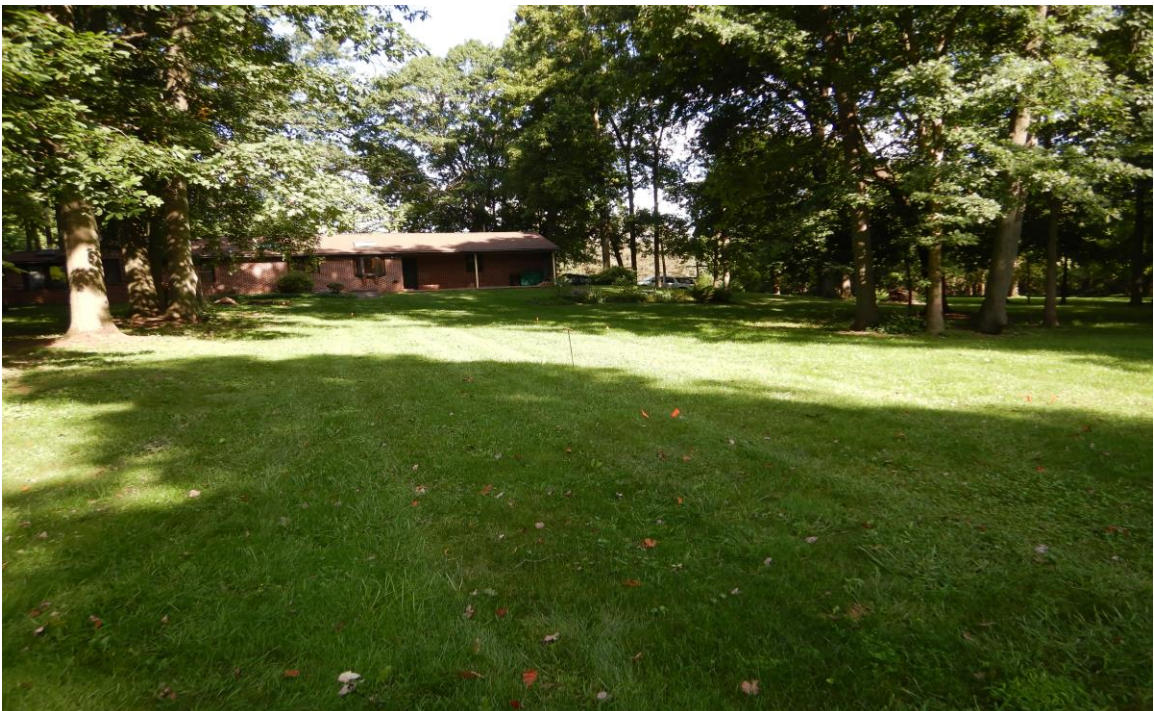
The two trenches were probed, looking for water holding in the stone. The trenches were probed from one end to the other. During this probing, it was observed that the trenches were found to be holding no, measurable amount of water. Moisture was present at the bottom of each trench, indicating that the water was properly making it to each trench. The stone aggregate was found clean, and clear, of any sludge debris. "Observation holes" were made into each trench to enable a direct view of the water levels and stone conditions. The trenches were found to be dry. PSMA guidelines state that in order to find an absorption area as satisfactory, a minimum of 5" dry stone must be found throughout each trench. Each trench was found to have 12", of dry stone, throughout.
