Inspection Report

Property Address:
2035 Clover Mill Rd
Quakertown Pa 18951

A1 House Prep LLC and Inspections

Date: 06/05/20	Time: 10:30 AM	Report ID: 6844 Ed & Joann Leber
Property: 2035 Clover Mill Rd Quakertown Pa 18951	Customer: Ed Leber	Real Estate Professional: Michelle Hunsberger Sanford Alderfer Real Estate

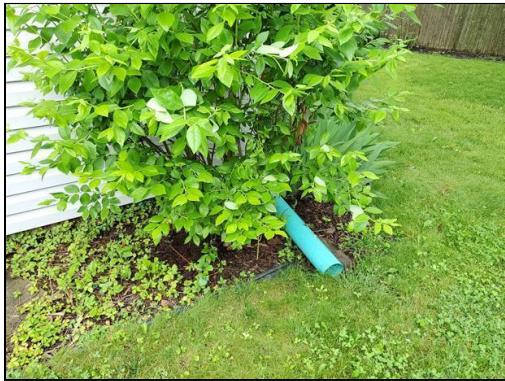
1.3 Item 1(Picture)

Downspouts are not moving water effectively away from the foundation. Suggest to extend downspouts as discussed for better drainage away from the foundation. Saturating foundation walls for extended periods of time can cause potential unseen structural damage from water and insects. Could not determine how long water was flowing towards the foundation.

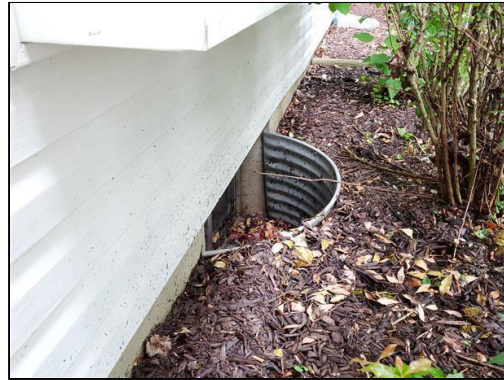
2.1 Item 1(Picture)

Missing a window well cover. Suggest to install clear plastic well cover over window well to prevent potential well saturation which could overflow window sill and spill into the basement. **This is considered optional.**

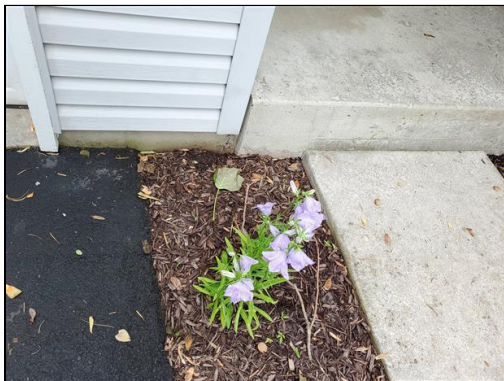
2.3 Item 1(Picture)

(1) Negative grading at the front of home. Highly recommend to correct grading as needed by a qualified person. Negative grading can cause unseen structural issues and water penetration if not corrected.

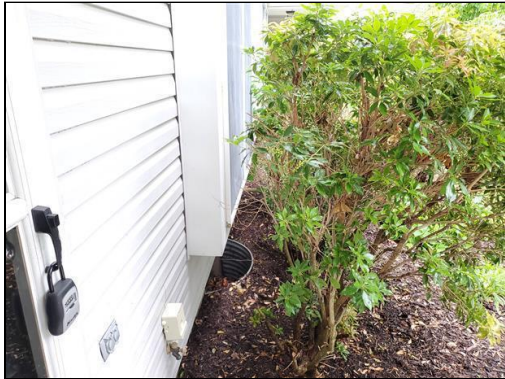
2.3 Item 4(Picture)

(2) Shrubbery is growing too close to the siding for proper ventilation. Recommend to trim shrubbery a minimum of 12 to 16 inches away from the siding to restore proper ventilation. This would be considered normal maintenance.

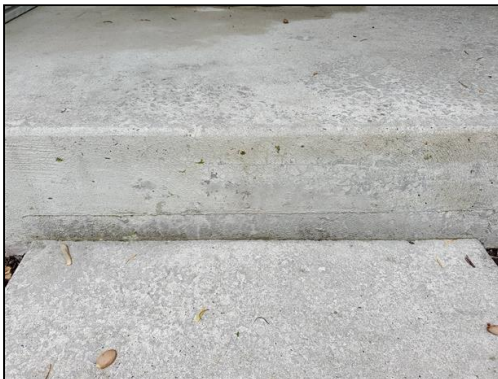
2.4 Item 1(Picture)

(1) Front step is considered higher than normal. Recommend to repair as needed by a qualified person. Potential tripping hazard exists.

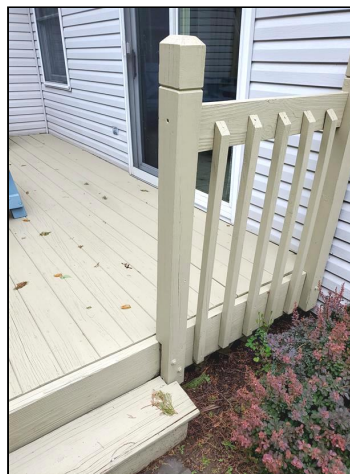
2.4 Item 2(Picture)

(2) Loose deck post. Recommend to secure as needed by a qualified person.

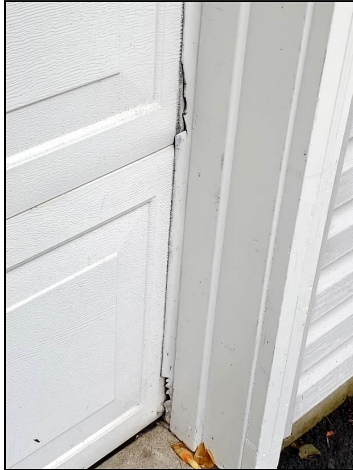
3.4 Item 1(Picture)

(1) Damaged weatherstripping around the garage door and under door. Recommend to replace weatherstripping as needed by a qualified person.

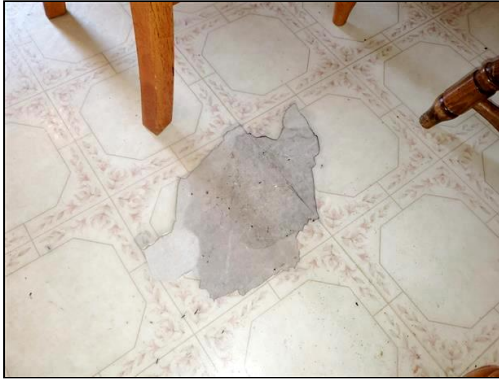
4.0 Item 1(Picture)

Damaged area in vinyl kitchen floor. Suggest to repair or replace flooring as needed by a qualified person.

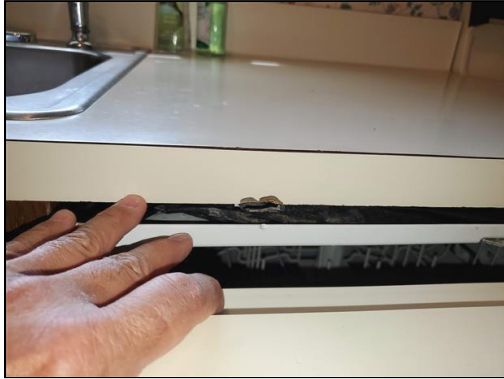
4.11 Item 1(Picture)

Dishwasher is not secured to the cabinet and missing a coverplate at the bottom. Recommend to secure and replace coverplate as needed by a qualified person.

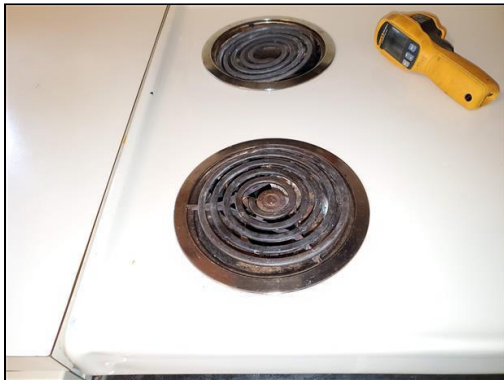
4.13 Item 1(Picture)

- Left front burner was nonfunctional. Recommend to repair left front burner as needed by a qualified person.
- Left rear burner is not fitting properly. Recommend to replace as needed by a qualified person.

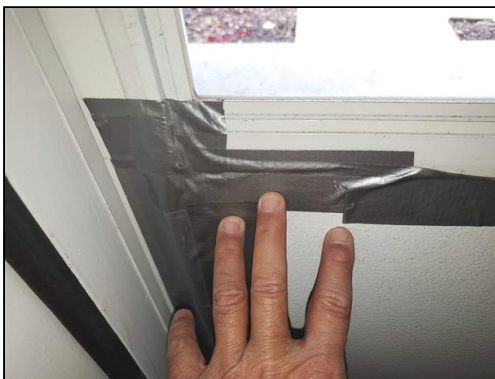
5.2.A Item 1(Picture)

Damaged storm door at the front entrance. Recommend to replace storm door as needed by a qualified person or professional.

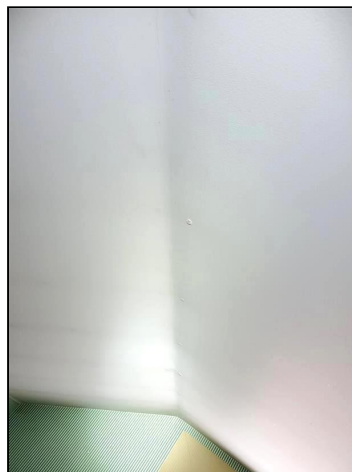
5.4.G Item 1(Picture)

Typical nail pops in bedroom #3 ceiling. Recommend to sand, spackle and paint as needed by a qualified person. **This would be considered normal maintenance.**

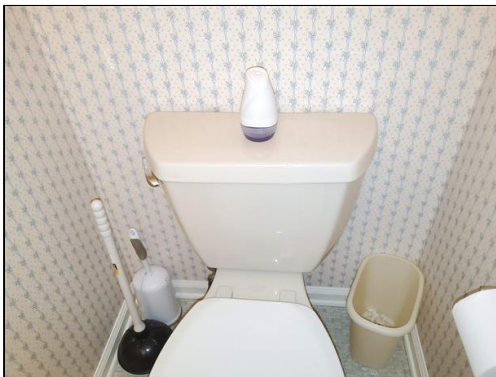
6.9.A Item 1(Picture)

Leak between the toilet tank and the bowl. Recommend to repair as needed by a qualified person.

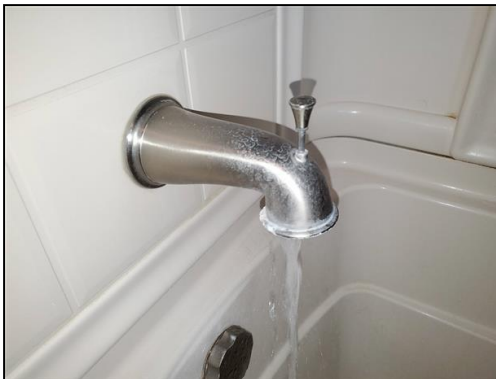
6.8.B Item 1(Picture)

Shower diverter valve is not functioning properly. Recommend to replace diverter valve as needed by a qualified plumber.

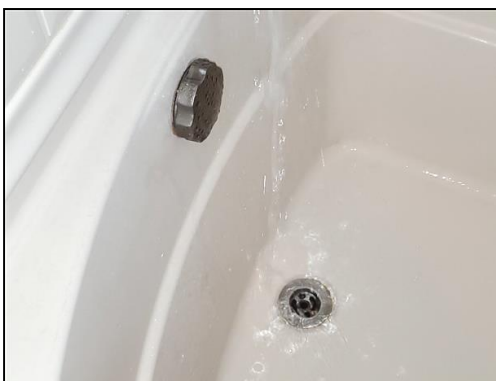
6.9.B Item 1(Picture)

Missing stopper in the hall bath tub. Recommend to repair or replace stopper as needed by a qualified person.

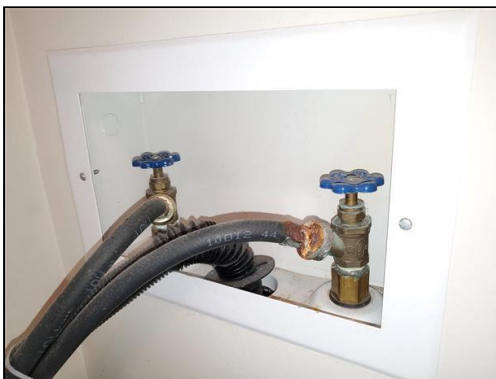
7.6 Item 1(Picture)

Suggest to replace rubber washing machine hose with stainless steel braided burst proof hose. This would be considered optional.

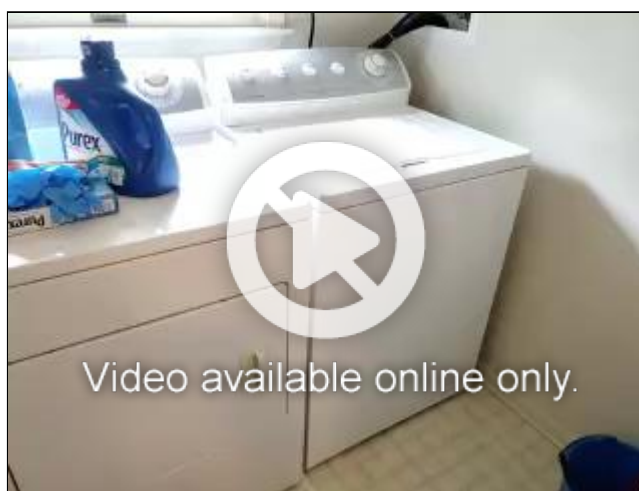
7.7 Item 1(Video) *** WASHER VIDEO ***

Washer is very noisy. Recommend to repair or replace as needed by a qualified professional.
View Washer Video.

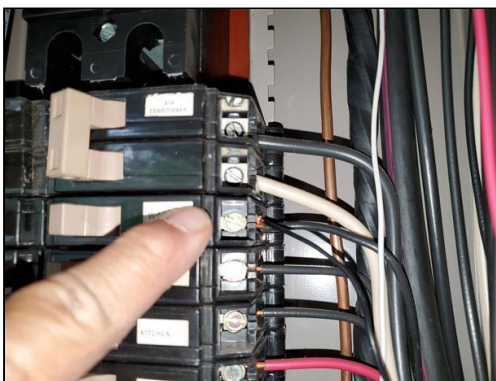
8.2 Item 1(Picture)

⚡ 1 double tapped breaker located in the main panel. Recommend to have panel inspected and repaired as needed by a qualified electrician. Potential safety hazard exists.

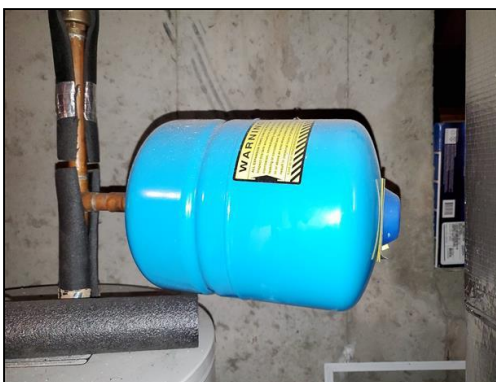
9.2 Item 1(Picture)

Hot water expansion tank is water logged. Recommend to recharge expansion tank as needed by a qualified person or plumber.

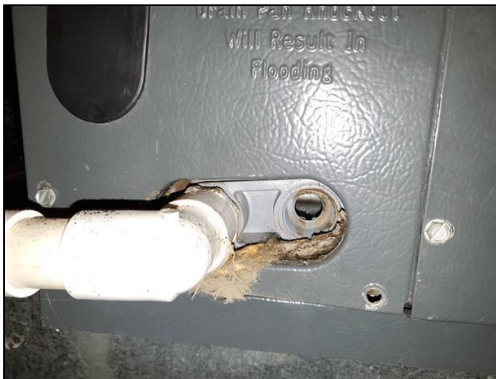
10.3 Item 1(Picture)

Missing a condensation tray plug. Recommend to replace as needed by a qualified person.

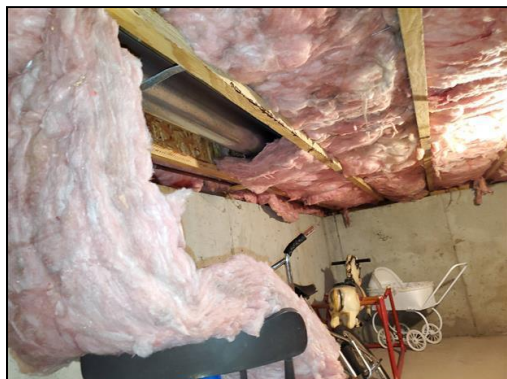
11.8 Item 1(Picture)

Areas of loose insulation in the crawlspace. Recommend to secure insulation back into position as needed by a qualified person.

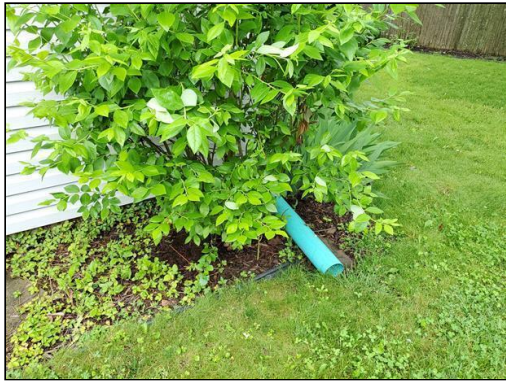
1.3 Item 1(Picture)

Downspouts are not moving water effectively away from the foundation. Suggest to extend downspouts as discussed for better drainage away from the foundation. Saturating foundation walls for extended periods of time can cause potential unseen structural damage from water and insects. Could not determine how long water was flowing towards the foundation.

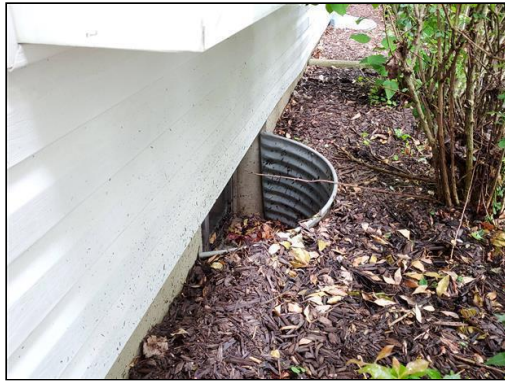
2.1 Item 1(Picture)

Missing a window well cover. Suggest to install clear plastic well cover over window well to prevent potential well saturation which could overflow window sill and spill into the basement. **This is considered optional.**

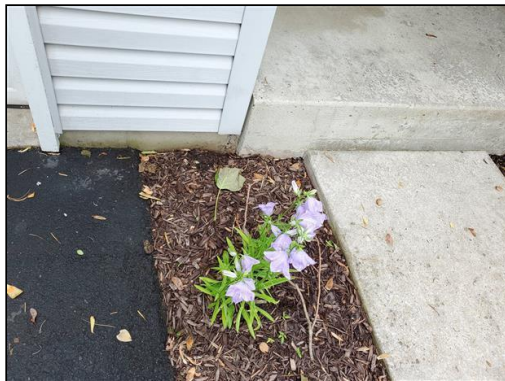
2.3 Item 1(Picture)

(1) Negative grading at the front of home. Highly recommend to correct grading as needed by a qualified person. Negative grading can cause unseen structural issues and water penetration if not corrected.

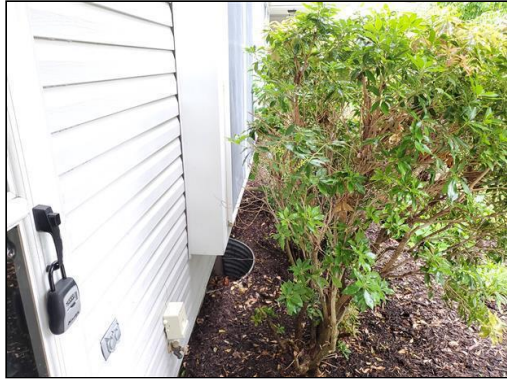
2.3 Item 4(Picture)

(2) Shrubberty is growing too close to the siding for proper ventilation. Recommend to trim shrubberty a minimum of of 12 to 16 inches away from the siding to restore proper ventilation. This would be considered normal maintenance.

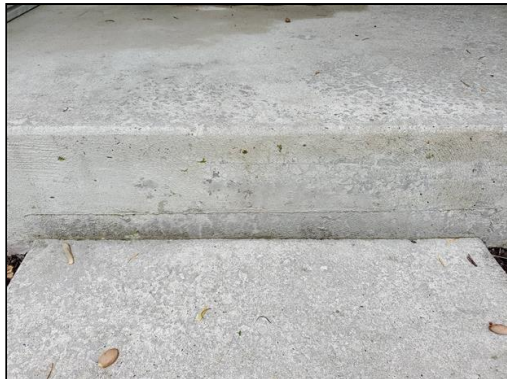
2.4 Item 1(Picture)

(1) Front step is considered higher than normal. Recommend to repair as needed by a qualified person. Potential tripping hazard exists.

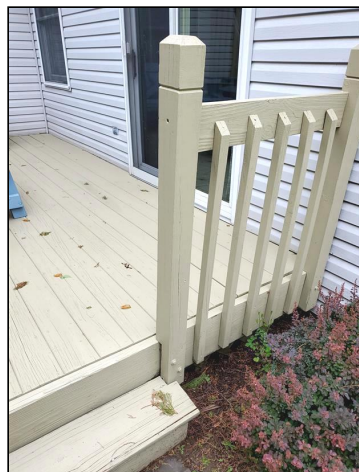
2.4 Item 2(Picture)

(2) Loose deck post. Recommend to secure as needed by a qualified person.

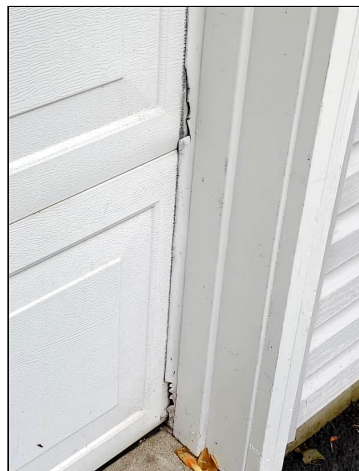
3.4 Item 1(Picture)

- (1) Damaged weatherstripping around the garage door and under door. Recommend to replace weatherstripping as needed by a qualified person.

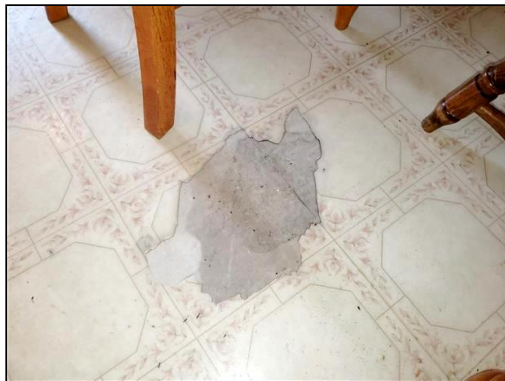
4.0 Item 1(Picture)

Damaged area in vinyl kitchen floor. Suggest to repair or replace flooring as needed by a qualified person.

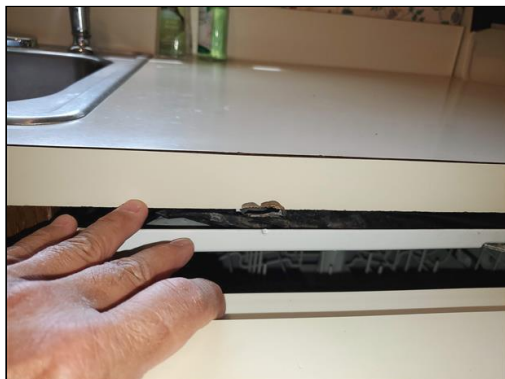
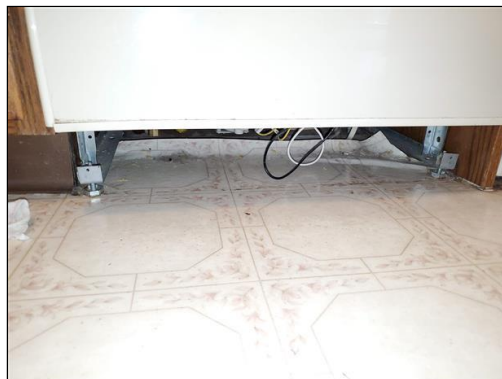
Dishwasher is not secured to the cabinet and missing a coverplate at the bottom. Recommend to secure and replace coverplate as needed by a qualified person.

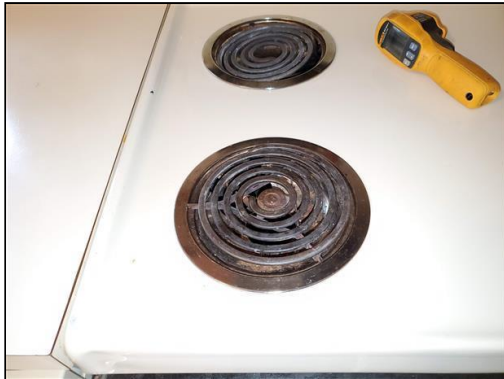
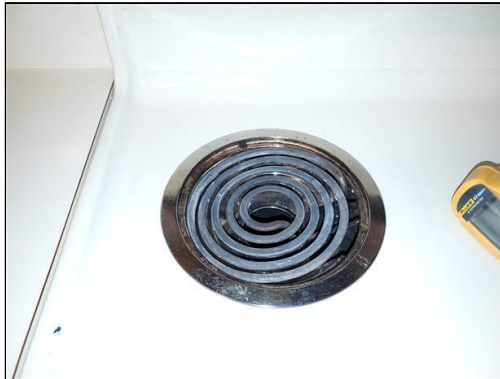
- Left front burner was nonfunctional. Recommend to repair left front burner as needed by a qualified person.
- Left rear burner is not fitting properly. Recommend to replace as needed by a qualified person.

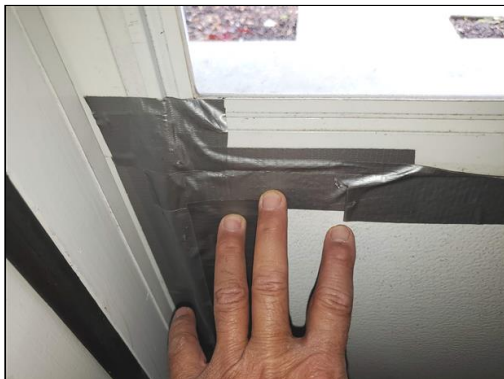
5.2.A Item 1(Picture)

Damaged storm door at the front entrance. Recommend to replace storm door as needed by a qualified person or professional.

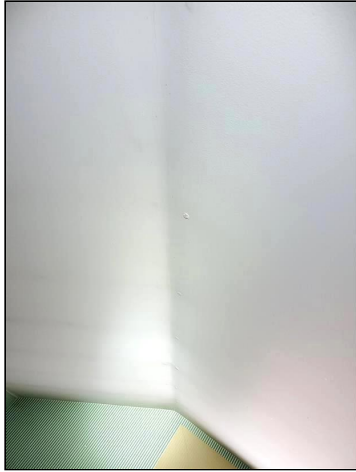
5.4.G Item 1(Picture)

Typical nail pops in bedroom #3 ceiling. Recommend to sand, spackle and paint as needed by a qualified person.
This would be considered normal maintenance.

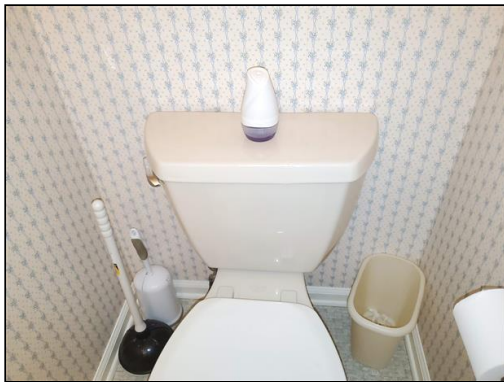
6.9.A Item 1(Picture)

Leak between the toilet tank and the bowl. Recommend to repair as needed by a qualified person.

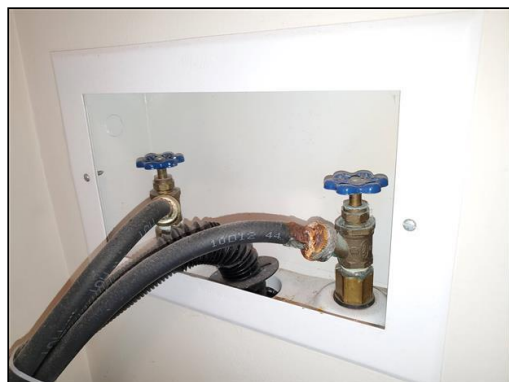
7.6 Item 1(Picture)

Suggest to replace rubber washing machine hose with stainless steel braided burst proof hose. This would be considered optional.

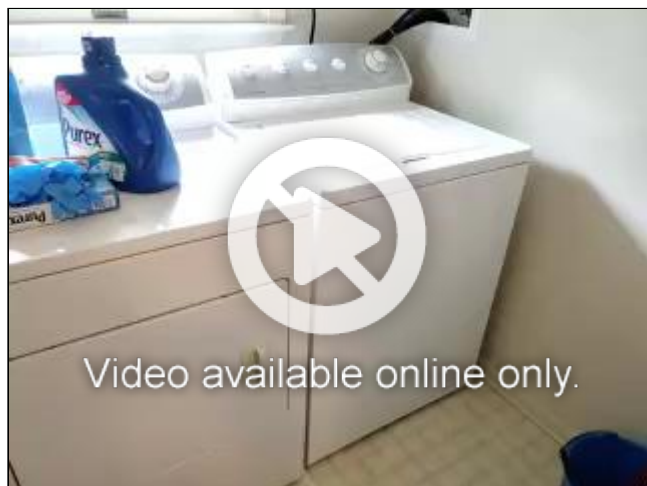
7.7 Item 1(Video) *** WASHER VIDEO ***

Washer is very noisy. Recommend to repair or replace as needed by a qualified professional. **View Washer Video.**

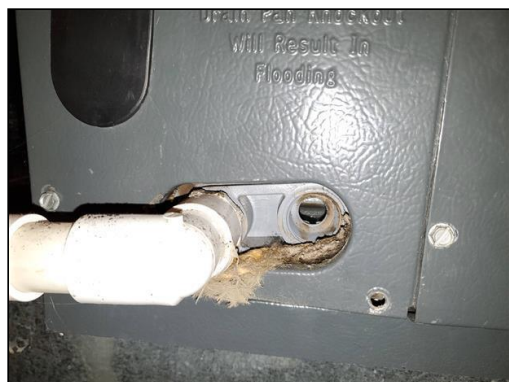
10.3 Item 1(Picture)

Missing a condensation tray plug. Recommend to replace as needed by a qualified person.

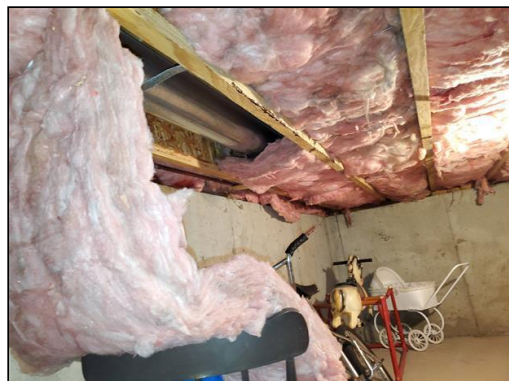
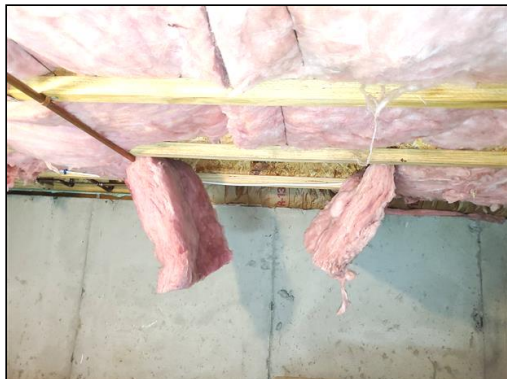
Areas of loose insulation in the crawlspace. Recommend to secure insulation back into position as needed by a qualified person.

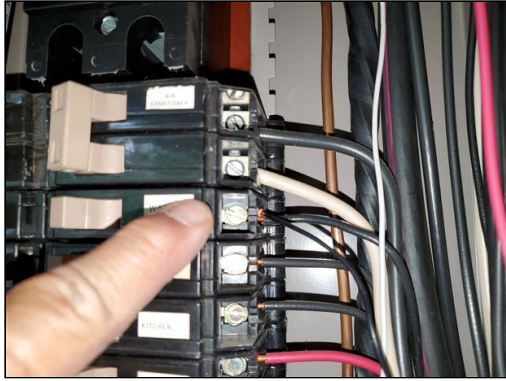
8.2 Item 1(Picture)

1 double tapped breaker located in the main panel. Recommend to have panel inspected and repaired as needed by a qualified electrician. Potential safety hazard exists.

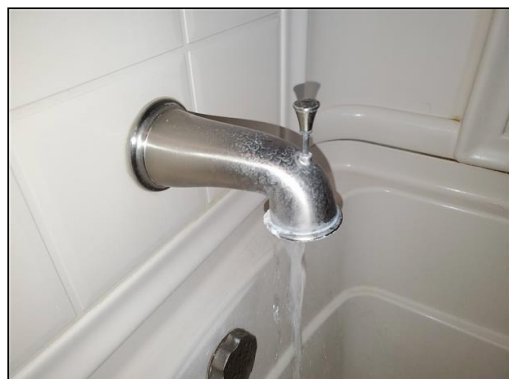
6.8.B Item 1(Picture)

Shower diverter valve is not functioning properly. Recommend to replace diverter valve as needed by a qualified plumber.

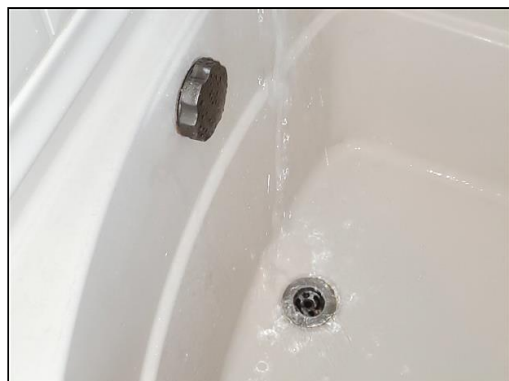
6.9.B Item 1(Picture)

Missing stopper in the hall bath tub. Recommend to repair or replace stopper as needed by a qualified person.

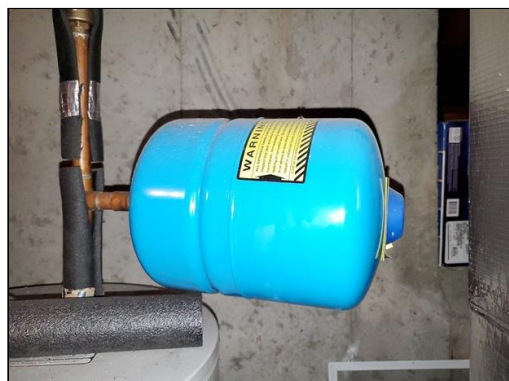
9.2 Item 1(Picture)

Hot water expansion tank is water logged. Recommend to recharge expansion tank as needed by a qualified person or plumber.
