Inspection Report

Property Address:
2035 Clover Mill Rd
Quakertown Pa 18951

A1 House Prep LLC and Inspections

Date: 06/05/20	Time: 10:30 AM	Report ID: 6844 Ed & Joann Leber
Property: 2035 Clover Mill Rd Quakertown Pa 18951	Customer: Ed Leber	Real Estate Professional: Michelle Hunsberger Sanford Alderfer Real Estate

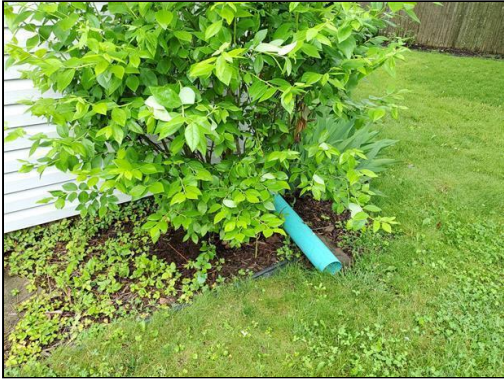
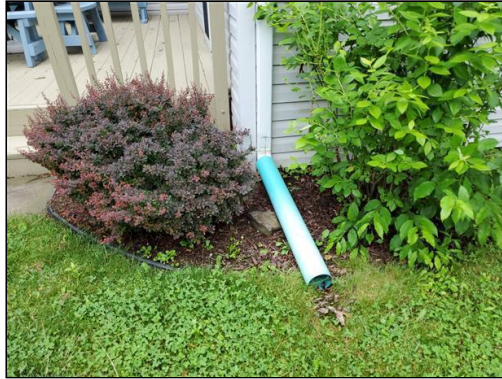
Downspouts are not moving water effectively away from the foundation. Suggest to extend downspouts as discussed for better drainage away from the foundation. Saturating foundation walls for extended periods of time can cause potential unseen structural damage from water and insects. Could not determine how long water was flowing towards the foundation.

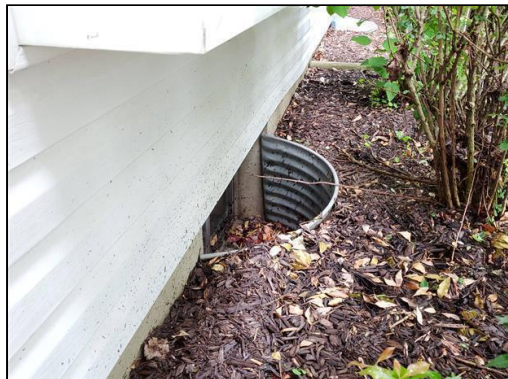
2.1 Item 1(Picture)

Missing a window well cover. Suggest to install clear plastic well cover over window well to prevent potential well saturation which could overflow window sill and spill into the basement. **This is considered optional.**

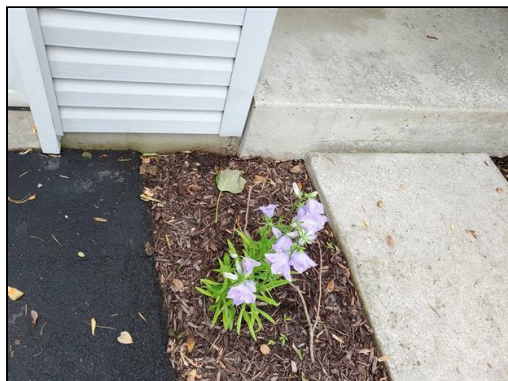
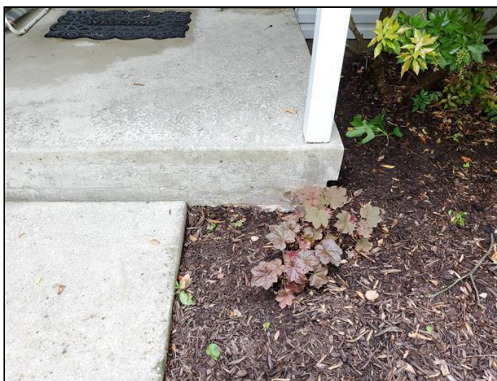
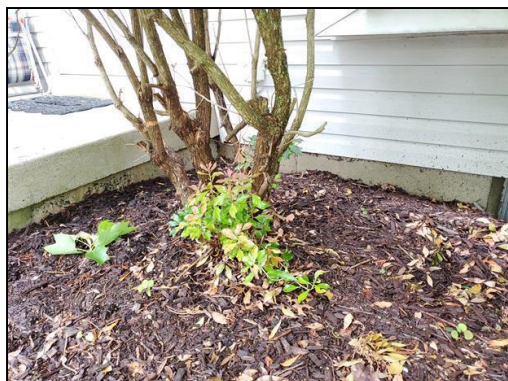
(1) Negative grading at the front of home. Highly recommend to correct grading as needed by a qualified person. Negative grading can cause unseen structural issues and water penetration if not corrected.

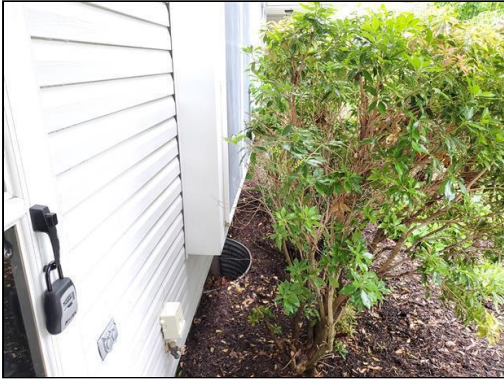
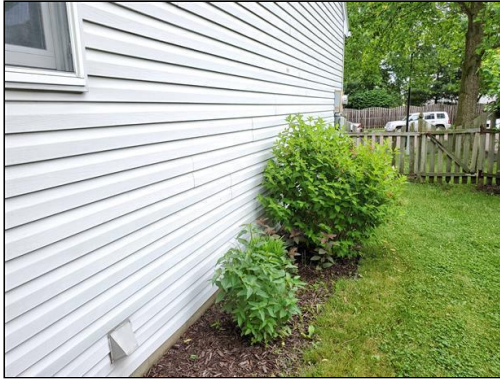
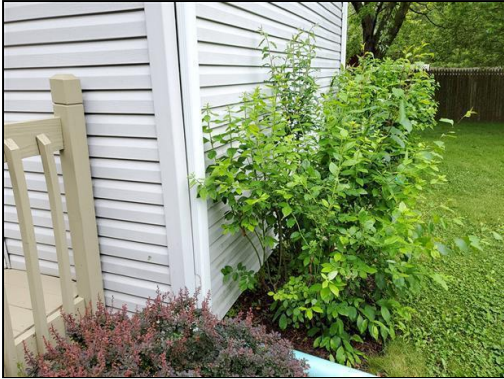
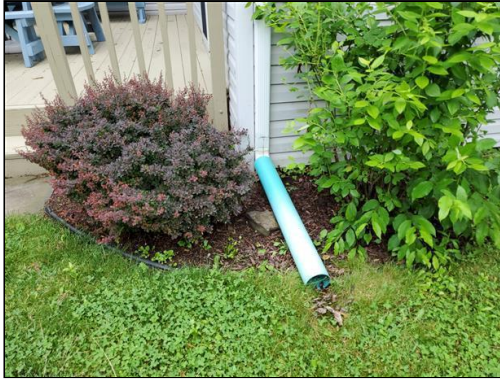
(2) Shrubberty is growing too close to the siding for proper ventilation. Recommend to trim shrubberty a minimum of of 12 to 16 inches away from the siding to restore proper ventilation. This would be considered normal maintenance.

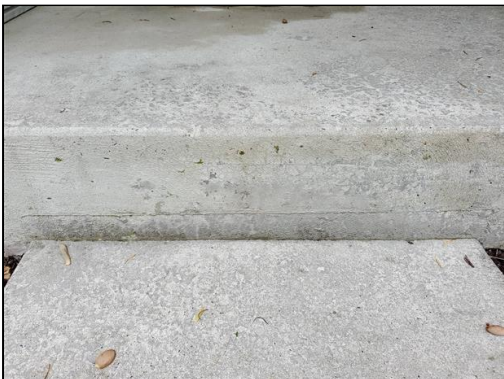
2.4 Item 1(Picture)

(1) Front step is considered higher than normal. Recommend to repair as needed by a qualified person. Potential tripping hazard exists.

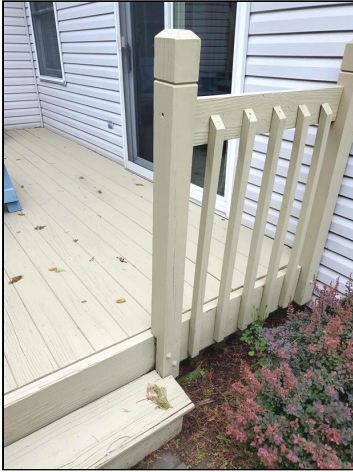
2.4 Item 2(Picture)

(2) Loose deck post. Recommend to secure as needed by a qualified person.

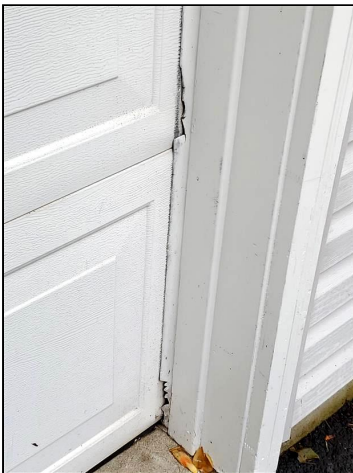
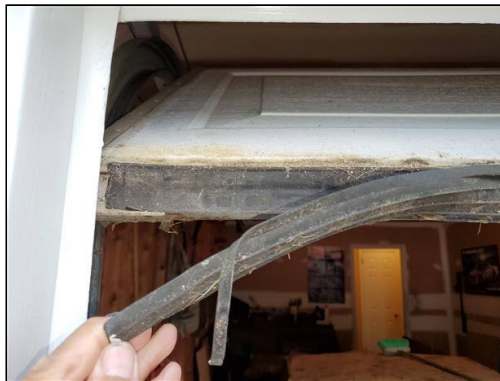
(1) Damaged weatherstripping around the garage door and under door. Recommend to replace weatherstripping as needed by a qualified person.

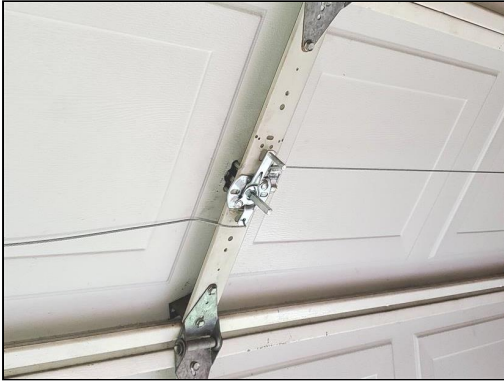
3.4 Item 3(Picture)

(2) Suggest to install a handle on the garage door.

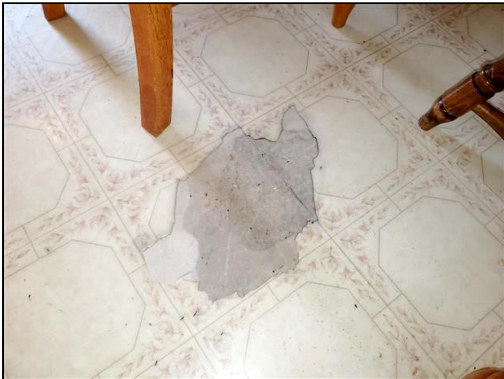
4.0 Item 1(Picture)

Damaged area in vinyl kitchen floor. Suggest to repair or replace flooring as needed by a qualified person.

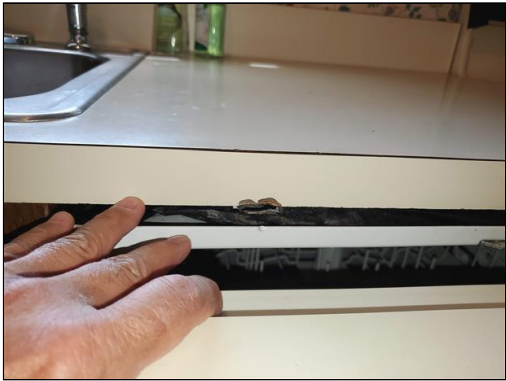
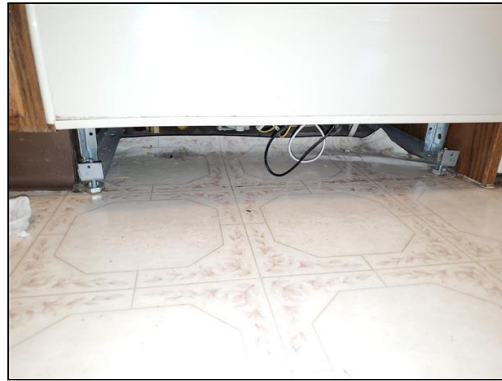
Dishwasher is not secured to the cabinet and missing a coverplate at the bottom. Recommend to secure and replace coverplate as needed by a qualified person.

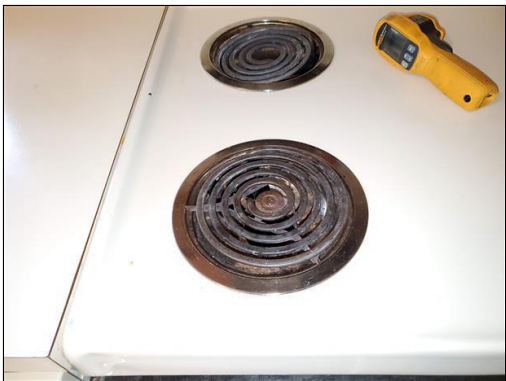
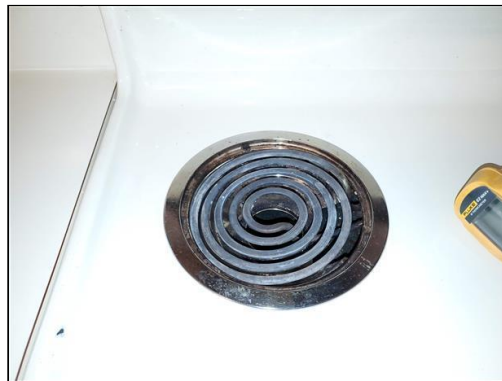
- Left front burner was nonfunctional. Recommend to repair left front burner as needed by a qualified person.
- Left rear burner is not fitting properly. Recommend to replace as needed by a qualified person.

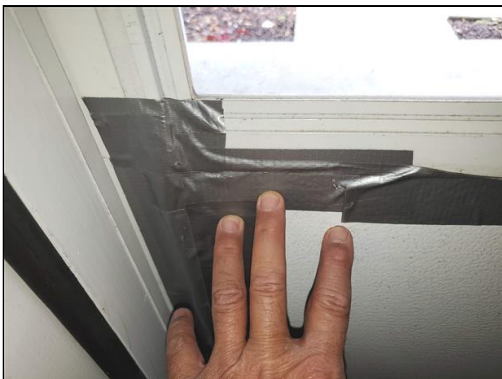
5.2.A Item 1(Picture)

Damaged storm door at the front entrance. Recommend to replace storm door as needed by a qualified person or professional.

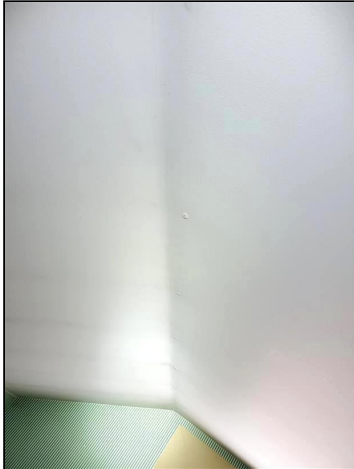
5.4.G Item 1(Picture)

Typical nail pops in bedroom #3 ceiling. Recommend to sand, spackle and paint as needed by a qualified person.

This would be considered normal maintenance.

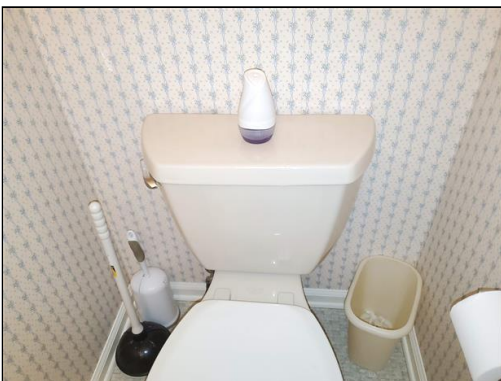
6.9.A Item 1(Picture)

Leak between the toilet tank and the bowl. Recommend to repair as needed by a qualified person.

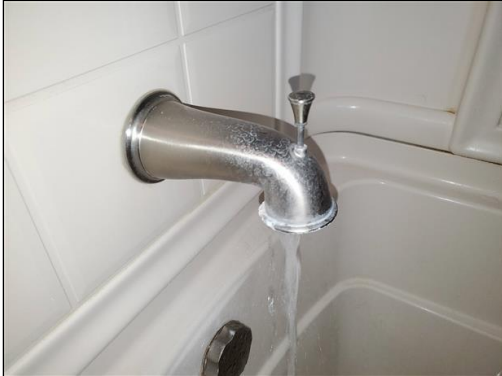
6.8.B Item 1(Picture)

Shower diverter valve is not functioning properly. Recommend to replace diverter valve as needed by a qualified plumber.

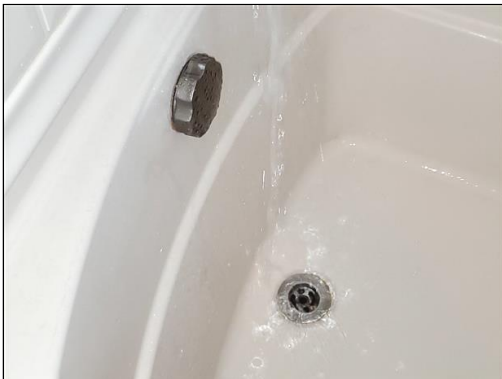
6.9.B Item 1(Picture)

Missing stopper in the hall bath tub. Recommend to repair or replace stopper as needed by a qualified person.

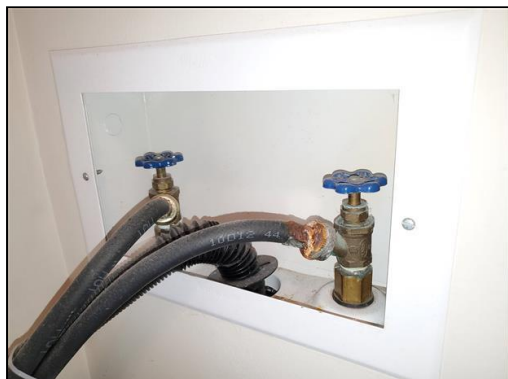
7.6 Item 1(Picture)

Suggest to replace rubber washing machine hose with stainless steel braided burst proof hose. This would be considered optional.

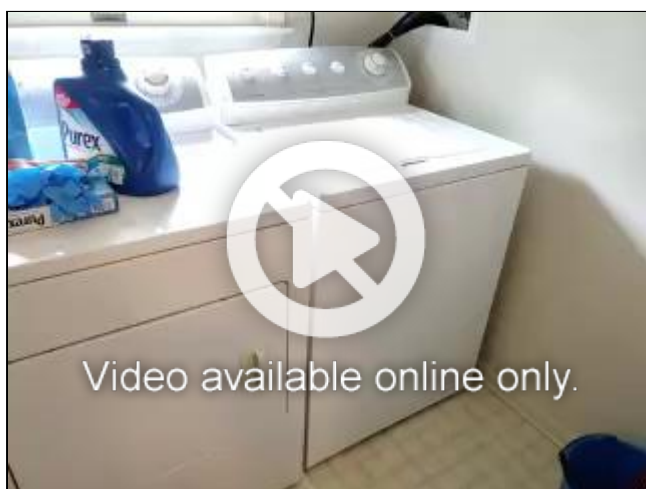
7.7 Item 1(Video) *** WASHER VIDEO ***

Washer is very noisy. Recommend to repair or replace as needed by a qualified professional. **View Washer Video.**

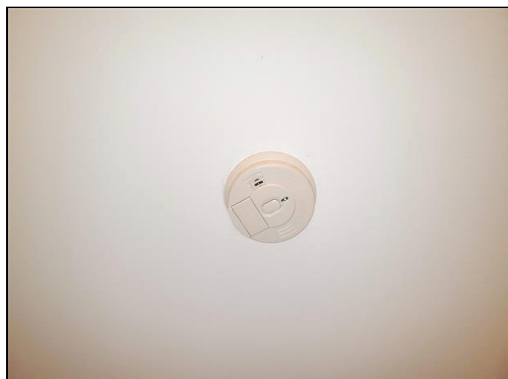
8.7 Item 1(Picture)

Recommend to install and replace all older smoke detectors as suggested by the Fire Protection Association.

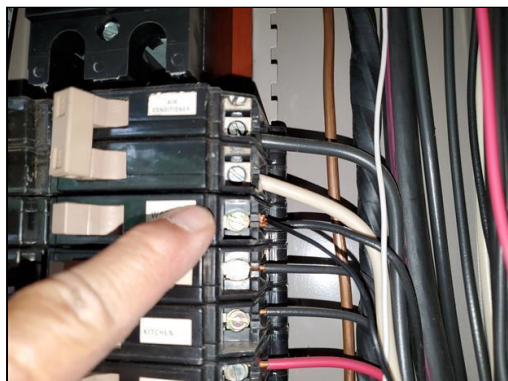
8.2 Item 1(Picture)

1 double tapped breaker located in the main panel. Recommend to have panel inspected and repaired as needed by a qualified electrician. Potential safety hazard exists.

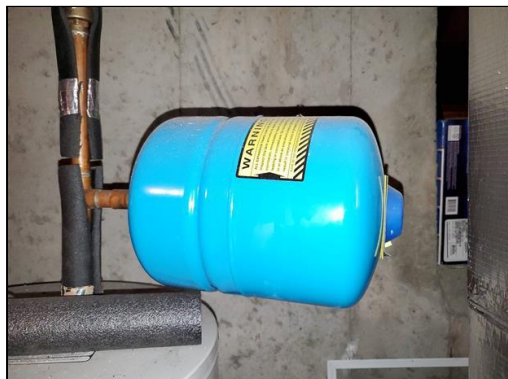
9.2 Item 1(Picture)

Hot water expansion tank is water logged. Recommend to recharge expansion tank as needed by a qualified person or plumber.

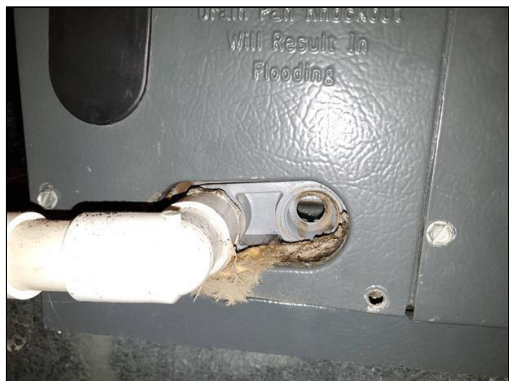
10.3 Item 1(Picture)

Missing a condensation tray plug. Recommend to replace as needed by a qualified person.

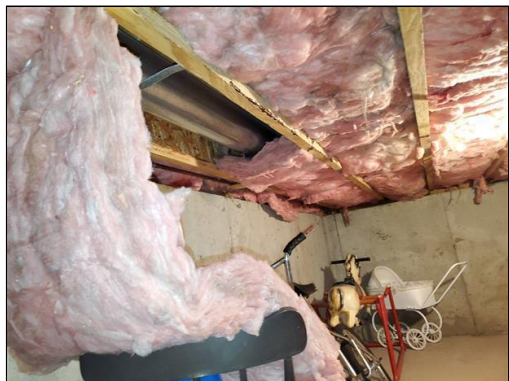
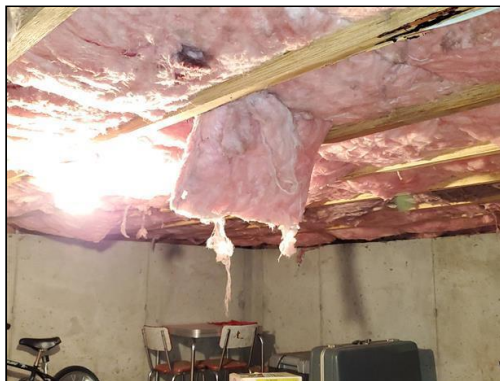
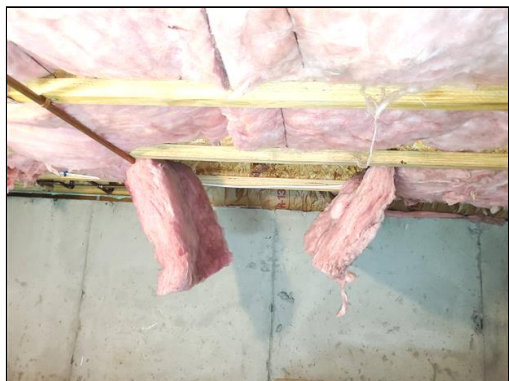
Areas of loose insulation in the crawlspace. Recommend to secure insulation back into position as needed by a qualified person.
