### **ASBESTOS SURVEY REPORT**

# MADISON AVENUE IL REMOTE DRIVE THRU PIMS NO. INMW081635REC COST CENTER NO.: RFC025621 210 NORTHEAST MADISON PEORIA, ILLINOIS

Terracon Project No.: 15089600 - 025621

October 22, 2008

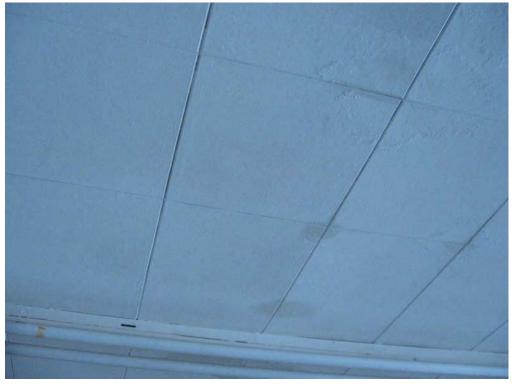
View of the 18" x 18" ceiling tile, group 01

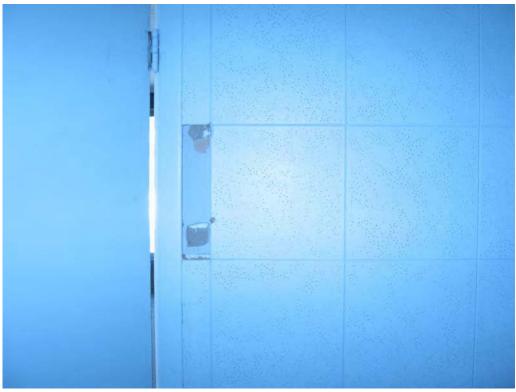
View of the 12" x 12" wall tile and mastic, group 02, 03

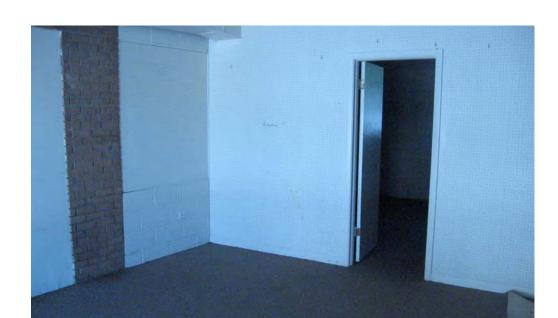
Yellow carpet adhesive with black/gray residuals located in the front and rear rooms

View of the carpet adhesive, group 04

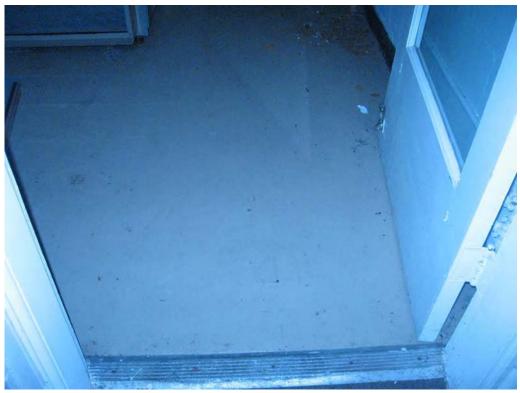
- 9" x 9" Floor tile, pink located in the mechanical room and restroom
- Mastic associated with the 9" x 9" floor tile, pink
- Floor tile, beige located in the front and rear rooms
- Mastic associated with the beige floor tile

The floor tiles and mastics are located in both units, and are considered Category I non-friable ACM in fair to poor condition.

View of the 9" x 9" green floor tile and mastic, group 05, 06

Terracon recommends that the identified Category I non-friable ACM be removed and disposed of by a Illinois-licensed asbestos abatement contractor prior to any renovation activity that will disturb the asbestos-containing materials identified

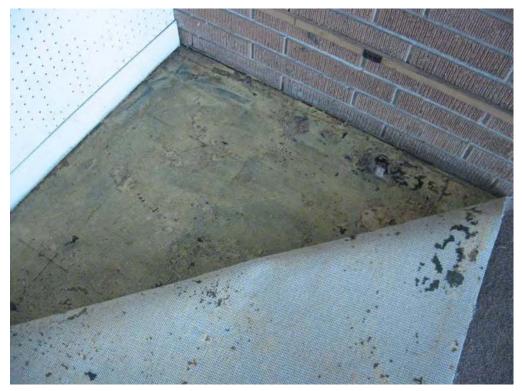
View of the beige floor tile and mastic below carpet, group 07, 08

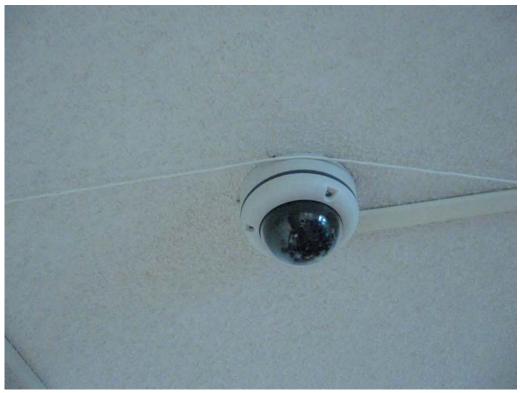
View of the popcorn texture ceiling material, group 09

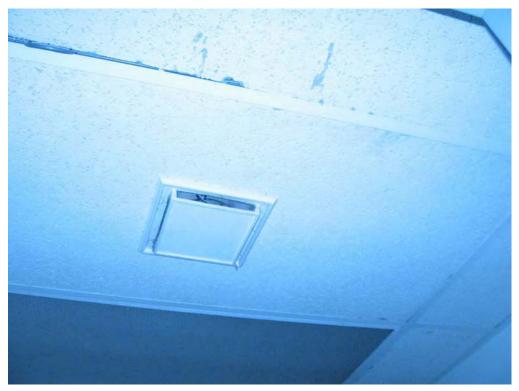
View of the 2' x 4' lay-in ceiling tile, group 10

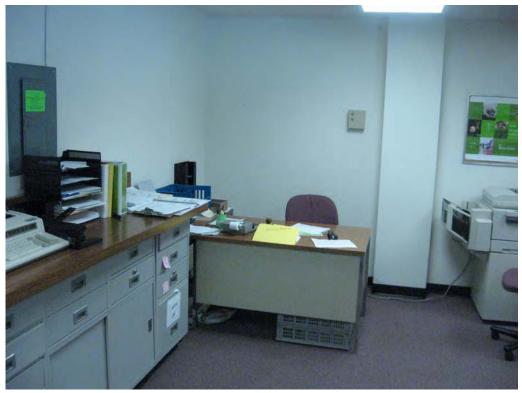
View of the drywall wall system, group 11

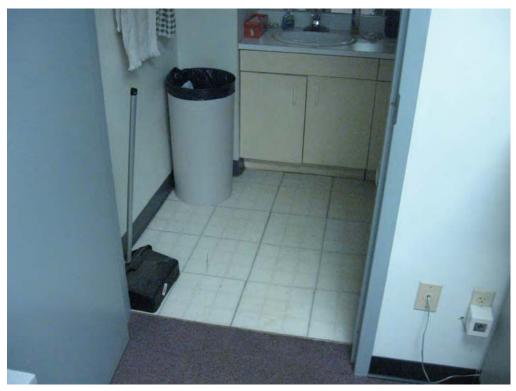
View of the 12" x 12' white floor tile and mastic, group 12, 13

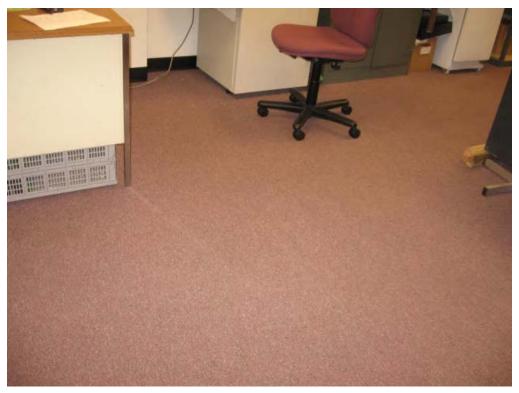
View of the carpet adhesive, group 15.
