ASBESTOS SURVEY REPORT

**MAYFIELD DOWNTOWN
COST CENTER # RFC023517
117 NORTH SEVENTH STREET
MAYFIELD, KENTUCKY**

Terracon Project No. 57089516

September 12, 2008

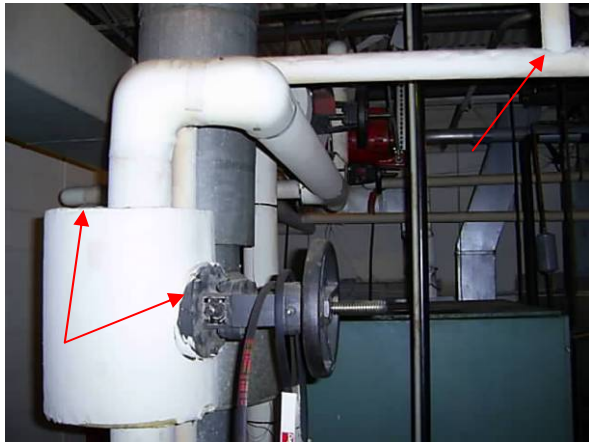
| Sample No. | Description | Material Location | Percent/Type Asbestos | NESHAP Classification | Condition | Estimated Quantity |
|---|---|---|---|---|---|---|
| 13-01 | White pipe compound/ compound | Mechanical room and above ceiling | 2% Chrysotile | Friable | Good Condition | 25ft ² |

Photo #1 White pipe compound/coating in mechanical room.

If the proposed renovations will impact identified ACM, Terracon recommends that the identified ACM be removed and disposed of by a KDAQ licensed asbestos abatement contractor prior to renovation of the building.

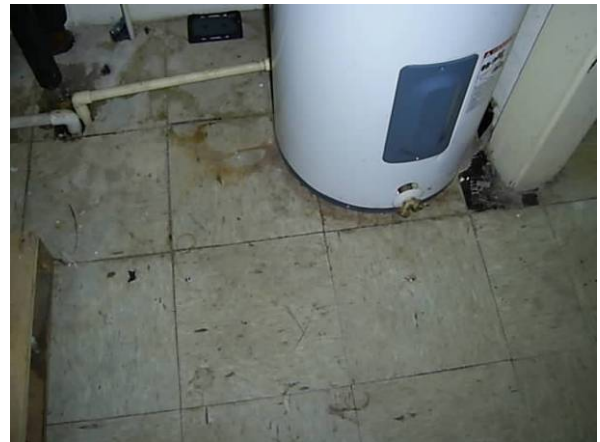
| Sample No. | Description | Material Location | Percent/Type Asbestos | NESHAP Classification | Condition | Estimated Quantity |
|---|---|---|---|---|---|---|
| 15-01 | 12x12 Gray floor tile mastic - black | Mechanical room and rear stairwell | 2% Chrysotile | Category I Non-Friable | Good Condition | 800 ft ² |

Photo #2 12x12 gray floor tile mastic – black located in the mechanical room and rear stairwell.

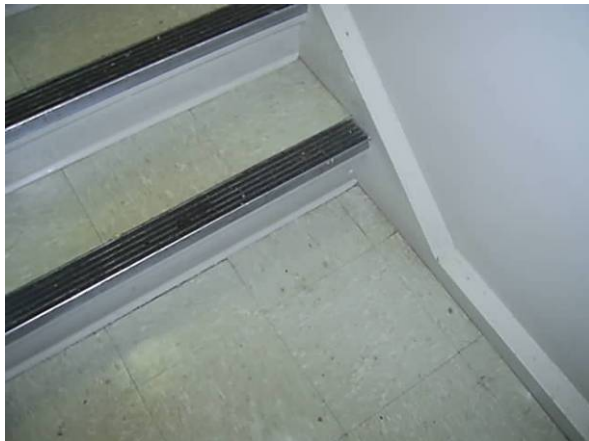
Photo #3 12x12 gray floor tile mastic – black located in the mechanical room and rear stairwell.

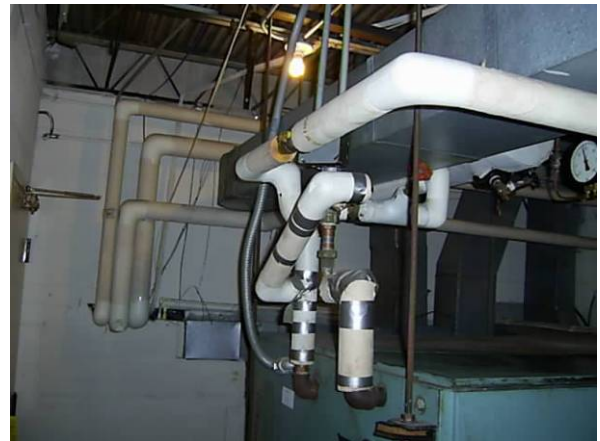
| Sample No. | Description | Material Location | Percent/Type Asbestos | NESHAP Classification | Condition | Estimated Quantity |
|---|---|---|---|---|---|---|
| 16-01 | Yellow fiberglass pipe insulation backing | Mechanical room and above ceiling | 2% Chrysotile | Category II Non-Friable | Good Condition | 500 ft |

Photo #4 Yellow fiberglass pipe insulation white backing in mechanical room.

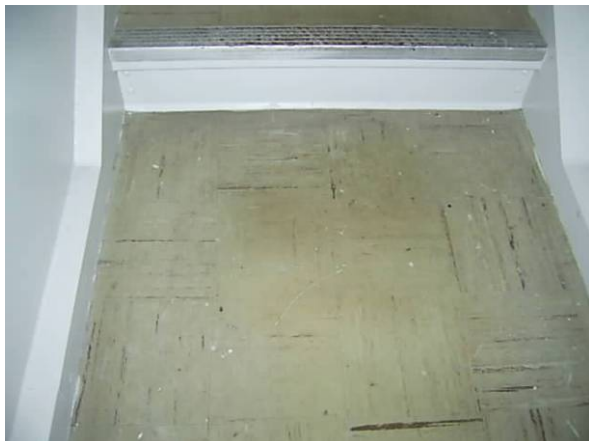
| Sample No. | Description | Material Location | Percent/Type Asbestos | NESHAP Classification | Condition | Estimated Quantity |
|---|---|---|---|---|---|---|
| 18-01 | 9"x9" Tan/brown floor tile | Front stairwell | 2% Chrysotile | Category I Non-Friable | Good Condition | 90 ft ² |

Photo #5 9" x 9" floor tile, tan/brown located in the front stairwell.

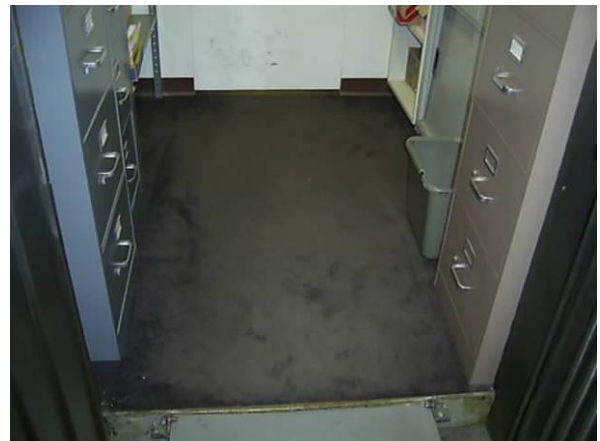
| Sample No. | Description | Material Location | Percent/Type Asbestos | NESHAP Classification | Condition | Estimated Quantity |
|---|---|---|---|---|---|---|
| 27-01 | Black/brown carpet mastic | Teller vault | 2% Chrysotile | Category I Non-Friable | Good Condition | 120 ft ² |

Photo #6 Carpet mastic (black/brown) located in the teller vault.
