Asbestos Abatement Close-out Report

**Mayfield Downtown
Cost Center No. RFC023517
117 North 7th Street
Mayfield, Kentucky**

August 3, 2018
Terracon Project No. 18187225

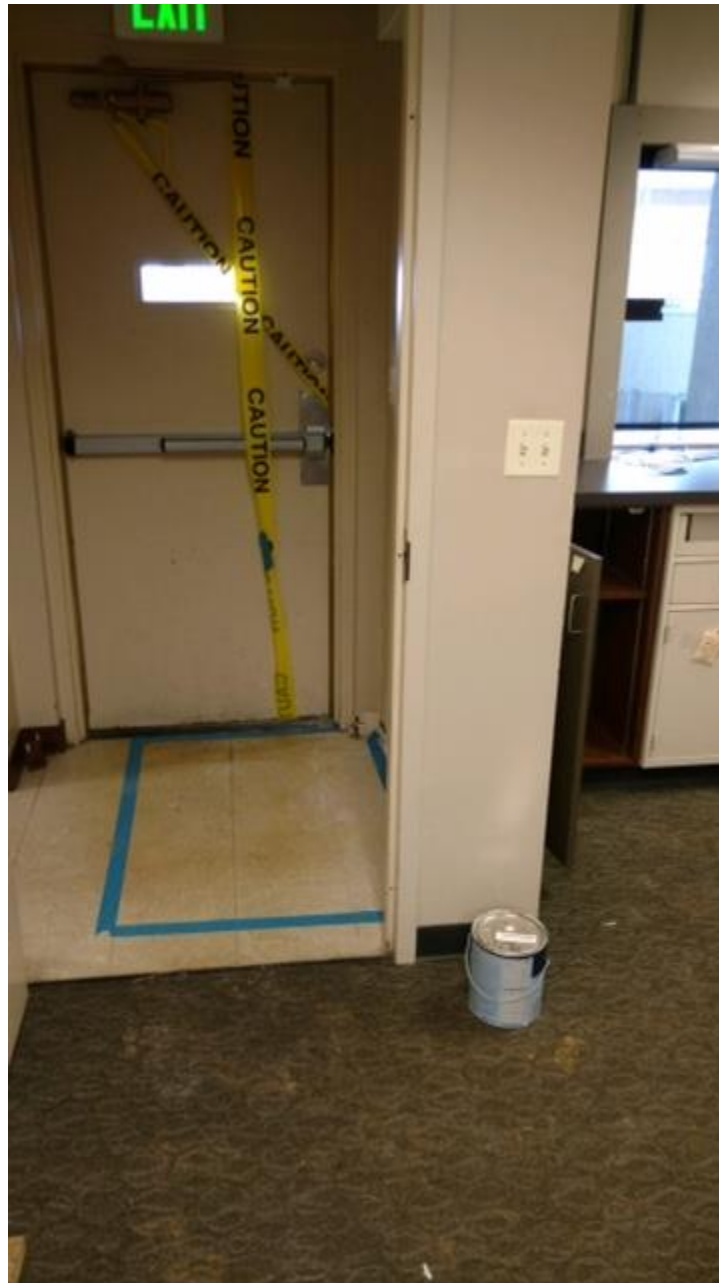
Photo 1: View of vinyl floor tile with ACM mastic indicating extent of removal.

Abatement of vinyl floor tile and associated ACM mastic from the rear stairwell as indicated on the attached photo and drawing. The abatement work schedule is to be determined. Abatement will need to be coordinated with CBRE and the renovation (re-installation) contractor.

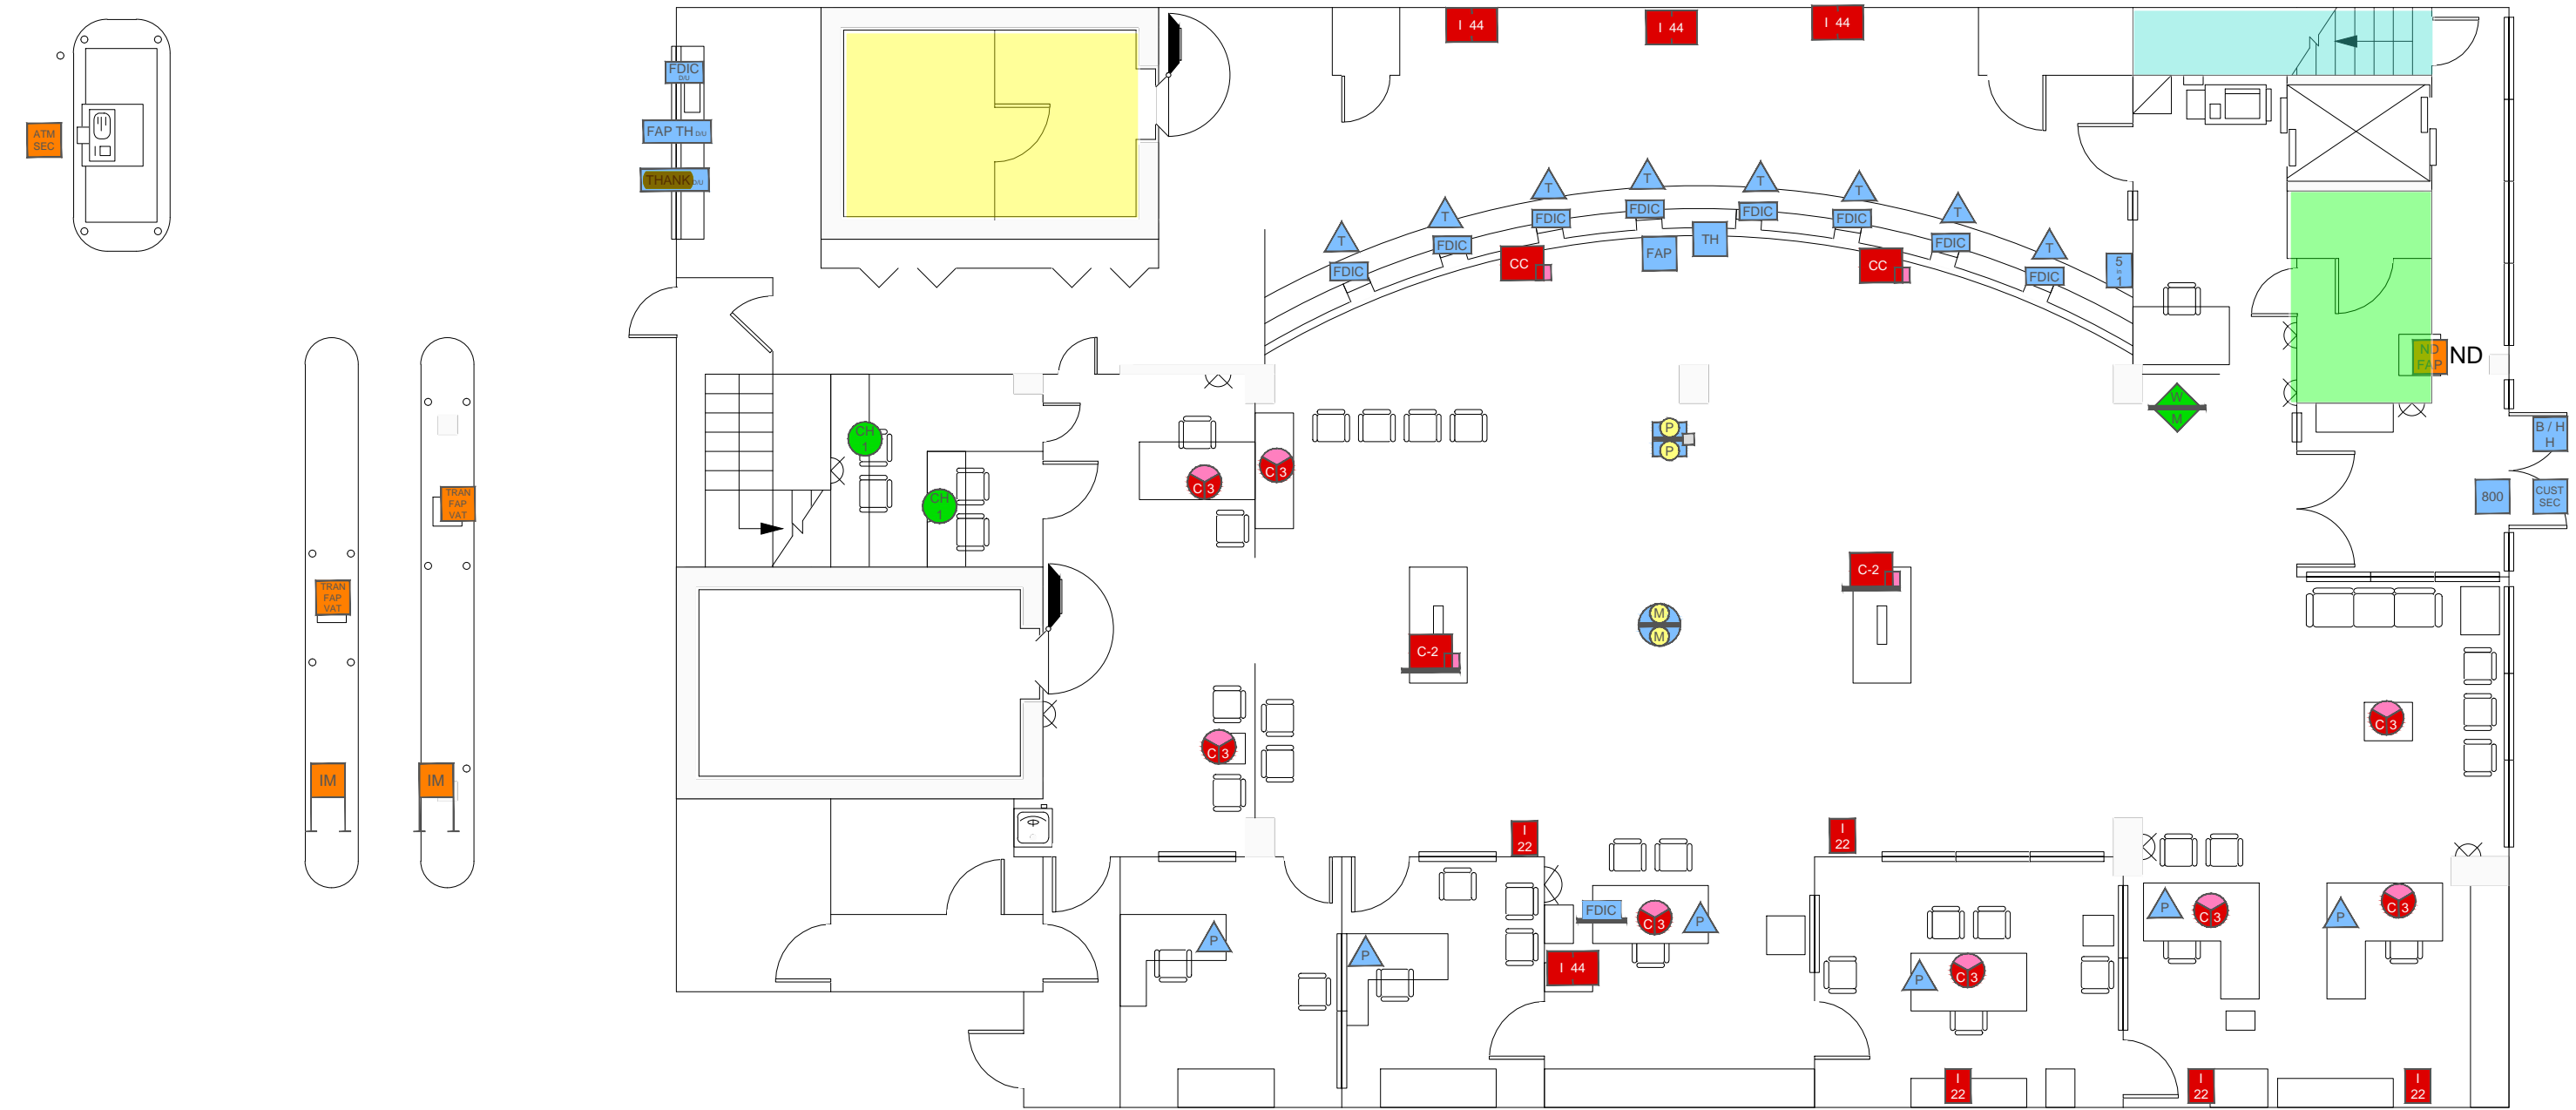
DRAWING OF REMAINING ACMs

- ACM carpet mastic present.
- ACM vinyl floor tile and mastic present
- ACM vinyl floor tile and mastic present.

- General ACM Notes:**
1. ACM pipe joint compound and pipe insulation backing was observed and sampled above the ceiling in the mechanical room and is assumed to be present throughout the branch.
 2. ACM window and marble caulk (brown) present on the exterior of the branch.
