**ASBESTOS SURVEY REPORT**

**SALEM  
COST CENTER NO. RFC#023524  
111 EAST MAIN STREET  
SALEM, KENTUCKY**

**Terracon Project No. 18097077  
PO No. CA117576**

**December 4, 2009**

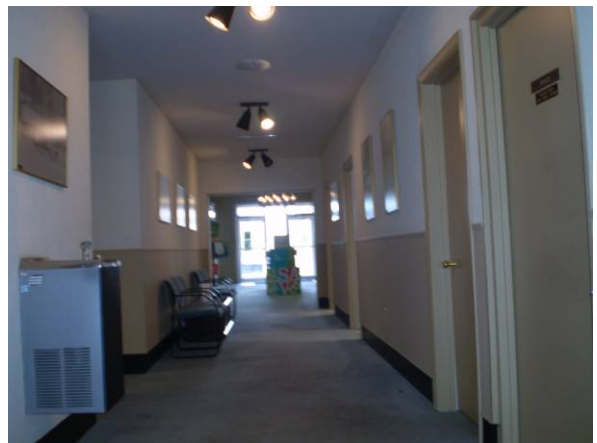
Photo #6 Hallway, Showing Textured Wall, Cream (HA#17) & Cove Base, Brown (HA#19)

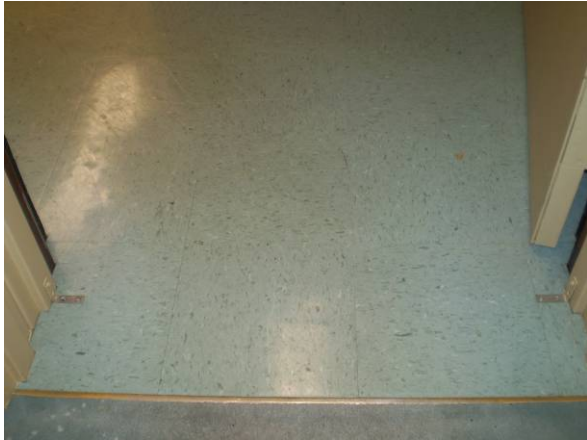
Photo #7 12"x12" Vinyl Floor, Mint Green (HA#1)

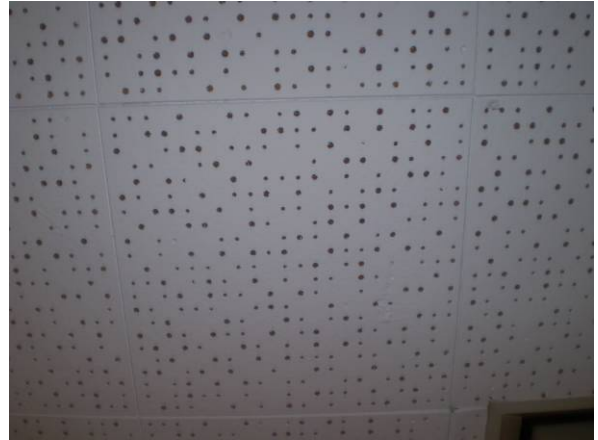
Photo #8 12"x12" Ceiling Tile with Large Holes (HA#7)

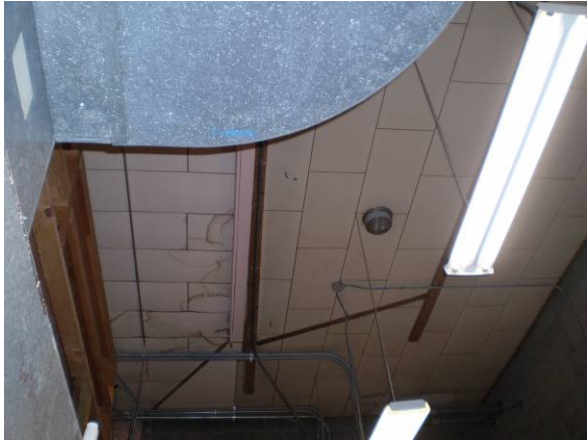
Photo #9 4'x2' Ceiling Panels with Water Damage in Attic (HA#8)

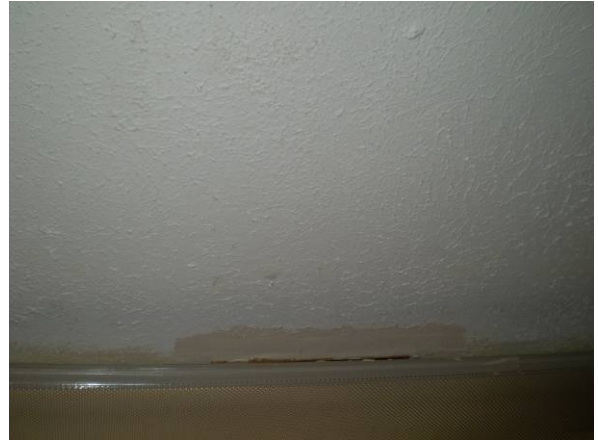
The textured ceiling material, located in safe deposit box room, and offices 6 and 7, is considered Friable ACM in good condition.

Photo #10 ACM Textured Ceiling (HA#16)

Terracon recommends that the identified and assumed non-friable and friable ACM be removed and disposed of by a Kentucky-licensed asbestos abatement contractor prior to the renovation activity that will disturb the asbestos-containing materials identified.

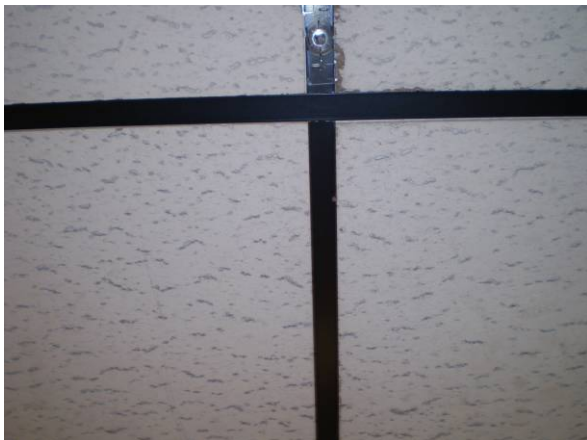
Photo #11 2'x2' Dropped Ceiling Tile with Squiggly Pattern (HA#5)

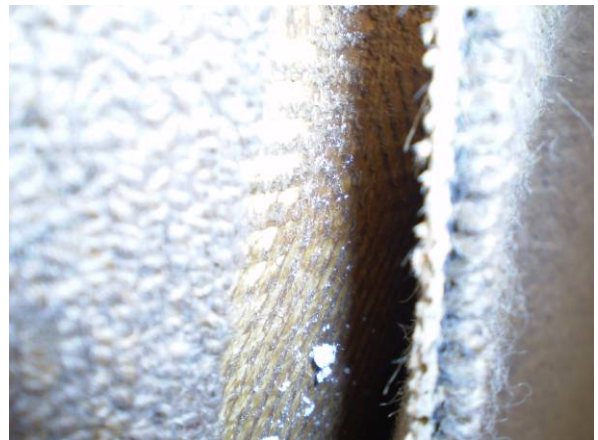
The brown colored wall carpet mastic, located in conference room and office 4, is considered a Category I non-friable ACM in good condition.

Photo #12 ACM Wall Carpet Mastic, Brown (HA#6)

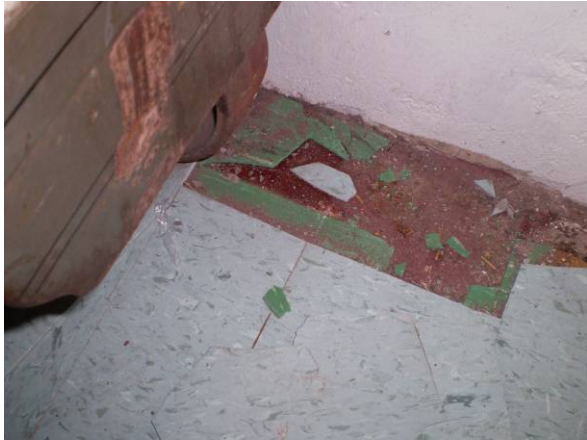
The 12"x12" beige and cream colored vinyl floor tile and the 9"x9" forest green colored vinyl floor tile are located under 12"x12" mint green colored vinyl floor tile and mastic in the safe deposit box room, the office supply storage room and the office storage room. These materials are considered to be Category I non-friable ACM in good condition.

Photo #13 ACM 9"x9" Vinyl Floor Tile, Forest Green (HA#3)

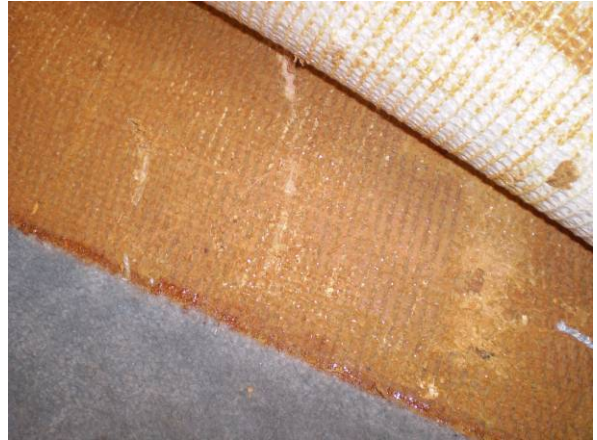
The carpet mastic, located in all carpeted areas of the building, is considered Category I non-friable ACM in good condition.

Photo #14 ACM Carpet Mastic, Brown (HA#18)

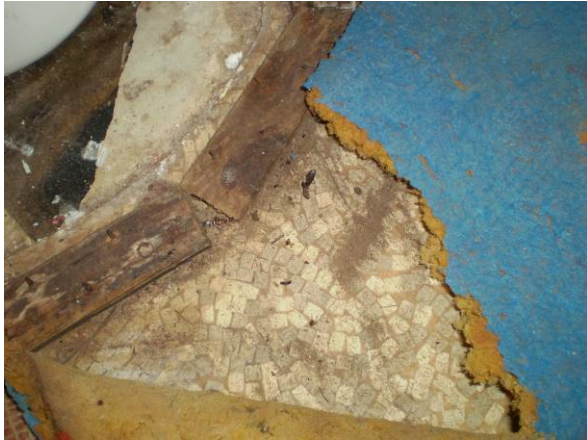
The cream colored vinyl floor tile and mastic, located under the carpet in the women's restroom, are considered Category I non-friable ACM in good condition.

The linoleum flooring, located under the carpet and vinyl floor tile in the women's restroom, is considered Category I non-friable ACM in good condition.

Photo #15 ACM Vinyl Floor Tile Cream & ACM Linoleum, Gold/Beige (HA#13 & 14)

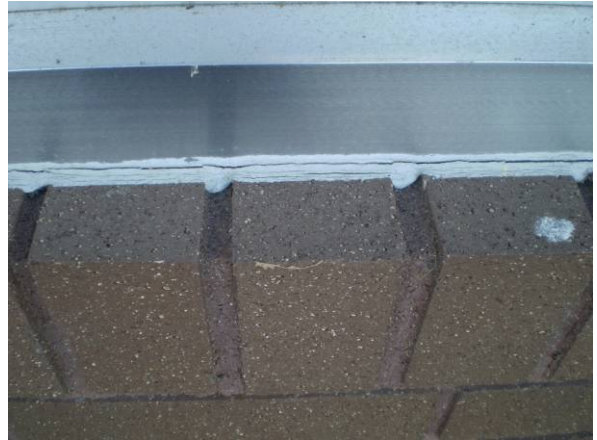
The window caulk, located on the interior and exterior of the windows at the front of the building, is considered a Category II non-friable ACM in good condition.

Photo #16 ACM Window Caulk, Gray, Front of Bank (HA#11)

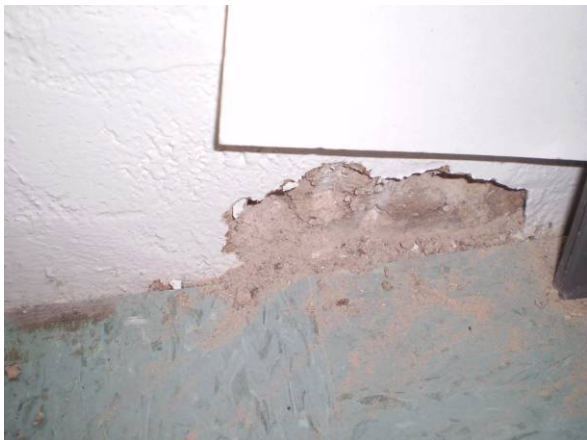
Photo #17 Plaster Skim Coat (HA#21)

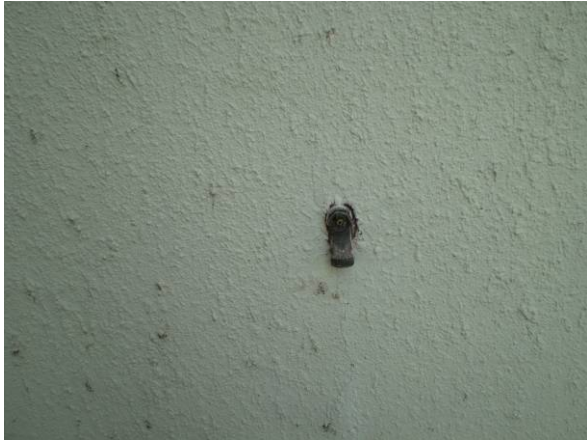
Photo #19 Stucco on rear Exterior Wall (HA#15)

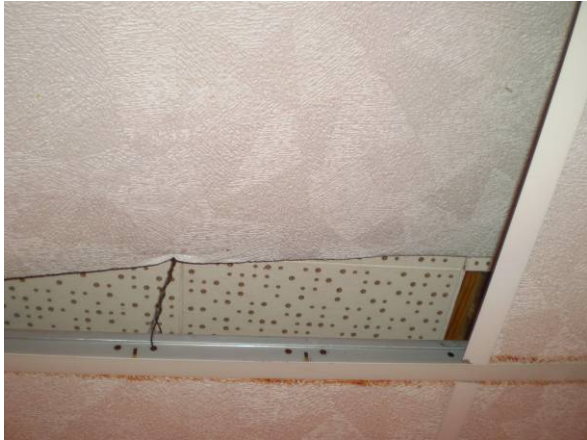
Photo #21 Above Fiberglass Ceiling Tile in Office 6 Showing HA#7

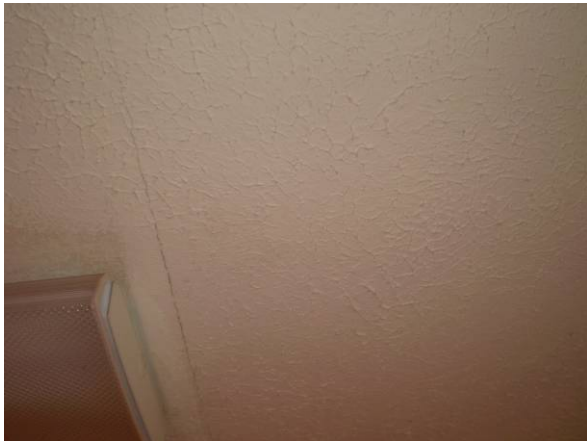
Photo #23 ACM Textured Ceiling, (HA#16)

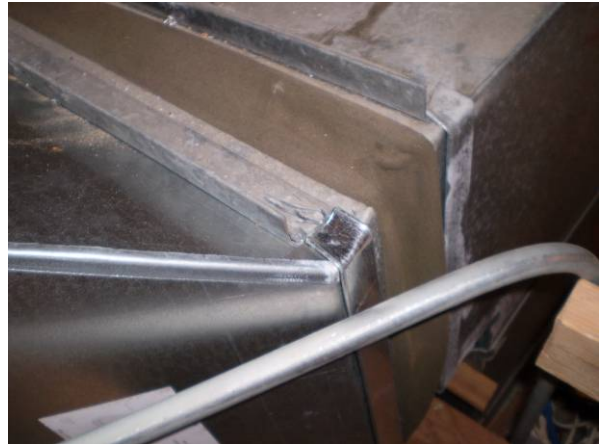
The HVAC cloth vibration joint material, located in the attic area, is considered a Friable ACM in good condition.

Photo #32 Assumed ACM Cloth Connector Fabric

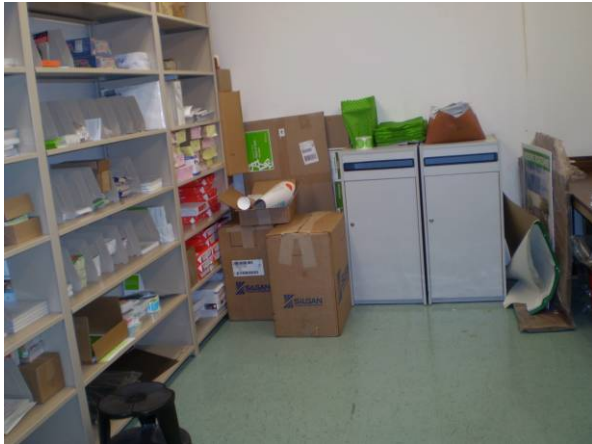
Photo #43 Office Storage with ACM Beige & Cream Vinyl Floor Tile (HA#2) under 12"x12" Mint Green Vinyl Floor Tile (HA#1)

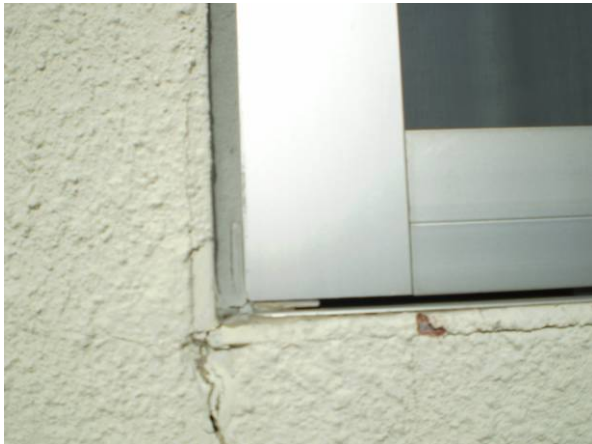
Photo #45 ACM Window Caulk, Light Gray (HA#12)

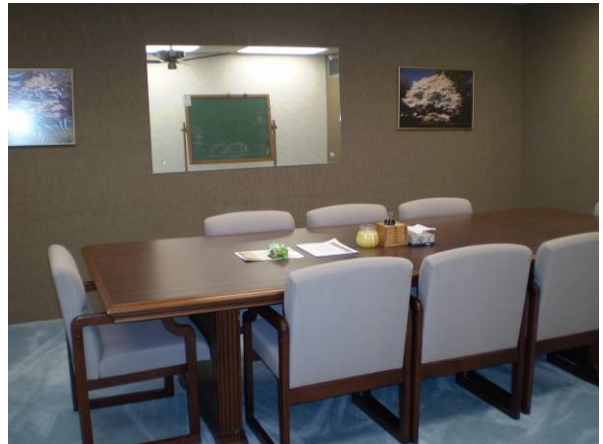
The joint compound associated with the gypsum wallboard, located throughout the building, is considered Category II non-friable ACM in good condition.

Photo #46 Conference Room Showing ACM Gypsum Wallboard Joint Compound (HA#20)
