ASBESTOS ABATEMENT REPORT

**REGIONS SALEM
COST CENTER NO. RFC023524
111 EAST MAIN STREET
SALEM, KENTUCKY**

**Terracon Project No. 57107000
January 28, 2010**

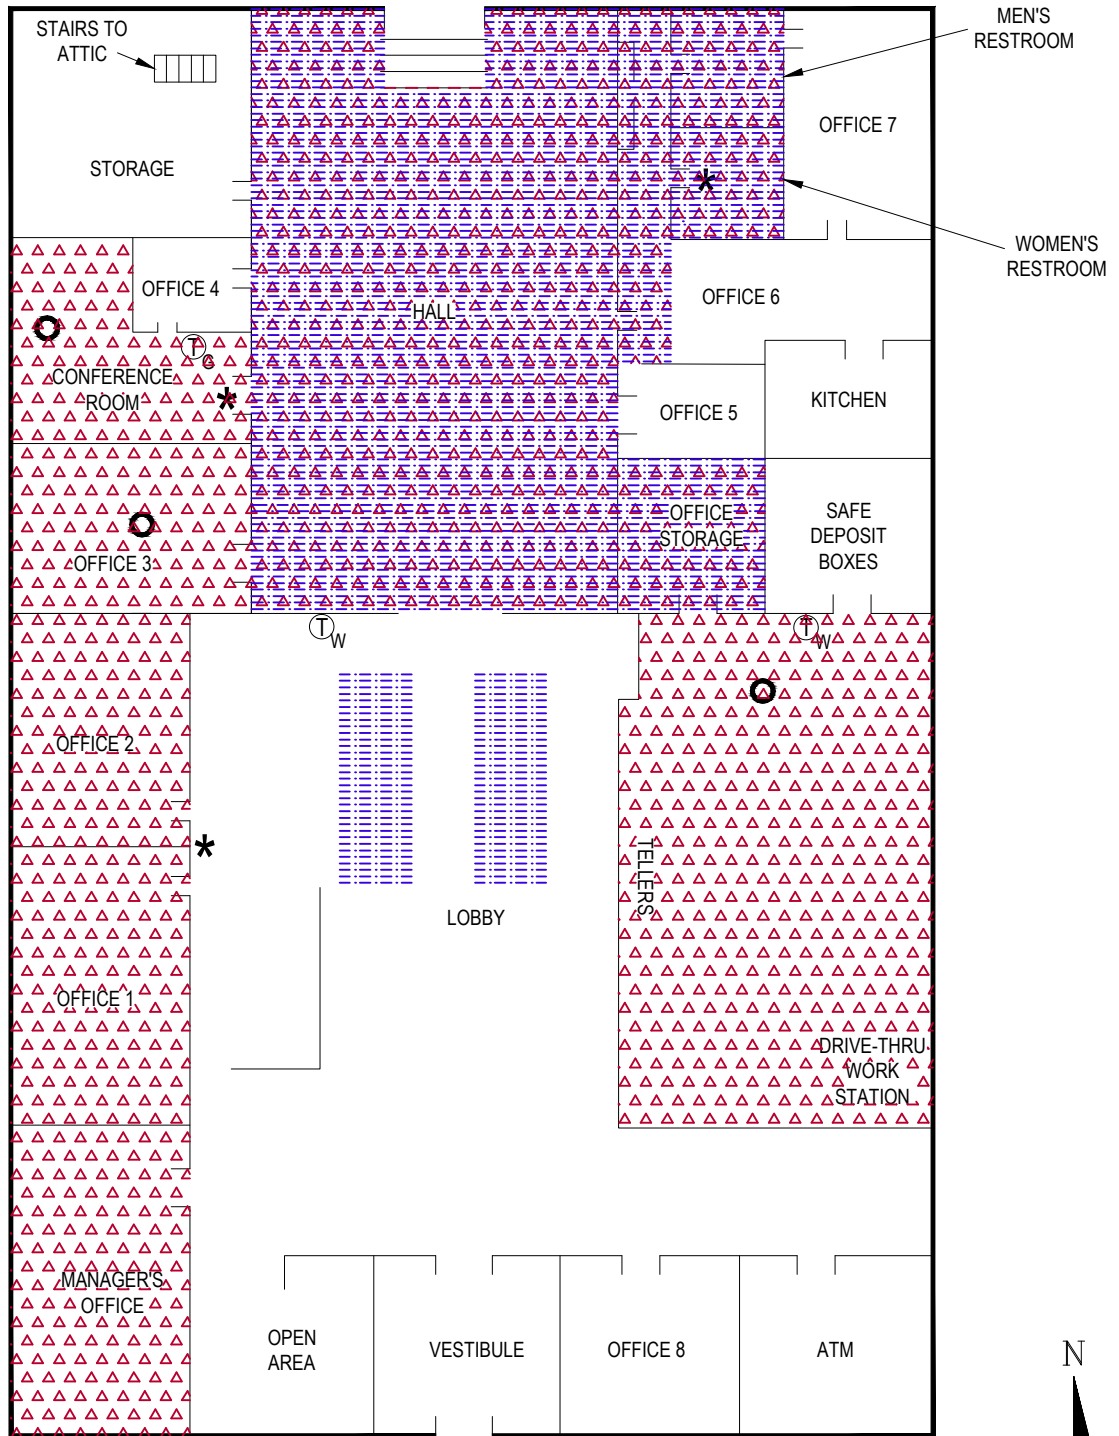
Additional ACM remains in the building in locations that were not located in proposed renovation areas. Specifically, window caulk, textured ceiling, and gypsum wallboard, tape and compound.
