Asbestos Survey Report

Remington
Cost Center No. RFC023341
15 South Ohio Street
Remington, Indiana

November 9, 2010
Terracon Project No. N1107185 / Task 1
P.O. No. CA398907IN

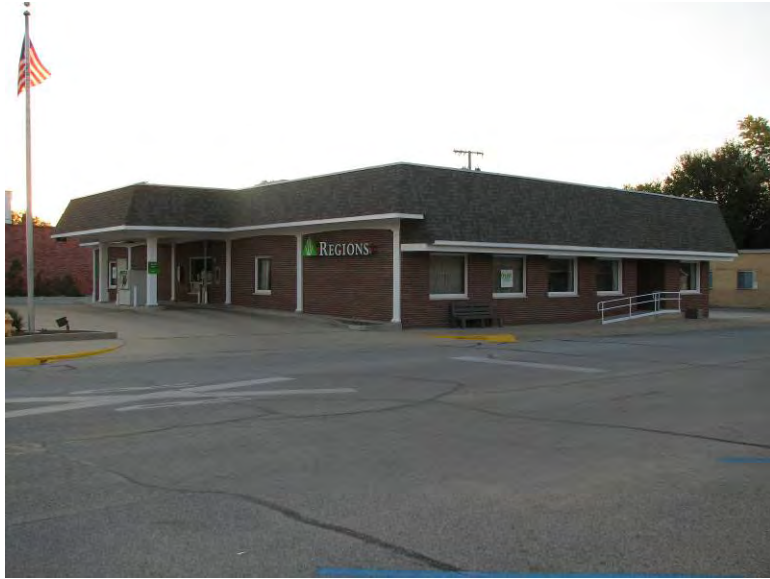
The joint compound for the drywall system is located throughout the structure. However, when composited with the gypsum board, the material was identified as having only a trace amount (< 1%) of asbestos. This material is still regulated by OSHA (i.e., respirable exposures in excess of 0.1 fibers per cubic centimeter are not acceptable), but this material is not, by definition, an ACM.

Photo 1: Exterior of the Regions Bank branch. Asbestos-containing joint compound is present on painted drywall seams throughout the structure (not observed on wallpaper seams).

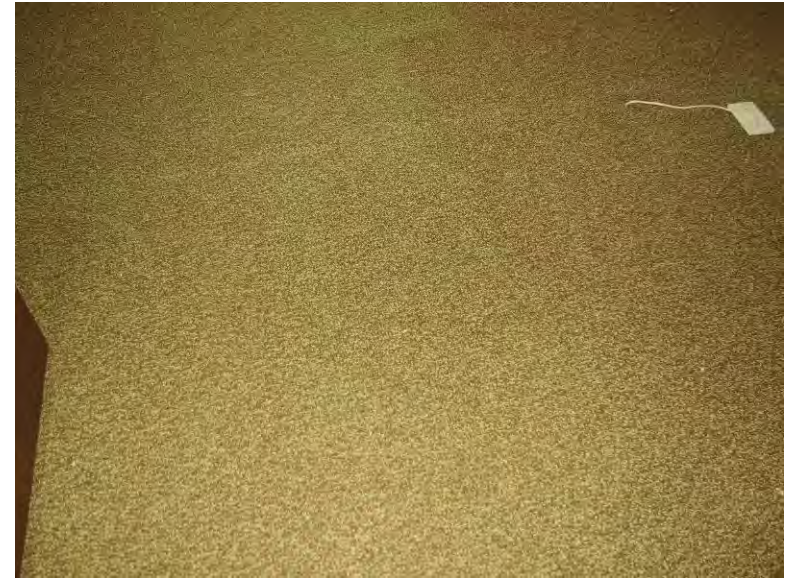
Photo 2: An example view of carpet that was glued to the floor with mastic.

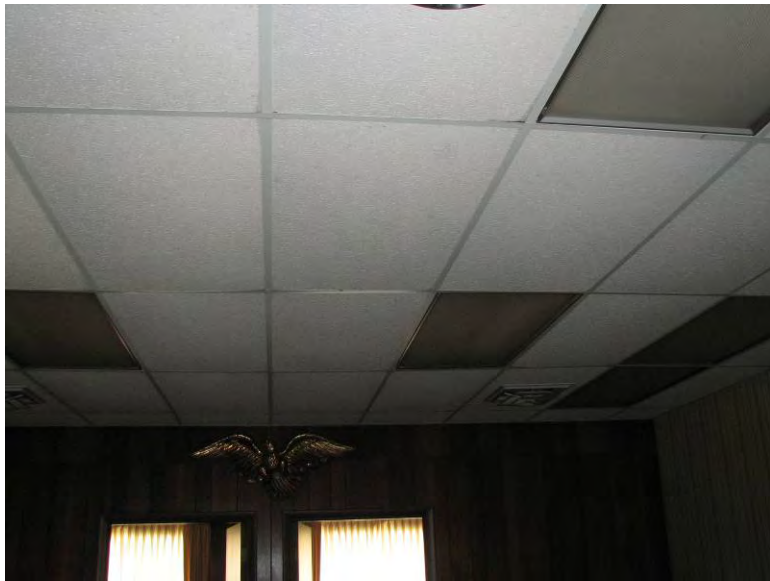
Photo 3: An example view of 2' x 4' drop ceiling tiles in the building.

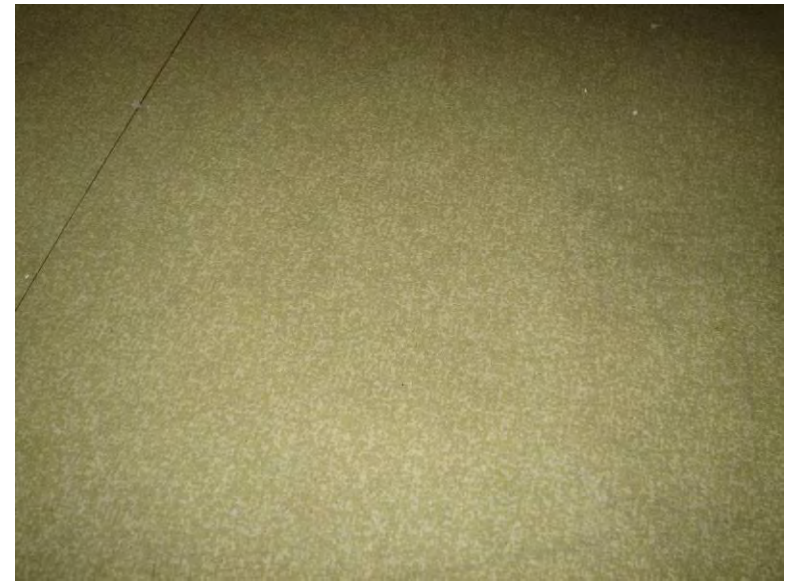
Tan pebble pattern sheet vinyl ('linoleum') flooring was observed on the floors of the men's room, women's room, and the customer standing area in front of the lobby counter. This material is considered Category I non-friable ACM in good condition. However, the material also has a fibrous backing that could be rendered friable if disturbed. Terracon further recommends that if this material is to be disturbed, then it should be abated as a regulated asbestos containing material (RACM).

Photo 4: An example view of linoleum in the structure.

Terracon recommends that the identified ACM be removed and disposed of by an IDEM licensed asbestos abatement contractor prior to the renovation activity that will disturb the asbestos-containing materials identified.

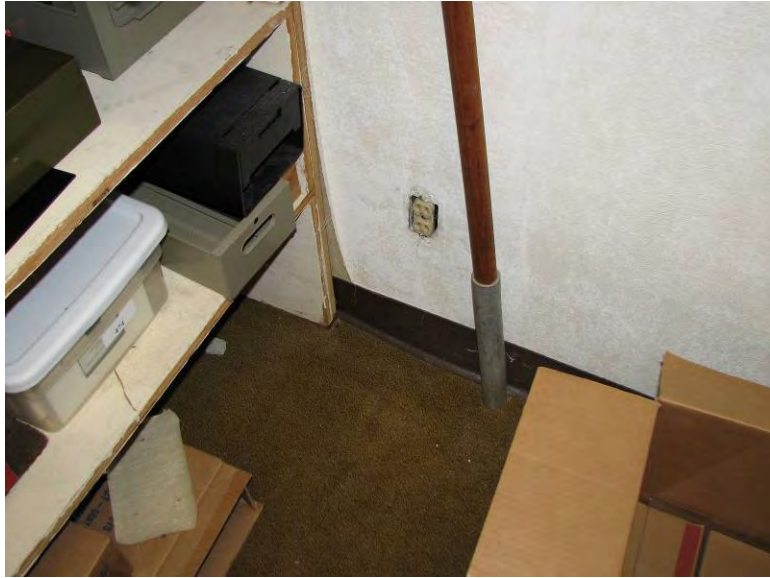
Photo 5: An example view of plaster and vinyl cove base in the structure.

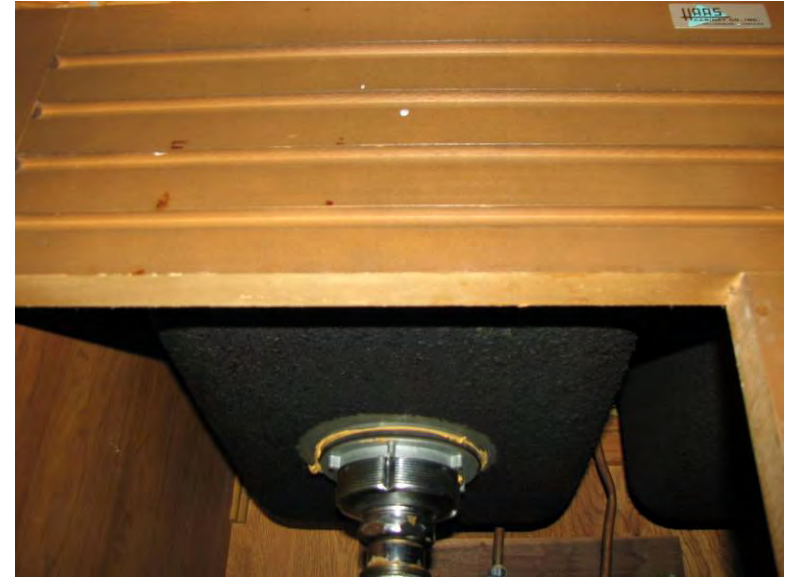
Black sink undercoating was observed in the kitchenette located to the north of the southeast conference room. This material is considered a Category I non-friable ACM in good condition.

Photo 6: View of asbestos-containing black sink undercoating in the kitchenette.

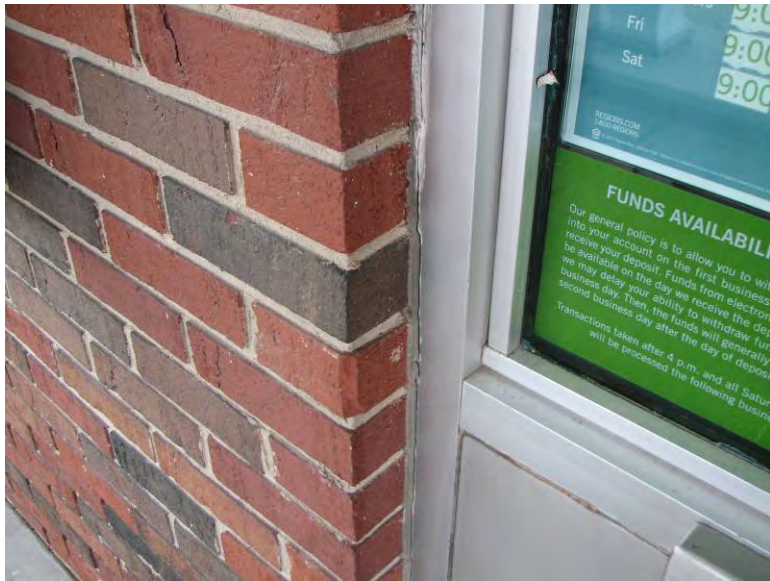
Gray caulk was observed on the exterior drive-thru window located on the north wall of the structure. This material is considered a Category II non-friable ACM in good condition.

Photo 7: View of asbestos-containing gray caulk on the north side of the building.

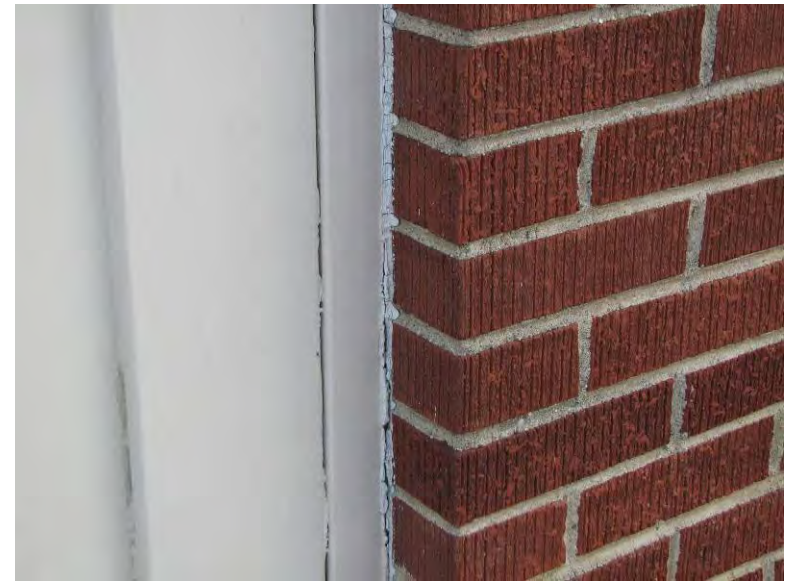
White caulk was observed on the exterior doors and the windows for the structure. This material is considered a Category II non-friable ACM in good condition.

Photo 8: An example view of asbestos-containing white caulk on other sides of the building.
