Asbestos Survey Report

Albany Main
Cost Center No. RFC003901
333 West Broad Street
Albany, Georgia

July 29, 2012
Terracon Project No. 49127218-3

ASBESTOS SURVEY REPORT

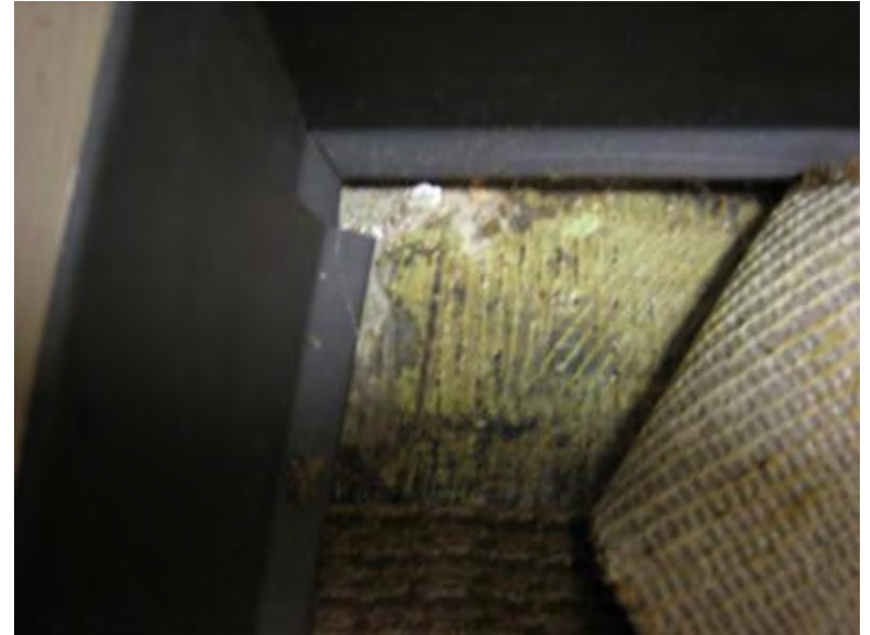
| HA No. | Description | Material Location | Percent/Type Asbestos | NESHAP Classification | Condition | Estimated Quantity* |
|---|---|---|---|---|---|---|
| 3 | Carpet mastic, green and black | Throughout 2 nd floor | ND – green mastic 5%C – black mastic | Category I non-friable | Good | 336 sf |

Photo 2: ACM black mastic beneath carpet, green mastic is non-ACM.

Terracon recommends that the identified ACM be removed and disposed of by a GA-licensed asbestos abatement contractor prior to the renovation activity that will disturb the asbestos-containing materials identified.

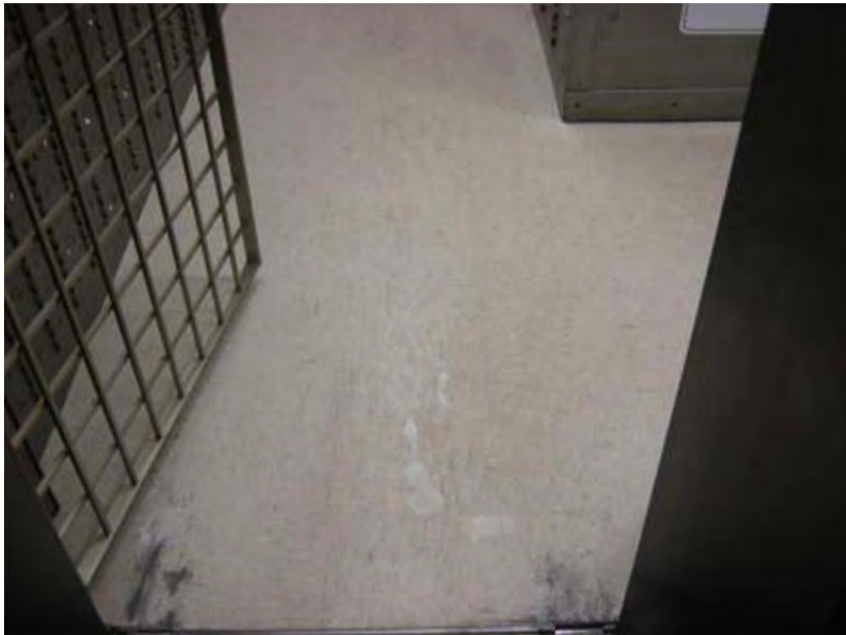
| HA No. | Description | Material Location | Percent/Type Asbestos | NESHAP Classification | Condition | Estimated Quantity* |
|---|---|---|---|---|---|---|
| 8 | 2 nd layer flooring, beneath carpet | 2 nd floor vault | 15%C – floor tile 2%C – black mastic | Category I non-friable | Good | 4,000 sf |

Photo 3: Non-ACM 12"x12" floor tile in 2nd floor vault, 2nd layer flooring is ACM.

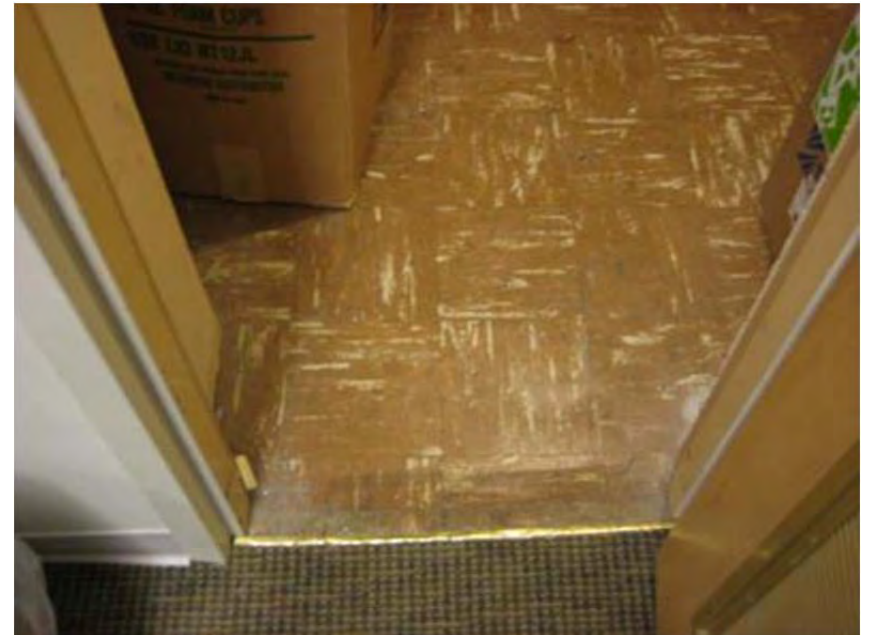
| HA No. | Description | Material Location | Percent/Type Asbestos | NESHAP Classification | Condition | Estimated Quantity* |
|---|---|---|---|---|---|---|
| 16 | 9"x9" floor tile, brown with white streaks | 1 st floor storage area | 15%C – floor tile 3%C – black mastic | Category I non-friable | Good | Included with HA 15 |

Photo 4: ACM 9"x9" floor tile brown with white streaks.

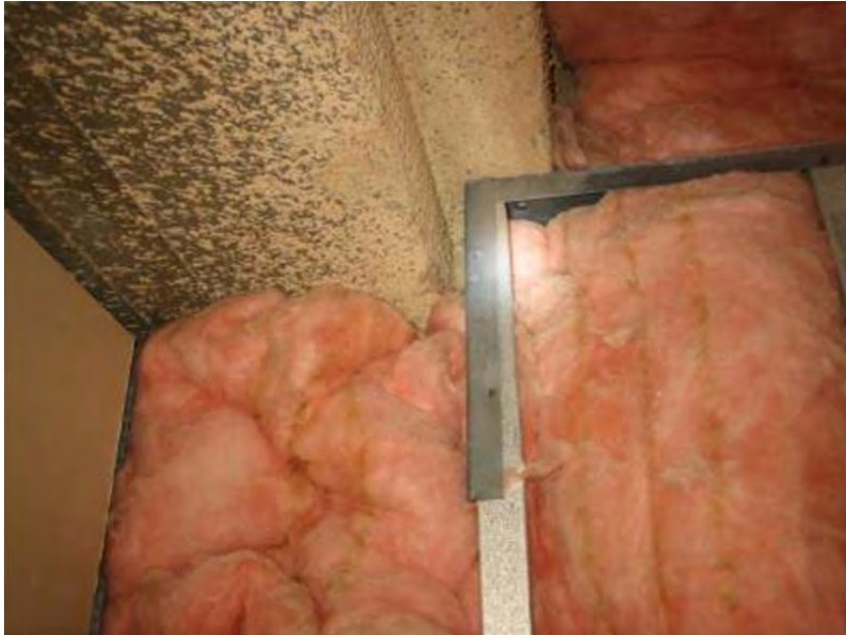
| HA No. | Description | Material Location | Percent/Type Asbestos | NESHAP Classification | Condition | Estimated Quantity* |
|---|---|---|---|---|---|---|
| 19 | Fireproofing | 1 st floor front office area | 3%C - fireproofing | RACM | Good | 1,500 sf |

Photo 5: ACM fireproofing in 1st floor front office area.

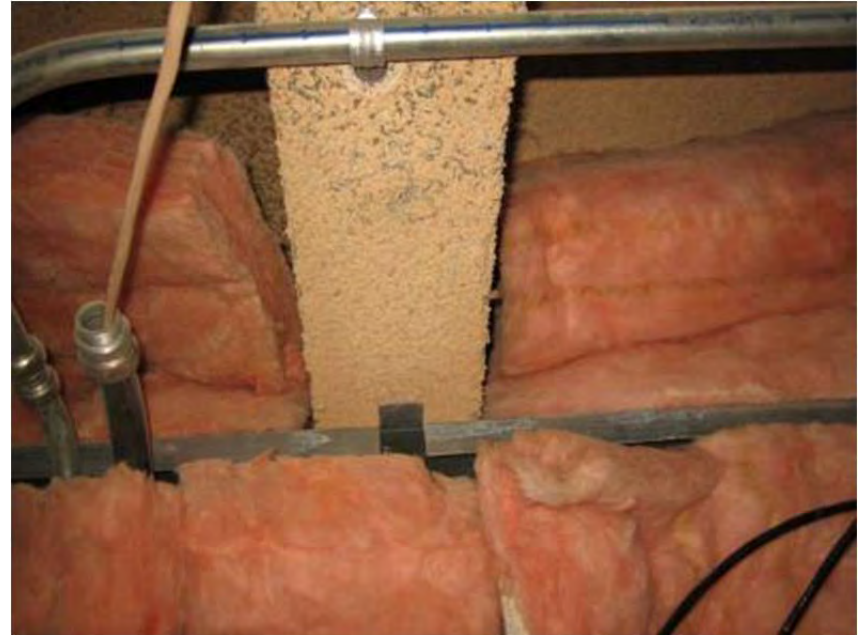
Photo 6: ACM fireproofing in 1st floor front office area.

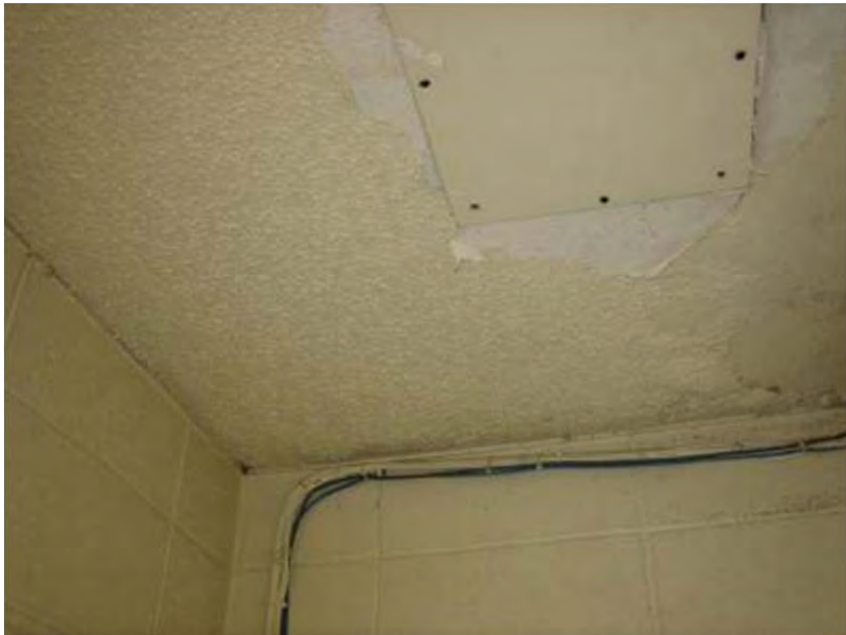
Photo 7: Non-ACM ceiling texture in drive-through teller booths.

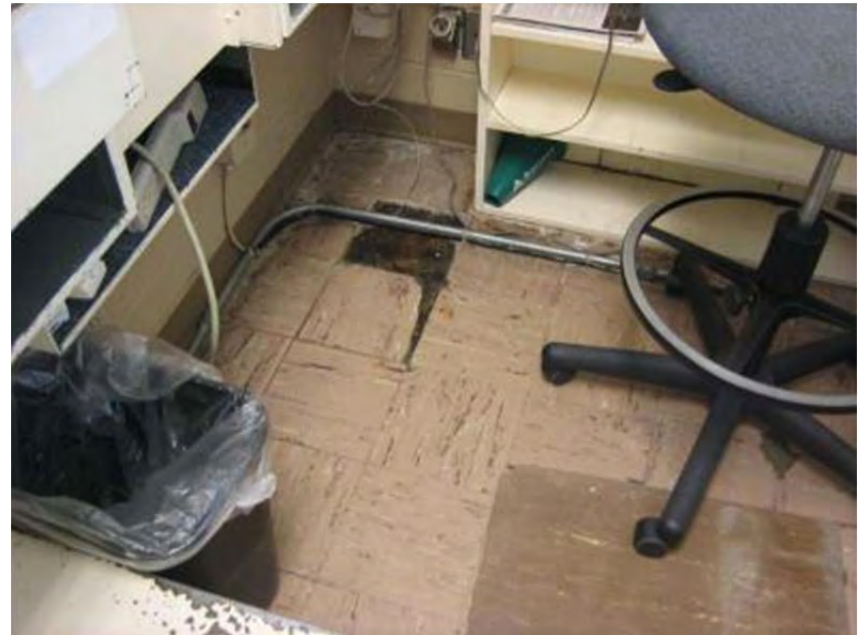
Photo 8: ACM 9"x9" floor tile in drive-through teller booths.

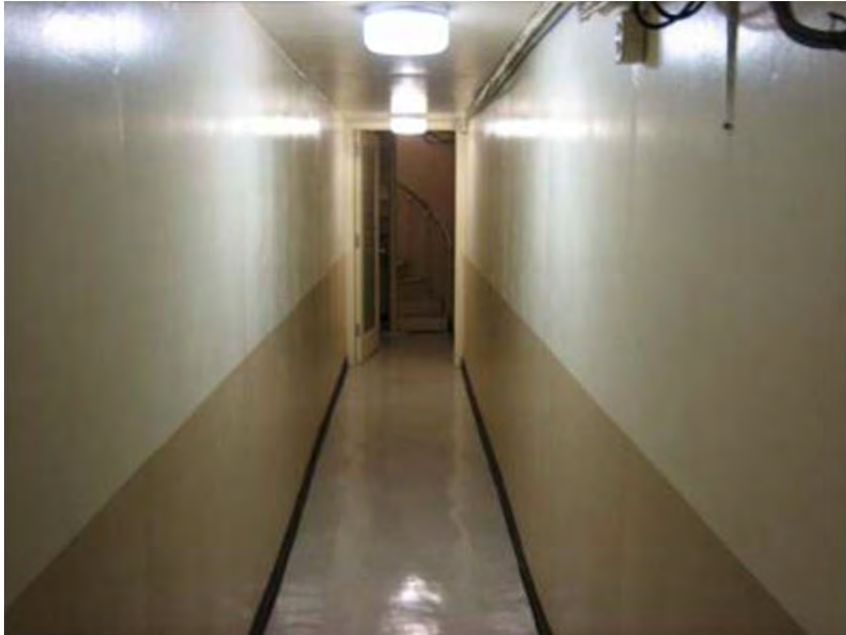
| HA No. | Description | Material Location | Percent/Type Asbestos | NESHAP Classification | Condition | Estimated Quantity* |
|---|---|---|---|---|---|---|
| 21 | 2 nd layer flooring, beneath non-ACM 12"x12" beige with brown streaks floor tile | Drive through teller tunnel | ND – yellow mastic 10%C – floor tile 5%C – black mastic | Category I non-friable | Good | Included with HA 15 |

Photo 9: Drive-through teller tunnel, 2nd layer flooring is ACM.

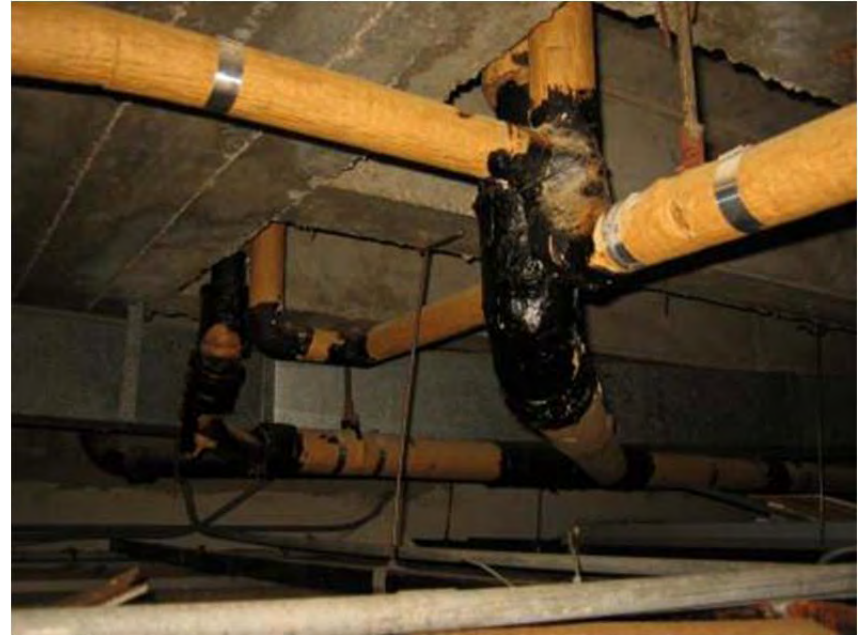
Photo 10: View above ceiling on 2nd floor. Black pipe mastic was identified as ACM in August 2010.

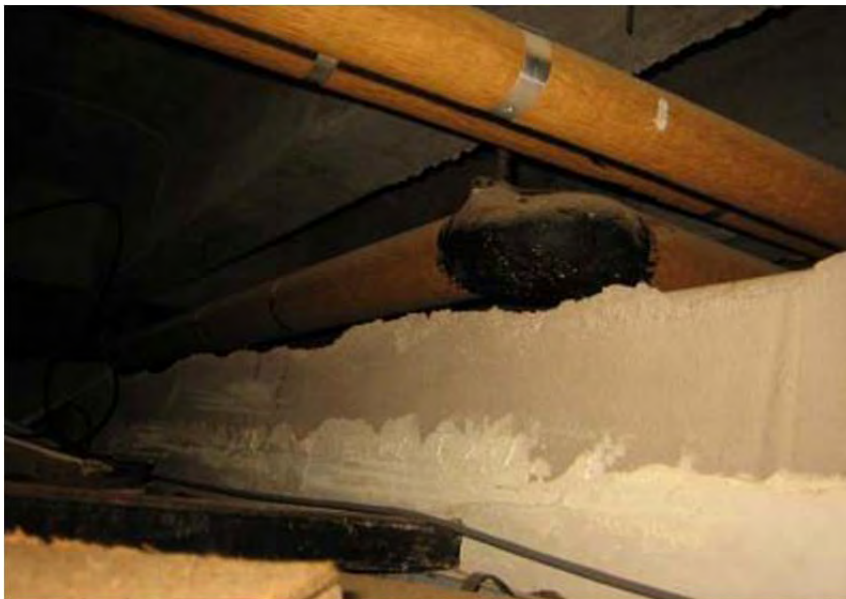
Photo 11: Non-ACM plaster wall in 2nd floor.
