ASBESTOS SURVEY REPORT

NETTLETON
COST CENTER NO. RFC004904
4902 EAST NETTLETON AVENUE
JONESBORO, ARKANSAS 72401

Terracon Project No. 94107574.004
PO No. CA398907AR

October 14, 2010

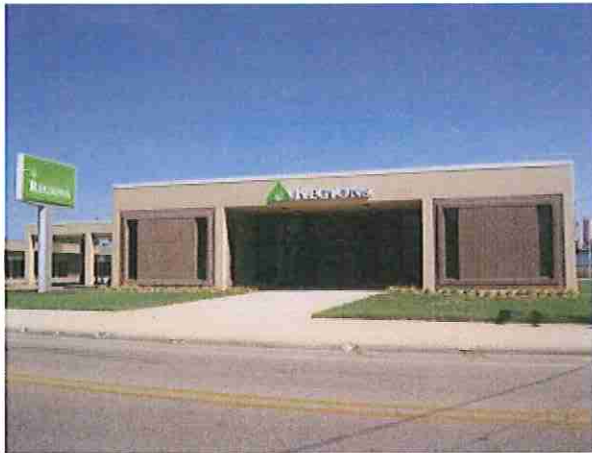
Photo #1 Front of bank.

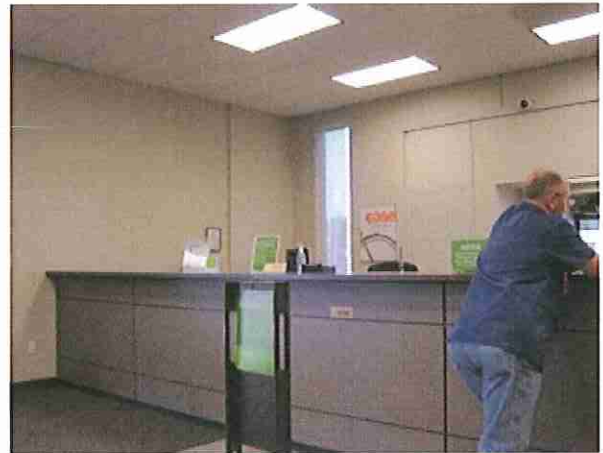
Photo #2 Lobby and teller line, light fixtures set in 2' x 2' Ceiling tile (white, pinholes, indents) system

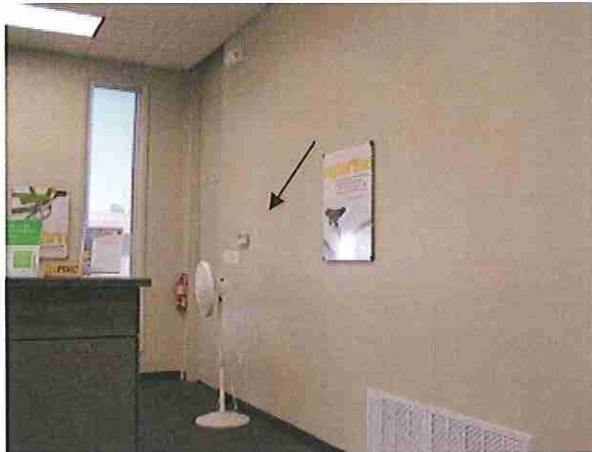
The wall texture/drywall/joint compound (tan, semi-smooth) is located throughout Suite 1 and is assessed as a non-friable ACM in good condition.

Photo #3 Thermostat on wall texture/drywall/joint compound (tan, semi-smooth)

The identified non-friable ACM must be removed and disposed of by an ADEQ-licensed asbestos abatement contractor prior to renovation if the asbestos containing materials will be affected by the planned renovation activity.

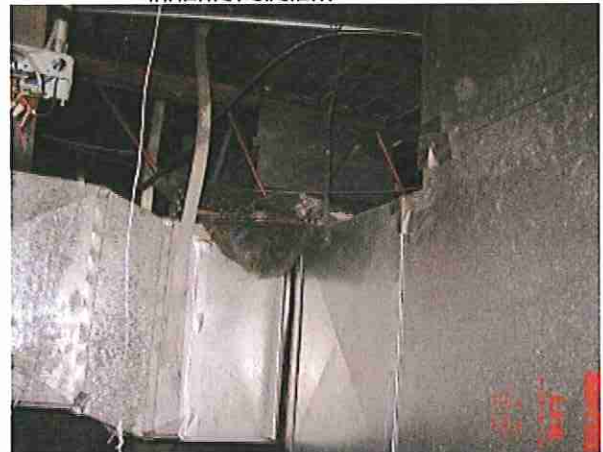
Photo #4 Duct work located above the lay-in ceiling tile system.

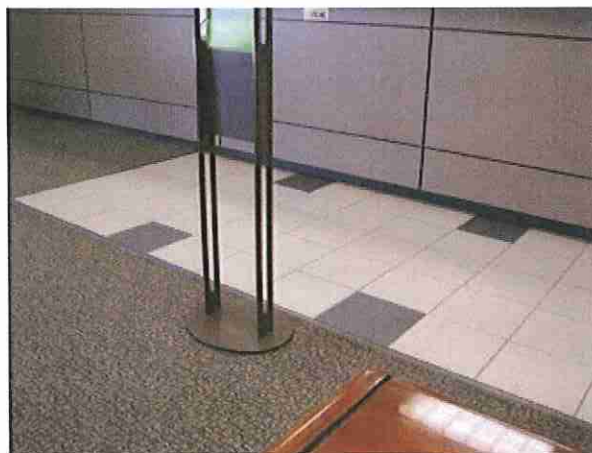
Photo #5 Grout (gray) associated with ceramic floor tile and carpet mastic (tan).

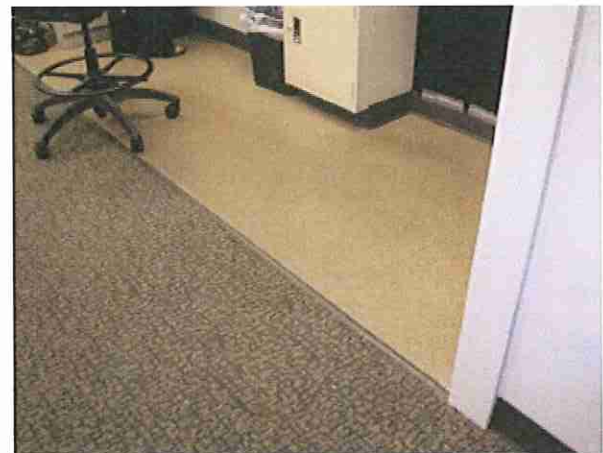
Photo #6 Resilient sheet flooring (brown) and cove base mastic (tan).

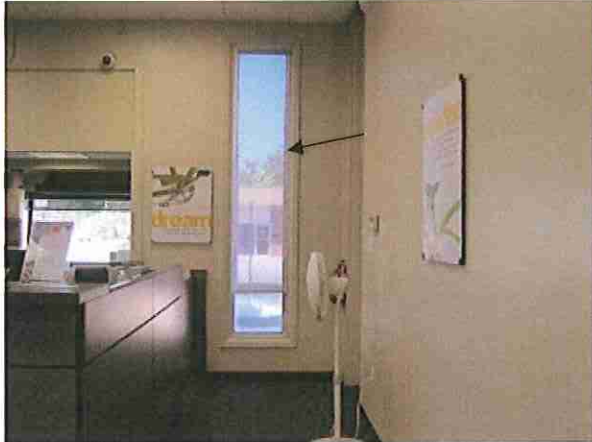
The interior and exterior window caulk (black) is located on the windows throughout the building and is assessed as a non-friable ACM in good condition.

Photo #7 Interior window caulk (black).

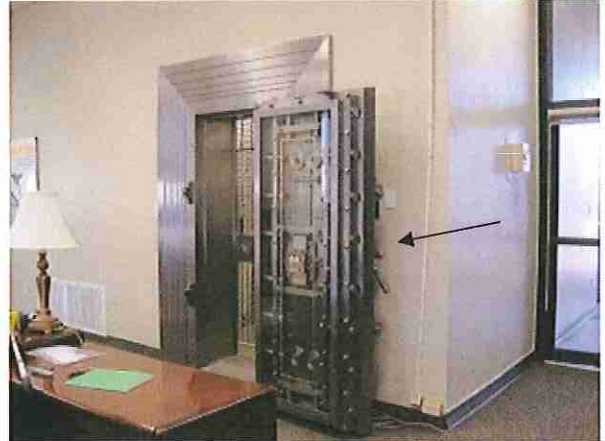
Photo #8 Texture associated with concrete (tan).

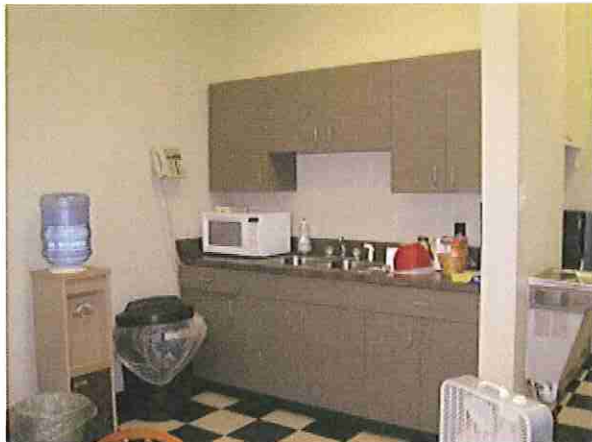
The mastic (black) associated with 12" x 12" Floor tile (black/white checker pattern) is located in Suite 1 in the break room, restrooms, and hallway and is assessed as a non-friable ACM in good condition.

Photo #9 Sink undercoat (white) and 12" x 12" floor tile (black/white checker) with mastic (black).

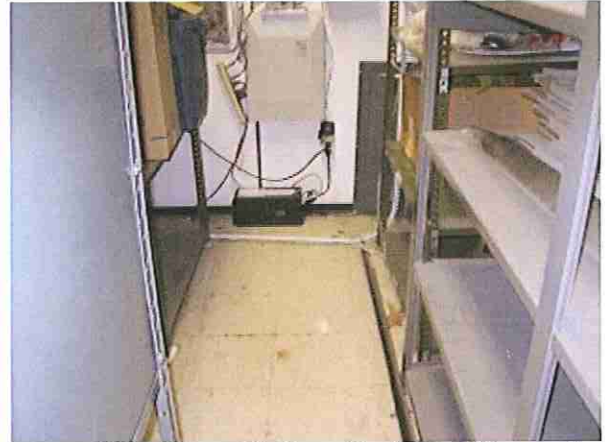
The 12" x 12" Floor tile (tan) with mastic (black) is located in Suite 1 in the storage room and is assessed as a non-friable ACM in good condition.

Photo #10 12" x 12" floor tile (tan) with mastic (black).

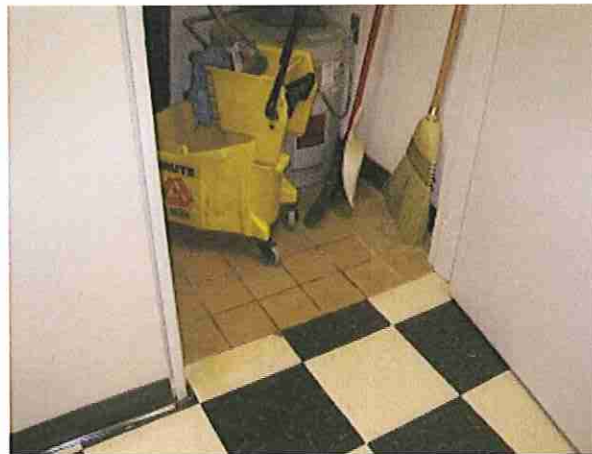
The mastic (black) associated with grout (dark gray/black) associated with ceramic floor tile is located in Suite 1 in the janitors closet and is assessed as a non-friable ACM in good condition.

Photo #11 Grout (dark gray/black) associated with ceramic floor tile.

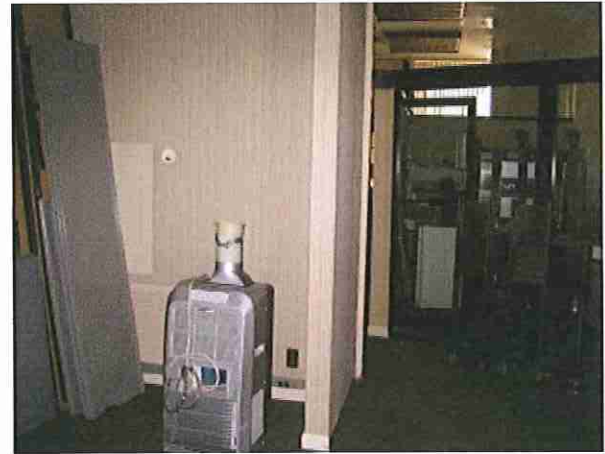
The drywall/joint compound associated with wall covering (multi-color) is located throughout Suite 2 and is assessed as a non-friable ACM in good condition.

Photo #12 Drywall/joint compound associated with wall covering (multi-color)..

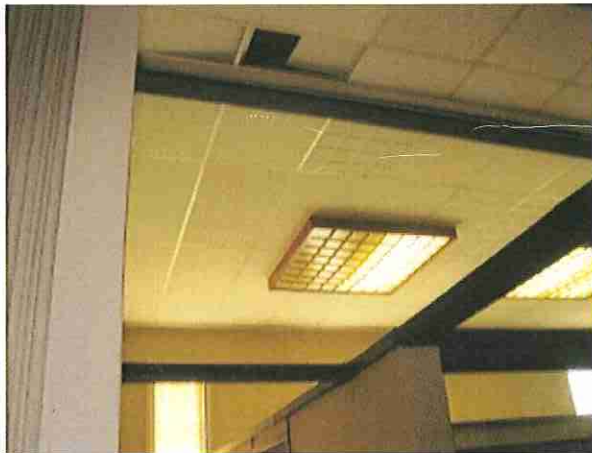
Photo #13 2' x 4' Ceiling tile (white, pinholes, and fissures) and 2' x 2' Ceiling tile (white, pinholes indents, small squares).

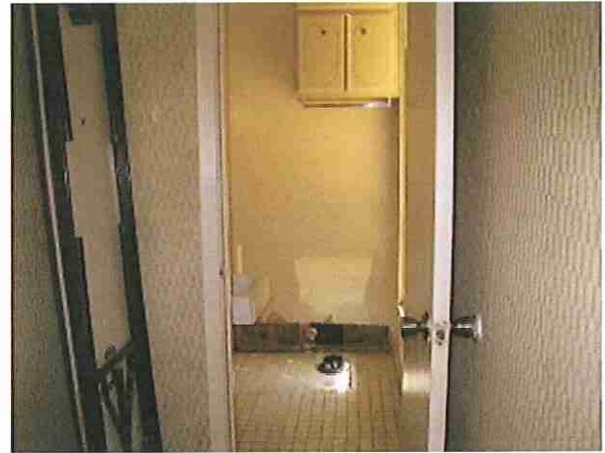
Photo #14 Grout (gray) associated with ceramic floor tile and wall texture/drywall/joint compound (beige, semi-smooth).

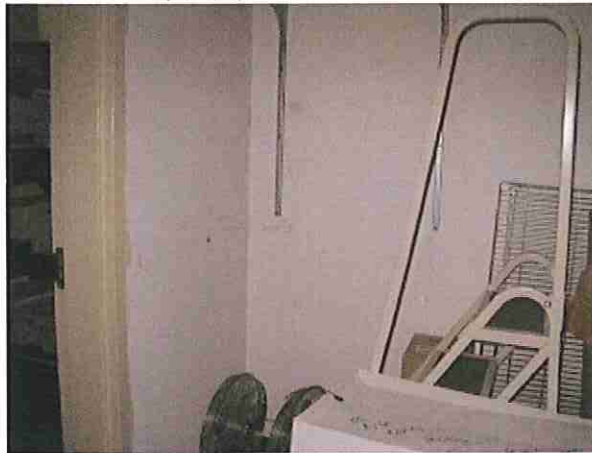
Photo #15 Texture associated with concrete (off-white, semi-smooth).

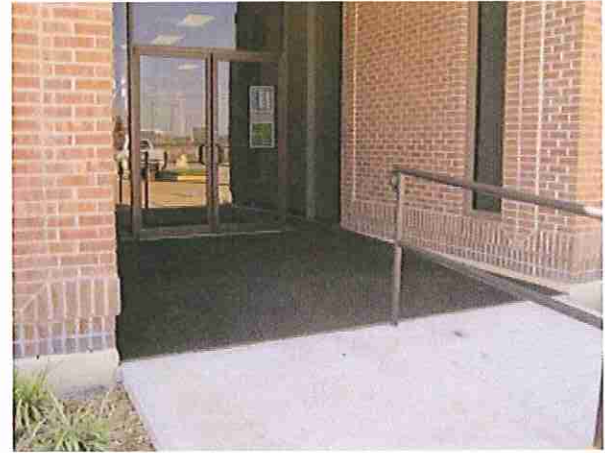
Photo #16 Exterior carpet mastic (yellow).

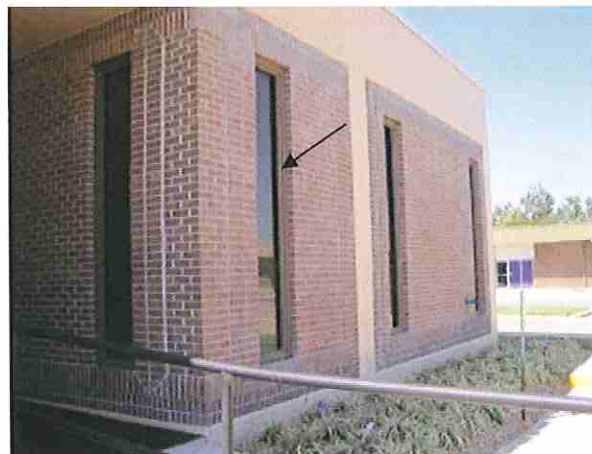
Exterior window caulk (black)	Throughout on exterior windows	3% Chrysotile	Category II non-friable	Good	675 ln. ft.

Photo #17 Exterior window caulk (black) and exterior building caulk (gray).

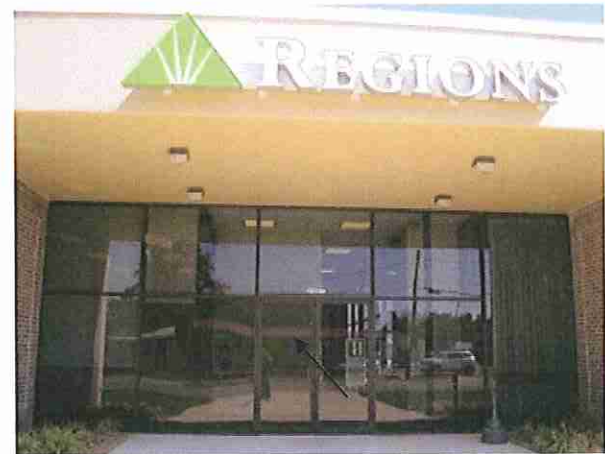
Photo #18 Exterior texture (tan).
