# Asbestos Abatement Report

**Houston Main**  
**Cost Center No. RFC021825**  
**117 N. Jackson Street**  
**Houston, Mississippi**

November 26, 2014  
Terracon Project No. EB147127

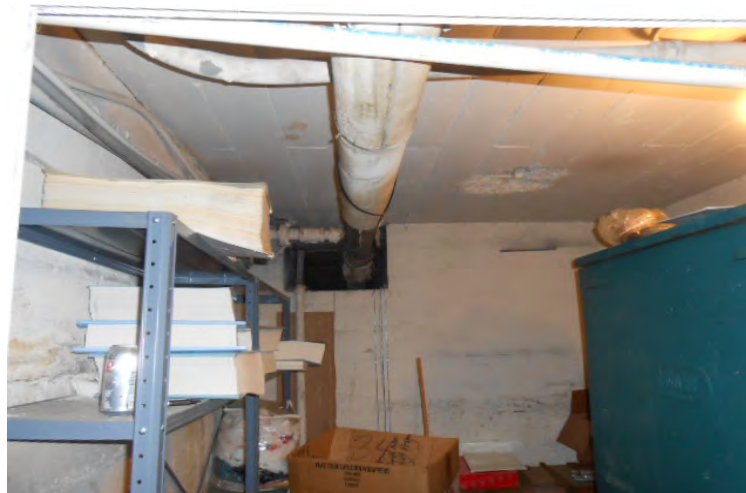
TSI in elevator room.

Activity	ACM	Location (Area)	Estimated Quantity
Removal of ACM TSI via glove bag method with poly drop beneath; HEPA vacuum and encapsulation; clearance via visual & PCM air sampling by Terracon.	65% C – air cell 15% C – applied insulation 10% A – applied insulation	Basement storage (elevator equipment) room	~6 lf (elevator room) ~6 lf (hallway to fiberglass run)

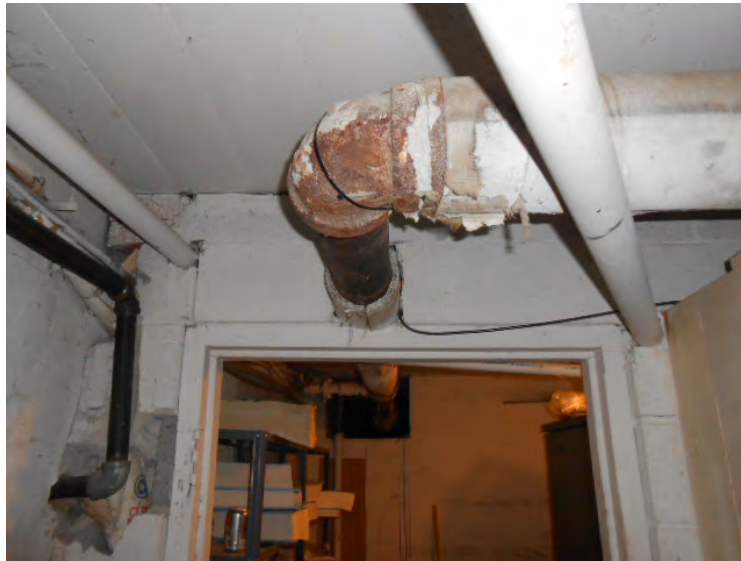
TSI leading out of elevator room to hallway.

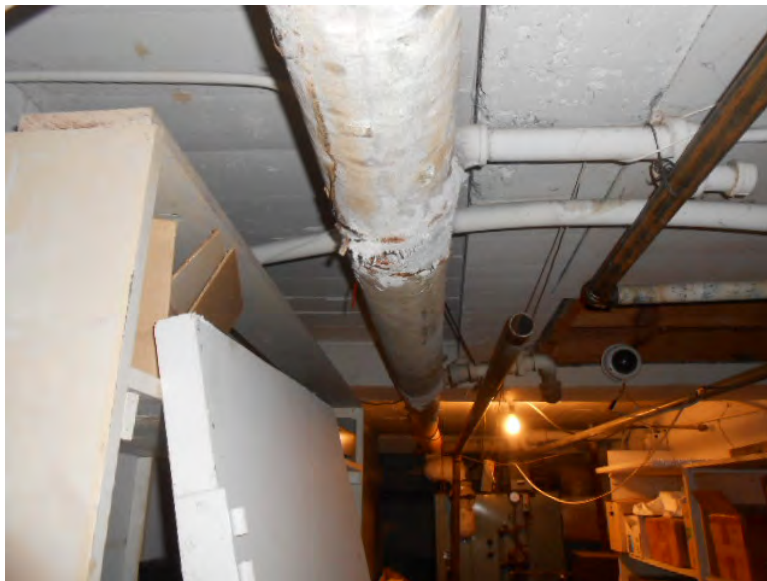
Same as above, stop at fiberglass TSI.

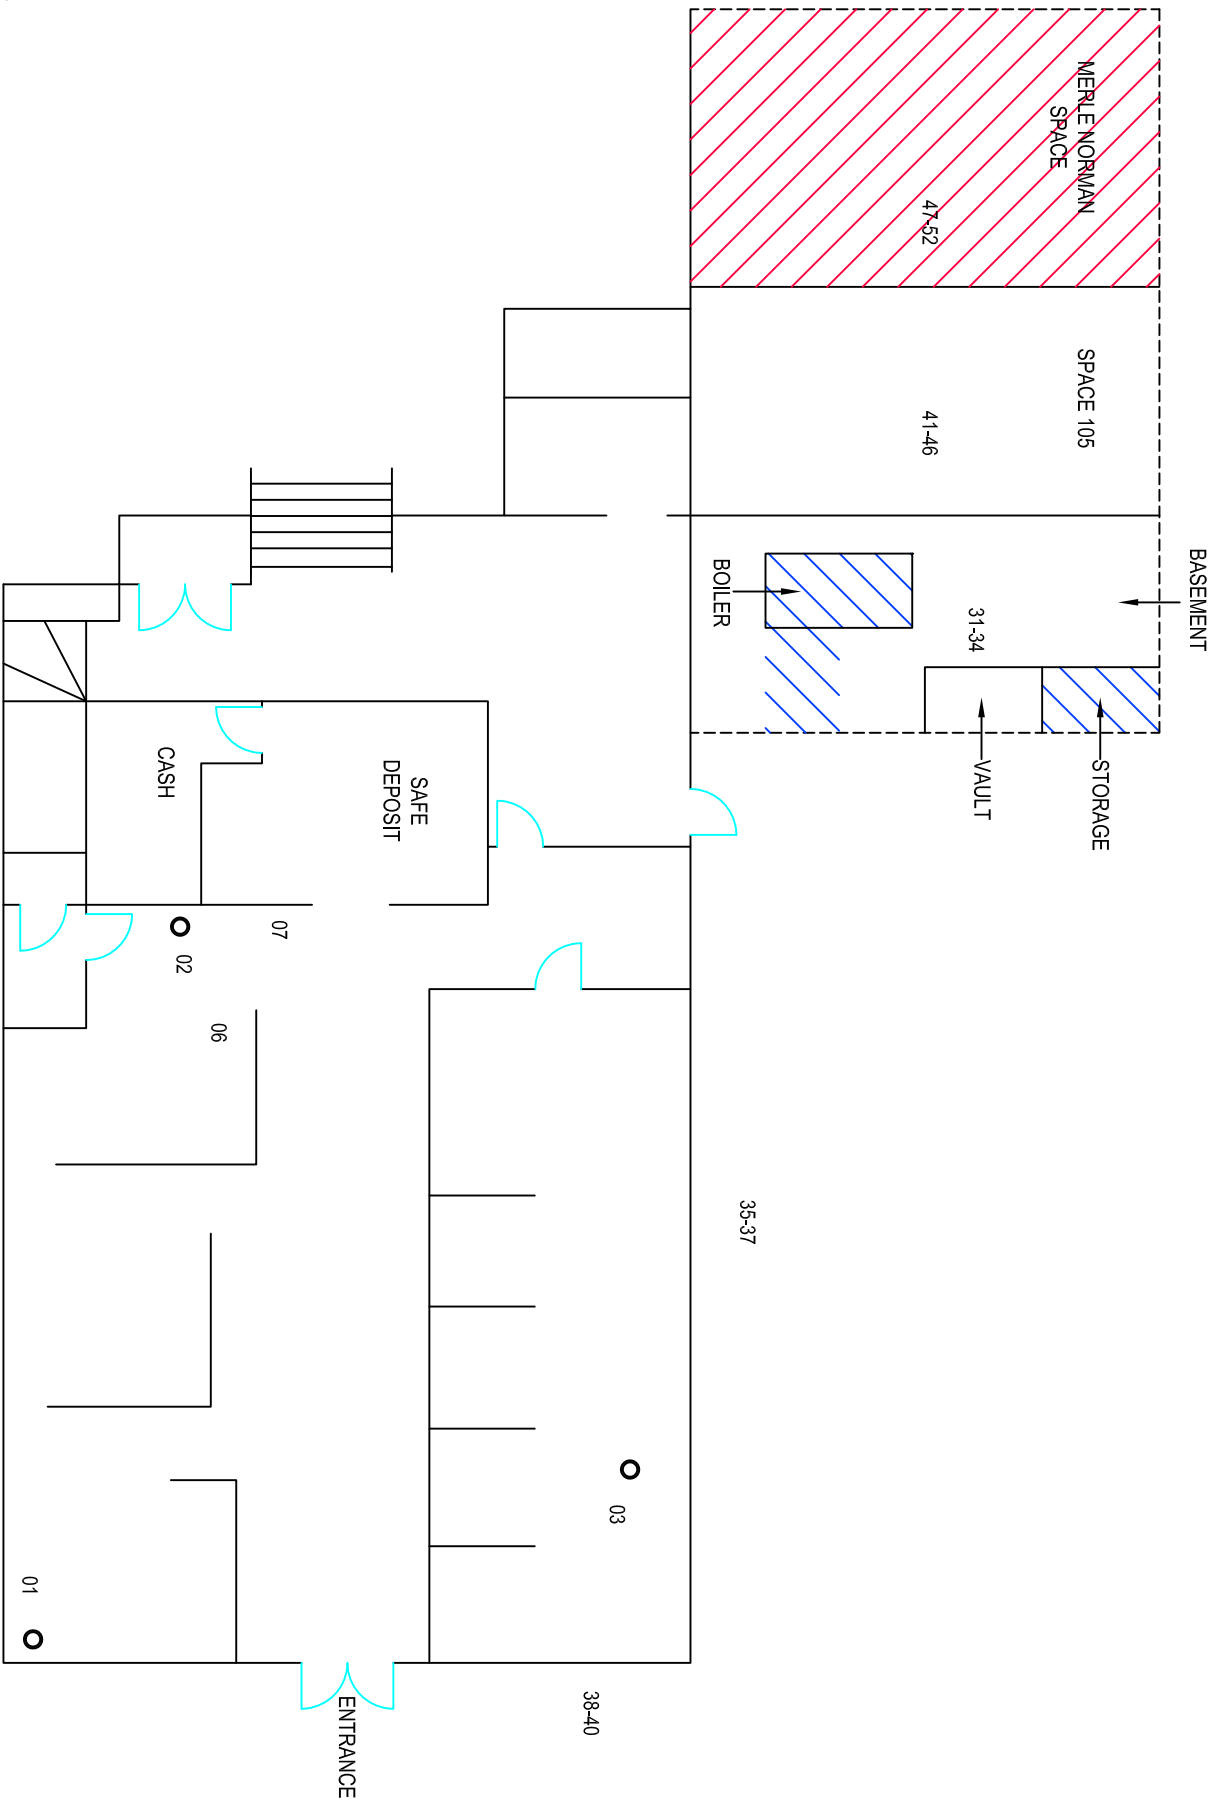
**SITE DIAGRAM - FIRST FLOOR**  
 ASBESTOS INSPECTION  
 REGIONS BANK - HOUSTON

The following ACM were not removed or disturbed during these abatement activities and were observed to be in good condition:

- 9" x 9" black floor tile in former Merle Norman space
- 9" x 9" brown floor tile in former Merle Norman space
