LIMITED ASBESTOS SURVEY

Wells Fargo Bank
BE# 100554
806 Monroe Street
Sheboygan Falls, Wisconsin 53085

Report Date: January 31, 2020

ATC Project ID: 204BS02682

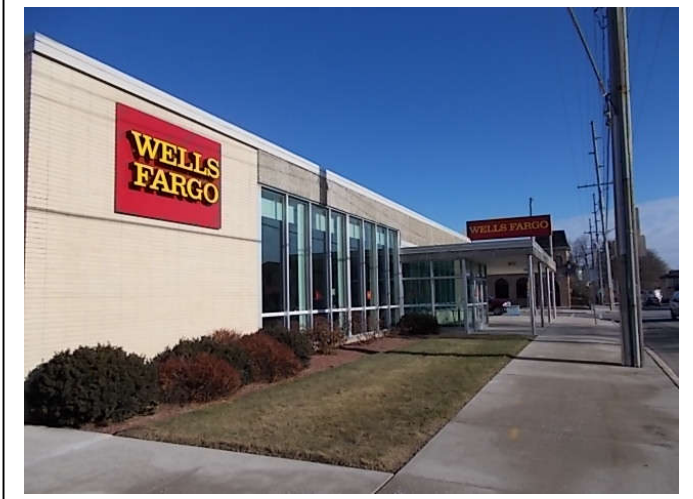
View Of: Front of building

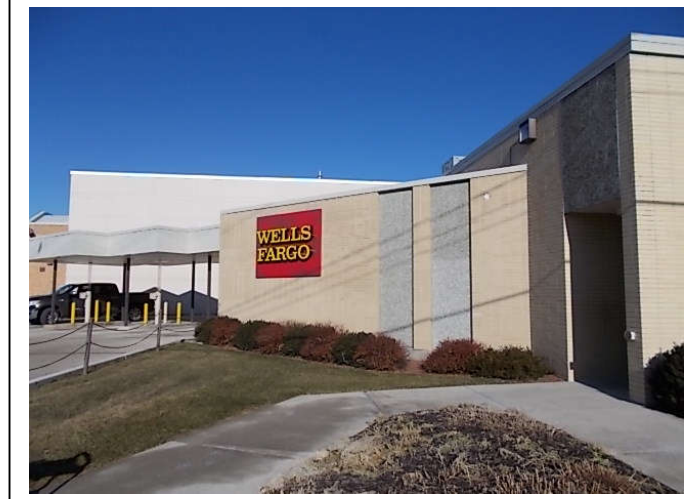
View Of: West side of building

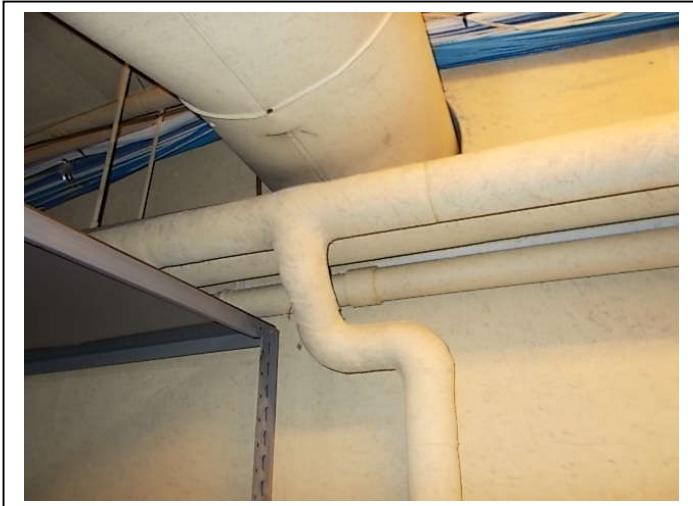
TABLE 2: ASBESTOS-CONTAINING MATERIALS				
SAMPLE NUMBER	MATERIAL	LOCATION	APPROX. QUANTITY	ASBESTOS CONTENT*
13	Pipe fitting insulation	Mechanical room	26 MF observed	10% Amosite 10% Chrysotile
SF = Square Feet, LF = Linear Feet, MF = Mechanical Fittings

View Of: Pipe fitting insulation, **ACM (Sample 13)**

accessible suspect building materials sampled were found to contain more than 1% asbestos. ATC recommends that all of the ACMs listed above that are impacted by the planned renovation be properly removed and disposed by a Wisconsin-licensed asbestos abatement contractor using trained workers prior to disturbing.

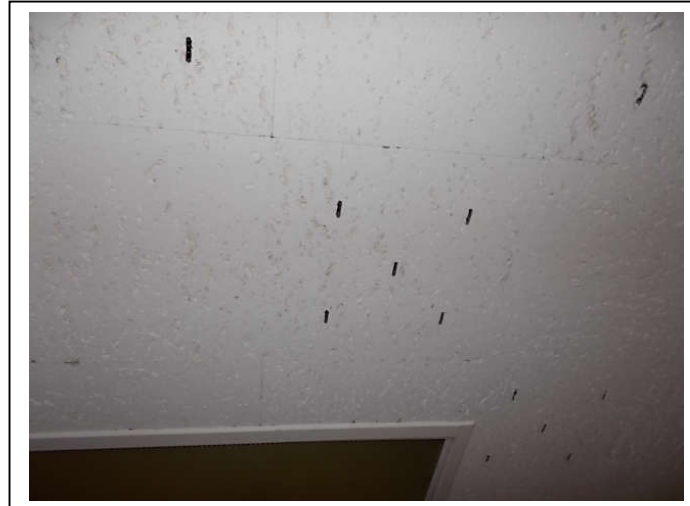
View Of: 1' x 1' concealed spline ceiling time, non-ACM (Samples 1, 10)

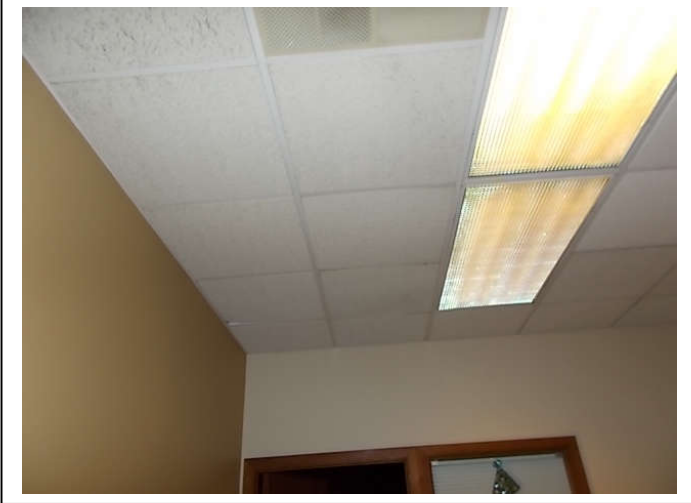
View Of: 2' x 2' ceiling tile, rough, recessed edges, non-ACM (Sample 3)

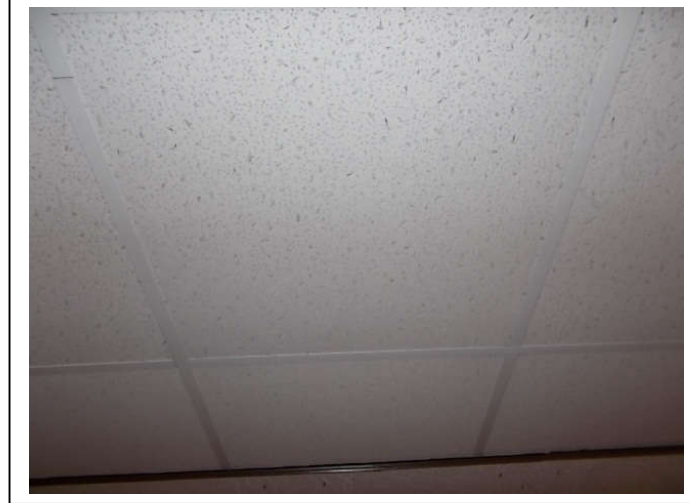
View Of: 2' x 2' Ceiling tiles, non-ACM (Sample 11)

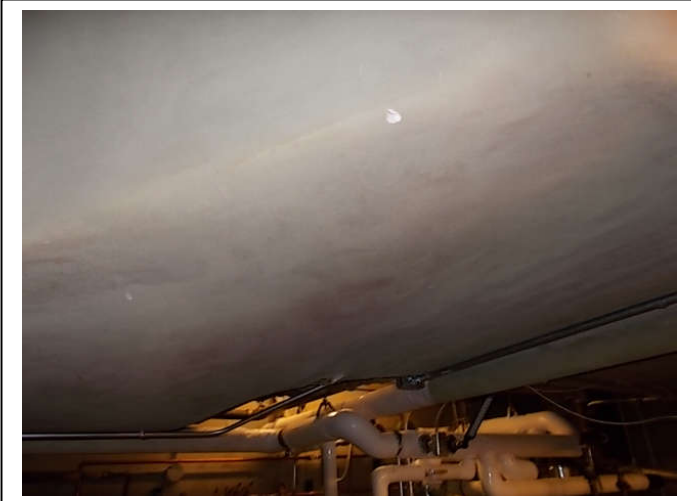
View Of: Boiler room plaster ceiling, non-ACM (Sample 9)

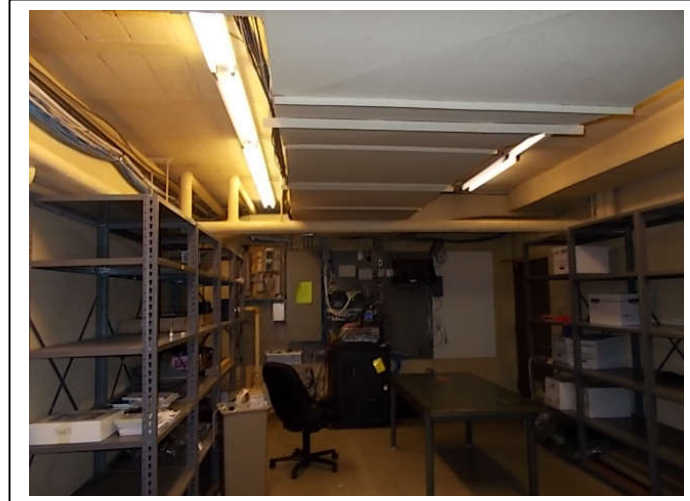
View Of: Lower level mechanical office, ACM fittings observed
