Subject:

Asbestos Complete Interior Survey  
Bank of America – Gridley Branch  
901 Hazel Street  
Gridley, California 95948  
Mail Code: CA2-103

Date:  
January 22, 2012

Our ref:  
HT120256.0046  
Task 00001

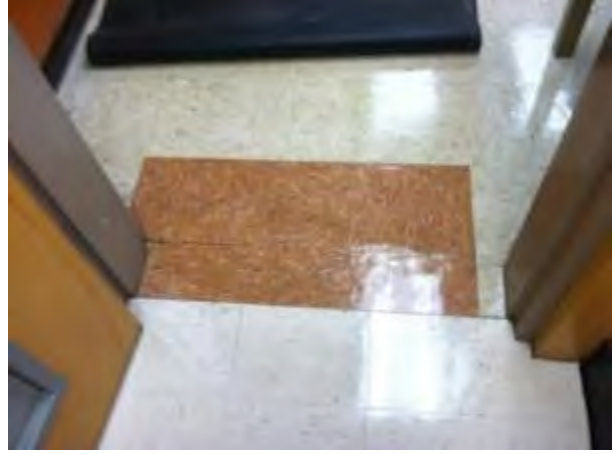
**HA-8: 12" x 12" Brown with white streaks floor tiles**

**HA-14: Yellow/black floor tile mastic**

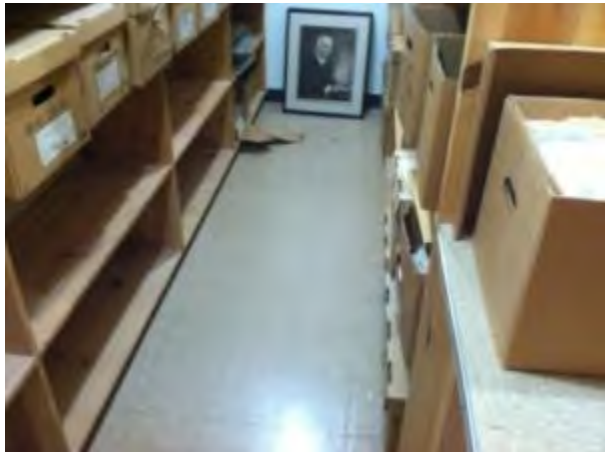
**HA-9: 12" x 12" White with brown streaks floor tiles  
HA-15: Black floor tile mastic**

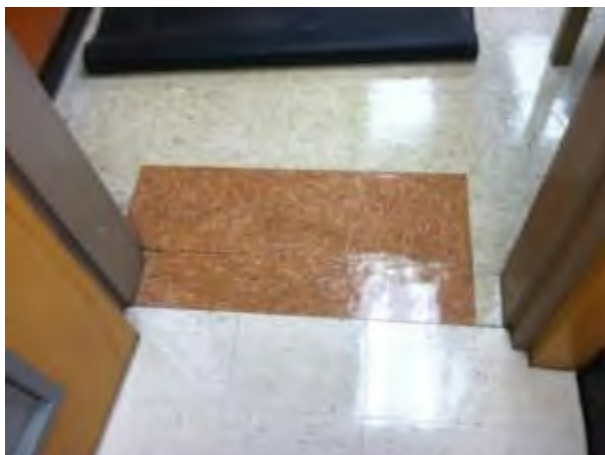
**HA-12: 12" x 12" Tan with brown streaks floor tiles  
HA-13: Black floor tile mastic**

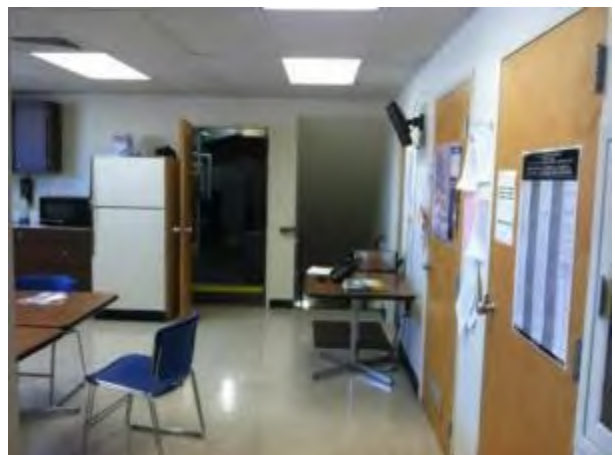
**HA-16: 2' x 4' Suspended by "T" Bar**

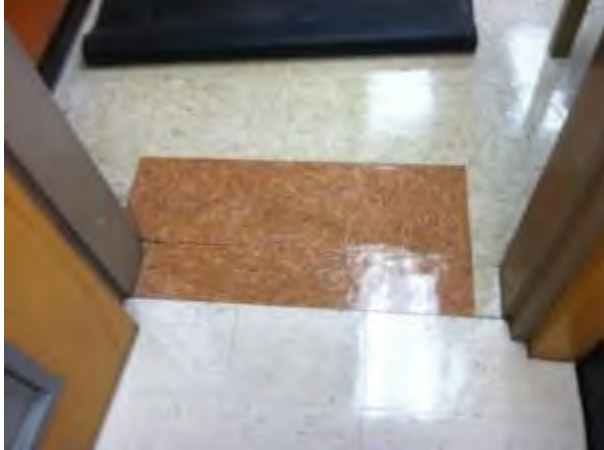
**HA-17: 12" x 12" White with tan streaks floor tiles  
HA-18: Black floor tile mastic**

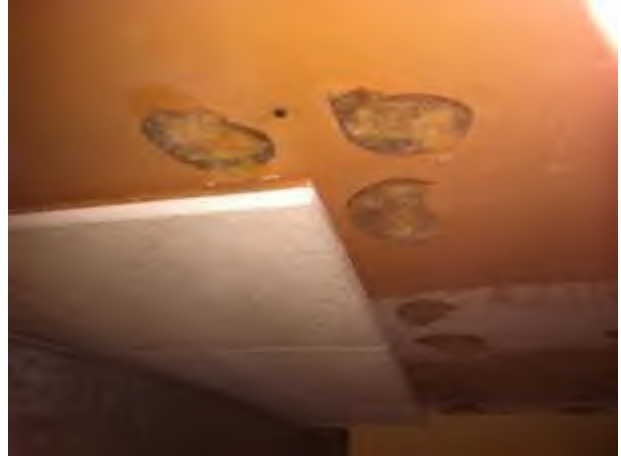
**HA-19: 1' x 1' Ceiling tiles - Glue On  
HA-33: Brown ceiling tile glue**

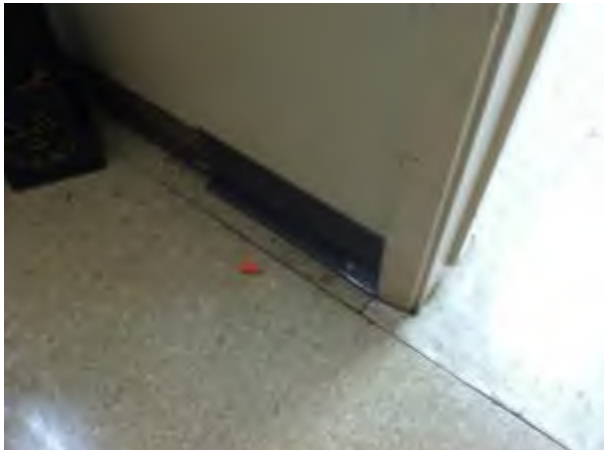
**HA-20: Clear cove base mastic  
HA-21: Black 4" rubber cove base  
HA-34: Brown cove base mastic**

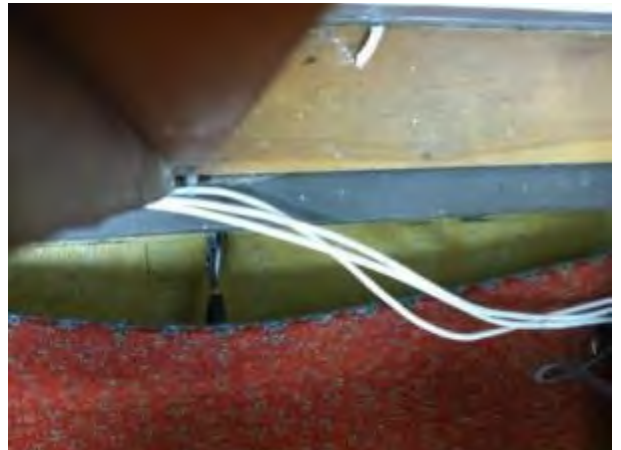
**HA-24: Brown & white specks floor tiles (Under  
Carpet)  
HA-25: Black floor tile mastic**

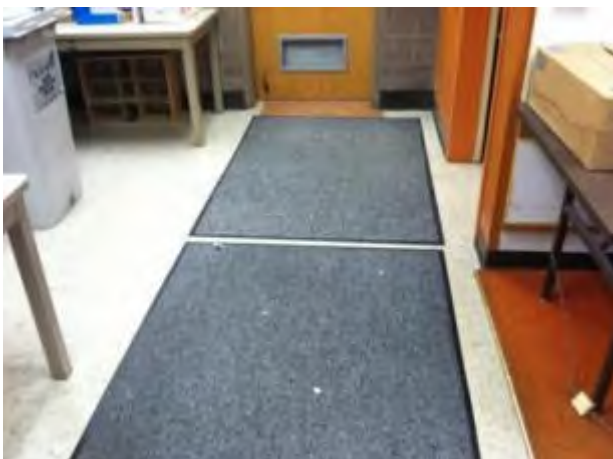
**HA-27: 12" x 12" Beige with large brown streaks floor  
tiles  
HA-28: Black floor tile mastic  
HA-29: White levalastic beneath HA-27/HA-28**

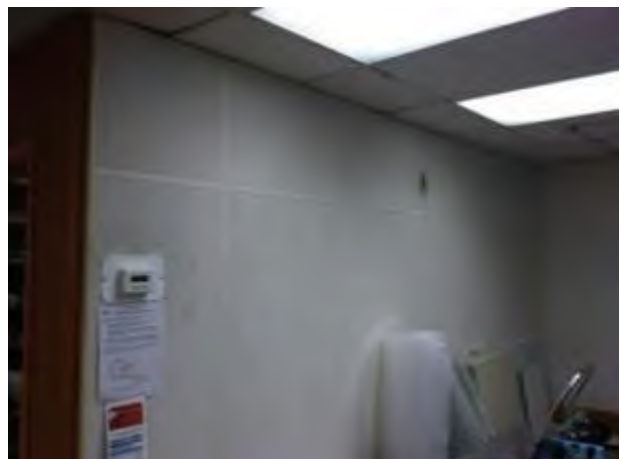
**HA-30: Mastic associated with HA-48  
HA-48: Gray sound wall**

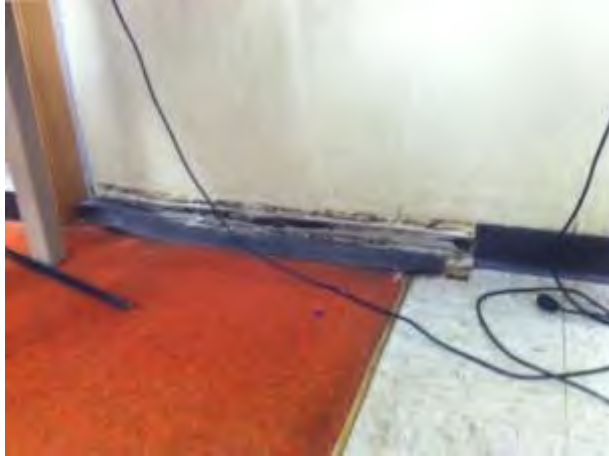
**HA-36: Brown 4" cove base  
HA-37: Brown cove base mastic**

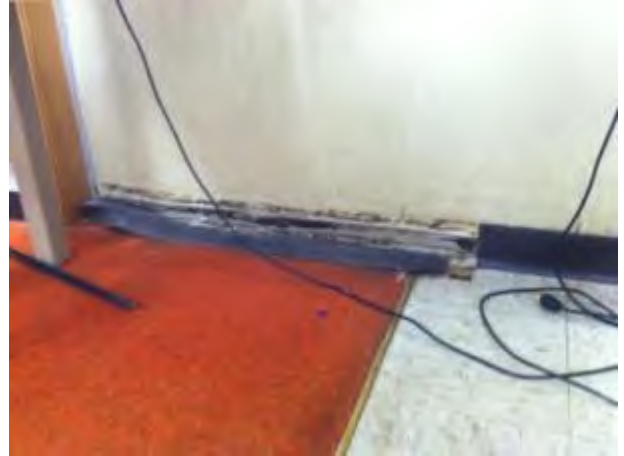
**HA-38: Clear wallpaper glue associated with HA-49  
HA-49: Beige wallpaper**

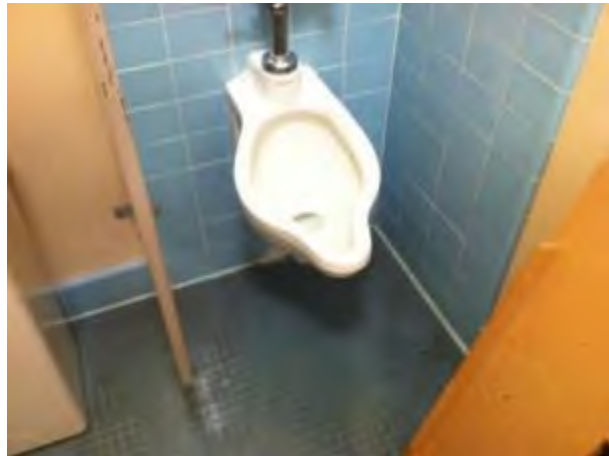
**HA-39: Blue 4" x 6" ceramic wall tiles/cove base  
HA-40: Tile adhesive  
HA-41: White tile grout**

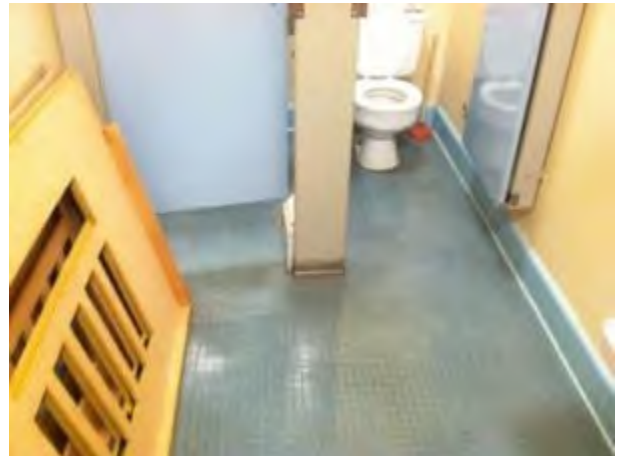
**HA-42: Beige 1" x 1" ceramic floor tiles  
HA-43: White tile adhesive  
HA-44: White tile grout**

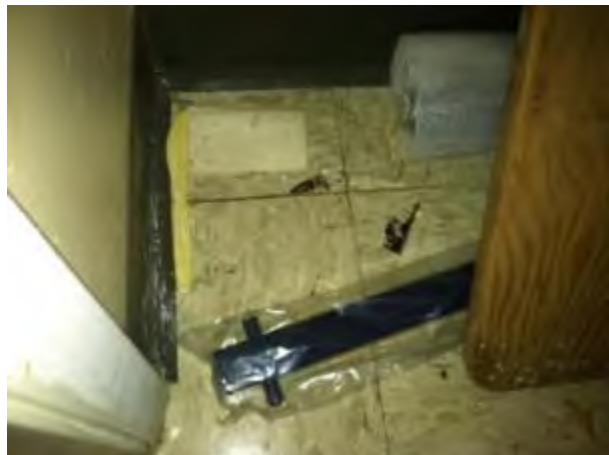
**HA-45: Beige sheet flooring (beneath vinyl floor tiles)  
HA-46: Brown sheet floor backing**

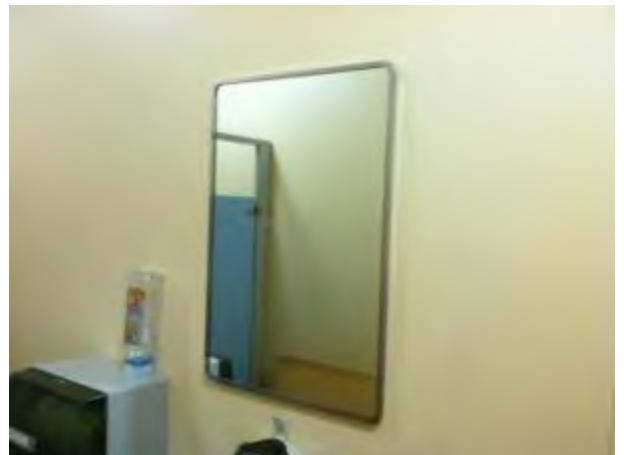
**HA-47: Mirror mastic**

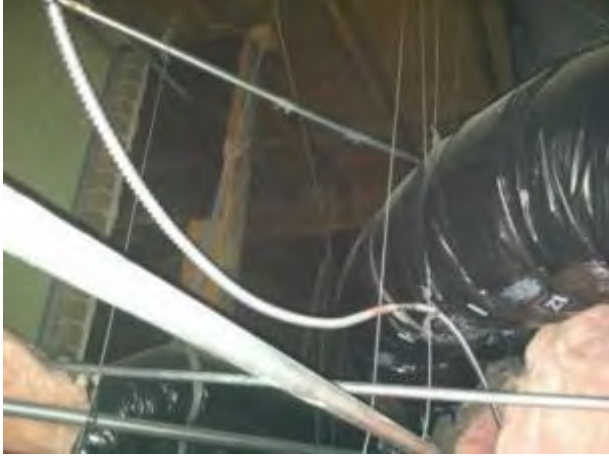
**HA-50: Pink fiberglass batt insulation  
HA-51: Black plastic-wrapped fiberglass duct  
insulation**
