Asbestos Complete Interior Survey
Bank of America – Lake Grove
913 North Summit Street
Crescent City, Florida 32112
Property ID: FL8-095

ARCADIS U.S., Inc. (ARCADIS) conducted a Complete Interior Survey (CIS) of asbestos-containing materials (ACMs) at the above-referenced site for Bank of America. The survey was requested to identify the location and quantity of ACMs in the building as part of a planned American's with Disabilities Act (ADA) renovation project. The ADA renovation project will include modification of the teller line and restrooms. The focus of the survey was to identify visible and accessible suspect ACMs. Background information on the site, a summary of the asbestos survey, and the inspector's qualifications are provided below.

January 28, 2015

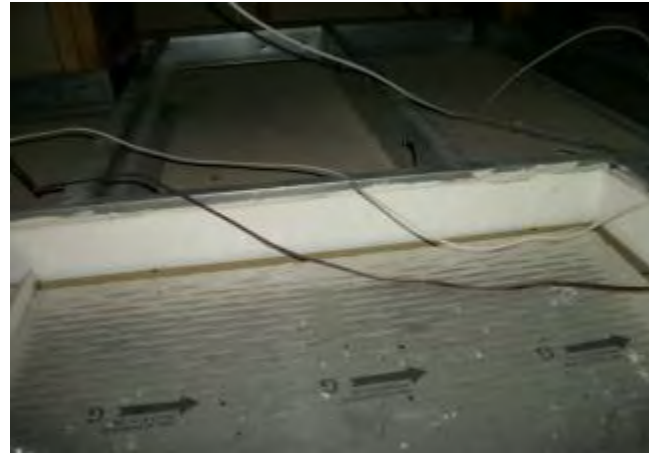
HA-1: White Gypsum Board, HA-2: Associated White Joint Compound

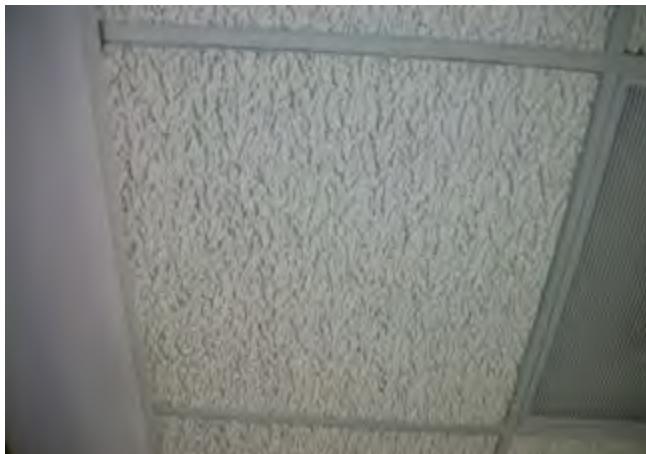
HA-3: White 2' x 2' Suspended Ceiling Tiles

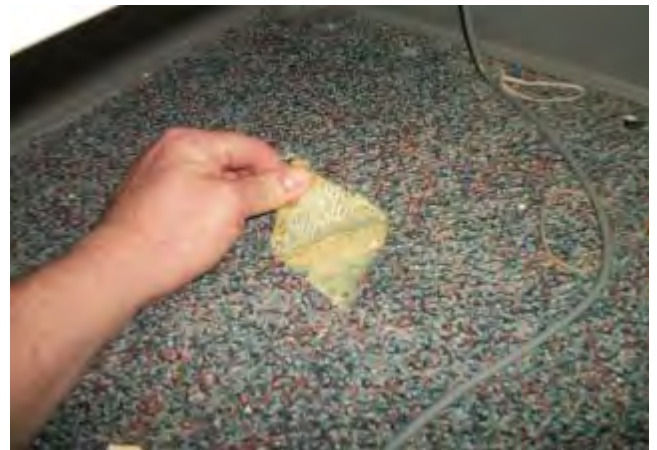
HA-4: Green Carpet Mastic

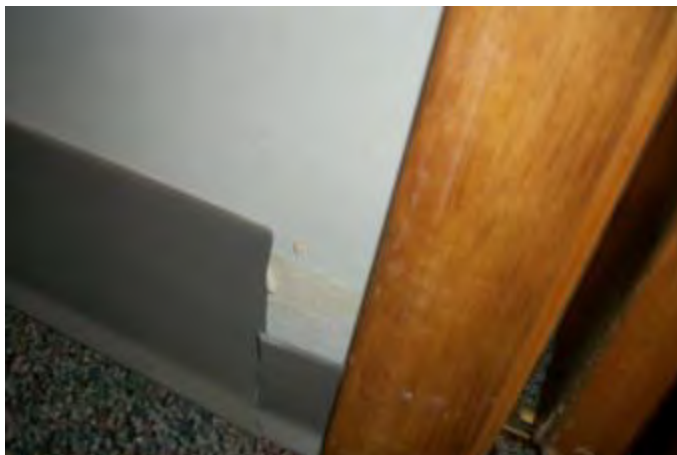
HA-5: Gray 4" Vinyl Cove Base, HA-6: Associated Yellow Cove Base Mastic

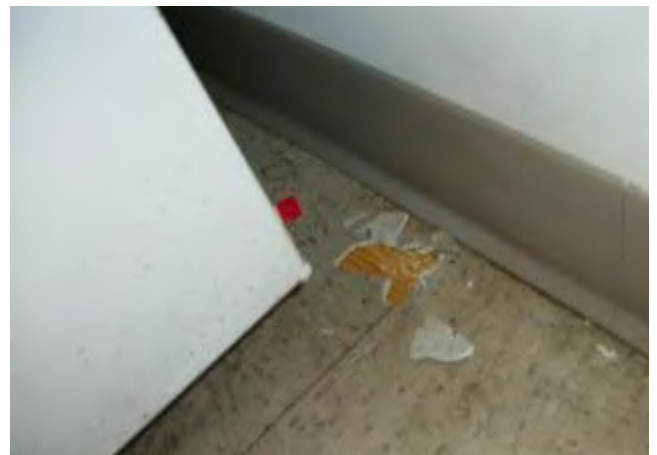
HA-7: Gray 12" x 12" Vinyl Floor Tile, HA-8: Associated Yellow Floor Tile Mastic

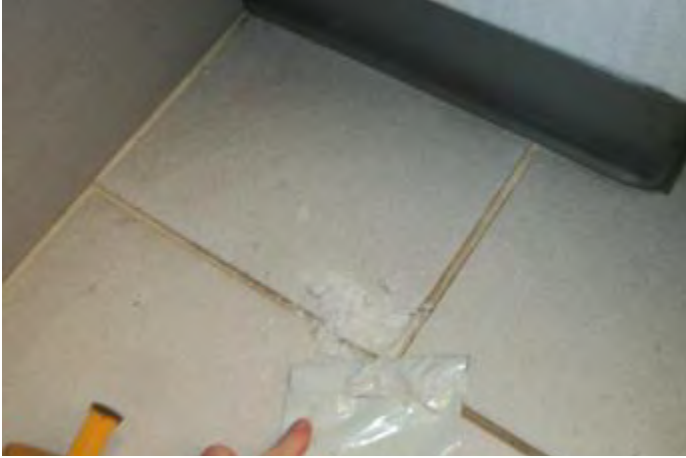
HA-9: Gray 12" x 12" Ceramic Floor Tile, HA-10: Associated Gray Floor Tile Grout, HA-11: Associated Gray Floor Tile Adhesive

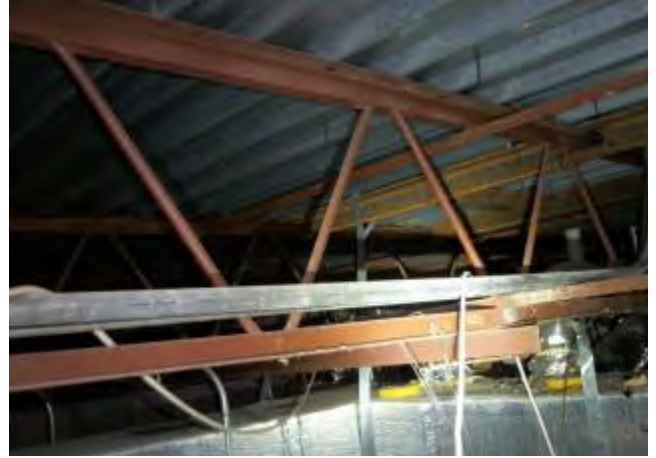
HA-12: Yellow Fiberglass HVAC Duct Insulation

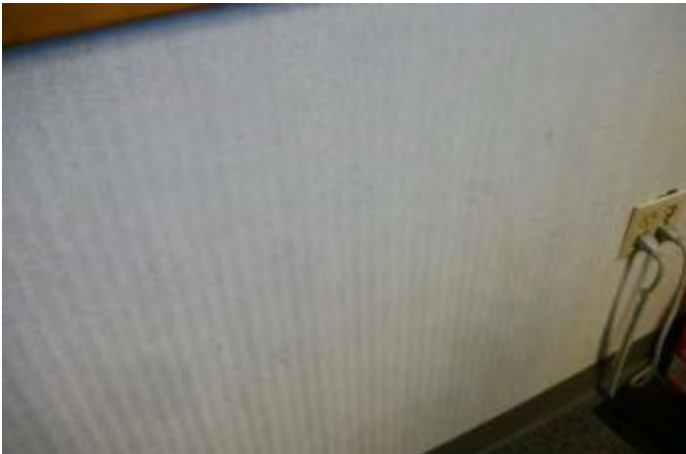
HA-13: Blue Wallpaper, HA-14: Associated White Adhesive

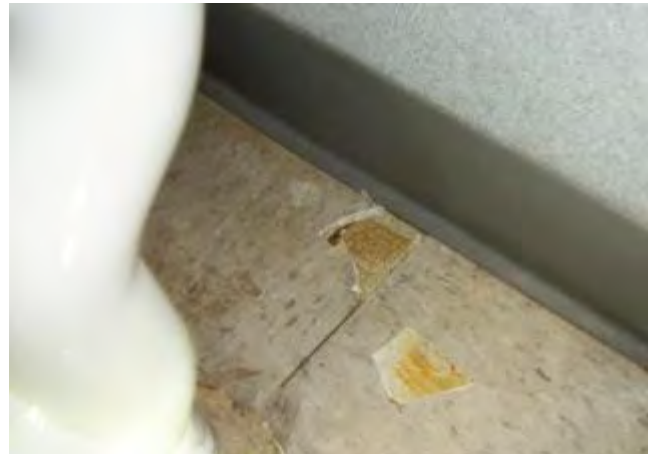
HA-15: Gray Vinyl Sheet Flooring (2nd layer), HA-16: Associated Yellow Floor Tile Mastic, HA-17: Gray Vinyl Sheet Flooring (3rd layer), HA-18: Associated Yellow Floor Tile Mastic

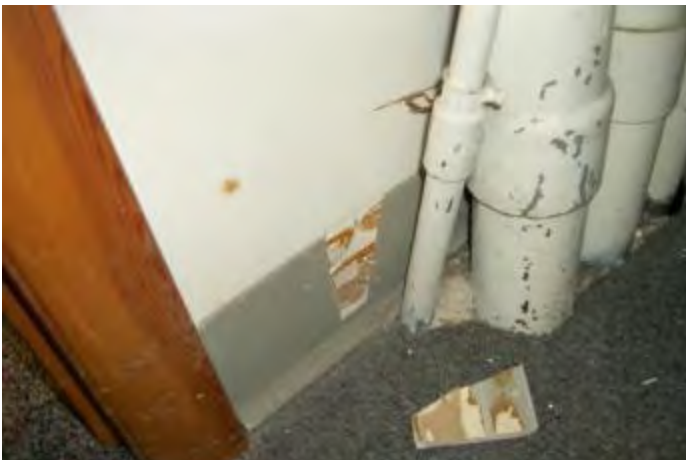
HA-19: Gray 4" Vinyl Cove Base, HA-20: Associated Brown Cove Base Mastic

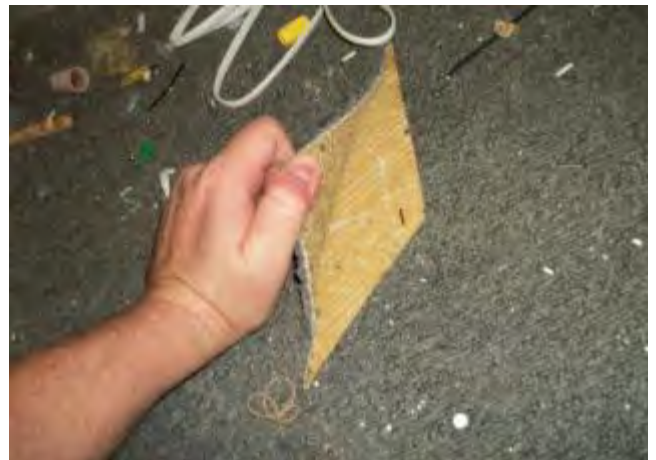
HA-21: Yellow Carpet Mastic
