March 26, 2010

Project No. HT116968.0000

Re: Asbestos Complete Interior Survey  
Retail Banking Branch  
20 Main Street  
Le Roy, New York  
Mail Code: NY7-139

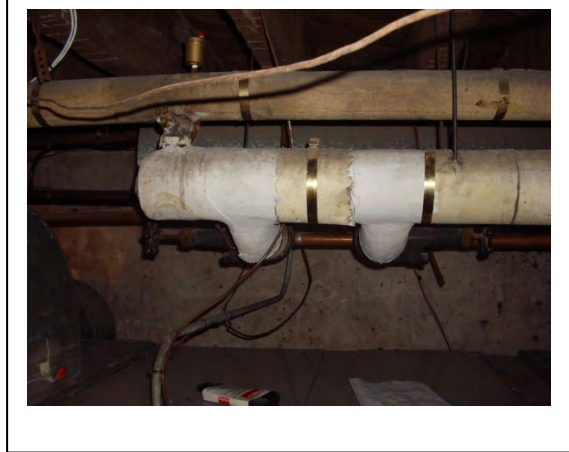
| HA No. | Material Type | Primary Color | Texture | Description | NESHAP Cat. | Floor | Rooms | Location | Condition | Amt. | Units | Status | Modified Date | Description | PK | ModDate |
|---|--|---|---|--|---|---|---|---|---|---|---|---|---|--|---|---|
| 2 | T - Pipe Insulation (Fittings, Elbows, Runs) | Gray | Rough | Mudded Fittings | Friable RACM | Basement | Basement | Other | Sig. Damaged | 26 | EA | | | | | |

**HA - 1/2: Aircell pipe insulation and muddied fittings.**

ACBMs that are “Damaged” or “Significantly Damaged” present a greater risk of releasing asbestos fibers. Therefore, these materials should be evaluated to determine if they require repair or abatement. If the materials are repaired or abated, the HAT should be updated to reflect this modification to the materials. Contact the building’s Property Manager to determine what actions are necessary with respect to these “Damaged” or “Significantly Damaged” materials.

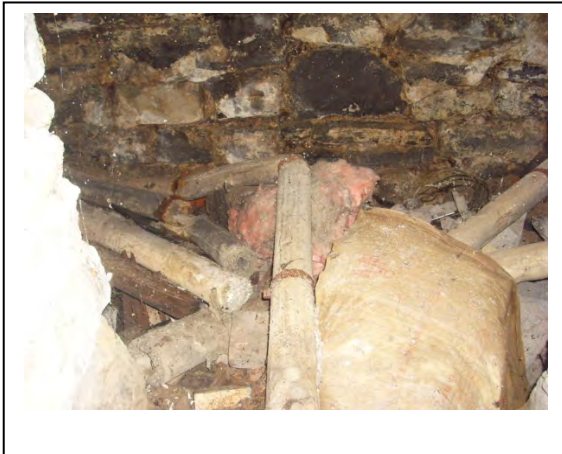
| HA No. | Material Type | Primary Color | Texture | Description | NESHAP Cat. | Floor | Rooms | Location | Condition | Amt. | Units | Status | Modified Date | Description | PK | ModDate |
|---|--|---|---|--|---|---|---|---|---|---|---|---|---|--|---|---|
| 1 | T - Pipe Insulation (Corrugated Air-Cell, Block, etc.) | Gray | Rough | AirCell Pipe Insulation | Friable RACM | Basement | Basement | Other | Sig. Damaged | 400 | LF | | | Approximately 50 LF of ACM TSI is significantly damaged in the basement crawlspace. The remainder of the TSI was in good condition with repair to open ends. | | |

| HA No. | Material Type | Id | Location | Content | Type | Friable | Sample Date | Consultant | Method | Lab | Notes | PK | ModDate |
|---|--|---|---|---|---|---|---|---|---|---|---|---|---|
| 1 | T - Pipe Insulation (Corrugated Air-Cell, Block, etc.) | 970311 | BASEMENT | >10% | Chrysotile | Yes | 3/3/2010 | LFR | PLM | EMSL | | | |

**HA - 1: Air cell in crawl space.**

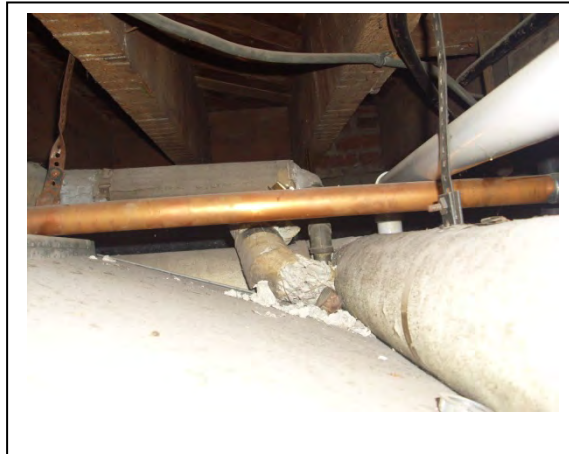
| HA No. | Material Type | Id | Location | Content | Type | Friable | Sample Date | Consultant | Method | Lab | Notes | PK | ModDate |
|---|--|---|---|---|---|---|---|---|---|---|---|---|---|
| 2 | T - Pipe Insulation (Fittings, Elbows, Runs) | 970314 | BASEMENT | >10% | Chrysotile | Yes | 3/3/2010 | LFR | PLM | EMSL | | | |

**HA - 2: Severely damaged muddied fitting.**

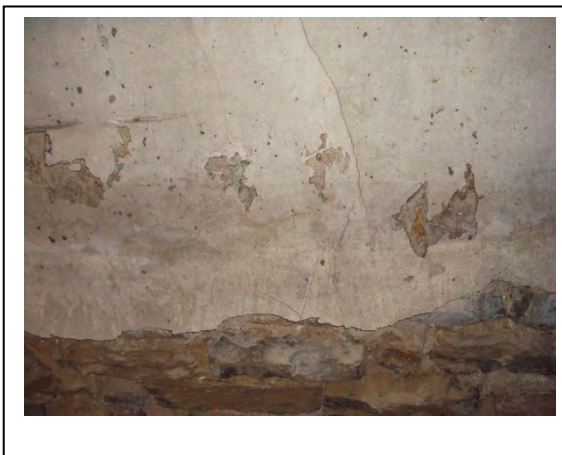
**HA - 3/6: Plaster skim coat and stone grout.**

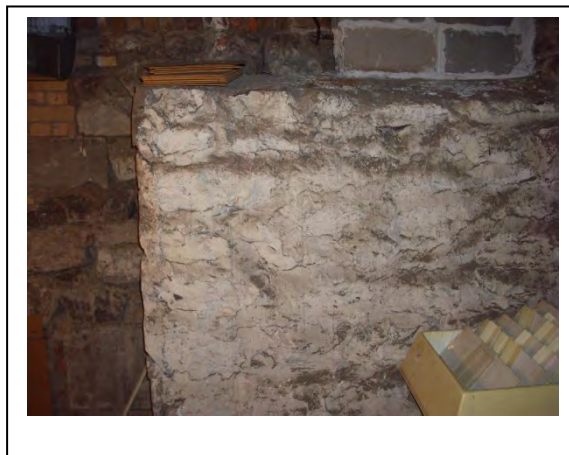
**HA - 4: Surface plaster.**

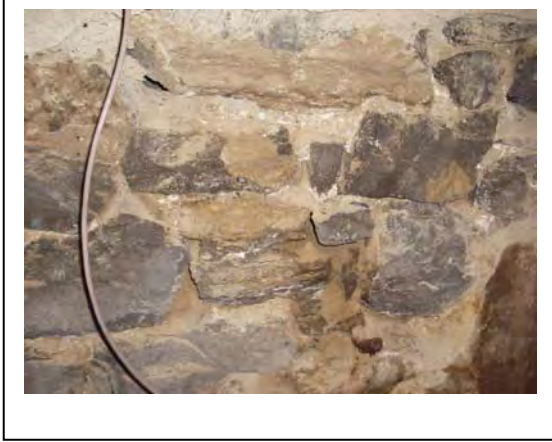
**HA - 5: Black waterproofing.**

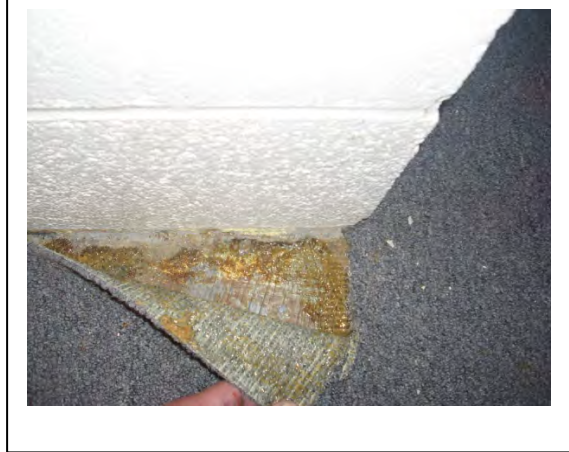
**HA -7: Carpet adhesive.**

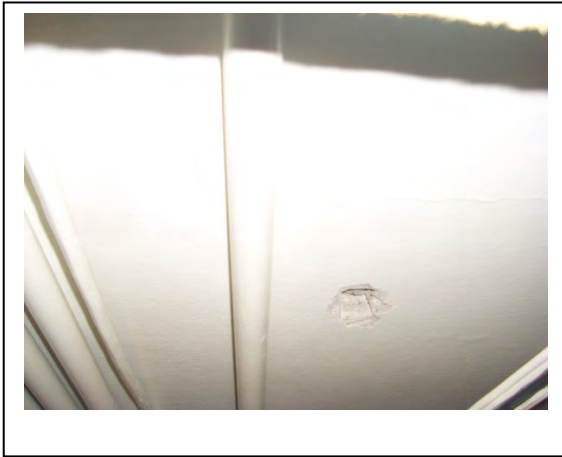
**HA - 8/9. Plaster ceiling skim coat and plaster on metal laths.**

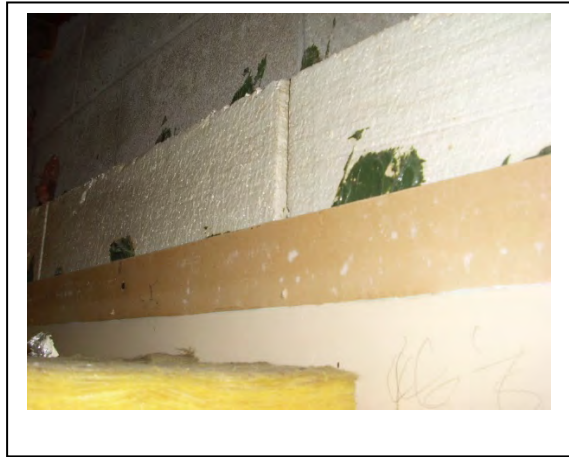
**HA - 10: Green adhesive on foam board.**

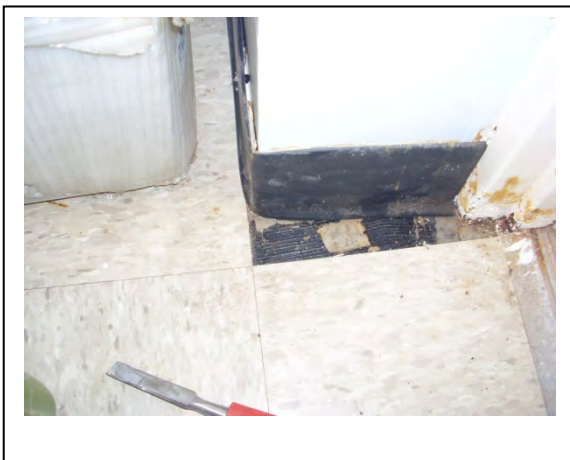
**HA - 11/12: 12" x12" Gray marbled floor tile;  
Mastic for Gray floor tile.**

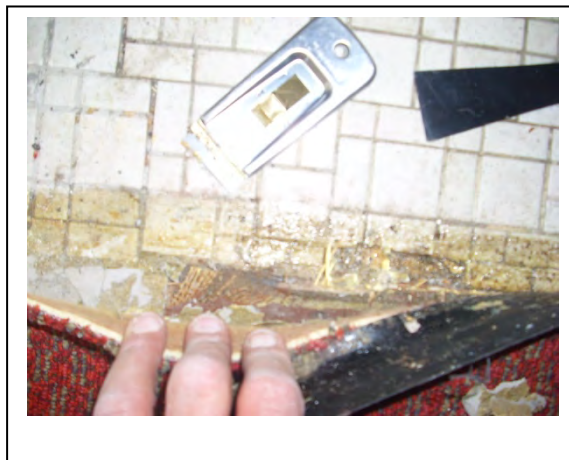
**HA - 13: Canvas floor backing.**

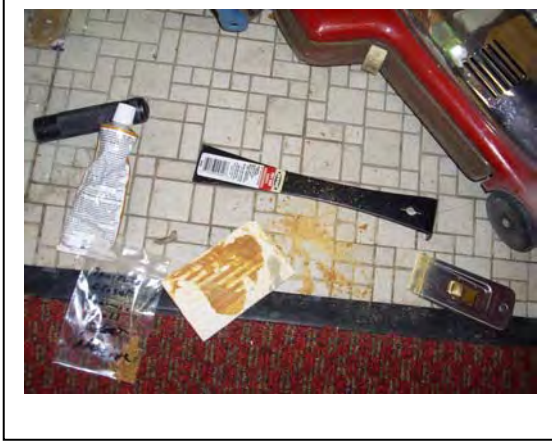
HA - 14/15: Ceramic floor and wall adhesive.

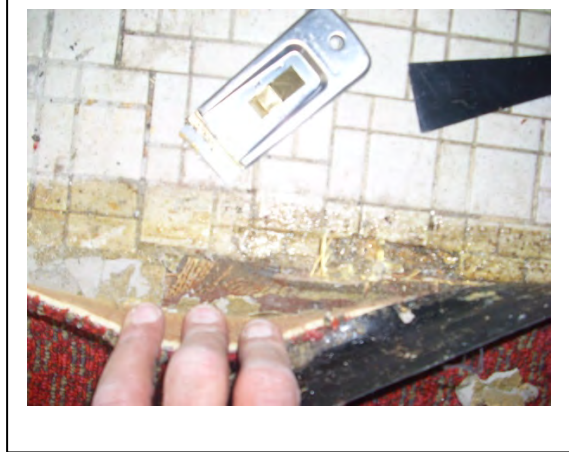
HA - 16: Carpet adhesive.

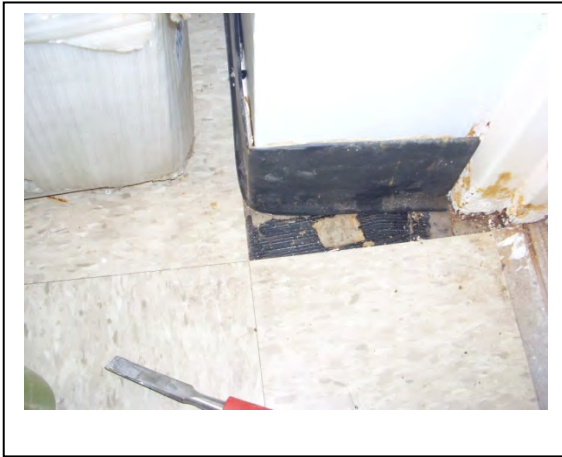
HA - 17/18: 6" Black cove base and adhesive.

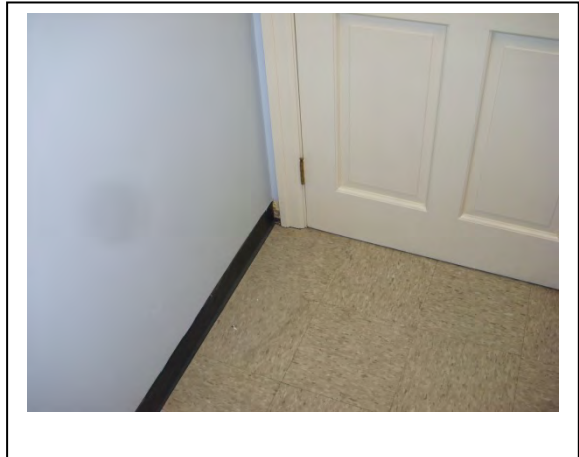
HA - 19/20: 4" Black cove base and adhesive.

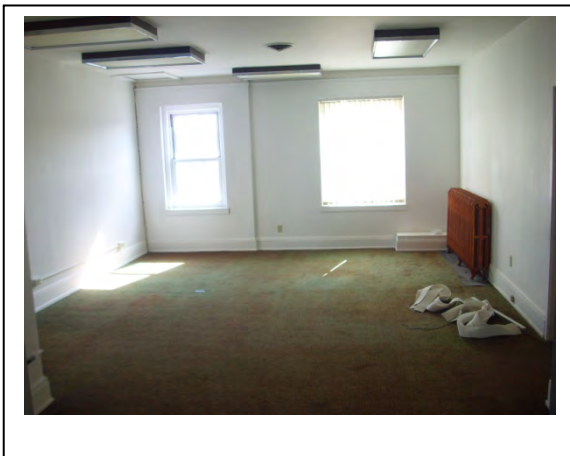
HA - 21: 2'x4' Fissured ceiling tiles.

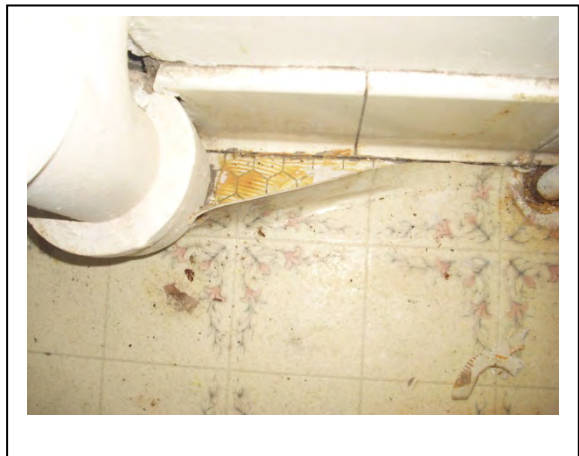
HA - 22/23: Vinyl floor sheet and associated adhesive.

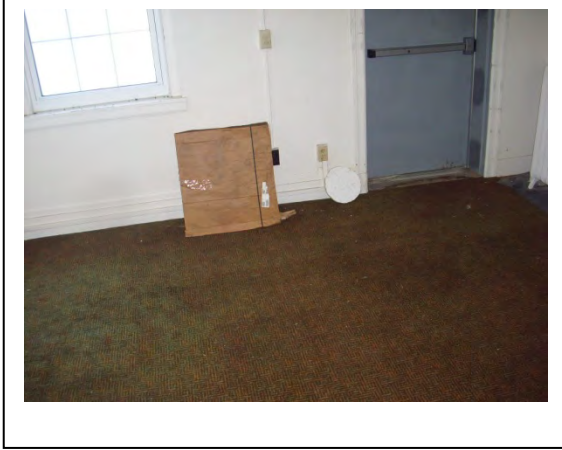
| HA No. | Material Type | Id | Location | Content | Type | Friable | Sample Date | Consultant | Method | Lab | Notes | PK | ModDate |
|---|--|---|---|---|---|---|---|---|---|---|---|---|---|
| 24 | M - Carpet Glue/Mastic | 970362 | 2ND FLOOR REAR OFFICE | 0.1% to <1% | Chrysotile | No | 3/3/2010 | LFR | PLM/TEM NOB | EMSL | | | |

**HA - 24: Carpet adhesive.**

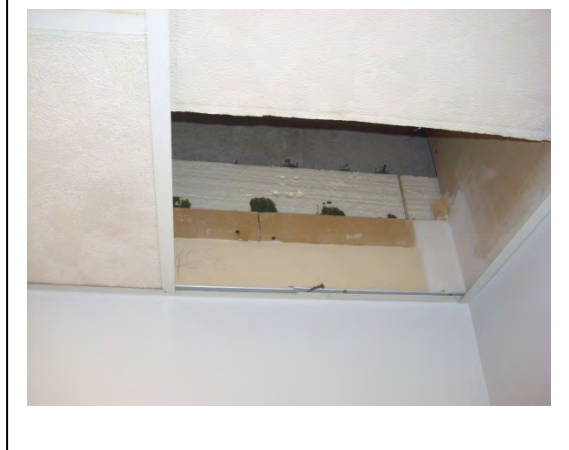
**HA - 25/26: Joint compound and drywall.**

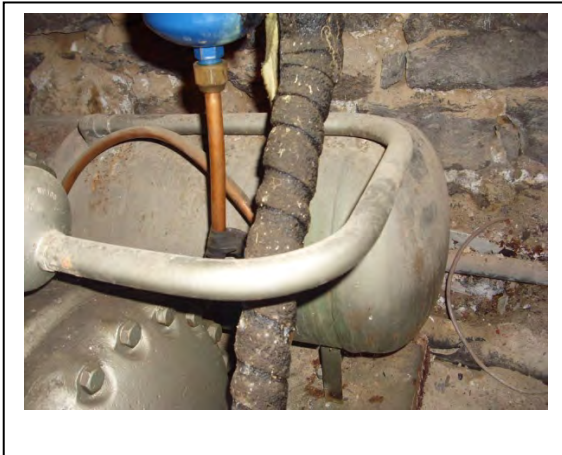
**HA - 27: Refrigeration tape.**

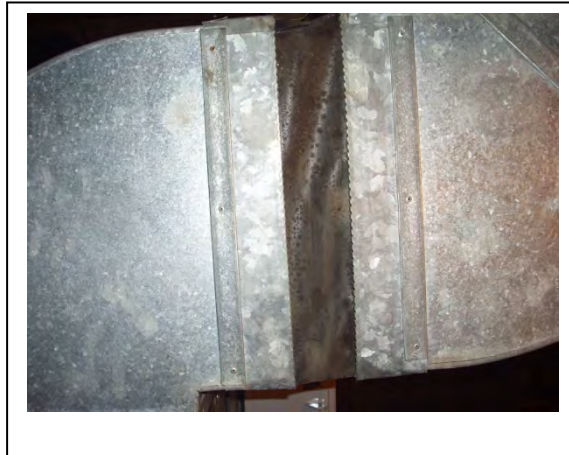
**HA - 28: HVAC flex connector.**

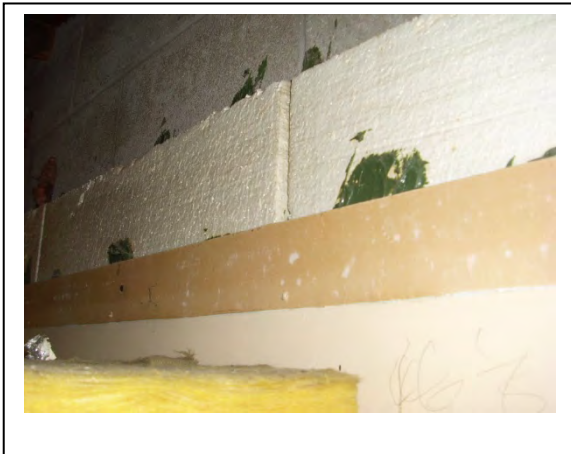
**HA - 29: Foam insulating panels.**
