Subject:
Banking Center Closure
Blaine Site
277 G Street, Blaine, Washington 98230
Mail Code: WA4-105

Date:
May 18, 2011

ARCADIS U.S., Inc. (ARCADIS) was retained by Cushman & Wakefield, Inc. (C&W) to conduct an investigation of the banking center located at 277 G Street, Blaine, Washington, in response to a Banking Center Closure. The building is owned by Bank of America and operates as a retail banking center.

C&W requested that ARCADIS perform the investigation because Bank of America associates working at the branch reported smelling burning or smoke odors in the branch on May 11, 2011. The building was subsequently evacuated and North Whatcom Fire and Rescue (NWFR) responded.

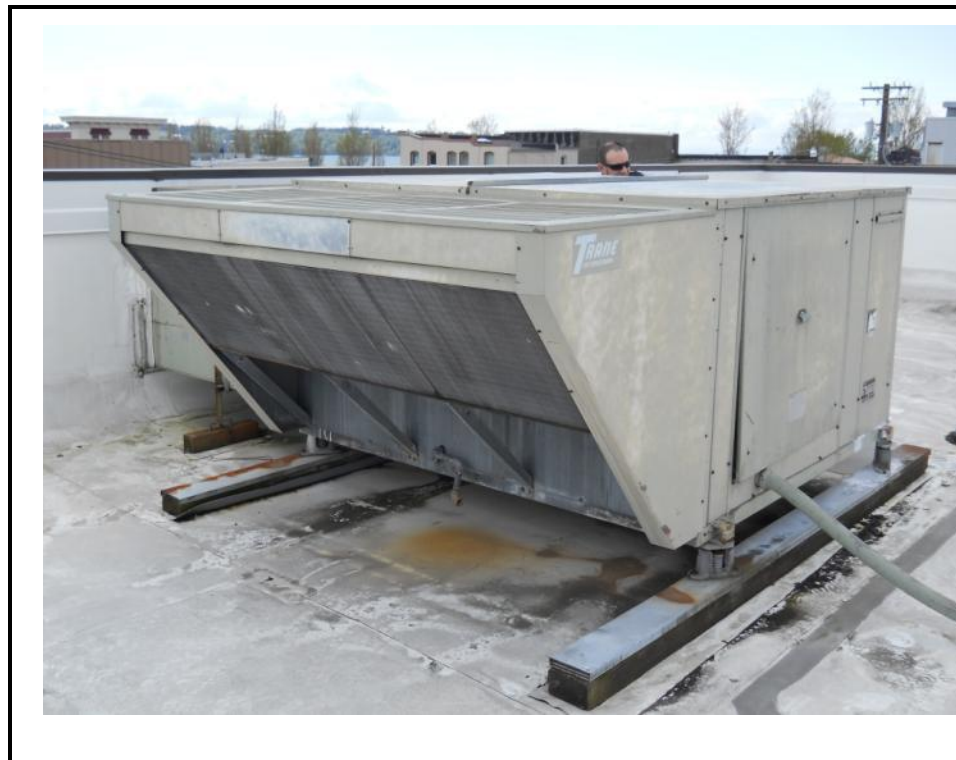
Photograph #2

Description of Photograph:
Rooftop air-handling unit (AHU).

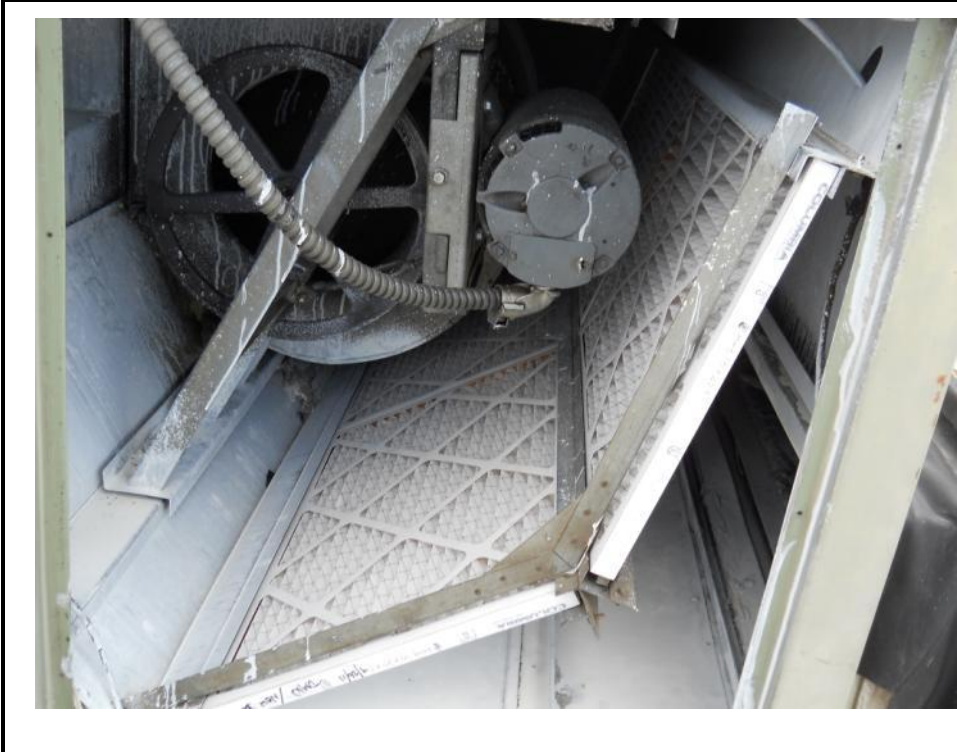
Photograph #3

6. The field testing parameters within the area of concern were found to be within the published guidance values (refer to Table 1).
7. The rooftop air handling unit (AHU) was generally in good condition. (Refer to Table 2). The pleated filters had been replaced on April 26, 2011. The cooling coil and condensate pan were clean and dry. White encapsulant was observed throughout the interior of the unit. The encapsulant was related to the February 2011 remediation of deteriorated insulation within the unit. ARCADIS was not able to access the unit's electric heating coil.

Based on the summary of key findings outlined above, ARCADIS was not able to identify a root cause for the odor. It is possible that the odor was the result of accumulated dust or encapsulant overspray burning off of the electric heating coil within the air handling unit, but this was not verified. Another possible source of this type of odor is a failed or failing fluorescent light ballast.

Description of Photograph:
Interior of AHU. Note encapsulant overspray.

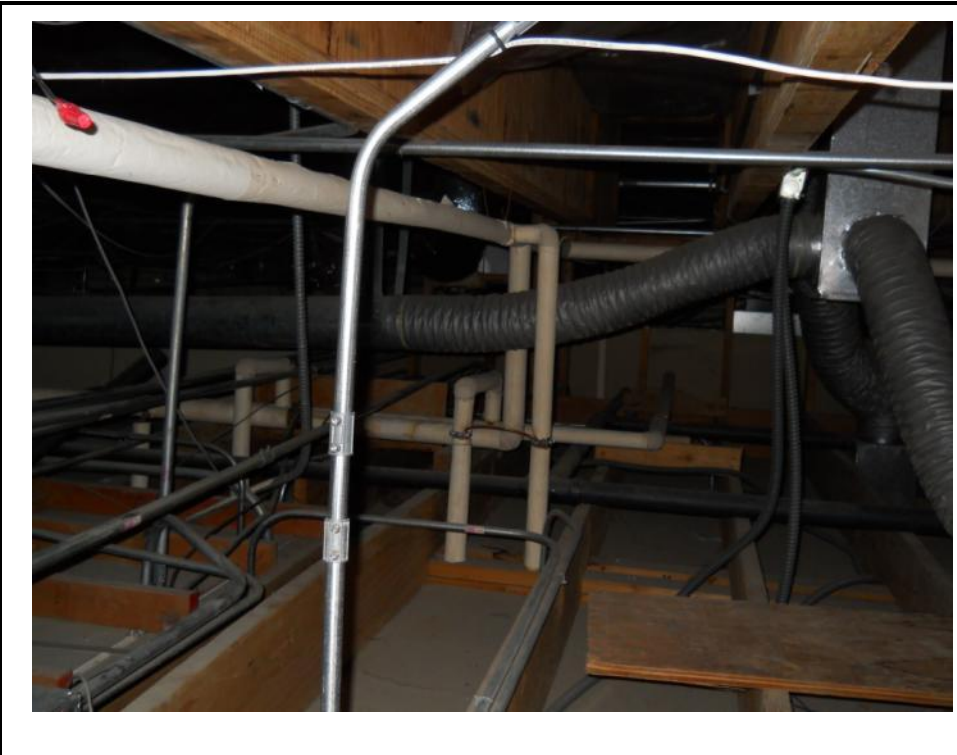
Photograph #4

5. The ceiling plenums throughout the branch appeared to be clean and orderly, with no significant buildup of dust or debris. Minor dust accumulation was observed on the ceiling in the vicinity of the diffusers servicing the teller line. Mechanical equipment observed above the suspended ceiling appeared to be clean and in good operating condition throughout the branch.

Description of Photograph:
Ceiling plenum.

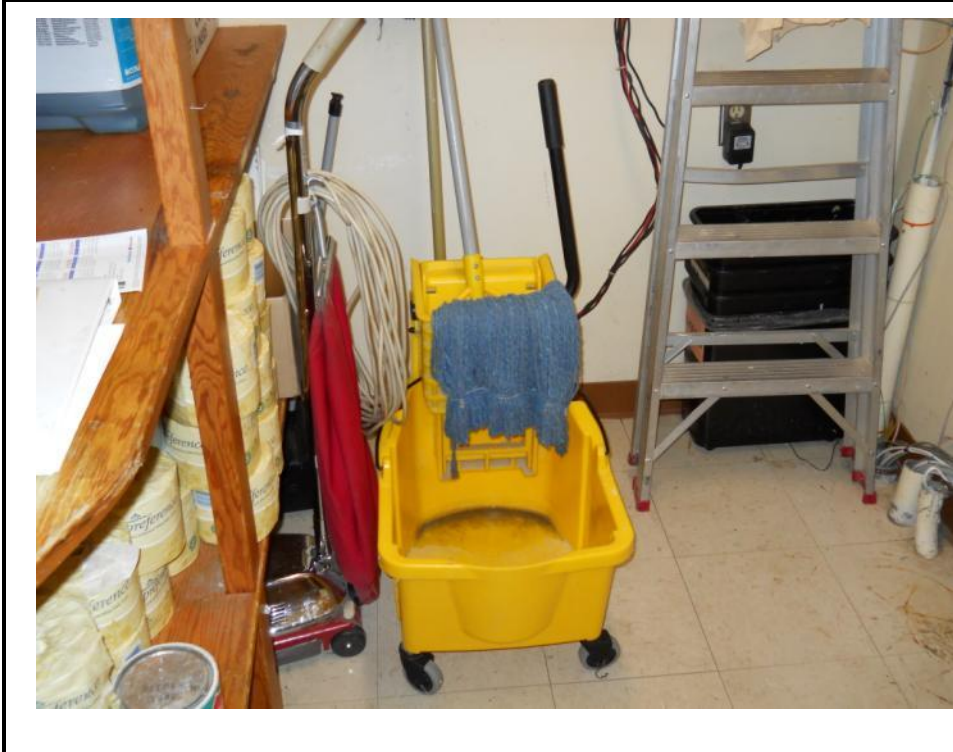
Photograph #5

4. The janitor's closet was generally clean and orderly. A dedicated exhaust fan servicing the janitor's closet and restrooms was operating effectively.

Description of Photograph:
Janitor's closet.

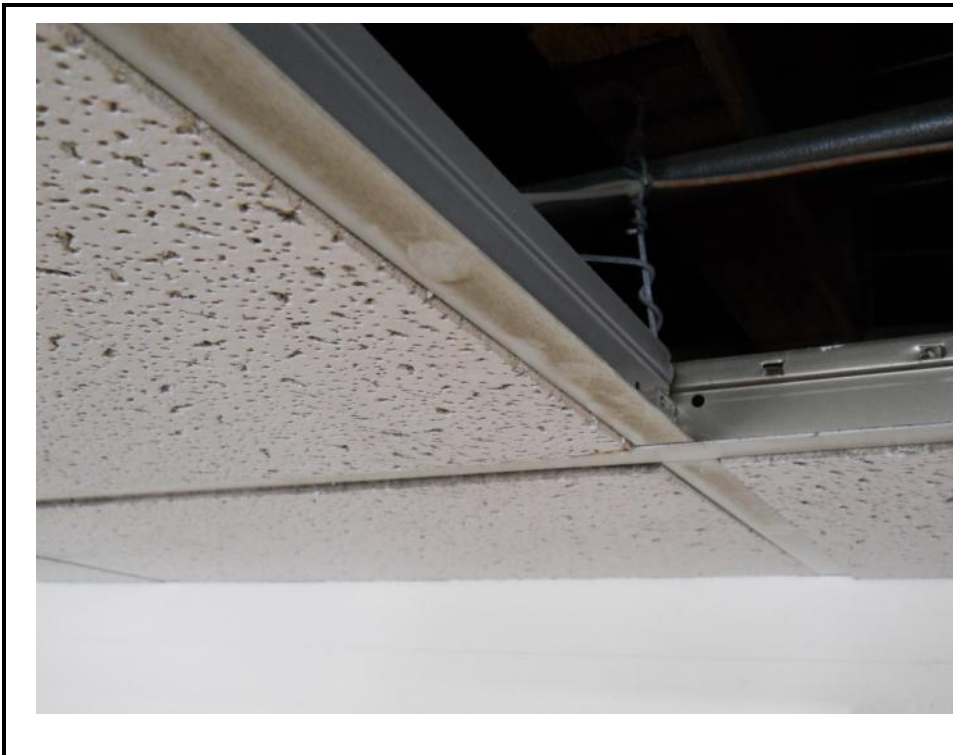
Photograph #6

Description of Photograph:
Dust on suspended ceiling grid
above teller area.

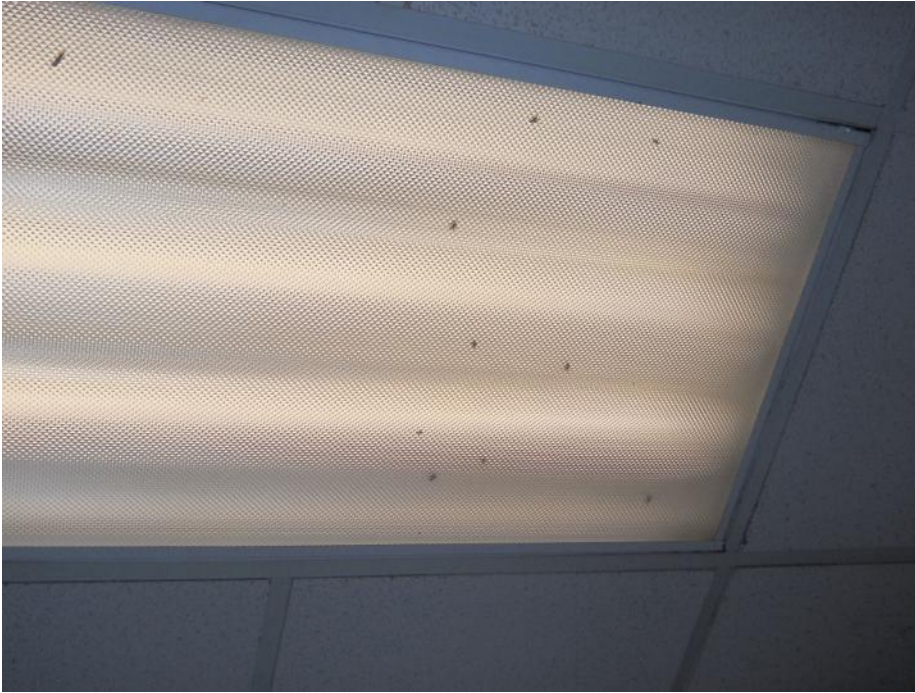
Photograph #7

1. The affected area was reported to encompass the lobby and teller line area, but the smoke or burning odor was reportedly most noticeable in the vicinity of the drive-up teller station.
2. There was no evidence of pest infestation observed in the building. Approximately a dozen dead flies were observed within the fluorescent light fixture above the drive-up teller station.
3. Minor stains were observed on approximately 4 to 5 ceiling tiles in the vicinity of the janitor's closet and back hallway. The staining totaled less than 3 square feet in area. The tiles were dry at the time of the site inspection, and no indications of roof leaks were observed above the tiles.

Description of Photograph:
Dead insects in light fixture above
unused drive-up teller area.

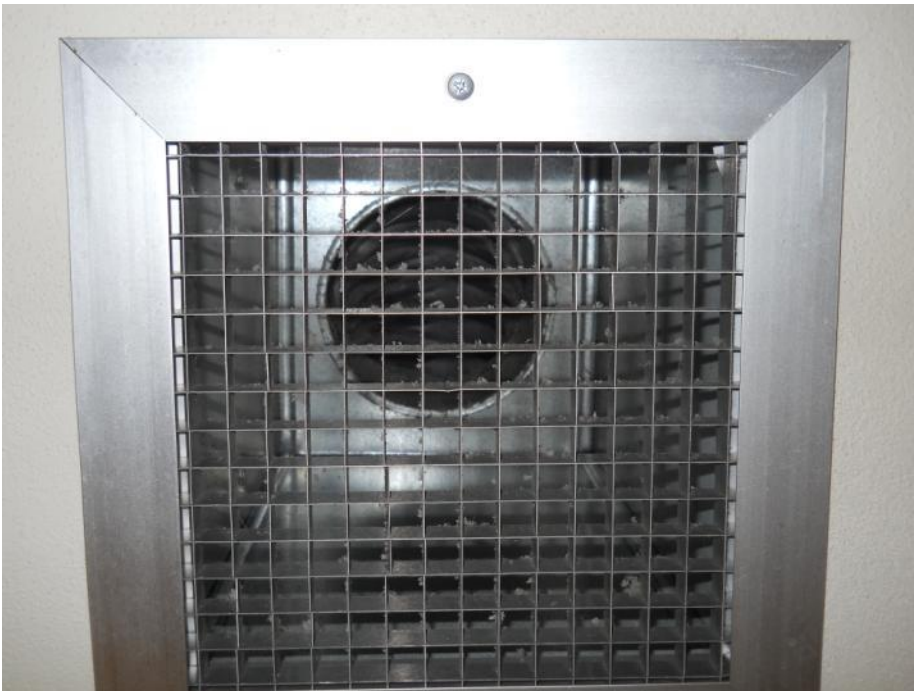
Photograph #8

Description of Photograph:
Exhaust duct in men's restroom.
