Subject:  
Asbestos Complete Interior Survey  
Blaine Retail Banking Center  
277 G Street  
Blaine, Washington  
Mail Code: WA4-105

Date:  
January 24, 2011

Our ref:  
HT117857.0094

## ASBESTOS SURVEY

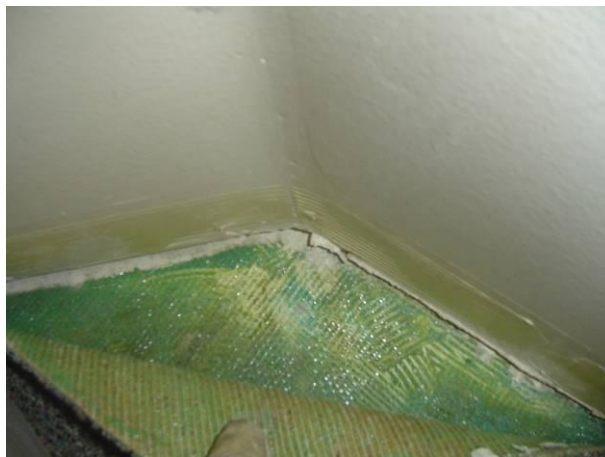
**HA-12, Carpet Glue**

9	M - Cove Base Mastic	9-1	TELLER	ND		No	1/6/2011	ARCADIS	PLM	EMSL			
9	M - Cove Base Mastic	9-2	KITCHEN	ND		No	1/6/2011	ARCADIS	PLM	EMSL			
9	M - Cove Base Mastic	9-3	WORK ROOM	ND		No	1/6/2011	ARCADIS	PLM	EMSL			
10	S - Textured Paints/Coatings	10-1	WORK ROOM	ND		No	1/6/2011	ARCADIS	PLM	EMSL			
10	S - Textured Paints/Coatings	10-2	HALLWAY	ND		No	1/6/2011	ARCADIS	PLM	EMSL			
10	S - Textured Paints/Coatings	10-3	BREAK ROOM	ND		No	1/6/2011	ARCADIS	PLM	EMSL			
11	M - Ceiling Tiles and Lay-in Panels	11-1	LOBBY	ND		Yes	1/6/2011	ARCADIS	PLM	EMSL			
11	M - Ceiling Tiles and Lay-in Panels	11-2	BREAK ROOM	ND		Yes	1/6/2011	ARCADIS	PLM	EMSL			
11	M - Ceiling Tiles and Lay-in Panels	11-3	WORK ROOM	ND		Yes	1/6/2011	ARCADIS	PLM	EMSL			
12	M - Carpet Glue/Mastic	12-1	SERVER ROOM	ND		No	1/6/2011	ARCADIS	PLM	EMSL			
12	M - Carpet Glue/Mastic	12-2	TELLER AREA	ND		No	1/6/2011	ARCADIS	PLM	EMSL			
12	M - Carpet Glue/Mastic	12-3	OFFICES	ND		No	1/6/2011	ARCADIS	PLM	EMSL

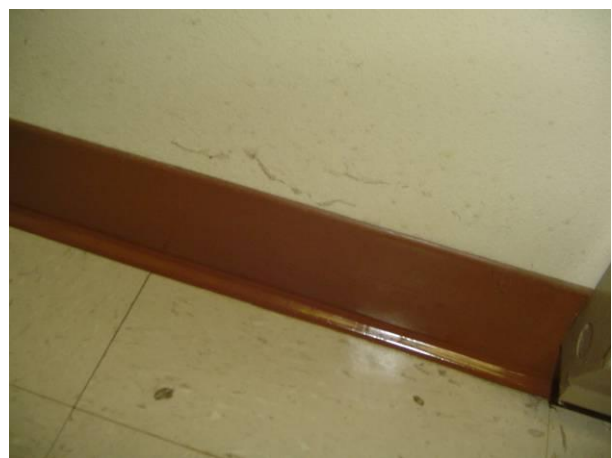
**HA-1, Cove Base; HA-2, Cove Base**

HA No.	Material Type	Id	Location	Content	Type	Friable	Sample Date	Consultant	Method	Lab	Notes	PK	ModDate
1	M - Cove Base	1-1	STORE ROOM	ND		No	1/6/2011	ARCADIS	PLM	EMSL			
1	M - Cove Base	1-2	HALLWAY	ND		No	1/6/2011	ARCADIS	PLM	EMSL			
1	M - Cove Base	1-3	ATM	ND		No	1/6/2011	ARCADIS	PLM	EMSL			
2	M - Cove Base Mastic	2-1	STORE ROOM	ND		No	1/6/2011	ARCADIS	PLM	EMSL			
2	M - Cove Base Mastic	2-2	HALLWAY	ND		No	1/6/2011	ARCADIS	PLM	EMSL			
2	M - Cove Base Mastic	2-3	ATM	ND		No	1/6/2011	ARCADIS	PLM	EMSL			
3	M - Vinyl Floor Tile	3-1	HALLWAY	>1%-10%	Chrysotile	No	1/6/2011	ARCADIS	PLM	EMSL			
3	M - Vinyl Floor Tile	3-2	BREAK ROOM	Pos Stop		No	1/6/2011	ARCADIS	PLM	EMSL			
3	M - Vinyl Floor Tile	3-3	SICK ROOM	Pos Stop		No	1/6/2011	ARCADIS	PLM	EMSL			
4	M - Floor Tile Mastic	4-1	HALLWAY	>1%-10%	Chrysotile	No	1/6/2011	ARCADIS	PLM	EMSL			
4	M - Floor Tile Mastic	4-2	BREAK ROOM	Pos Stop		No	1/6/2011	ARCADIS	PLM	EMSL

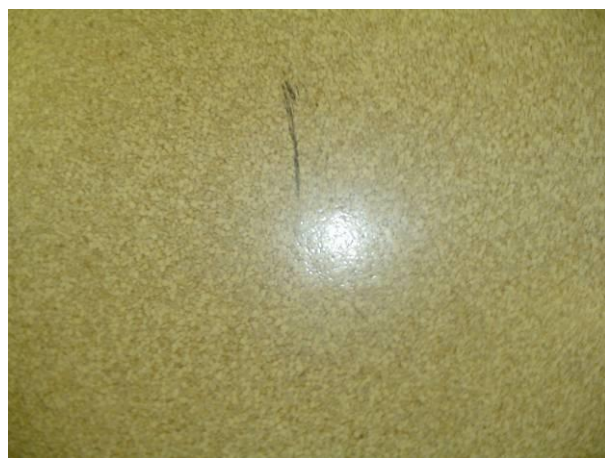
**HA-5, Vinyl Sheet Flooring**

4	M - Floor Tile Mastic	4-3	SICK ROOM	Pos Stop		No	1/6/2011	ARCADIS	PLM	EMSL			
5	M - Vinyl Sheet Flooring	5-1	MEN'S ROOM	>10%	Chrysotile	No	1/6/2011	ARCADIS	PLM	EMSL			
5	M - Vinyl Sheet Flooring	5-2	MEN'S ROOM	Pos Stop		No	1/6/2011	ARCADIS	PLM	EMSL			
5	M - Vinyl Sheet Flooring	5-3	WOMEN'S ROOM	Pos Stop		No	1/6/2011	ARCADIS	PLM	EMSL			
6	M - Cove Base	6-1	MEN'S ROOM	ND		No	1/6/2011	ARCADIS	PLM	EMSL			
6	M - Cove Base	6-2	MEN'S ROOM	ND		No	1/6/2011	ARCADIS	PLM	EMSL			
6	M - Cove Base	6-3	WOMEN'S ROOM	ND		No	1/6/2011	ARCADIS	PLM	EMSL			
7	M - Cove Base Mastic	7-1	MEN'S ROOM	ND		No	1/6/2011	ARCADIS	PLM	EMSL			
7	M - Cove Base Mastic	7-2	MEN'S ROOM	ND		No	1/6/2011	ARCADIS	PLM	EMSL			
7	M - Cove Base Mastic	7-3	WOMEN'S ROOM	ND		No	1/6/2011	ARCADIS	PLM	EMSL			
8	M - Cove Base	8-1	TELLER	ND		No	1/6/2011	ARCADIS	PLM	EMSL			
8	M - Cove Base	8-2	KITCHEN	ND		No	1/6/2011	ARCADIS	PLM	EMSL			
8	M - Cove Base	8-3	WORK ROOM	ND		No	1/6/2011	ARCADIS	PLM	EMSL

ARCADIS recommends that all suspect and confirmed ACBMs, if present, be managed in accordance with an O&M Program. In most cases, when an ACBM is in "Good" condition, we anticipate that the material can be managed under the in-place O&M Program, with abatement only being required when materials will be disturbed (i.e., renovation and some maintenance activities).

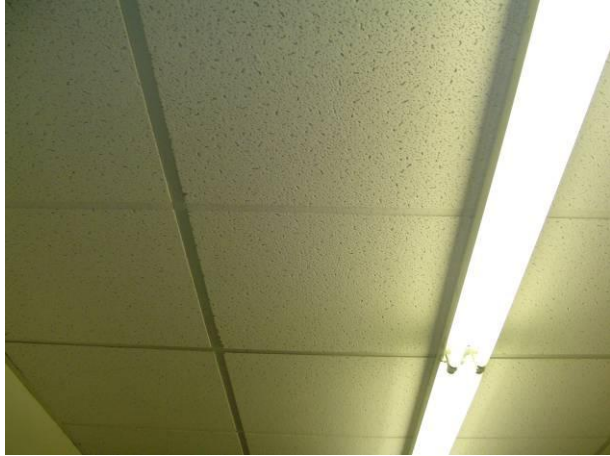
**HA-11, Suspended Ceiling Tile**

HA: 11 HA Number: 11 Material Type: M - Ceiling Tiles and Lay-in Panels Friable: Yes
