Path of Construction Asbestos Survey  
Bank of America – Blaine  
277 G Street  
Blaine, Washington 98230  
Mail Code: WA4-105

ARCADIS U.S., Inc. (ARCADIS) conducted a Path of Construction (POC) asbestos survey of certain homogeneous applications (HAs) that may be impacted during the flooring replacement project at the above-referenced site for Bank of America. The project will include the replacement flooring throughout the customer-facing areas of the building. ARCADIS' scope of work and the findings of POC survey are summarized below.

March 14, 2014

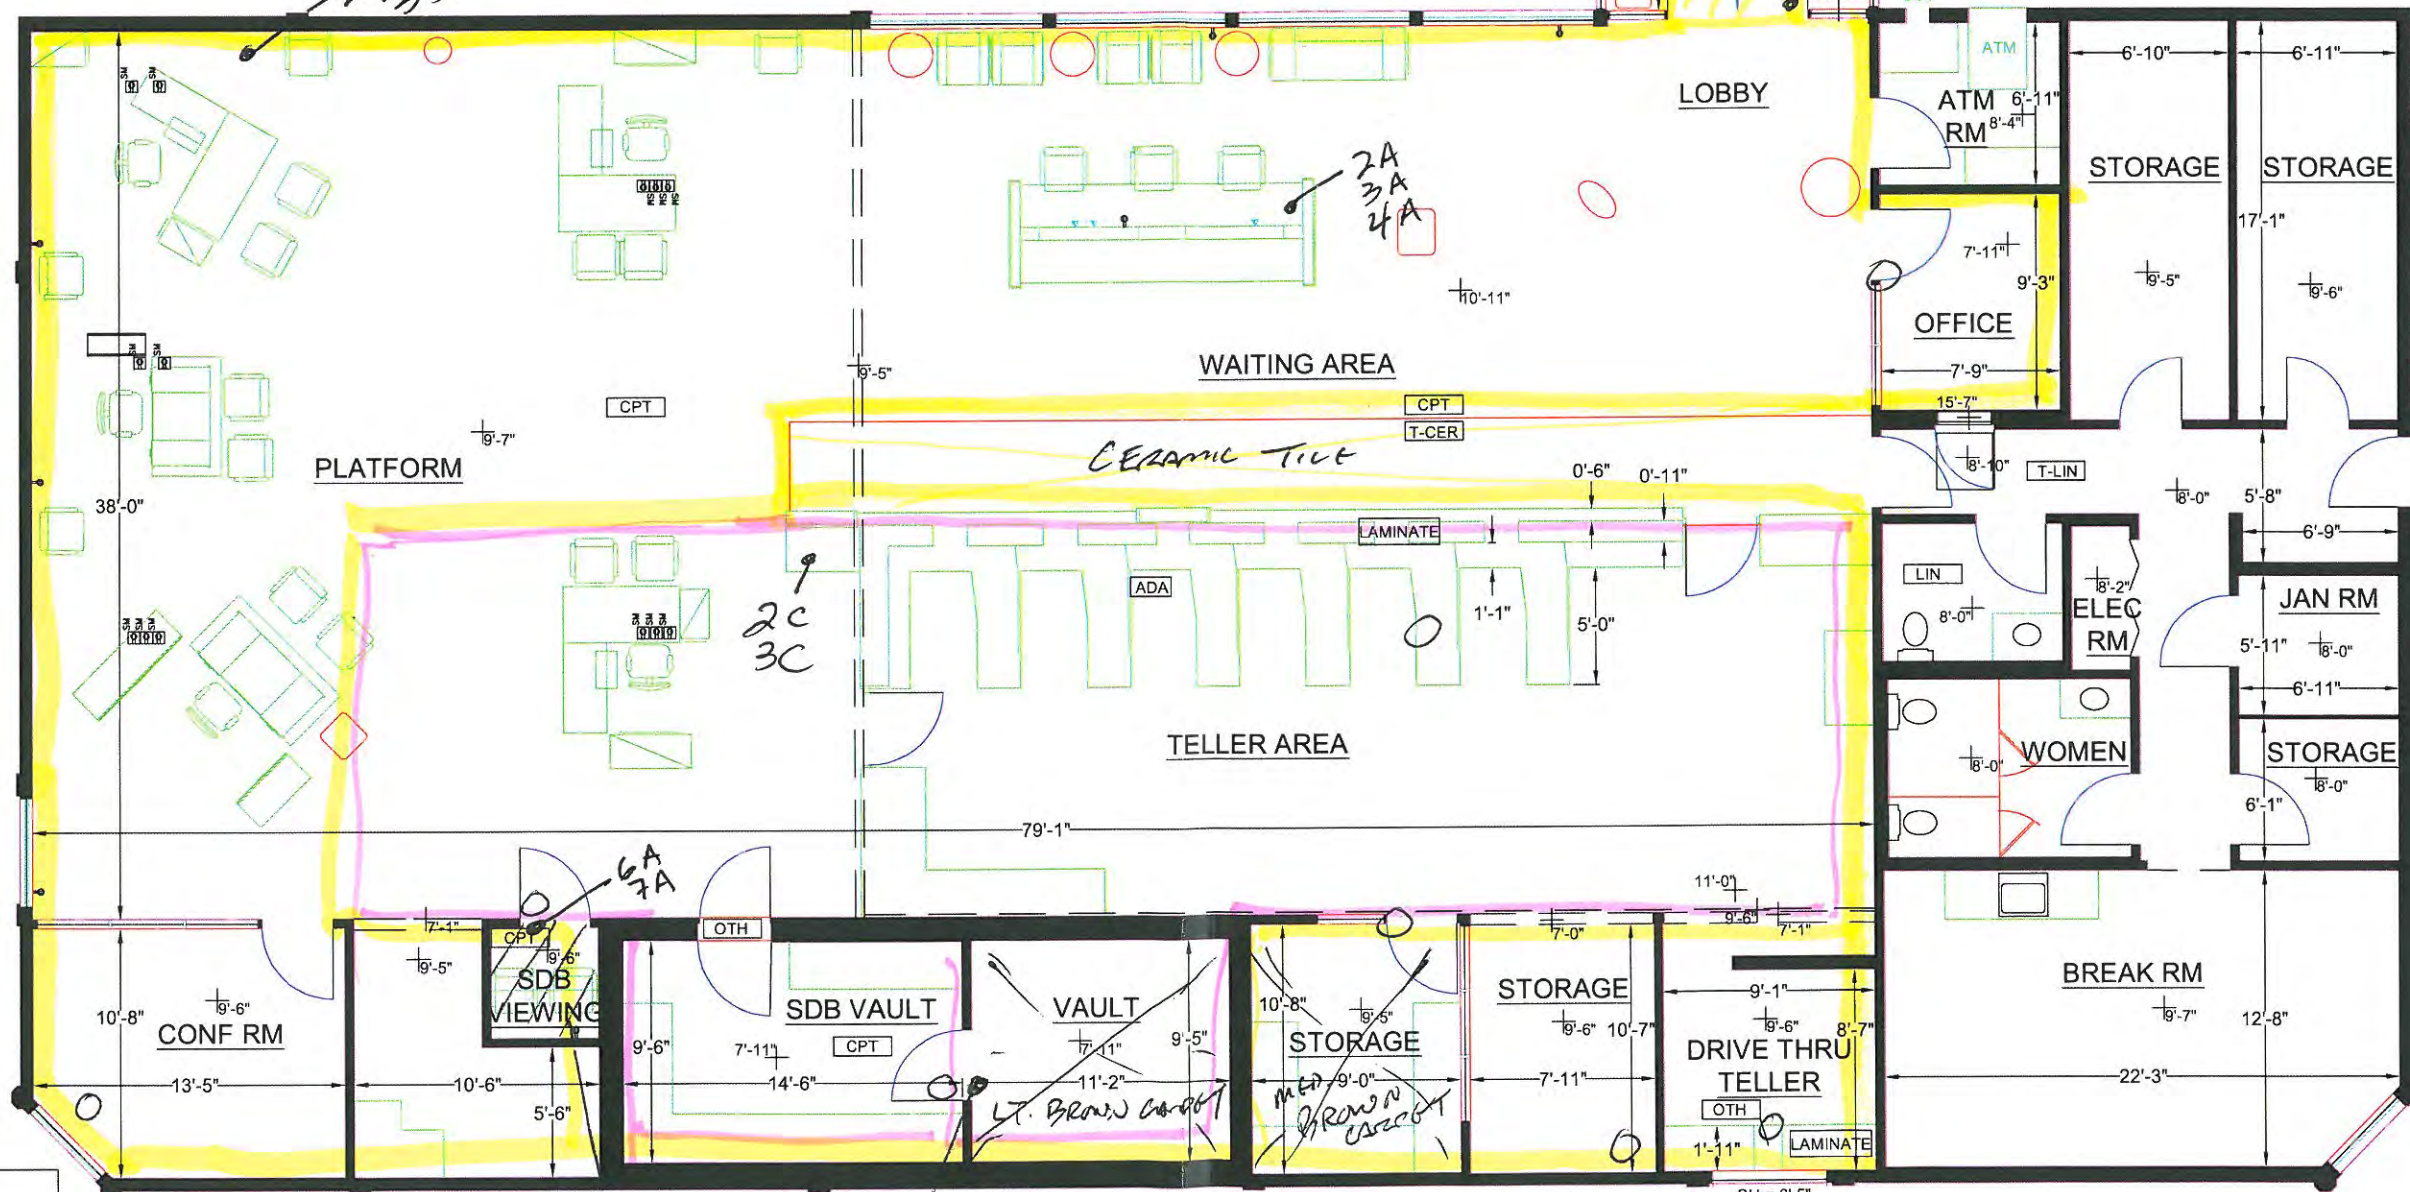
Sample Location Figure

Red carpet & mastics - APPROX 2,800 SF  
BLACK CARPET

4B, 7B, 9A  
All areas not otherwise noted are red carpet w/white and/or yellow mastic

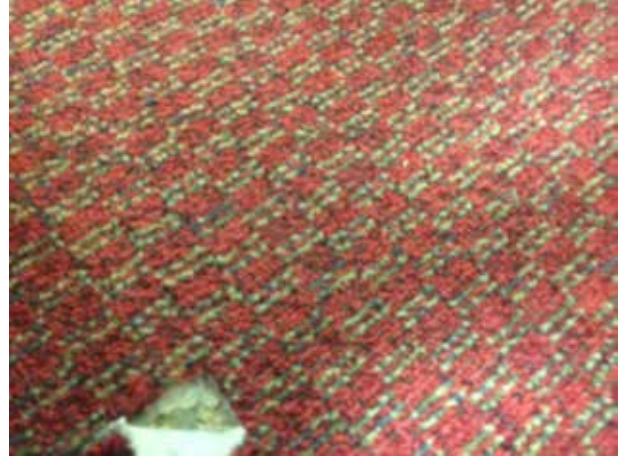
**HA-12: Yellow Carpet Glue; HA-28: Red Carpet;  
HA-29: White Carpet Glue**

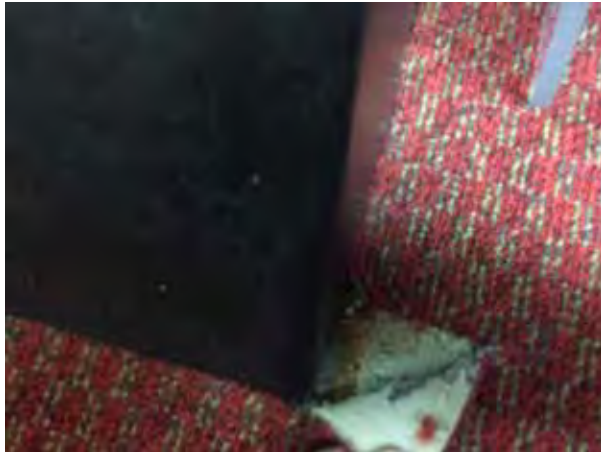
**HA-30: White Leveling Compound**

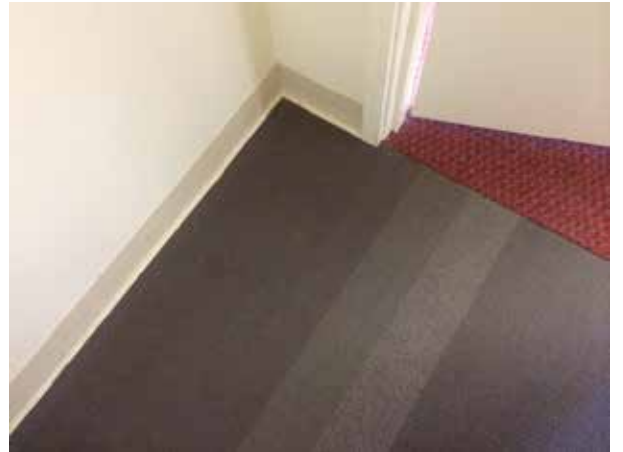
**HA-31: Brown Carpet; HA-32: Clear Carpet  
Adhesive; HA-33: Residual Brown Mastic**

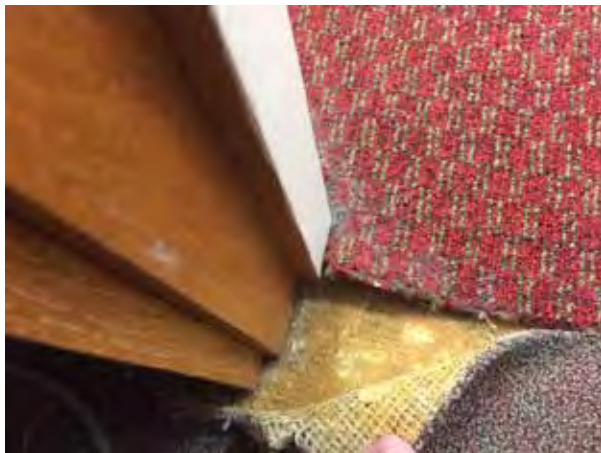
**HA-34: Light Brown Carpet; HA-35: Gray Leveling  
Compound**

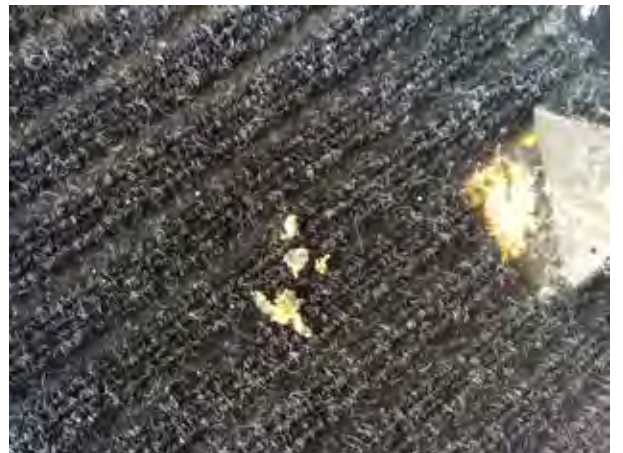
**HA-36: Black Walk-Off Mat; HA-37: Tan Carpet  
Glue**
