SECOR
INTERNATIONAL
INCORPORATED

October 17, 2005

**RE: UPDATE OF A PHASE I ENVIRONMENTAL SITE ASSESSMENT,
PIKE NURSERY
6100 LAWRENCEVILLE HIGHWAY
TUCKER, GEORGIA 30278
SECOR PN: B3OT.90706.00.0001**

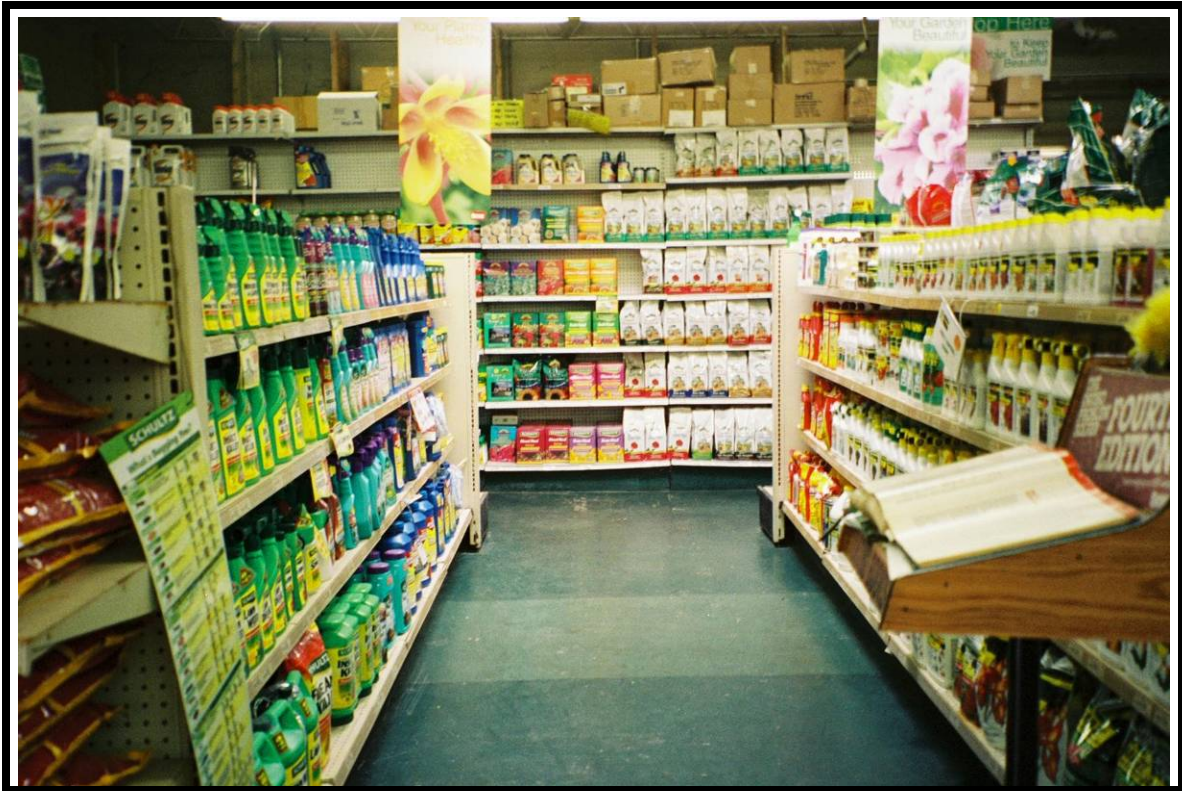
SECOR observed several containers of fungicides, pesticides, and herbicides on shelves in the retail building. The containers are for retail sale only. Reportedly, insecticides, fungicides, and fertilizers have been applied to the plant materials as a normal part of plant maintenance for retail purposes throughout the years. However, no wide scale fumigation, spraying, manufacturing or mixing of fungicides, pesticides, herbicides, and fertilizers has been performed at the subject property. As previously reported, empty containers of insecticides, fungicides, and fertilizers were disposed in the solid waste receptacles. No spills or releases were reported for the chemicals stored on-site. No other hazardous materials were noted, with the exception of household quantities of janitorial cleaners. No potential environmental risks were observed in association with these cleaning supplies.

1. Interior storage area of fungicides, pesticides, and herbicides for retail purposes.

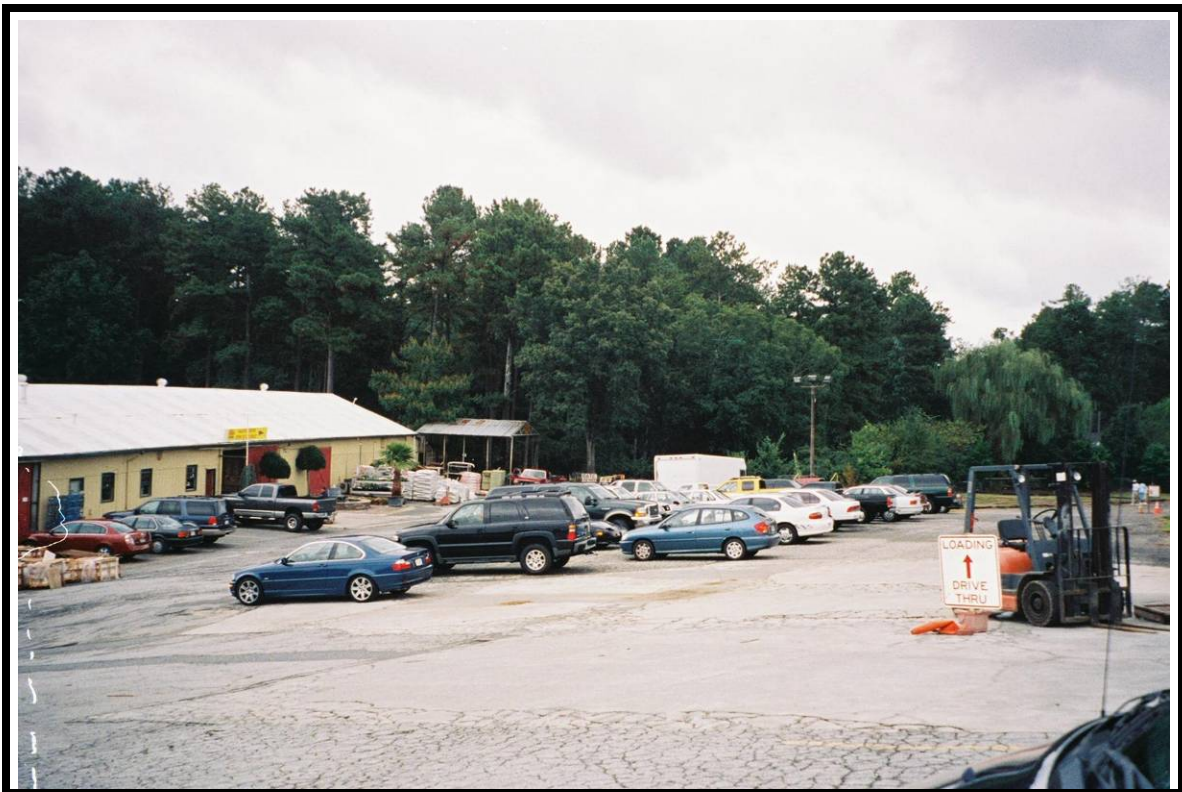
During the exterior reconnaissance, SECOR observed the asphalt paved parking area of the subject property to be in poor condition (severe cracking) with minimal amounts of vehicle oil stains. Portions of the asphalt-paved parking area were covered by retail supplies (i.e. rocks, bags of soil, bags of concrete, bags of mulch, sod, and plants). The areas not covered by pavement were naturally vegetated. Reportedly, all stormwater drains located throughout the subject property and the concrete stormwater flumes to the south of the sunscreen-covered areas discharge to an on-site detention area in the central portion of the subject property. No staining or stressed vegetation was observed in the detention area. Solid waste was disposed of in dumpsters located throughout the subject property. Two dumpsters for plants and packing materials (serviced by Allied Waste Services) were observed to the south of the retail greenhouses, and a dumpster for recyclable paper and cardboard (serviced by VISY) was also observed in the same area. A hydraulic trash compactor for diseased, insect infested, broken or damaged goods was located adjacent to the east side of the sunscreen-covered areas, and a dumpster for general waste, such as cardboard and paper, was located to the northeast of the sunscreen-covered areas. No staining or evidence of improper disposal was observed on the ground surface surrounding the solid waste receptacles.

2. View of the parking area between the subject property buildings.

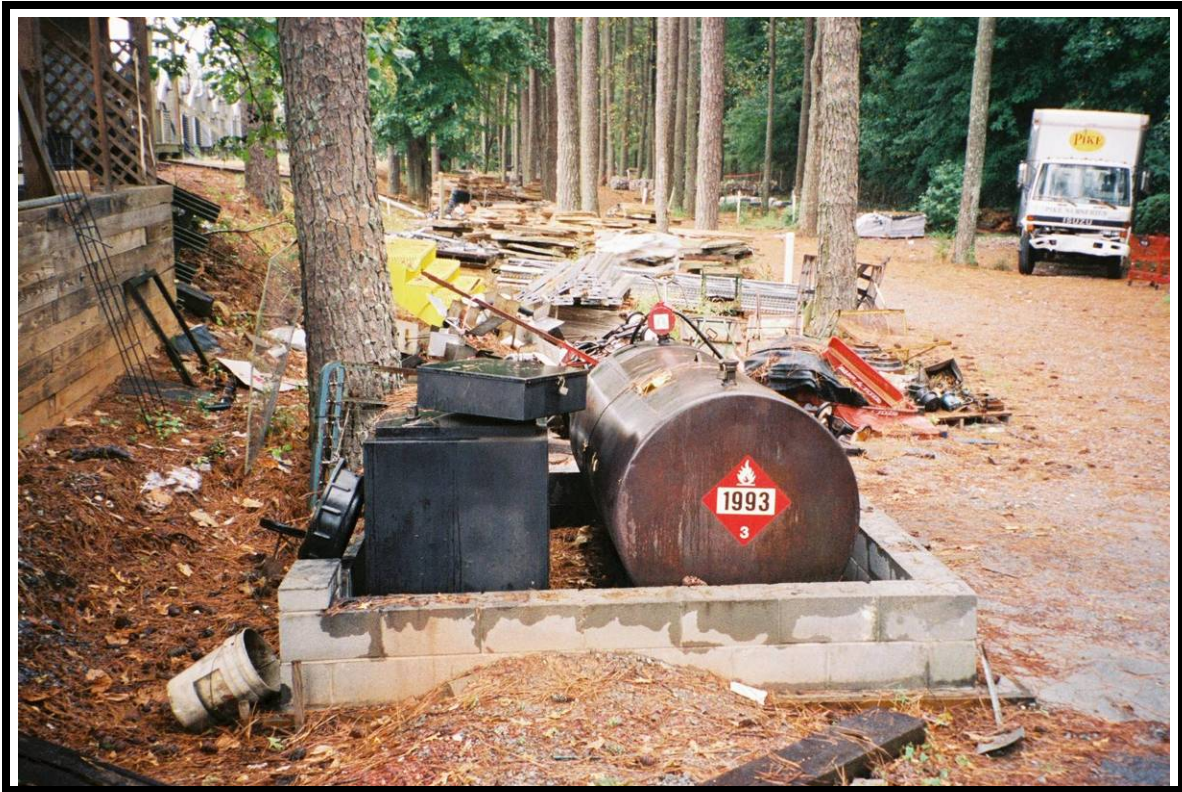
- SECOR noted that in the area behind the interior wholesale building, a concrete dike containing a 250-gallon AST containing used oil and a 500-gallon AST containing diesel fuel were in close proximity to the septic drainfield. No staining was observed by SECOR around the ASTs. Based on their proximity to the septic drainfield, should a release occur, used oil or diesel fuel could potentially contaminate groundwater.

south of the maintenance shop area, SECOR observed a 250-gallon used oil AST and a 500-gallon diesel AST. The two ASTs were situated within a bermed concrete/masonry dike, and no petroleum staining was noted within the diked area or on the ground surface surrounding the dike.

3. View of the ASTs to the southwest corner of the interior wholesale / rocks and aquatic building.

- SECOR noted fair housekeeping practices within the exterior area of the maintenance shop. However, SECOR was unable to access the interior of the maintenance shop during the site visit. SECOR also observed a concrete dike containing a 250-gallon AST containing used oil and a 500-gallon AST containing diesel fuel for maintenance of tractors adjacent to the maintenance shop area. No staining was observed by SECOR around the ASTs. Proper storage of hazardous materials and waste and petroleum products should be continued at the subject property for prevention of a possible release of contaminants to soil and/or groundwater.

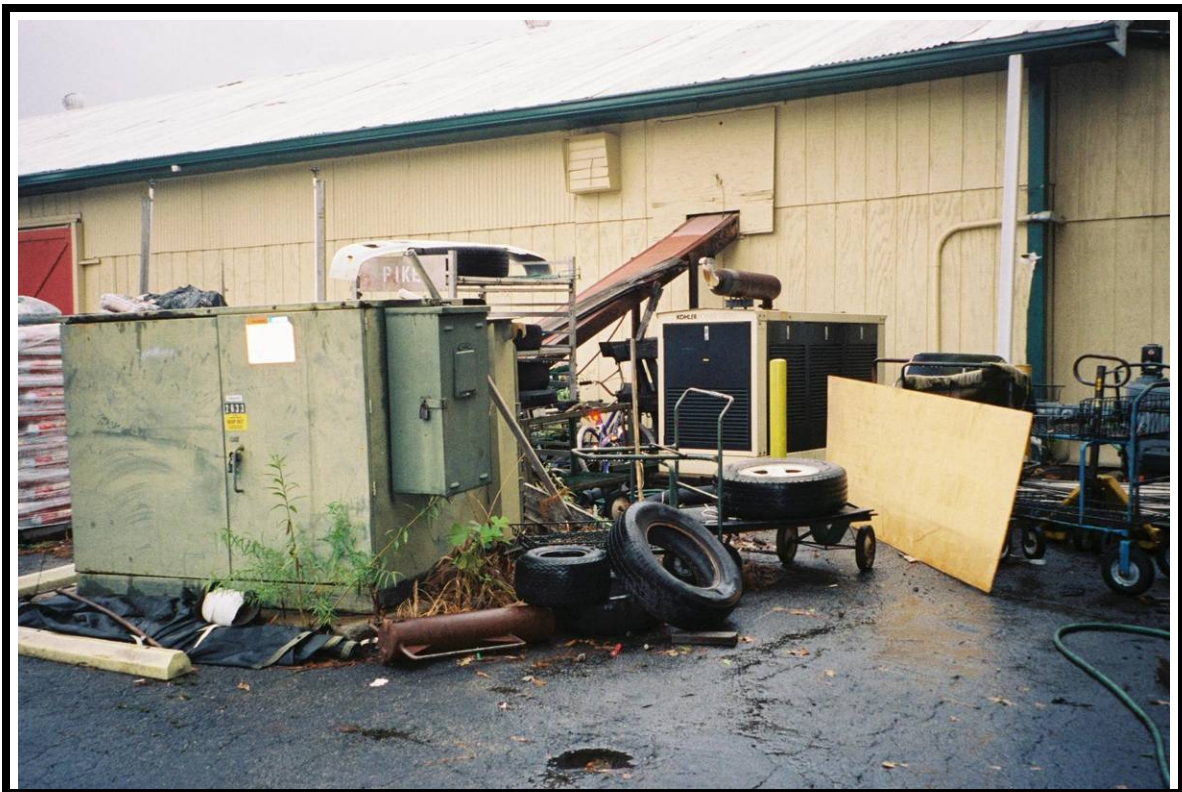
4. View of the pad-mounted transformer and the backup generator adjacent to the maintenance shop area.

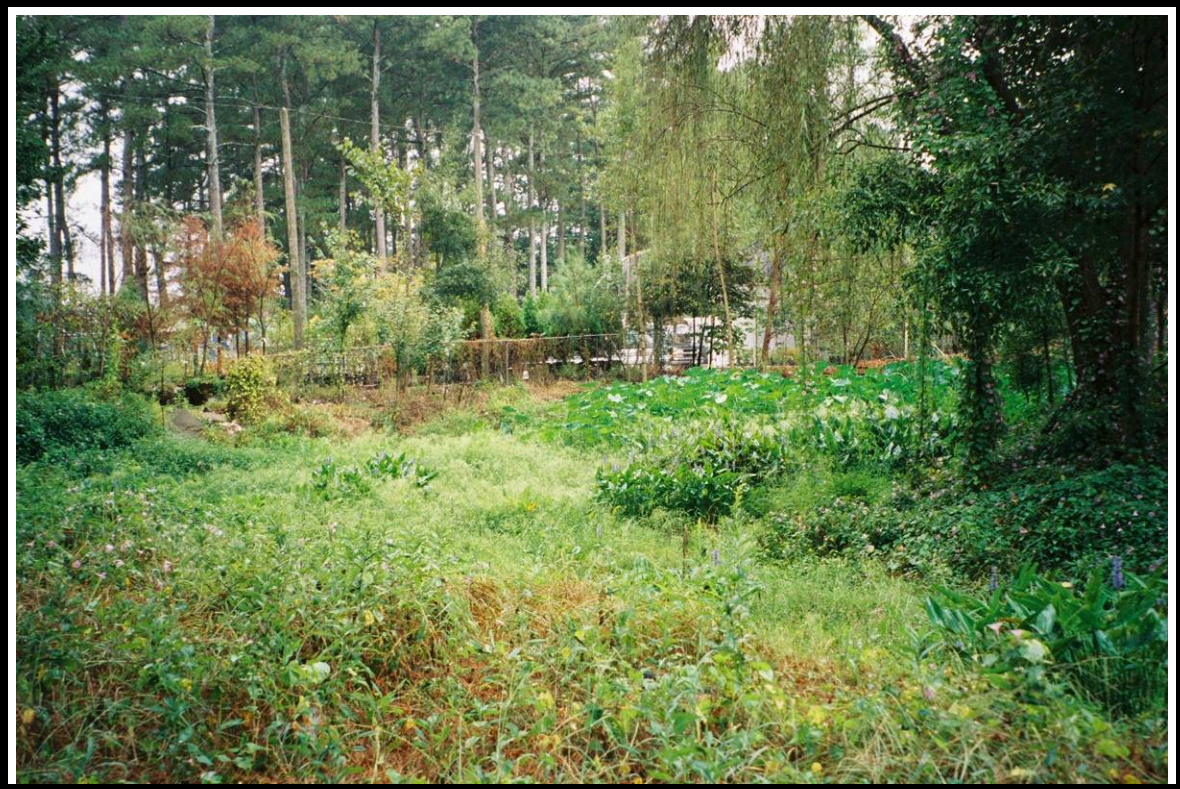
5. View of the detention area in the central portion of the subject property.

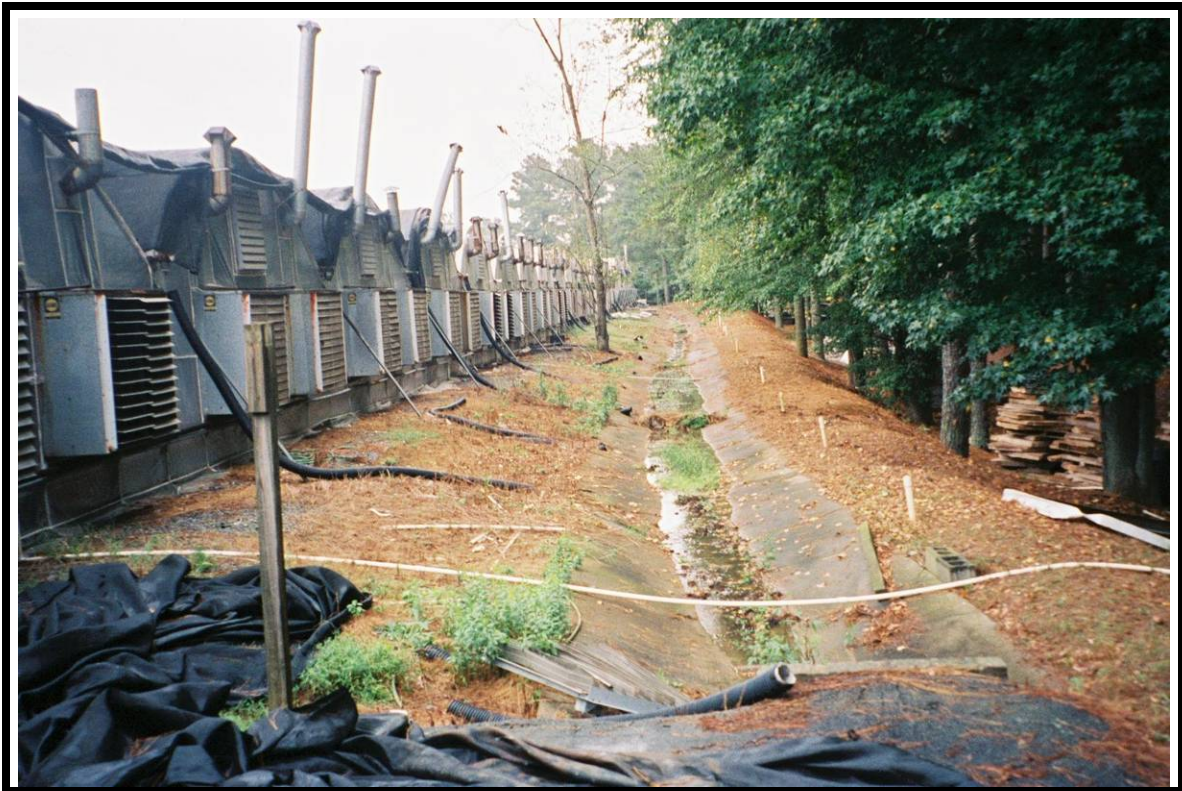
6. View of the concrete flumes for drainage located to the south of the sunscreen-covered areas.
