ASBESTOS ABATEMENT AND MOLD REMEDIATION CLOSEOUT

Bank of America Property Name	2700 Main St Site		
Property ID	NY7-127		
Site Address	2700 Main St, Newfane, NY 14108		
Client Name	CBRE		
Requestor	Kathy Frosolone		
Arcadis Project Number	HT126055.A041		
Primary Use	Banking Center		
Remediation Contractor Required?	<input checked="" type="checkbox"/> Yes	<input type="checkbox"/> No	
If Yes above, Who Hired Contractor?	<input checked="" type="checkbox"/> Arcadis	<input checked="" type="checkbox"/> IFM/PjM	<input type="checkbox"/> Other
Name of Remediation Contractor	Edgeco Environmental, Inc.		
Arcadis On-site Full Time During Remediation Work?	No - Periodic Visits and Final Clearance		
Project Start Date	Friday, April 28, 2017		
Project End Date	Sunday, April 30, 2017		
Asbestos or Mold was Removed?	<input checked="" type="checkbox"/> Asbestos	<input checked="" type="checkbox"/> Mold	
What Specific Materials were Removed?	Removal of approximately 135 linear feet of water damaged asbestos-containing pipe & fitting insulation, and approximately 440 square feet of asbestos-containing floor tile and associated mastic in the basement and first floor janitor's closet. Removal of approxim

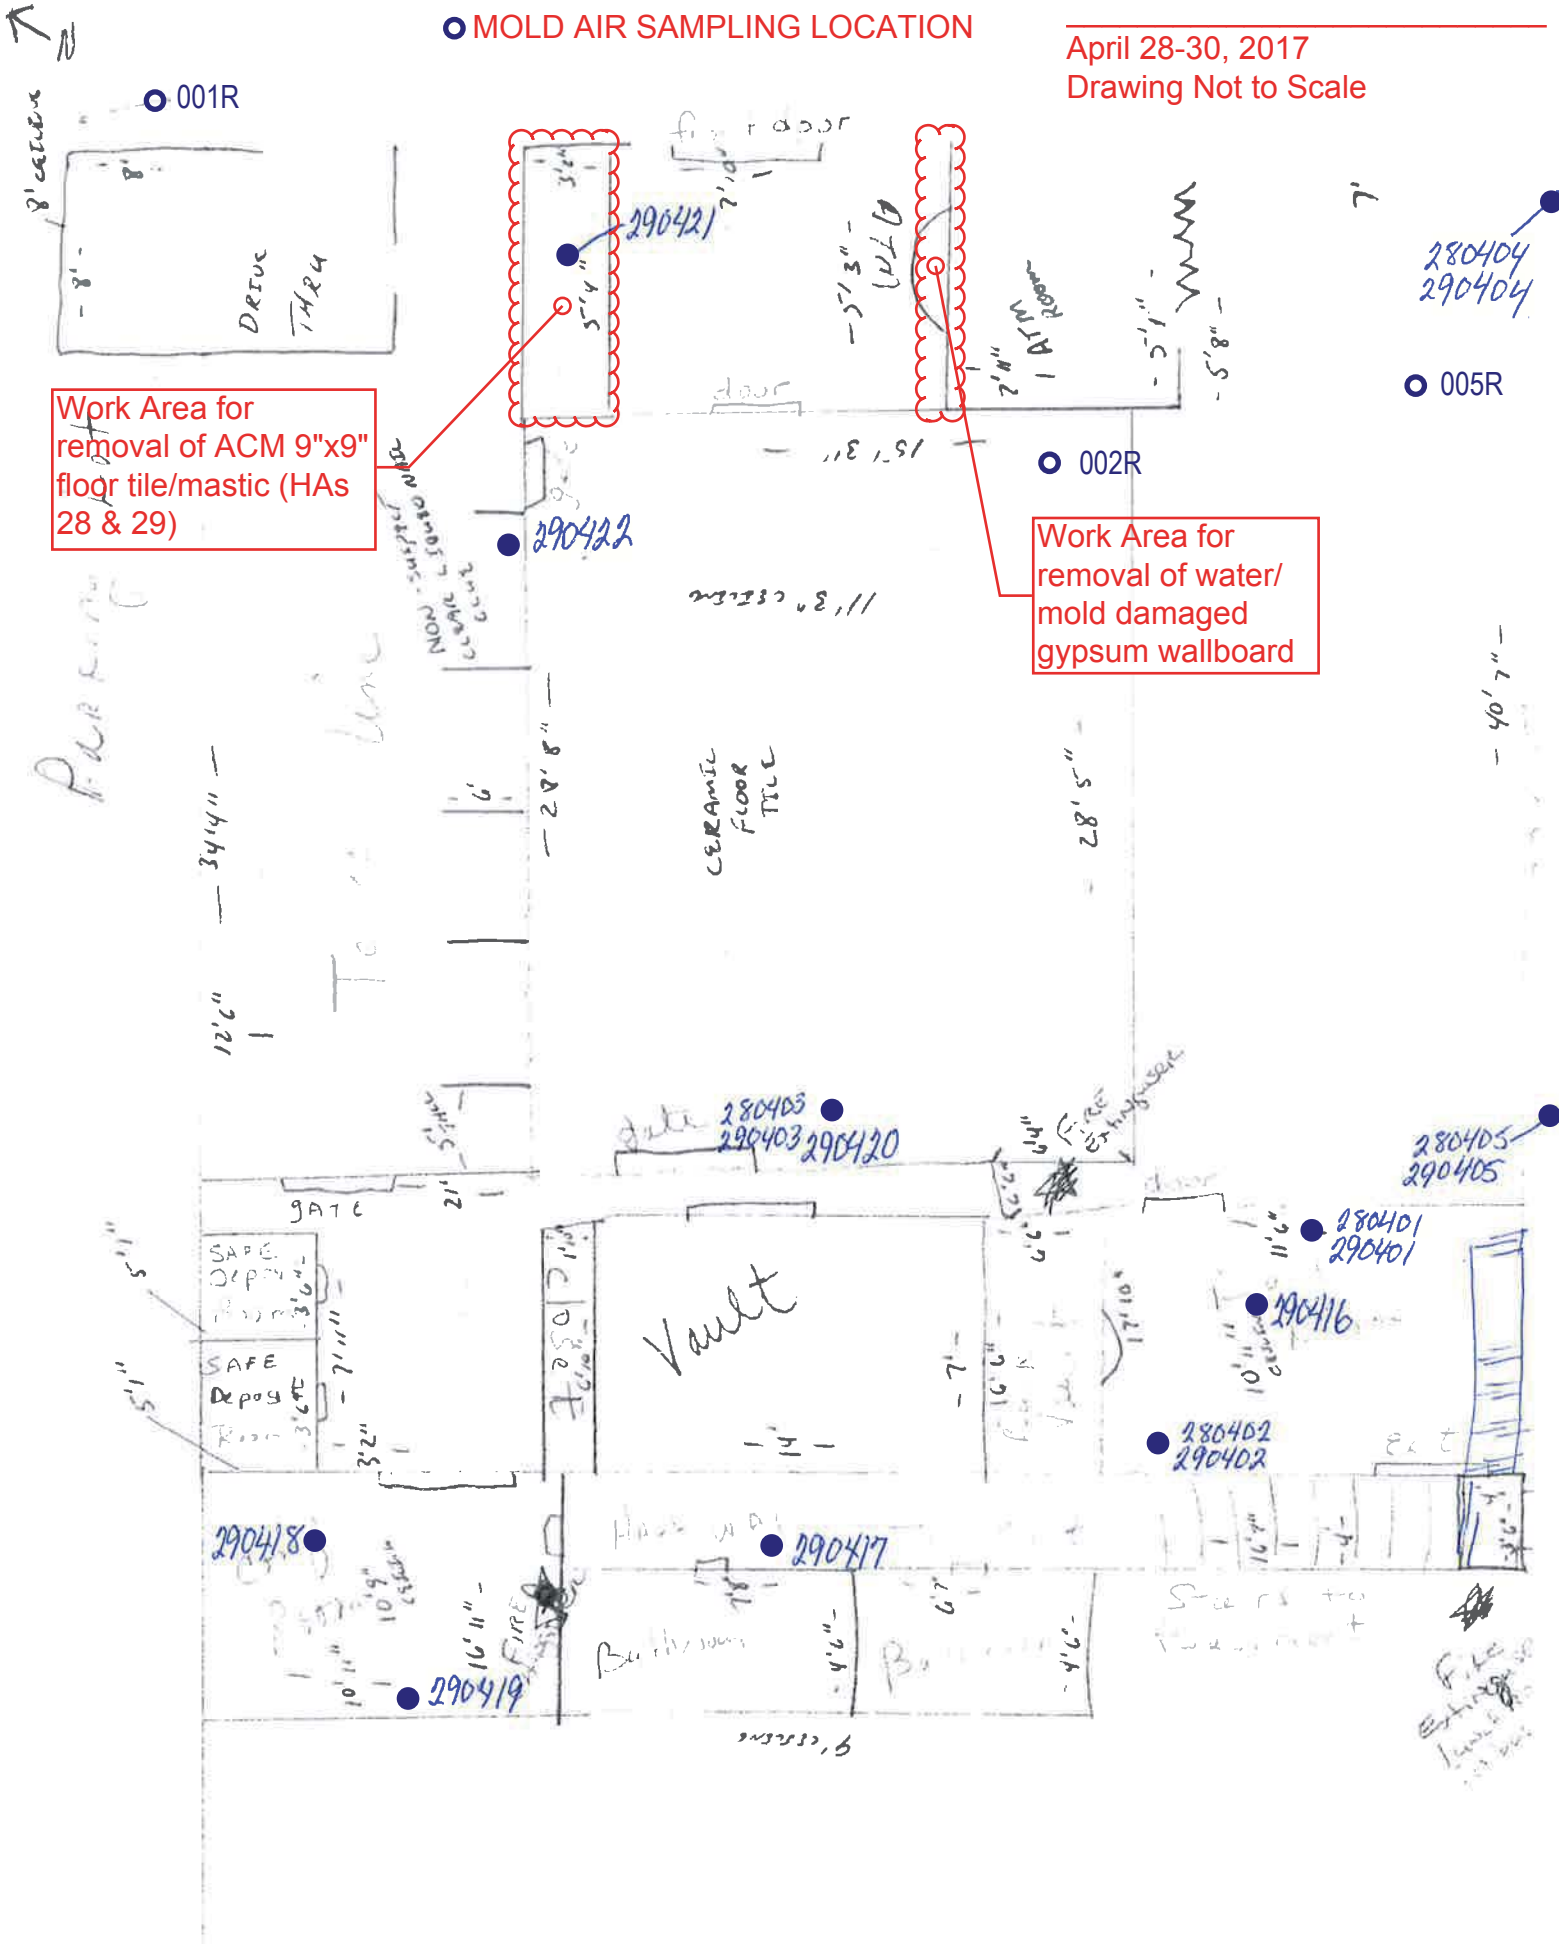
Work Area for removal of ACM 9"x9" floor tile/mastic (HAS 28 & 29)

Work Area for removal of water/mold damaged gypsum wallboard

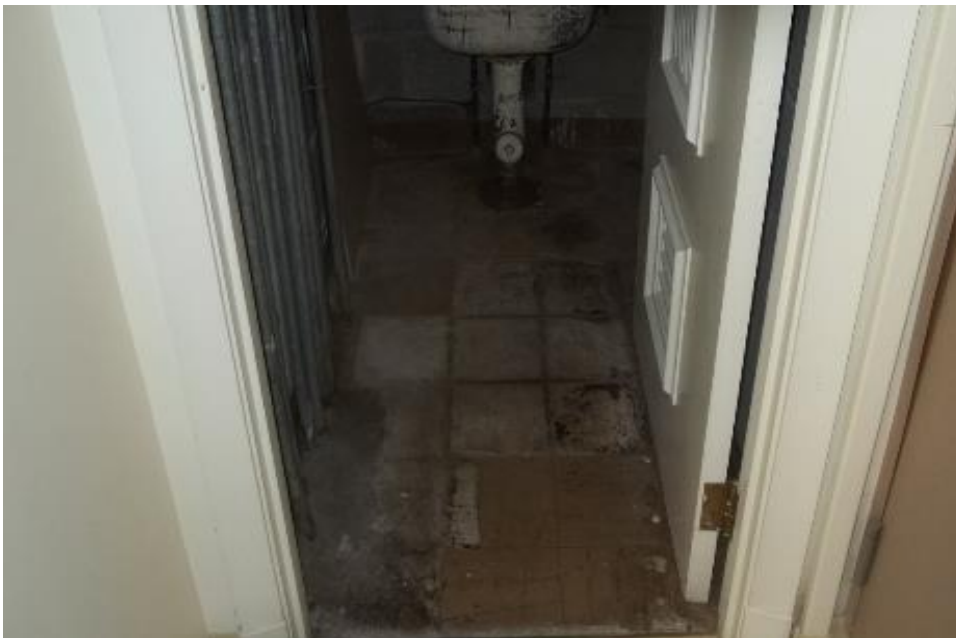
Photograph: 2

Description: Pre-remediation view of water damaged asbestos-containing floor tile and associated mastic in the 1st floor Janitor's Closet

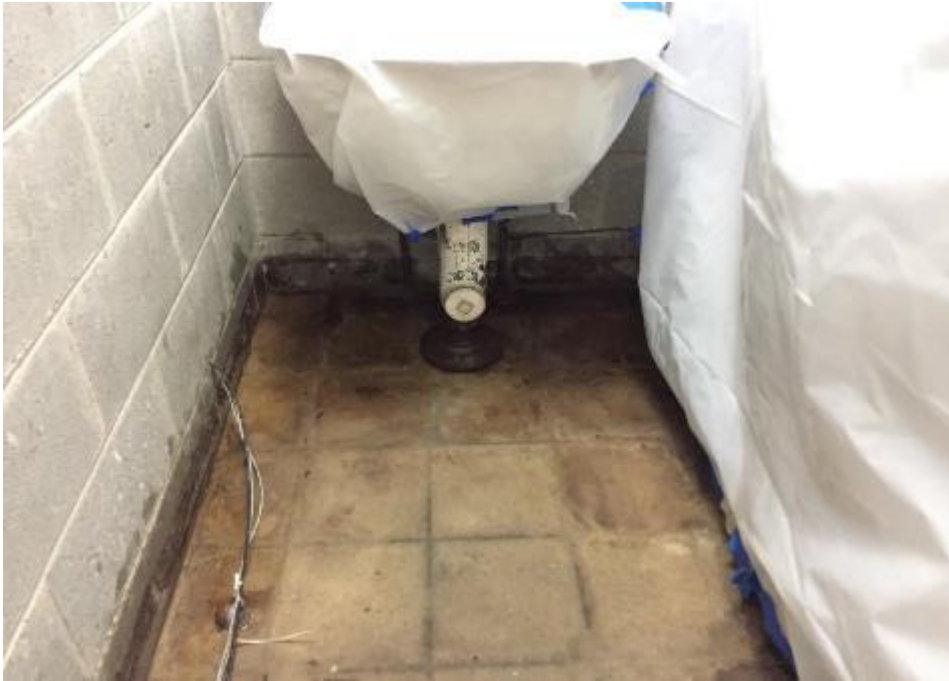
Photograph: 3

Description: Post-remediation view of 1st floor Janitor's Closet

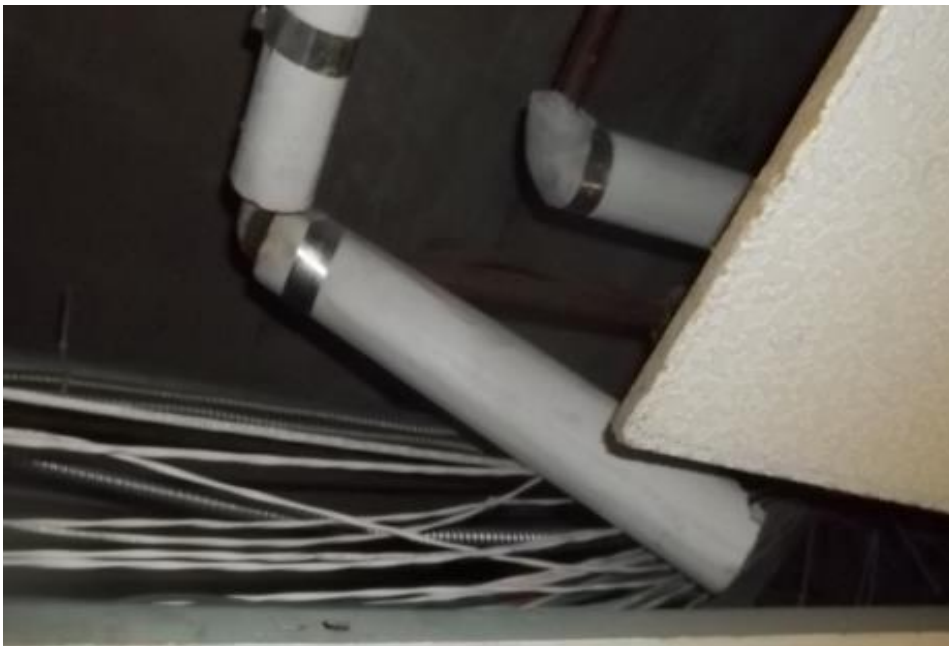
Photograph: 4

Description: Pre-remediation view of water damaged overhead asbestos-containing pipe & fitting insulation in basement

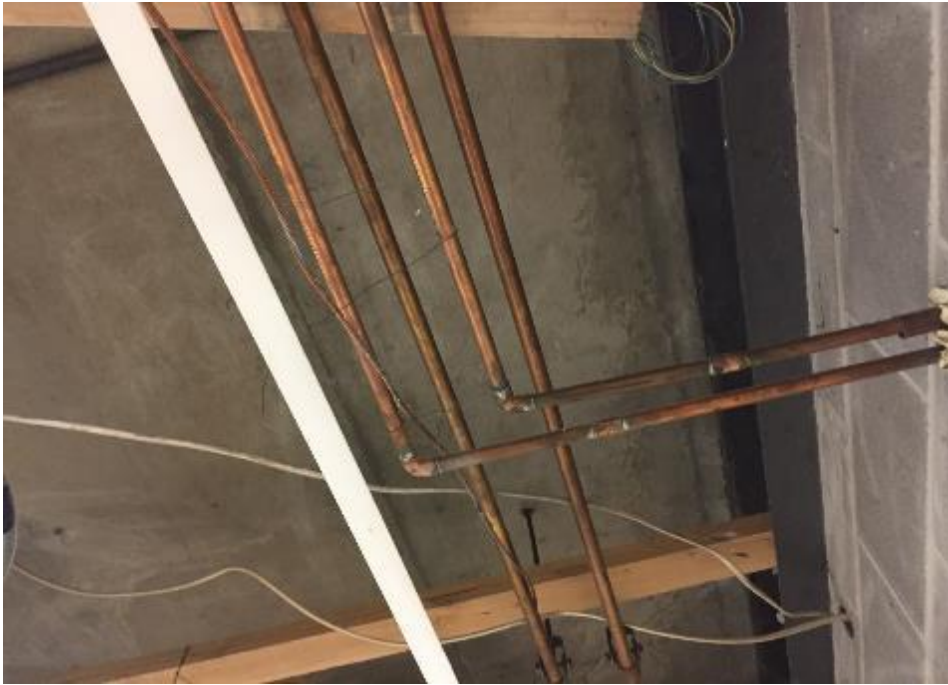
Photograph: 5

Description: Post-remediation view of overhead pipes in basement

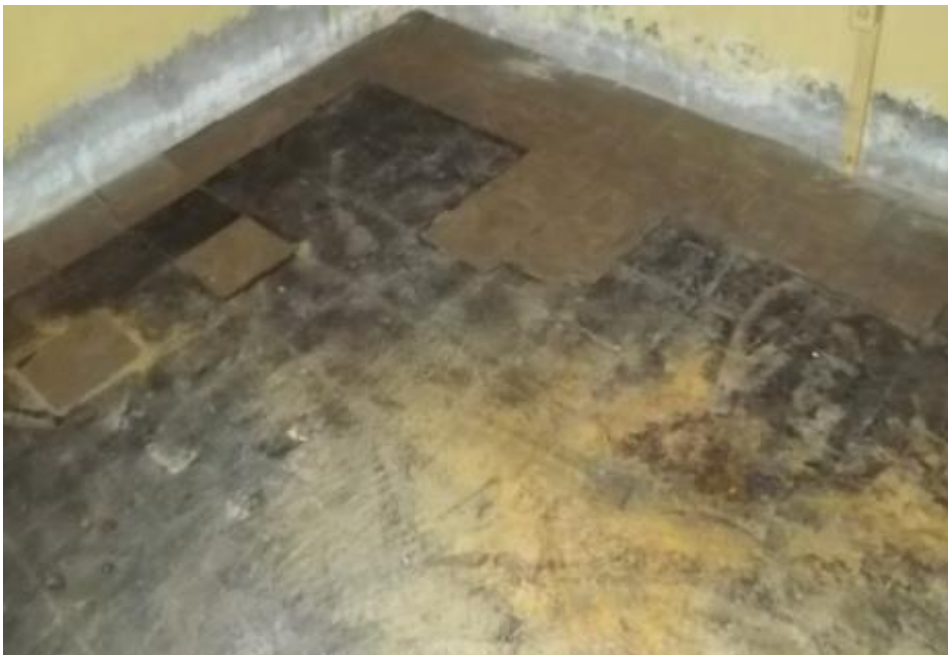
Photograph: 6

Description: Pre-remediation view of water damaged asbestos-containing floor tile and associated mastic in the basement Mechanical/Storage Room

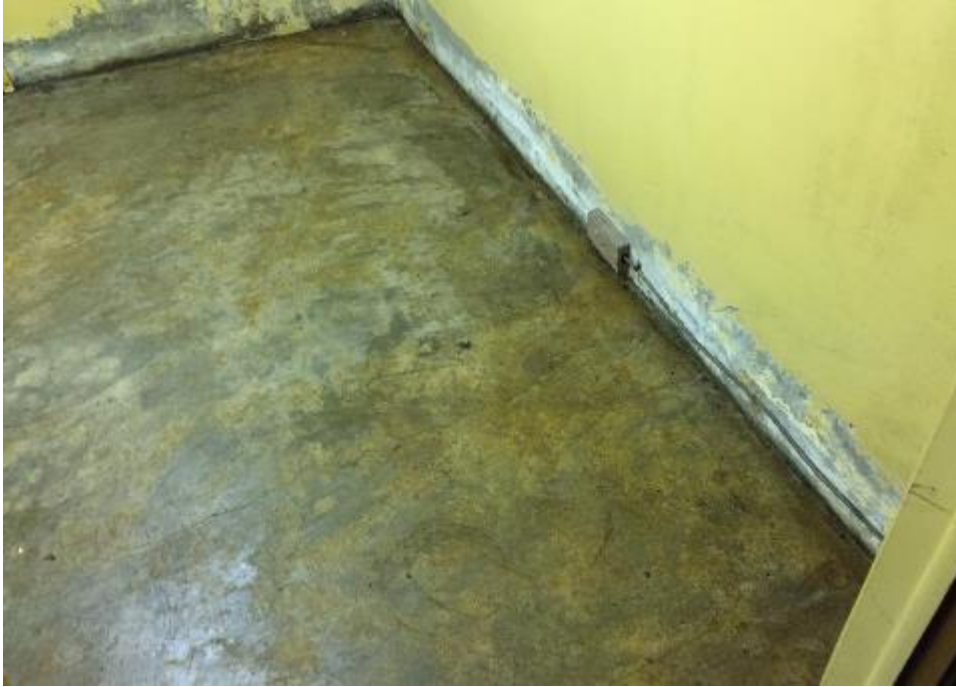
Photograph: 7

Description: Post-remediation view of basement Mechanical/Storage Room

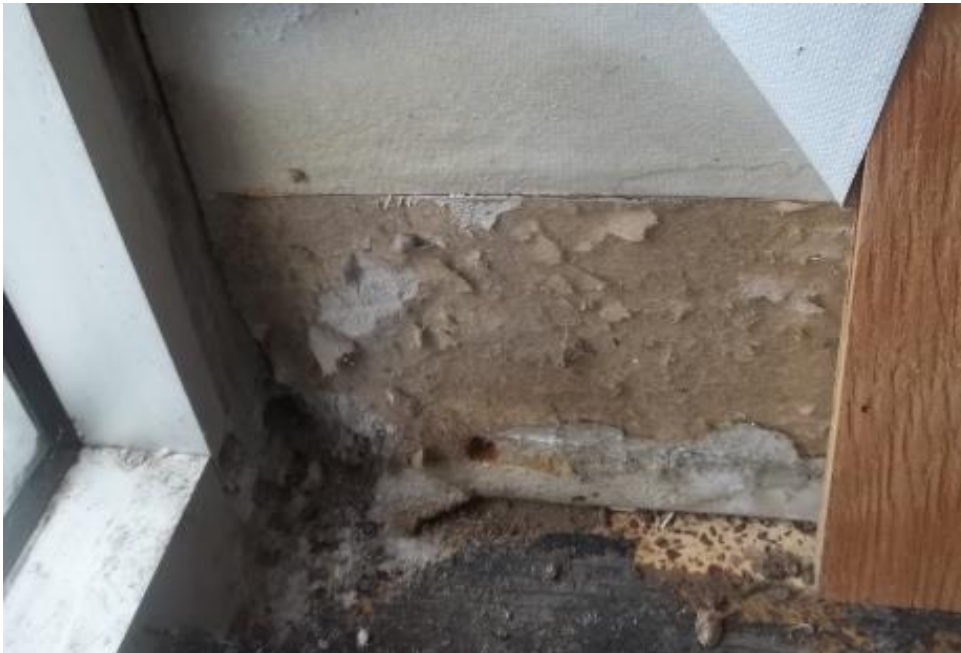
Photograph: 8

Description: Pre-remediation view of water/mold damaged gypsum wallboard in the Vestibule

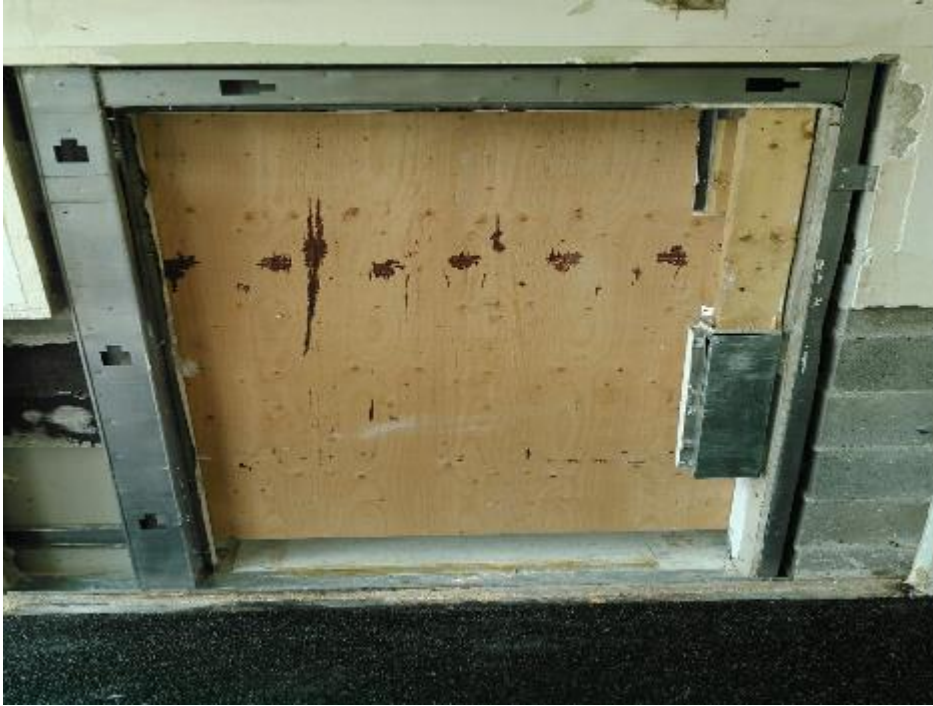
Photograph: 9

Description: Post-remediation view of Vestibule (water damaged gypsum wallboard removed)

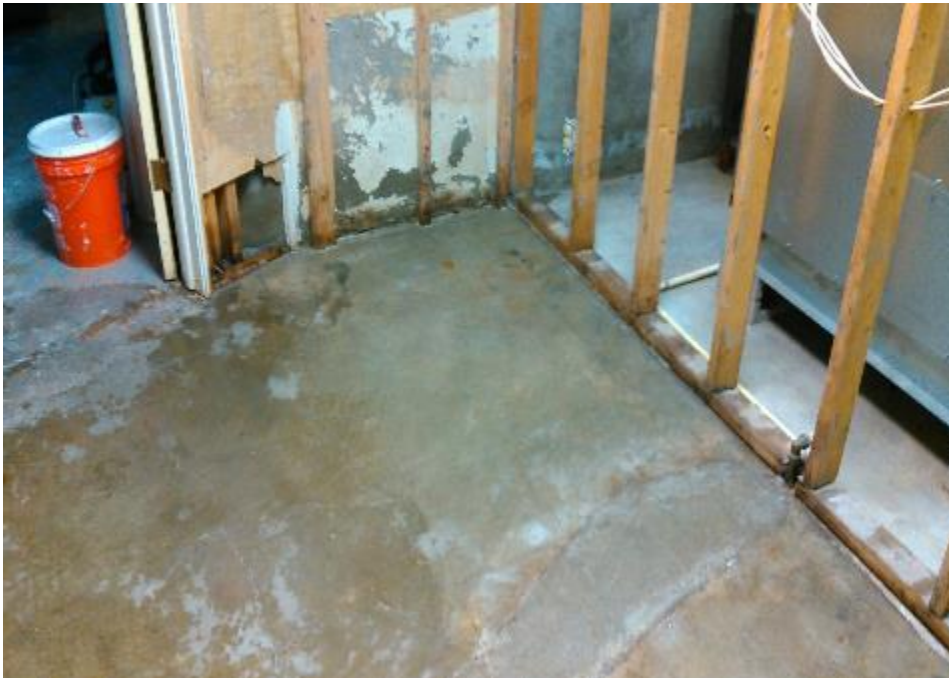
Photograph: 10

Description: Post-remediation view of basement Break Room (water damaged gypsum wallboard removed)
