Subject

Asbestos-Containing Material Abatement Oversight Bank of America – 2700 Main St Site 2700 Main St Newfane, New York 14108

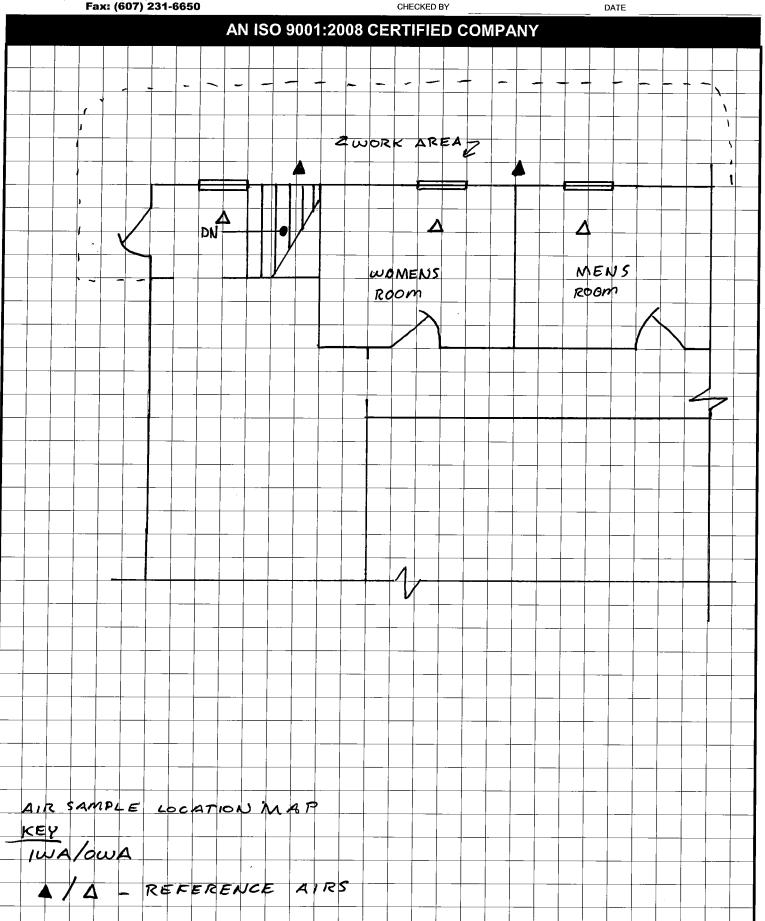
Site Diagram

The asbestos abatement was performed to remove asbestos-containing building materials (ACBMs) that may be impacted during scheduled renovation activities. The scope of work involved the removal of approximately 217 linear feet (LF) of asbestos-containing exterior window glazing (HAs #38, 41,42,43) and 63 LF of window caulking (HA #44). ARCADIS developed a scope of work based upon information gathered during the initial site evaluation. A site diagram denoting removal areas is included as Attachment B.
