Subject:

Path of Construction Asbestos Survey Bank of America - 2700 Main St Site 2700 Main Street Newfane, New York Mail Code: MY7-127

ARCADIS U.S., Inc. (ARCADIS) conducted a Path of Construction (POC) asbestos survey of certain Homogeneous Applications (HAs) that may be impacted during the planned construction project at the above-referenced building for the Bank of America. ARCADIS' scope of work and the findings of POC survey are summarized herein.

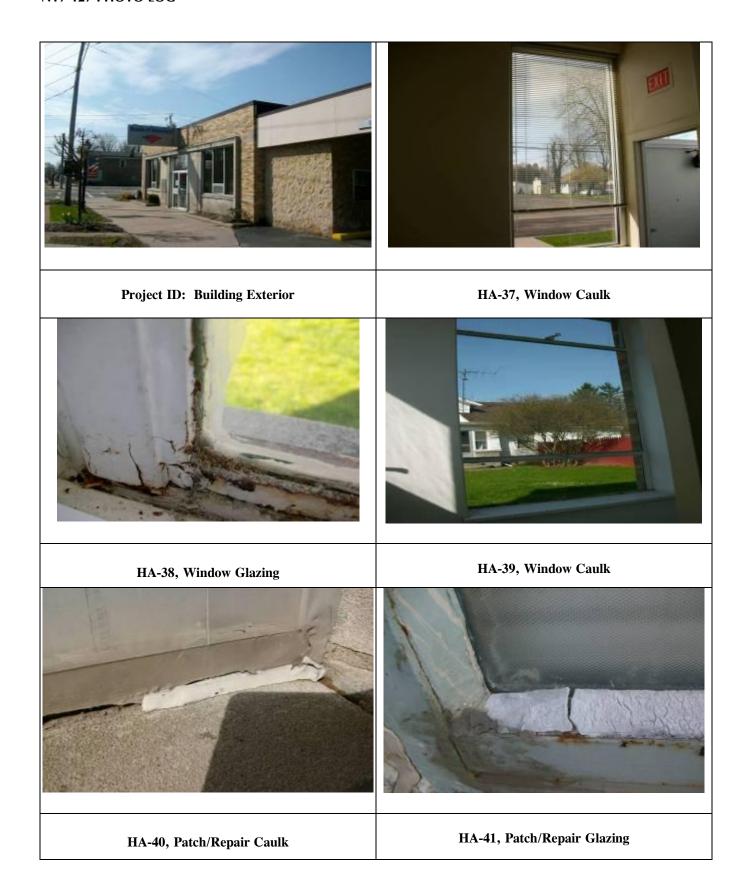
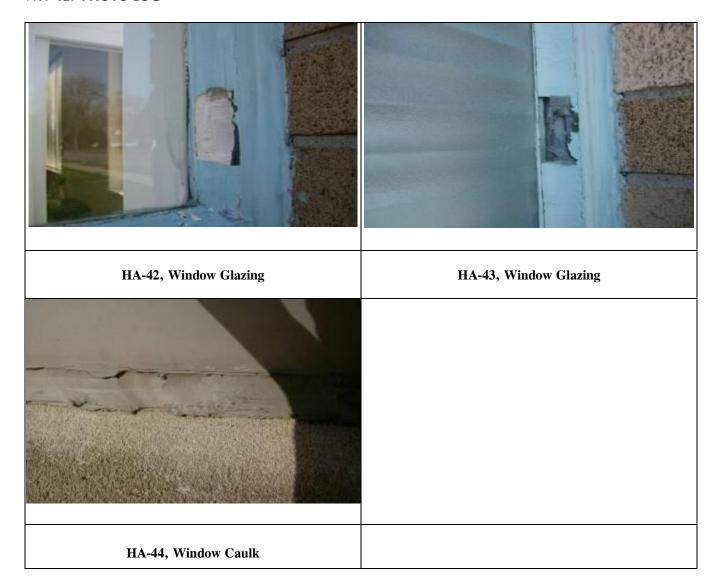
BANK OF AMERICA NY7-127 PHOTO LOG

- HA-38, Window Glazing, located in the stairwell and Men's & Women's Rooms;
- HA-41, Patch/Repair Glazing, West Elevation. Women's Room;
- HA-42, Window Glazing, West Elevation Men's & Women's Rooms;
- HA-43, Window Glazing, West Elevation Stairwell; and
- HA-44, Window Caulk, West Elevation Men's & Women's Rooms, Stairwell.

As the above listed ACBMs will be disturbed during construction activities, compliance with the asbestos regulations (notification, control measures and/or abatement) is required. Contact the Property Manager or ARCADIS if you have questions or need assistance concerning this report or in reading the HAT.

ARCADIS recommends that the ACBMs be managed in accordance with an Operations & Maintenance (O & M) Program with abatement only being required when materials will be disturbed (i.e., renovation and some maintenance activities). ACBMs that are "Damaged" or "Significantly Damaged" present a greater risk of releasing asbestos fibers. Therefore, these materials should be evaluated to determine if they require repair or abatement. If the materials are repaired or abated, the HAT should be updated to reflect this modification to the materials. Contact the building's Property Manager to determine what actions are necessary with respect to "Damaged" or "Significantly Damaged" materials, if present.
