PHASE I ENVIRONMENTAL SITE ASSESSMENT

PAMIDA -3106

314 Sturgis Road
Marion, Kentucky 42064

EMG Project #: 76377.06R-126.111
Date of Conversion: April 27, 2006
Original Project #: 70599.05R-131.050
Date of Report: June 13, 2005
On site Date: May 24, 2005

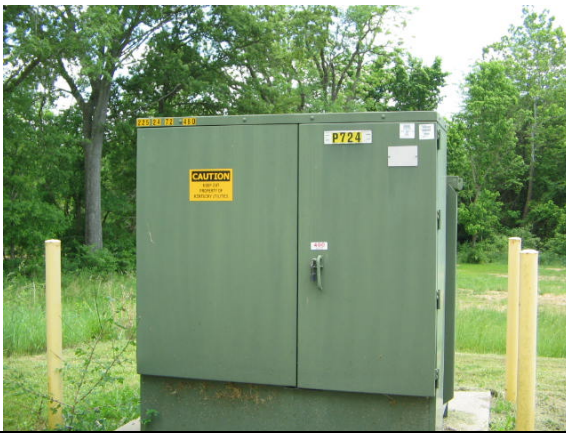
Polychlorinated Biphenyls (PCBs)	<p>The Project is supplied with secondary electrical service from a utility-owned pad-mounted transformer. The transformer was labeled "non-PCB." No environmental concerns noted.</p> <p>The Project also uses secondary electrical service from one privately owned "dry type" step-down transformer. Dry type transformers do not use oils for cooling purposes; therefore, this transformer is not expected to contain PCBs.</p> <p>A hydraulic cardboard bailer is located at the Project. PCB-containing hydraulic fluid has not been manufactured since 1977. Therefore, based on the date of installation (2000), PCB-containing hydraulic fluid is not likely to be found in the operating system. No environmental concerns noted.</p>
Asbestos-Containing Materials (ACM)	<p>Based on the date of construction and the Scope of Work, no suspect ACM were identified at the Project.</p>

Photo #7: Transformer

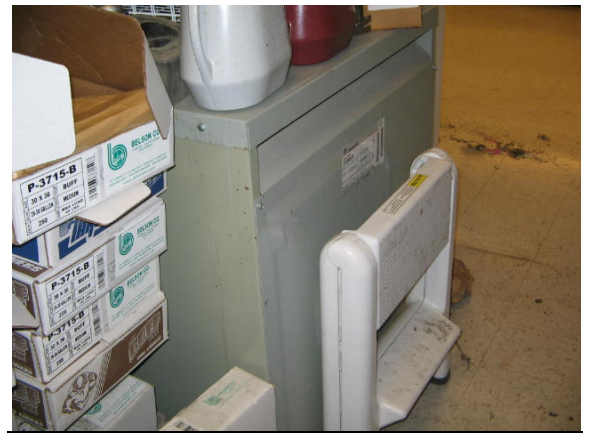
Photo #8: Dry type transformer

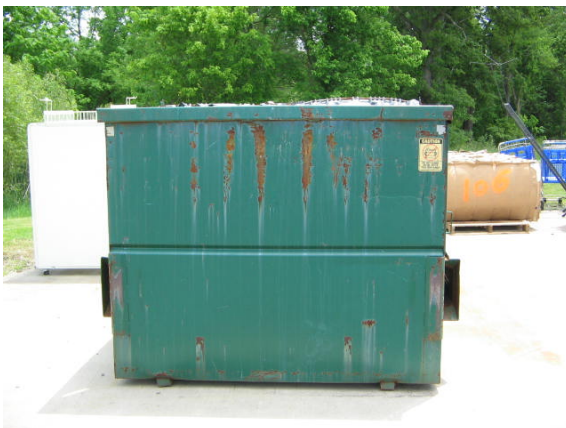
Photo #9: Typical dumpster

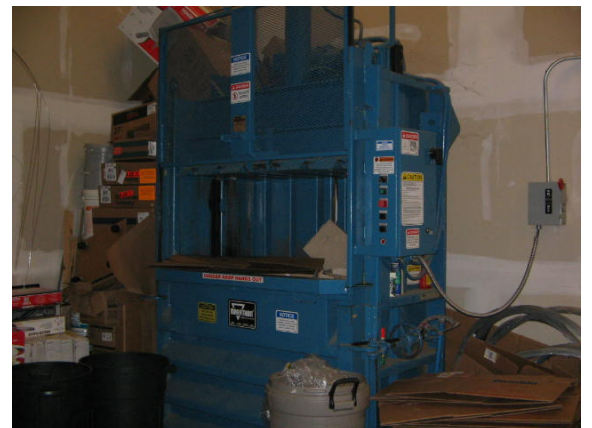
Photo #10: Hydraulic cardboard bailer

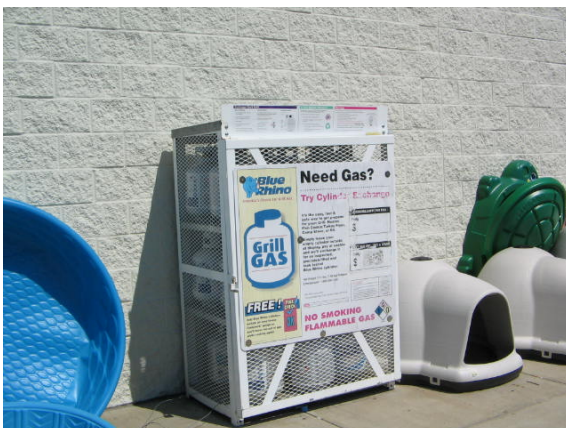
Photo #11: Propane for retail sale

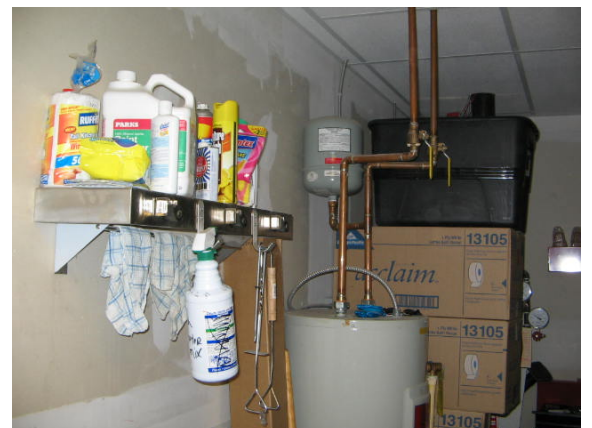
Photo #12: Janitor's supplies and water heater
