PROPERTY CONDITION ASSESSMENT REPORT FOR MORTGAGE FINANCING PURPOSES

PAMIDA - 3215

657 West Main Connector
Hodgenville, Larue County, Kentucky 42748

EMG Project #: 76377.06R-129.054
Date of Reissue: 5/17/2006
Original Project #: 70599.05R-134.042
Date of Original Report: 6/9/2005
On Site Date: 5/20/2005

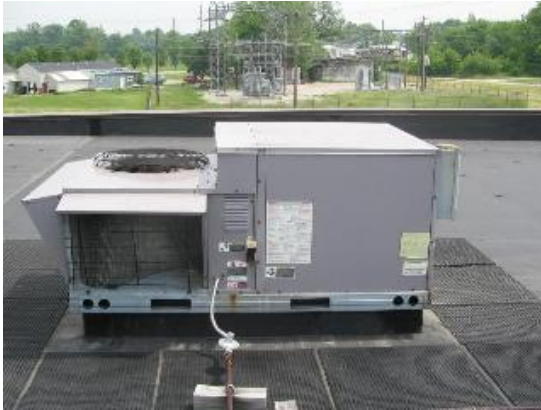
Photo #13: Rooftop unit. Section 7.1

Item	Description
Repair	Replace roof top units - 3 tons
Expected Useful Life (EUL) in years	15
Effective Age (years)	7
Percentage Replacement	100%

Item	Description
Replacement Cost per Unit	\$6,500.00
Quantity (EA)	13
Total Replacement Cost	\$84,500.00
Cost in Year 8	\$21,125.00
Cost in Year 9	\$21,125.00
Cost in Year 10	\$21,125.00
Cost in Year 11	\$21,125.00

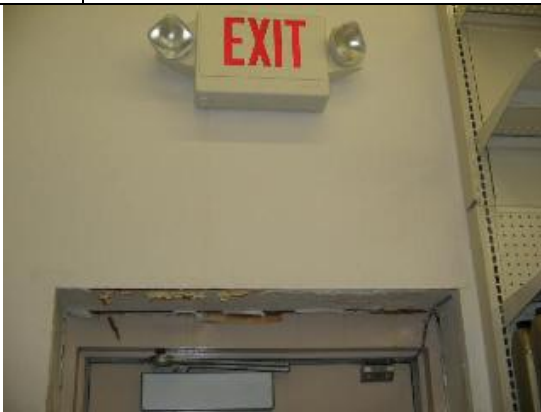
Item	Description
Physical Deficiency	drywall at exterior doors showing signs of water intrusion
Repair	Routine Maintenance - Recaulk and repair drywall

Photo #17: Emergency light and exit sign above drywall damaged door. Section 7.6

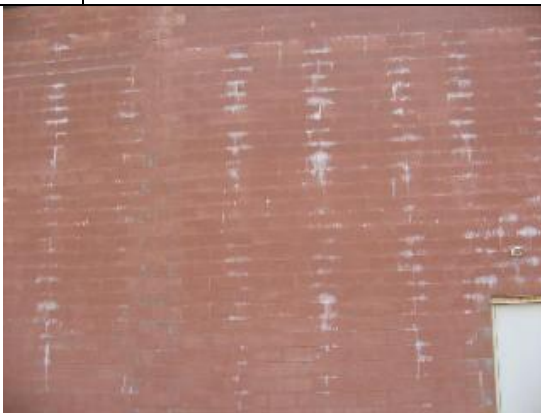
Item	Description
Physical Deficiency	CMU walls on both sides showing efflorescence. This should be repaired as part of the Routine maintenance program.
Repair	Paint exterior walls

Photo #27: CMU wall efflorescence. Section 6.4

Item	Description
Expected Useful Life (EUL) in years	10
Effective Age (years)	6
Percentage Replacement	100%
Replacement Cost per Unit	\$0.45
Quantity (SF)	34,995
Total Replacement Cost	\$15,747.75
Cost in Year 4	\$15,747.75
Responsibility	Tenant

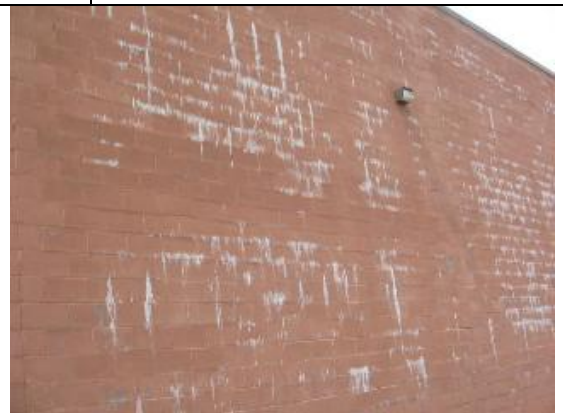
Photo #28: CMU wall efflorescence. Section 6.4

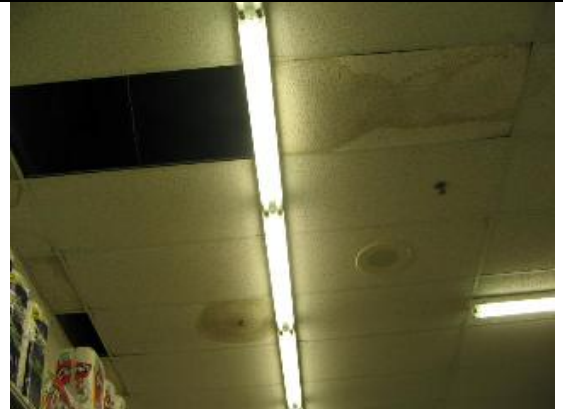
Item	Description
Physical Deficiency	Ceiling tiles damaged from previously repaired HVAC condensate leakage.
Repair	Routine Maintenance - Replace all damaged ceiling tiles.

Photo #30: Damaged ceiling tiles. Section 8.1
