5021 Martins Point Rd
Kitty Hawk NC 27949

6/13/2018

Burke Inspection Service dba HouseMaster - VA #3380001054
109-G Gainsboro Sq. - #165
Chesapeake, VA 23320
(757) 549-3433

Table of Contents

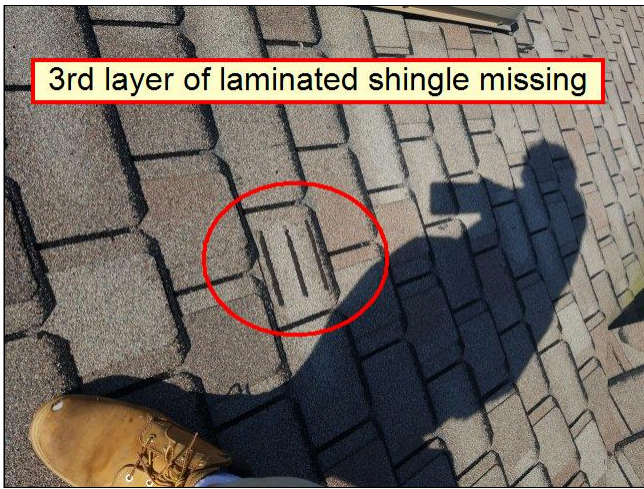
1.0 ROOFING Photo 1

●					<p>1.0 ROOFING The roof cover appears to be in generally good condition, but some minor damage was observed. Monitor conditions and maintain as needed. Shingles of this type often have a limited lifetime warranty. Buyer should inquire with Seller and/or manufacturer regarding transferability if applicable. (usually "single lifetime" which applies only to purchaser of product, but some are transferable)</p>
				●	<p>1.1 ROOFING #2 The covering below the rooftop deck / balcony was not evaluated, as only the edge is exposed. Monitor conditions on ceiling below closely and anticipate future repair or replacement needs.</p>
				●	<p>1.2 CHIMNEY / VENT #1 There is a faux chimney chase above the gas fireplace which is not functional.</p>
			●		<p>1.3 EXPOSED FLASHING (1) The ceiling of the Sunroom / Breakfast Rm has been damaged by leakage, which may have occurred at the flashing where the roof meets the siding above, but is more likely from the MBR windows. Have checked by a licensed Contractor and corrected as needed. (2) Exposed nails noted on flashing(s), recommend sealing and maintaining as needed with appropriate caulk.</p>

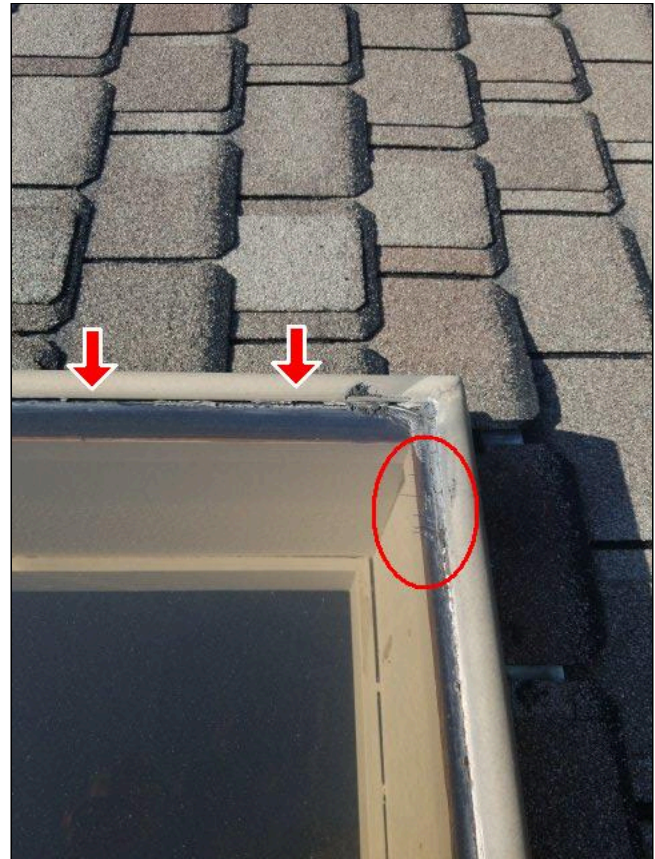
1.4 SKYLIGHT(S) Photo 4

●		<p>1.4 SKYLIGHT(S) The skylights are aging / beyond their expected service life. Caulking was found around the edges of the plastic domes, indicating a history of prior leaks. That caulking is now deteriorated, and hairline cracks were noted in the domes. Recommend having checked and repaired or replaced as needed by a licensed Roofing Contractor.</p>
●					<p>1.5 VENTILATION COVERS</p>
				●	<p>1.6 PLUMBING STACKS The rubber collars are deteriorating, particularly the one above the MBA, have checked and replaced or covered with "replacement collars" as needed by a licensed Roofing Contractor.</p>
				●	<p>1.7 RAIN GUTTERS No gutters present on structure, recommend adding to ensure proper site drainage and eliminate moisture penetration concerns.</p>
				●	<p>1.8 DOWNSPOUTS / ROOF DRAINS</p>
				●	<p>1.9 FASCIA / SOFFITS Decay was noted where the fascia boards and roofing intersect above BR#3 and the Family Rm, have checked and corrected as needed.</p>
