INSPECTION REPORT  
210 81st St  
Virginia Beach VA 23451

INSPECTED BY  
John Burke  
Beacon  
Inspections -  
OBX, LLC

INSPECTION DATE  
📅 9/28/2023  
🕒 09:00 AM

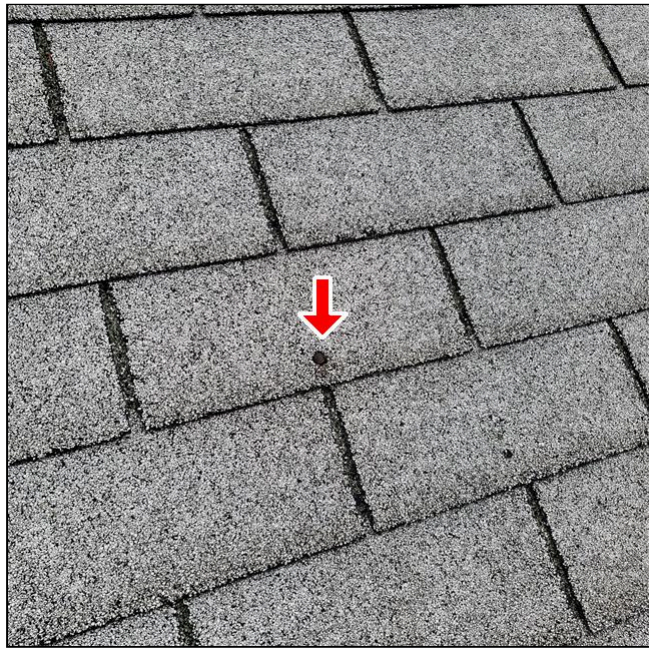
1.0 Item 1 (Picture)

**1.0 (1)** A nail pop was observed at the center of the main rear roof plane on the Guest House, presenting an active leakage concern, seal and maintain as needed.

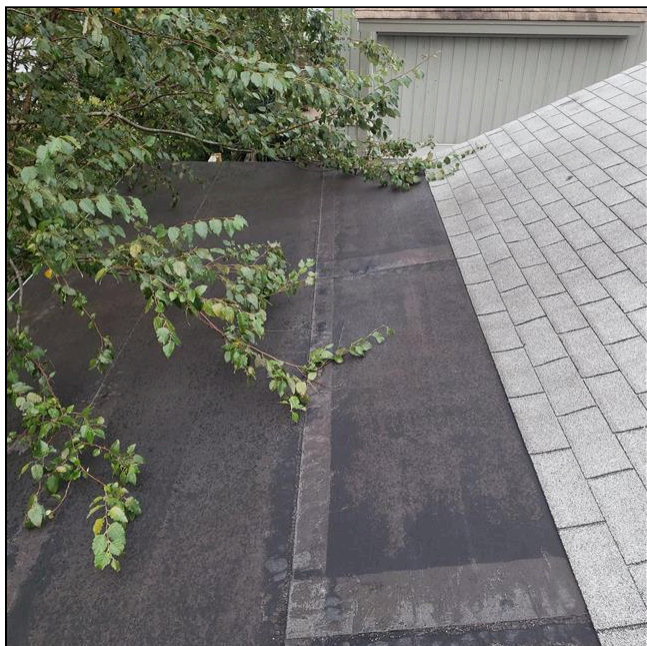
1.0 Item 4 (Picture)

**1.0 (2)** The roof covers on the Guest House / Apartments appear to be approaching the end of their service lives. Lifting was observed at the edge of the flat roofing membrane on the northern portion above the stairs. Buyer should have evaluated further and obtain estimates for future replacement.

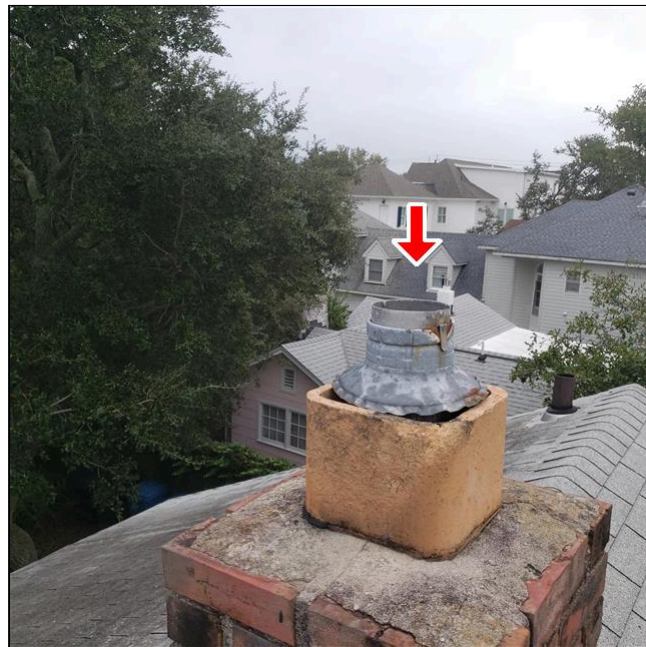
1.1 Item 6 (Picture)

**1.1 (2)** The cap is missing from the (type-b) appliance vent that was installed in the chimney of the Guest House. (which is in use for the 1st FI gas furnace) This will allow rain water to enter and could cause damage at the elbow where it extends into the Utility Rm, and/or allow water to enter the furnace. Have checked and corrected as needed by a licensed Mechanical Contractor.

The crown of that chimney is worn as well and should be sealed or replaced to protect the brick structure.

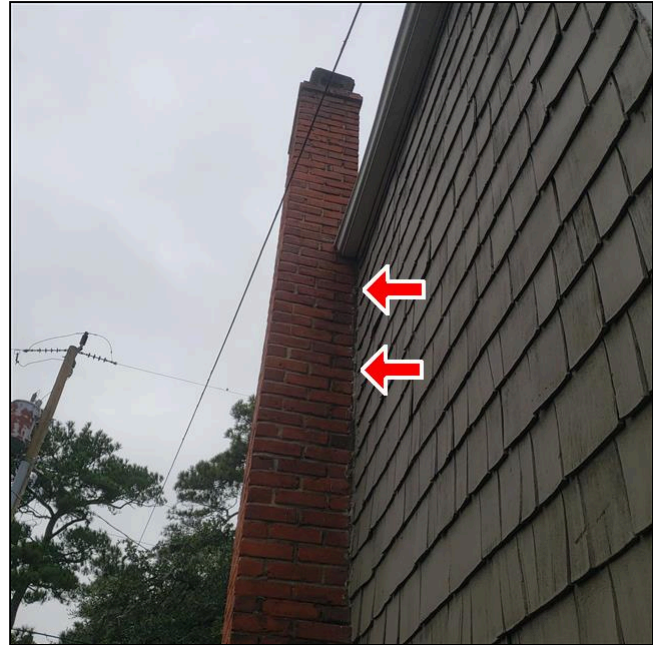
1.1 Item 8 (Picture)

**1.1** (3) The chimney for the 1st Fl Family Rm fireplace of the Main House has settled and pulled away from the house slightly. Conditions should be closely monitored and the gap re-sealed periodically or as needed to prevent water intrusion.

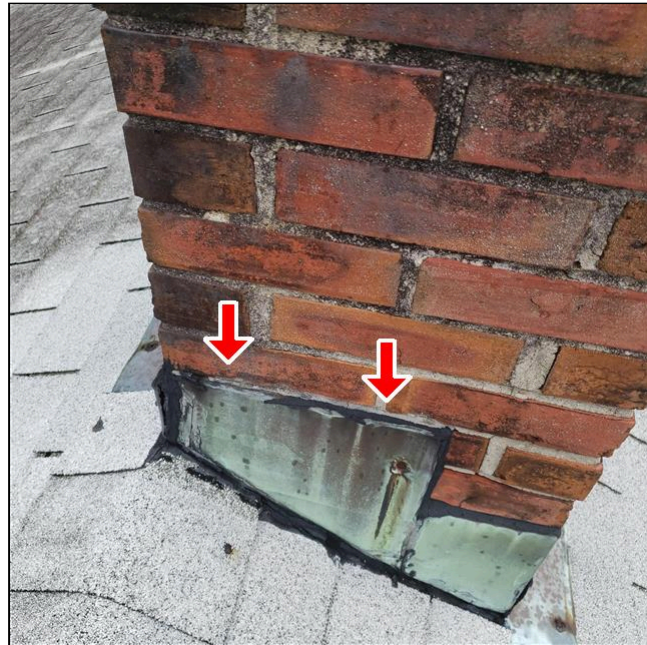
1.2 Item 1 (Picture)

**1.2** Deteriorated caulking was observed on the counter flashing at the Guest House appliance chimney, re-seal and maintain all flashing and counter flashing as needed to reduce the potential for leakage.

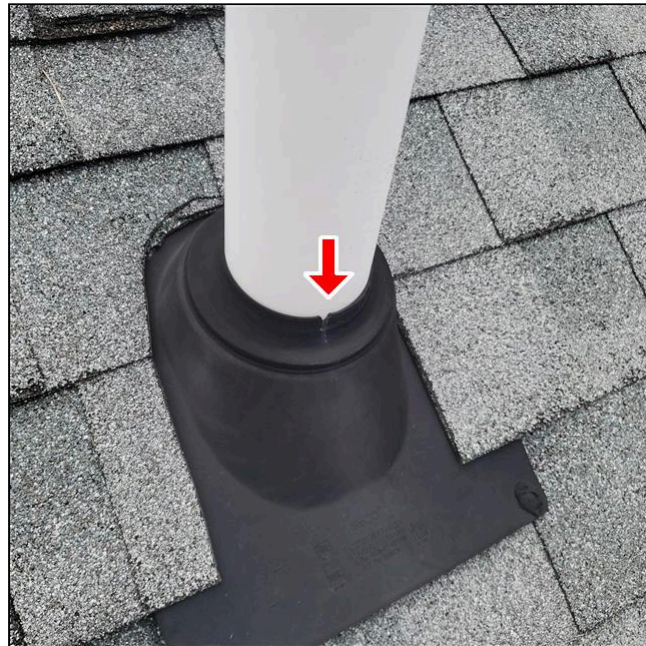
1.5 Item 1 (Picture)

**1.5** Rubber collars are aging/ beginning to crack and will require periodic maintenance. Check periodically and replace or seal with caulk as needed. Consider having "replacement collars" installed over the existing ones as a precaution.

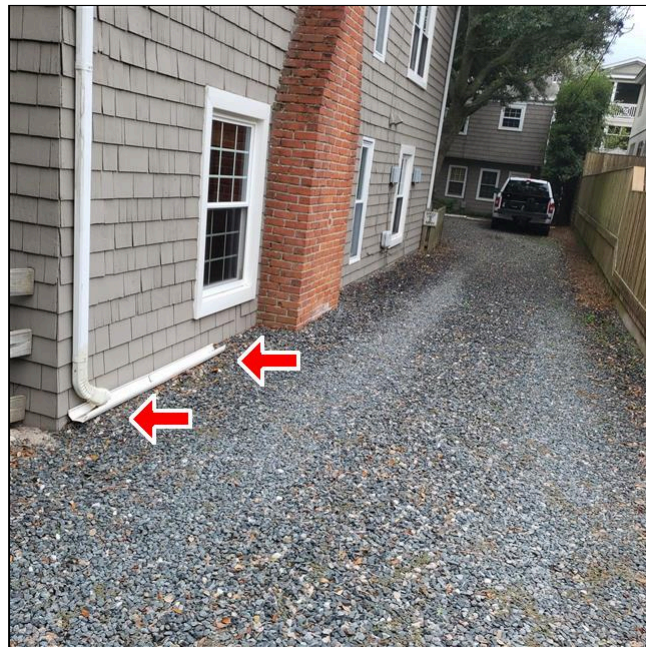
1.6 Item 4 (Picture)

**1.6 (2)** Some of the downspouts are discharging at the foundation, presenting the potential for water intrusion and settlement; install extensions and/or properly positioned splash blocks as needed to divert water away from structure.

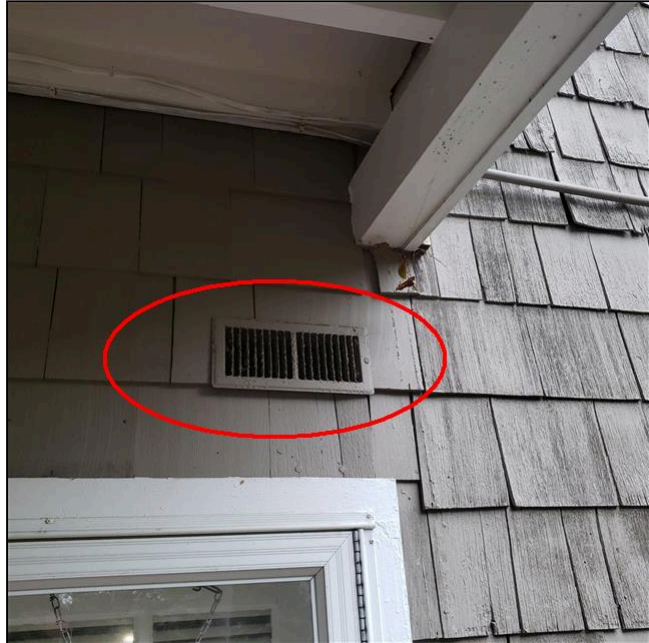
2.1 Item 1 (Picture)

**2.1 (1)** An HVAC register was improperly used as a air intake vent for the furnace / Utility Rm of the 1st Fl apartment in the Guest House. This vent no longer appears to be in use. Remove or cover as needed to reduce the potential for water intrusion and/or air infiltration.

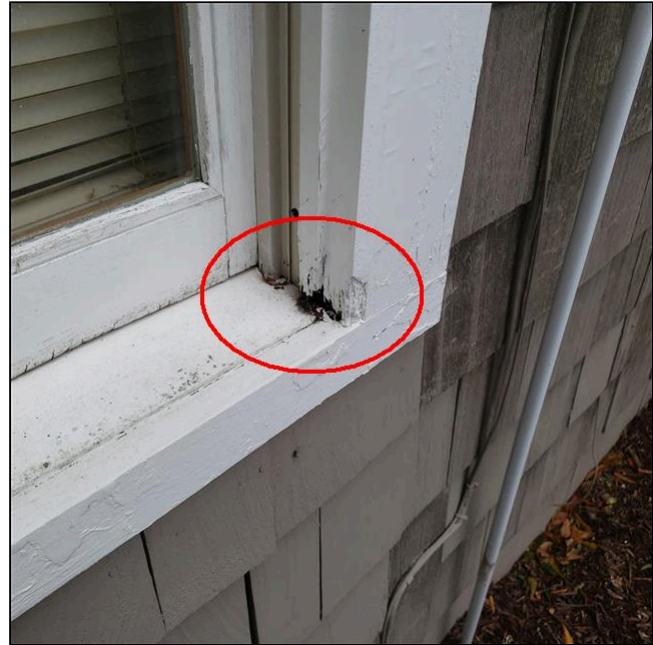
2.2 Item 4 (Picture)

**2.2 (2)** Significant decay was observed in a window sash and in the sills of the windows on the east side of the Guest House, correct as required to reduce the potential for water intrusion and additional damage, decay, and/or mold concerns.

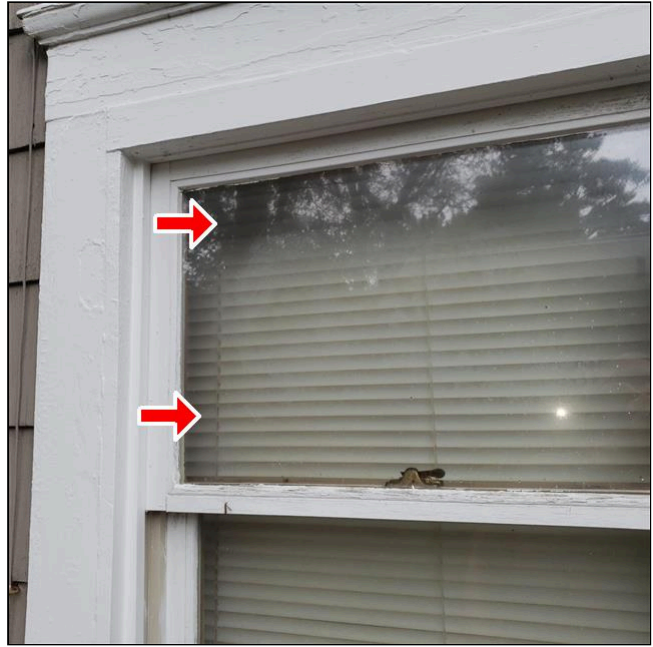
2.2 Item 8 (Picture)

**2.2 (3)** The seals for the insulated glass have failed at several of the windows, such as at the Main House Sunroom, and both of its Hall Baths; and at the 1st Fl windows on the east side of the Guest House. While not readily apparent at the time of inspection, other insulated-glass units may have also failed. Recommend a check of all units to determine extent of repair/replacement work required. Replacement of insulated glass windows or doors is usually required to correct failed or defective vacuum seals. Fortunately, the insulation value is usually not significantly reduced. Replacement time frame may be discretionary; however, conditions will gradually worsen with time.

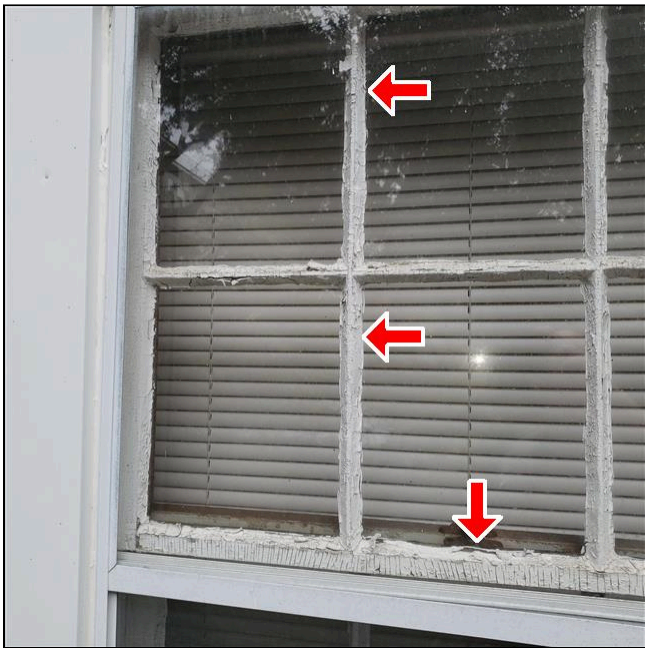
2.2 Item 9 (Picture)

**2.2 (4)** Deteriorated glazing was observed at several of the original windows of the Guest House, correct and maintain or upgrade as needed to reduce the potential for leakage and air infiltration.

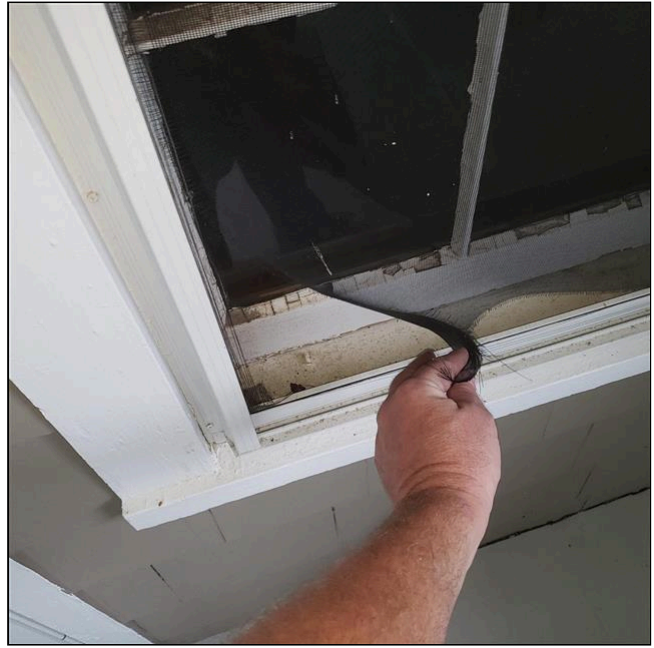
2.2 Item 12 (Picture)

2.2 (5) Missing and damaged screens noted, repair or replace as desired.

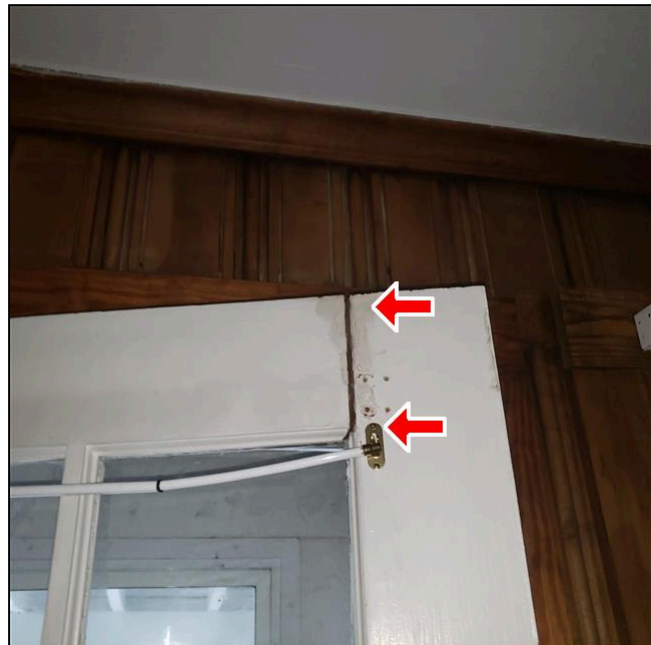
2.3 Item 1 (Picture)

2.3 (1) The door to the 2nd Fl apartment of the Guest House is separating at a joint at the top, repair or replace as needed.

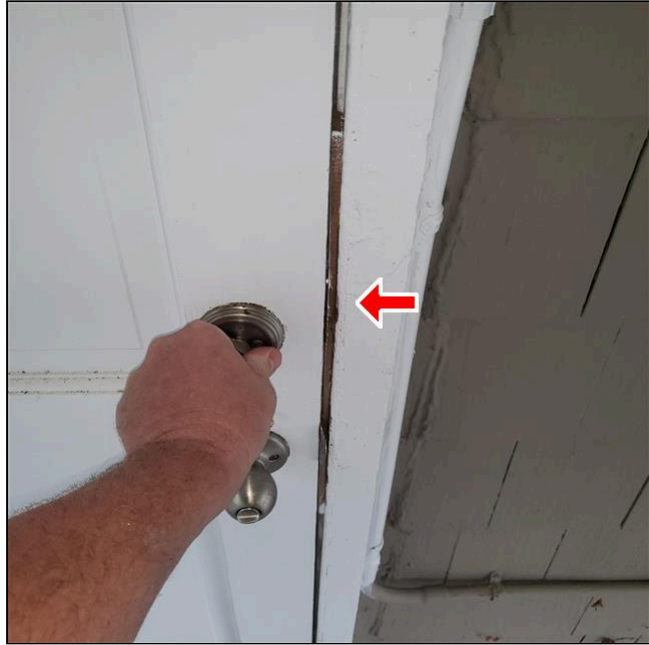
2.3 Item 2 (Picture)

2.3 (2) The deadbolt at the outer door to the balcony of the Guest House does not engage properly, adjust as needed / desired.

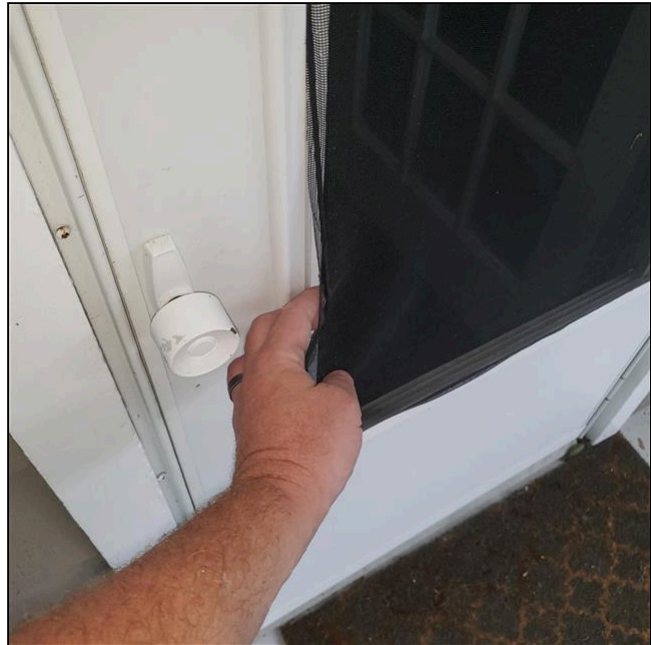
2.3 Item 4 (Picture)

2.3 (3) Damaged screens were noted at the screen doors of the Guest House, correct as desired.

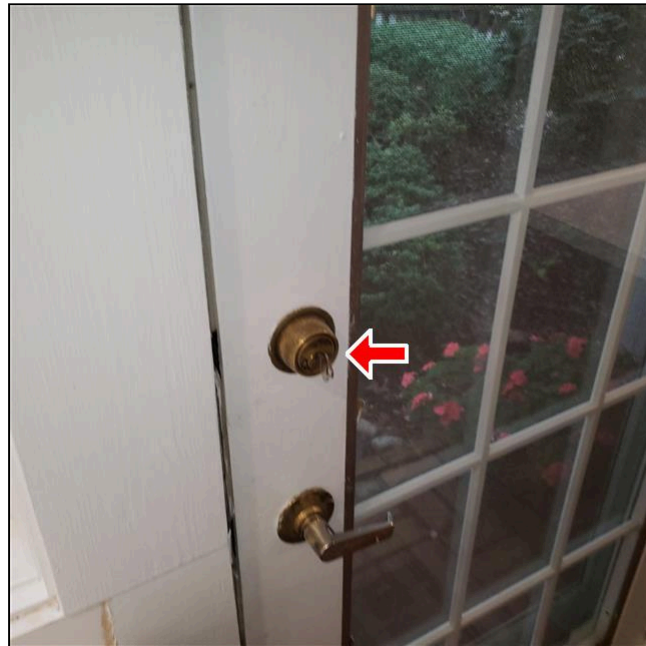
2.3 Item 5 (Picture)

**2.3 (4)** Use of deadbolts that are keyed on the interior side can present a safety concern, as they can inhibit egress in an emergency. Recommend replacing with deadbolts with ones that have thumb latches on the interior side.

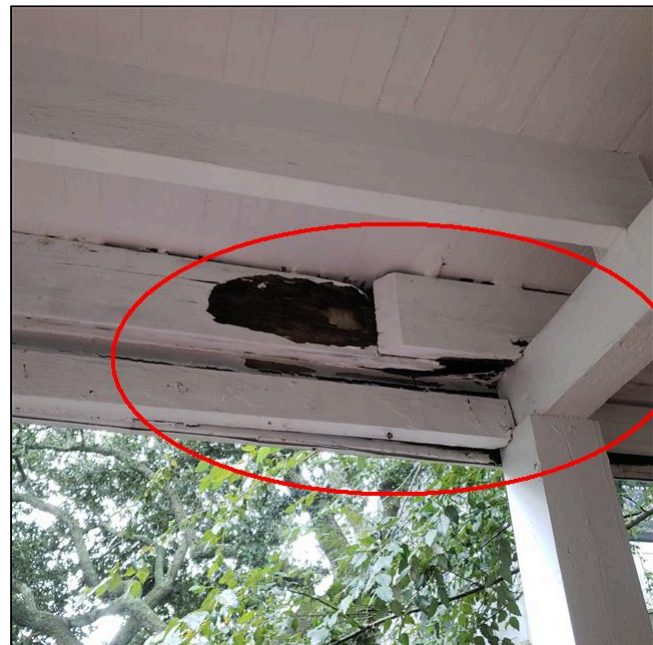
2.5 Item 2 (Picture)

**2.5 (1)** Significant decay was observed in the outer girder for the rear porch / balcony of the Guest House, and at the top of a post for it by its stairs, obtain repair estimates from a licensed Contractor and have corrected immediately.

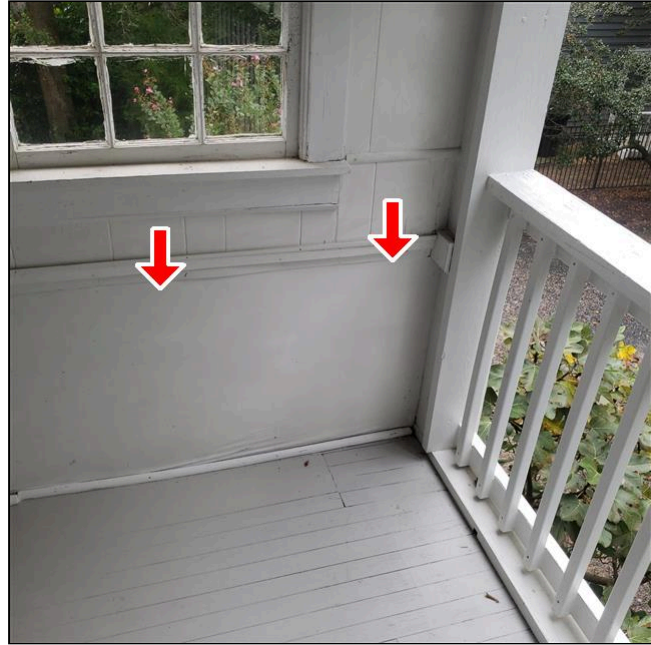
2.5 Item 3 (Picture)

**2.5 (2)** Plywood was improperly used as wall cladding at the east side of the Guest House porch / balcony, which has begun to delaminate, replace as needed.

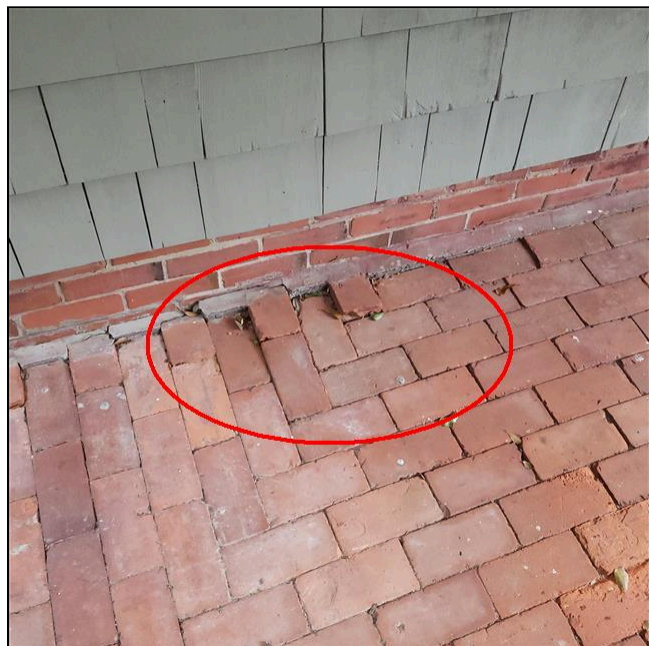
2.5 Item 6 (Picture)

**2.5 (3)** The brick mortar has deteriorated at the front porch of the Main House, and spalling / deteriorated and loosening bricks were noted at the patio area below the porch of the Guest House, correct and maintain as needed to eliminate potential tripping hazards.

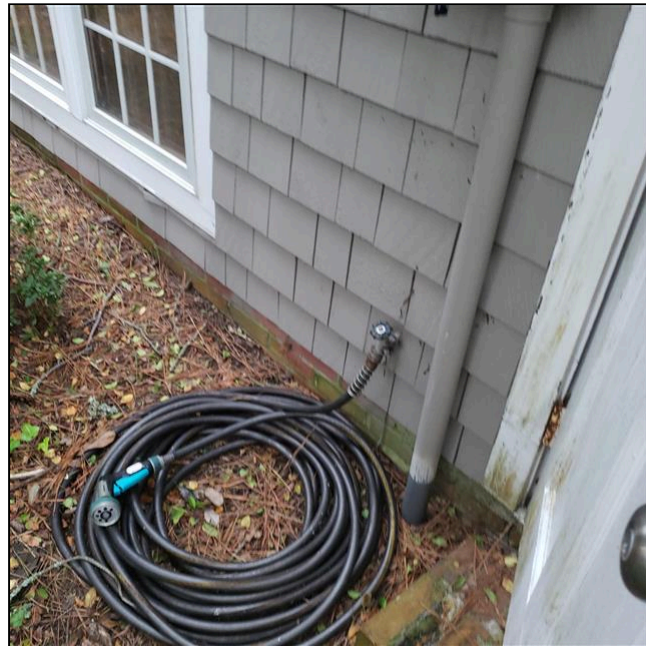
2.11 Item 1 (Picture)

**2.11** Only one hose bib was found, we recommend adding another on the opposite side of the home, and at least one at the Guest House for added convenience.

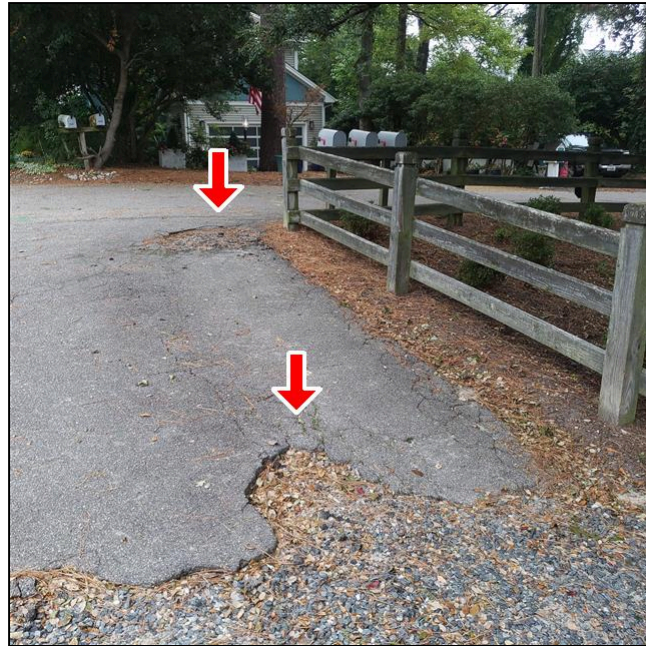
2.15 Item 1 (Picture)

**2.15** (1) The asphalt portion of the driveway is deteriorating, correct and maintain as needed.

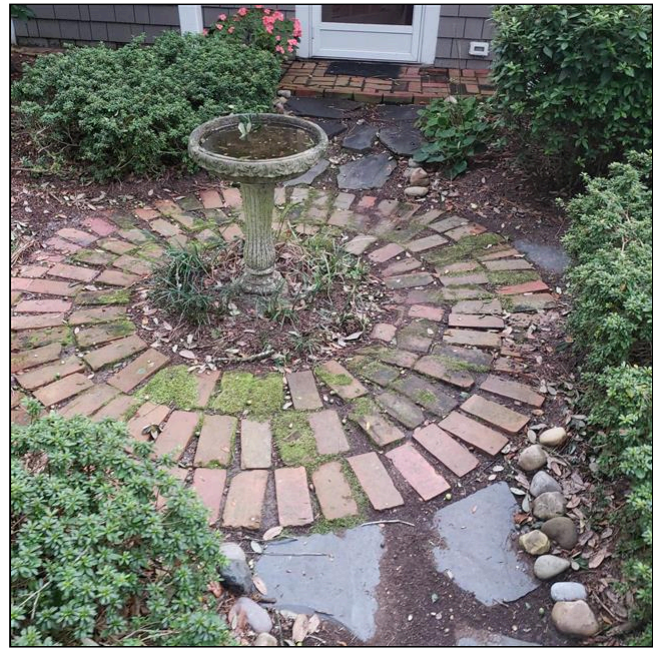
2.16 Item 4 (Picture)

**2.16** (1) Cracking and minor damage was observed in the concrete walkway at the front of the Guest House, correct and maintain as needed / desired.

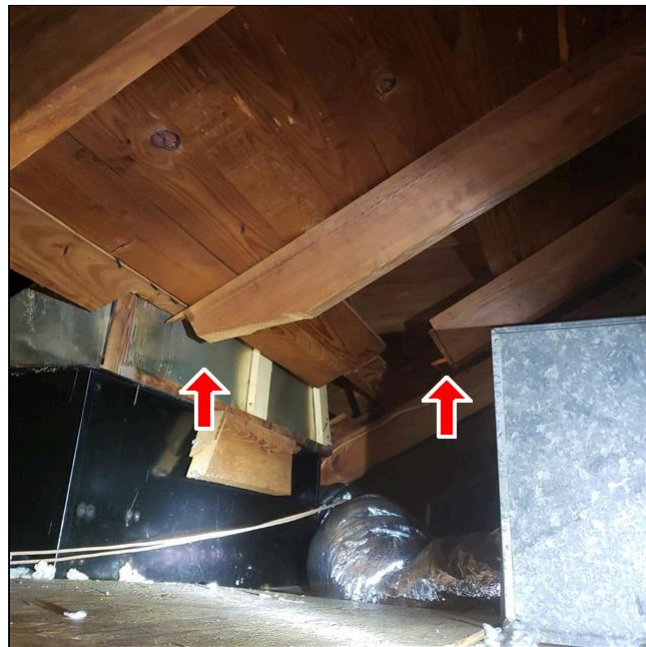
4.0 Item 1 (Picture)

**4.0 (1)** Two rafters were observed near the HVAC return box in the west attic space of the main house that were cut and left unsupported, have checked and corrected as needed by a licensed Contractor. (have an appropriate header installed)

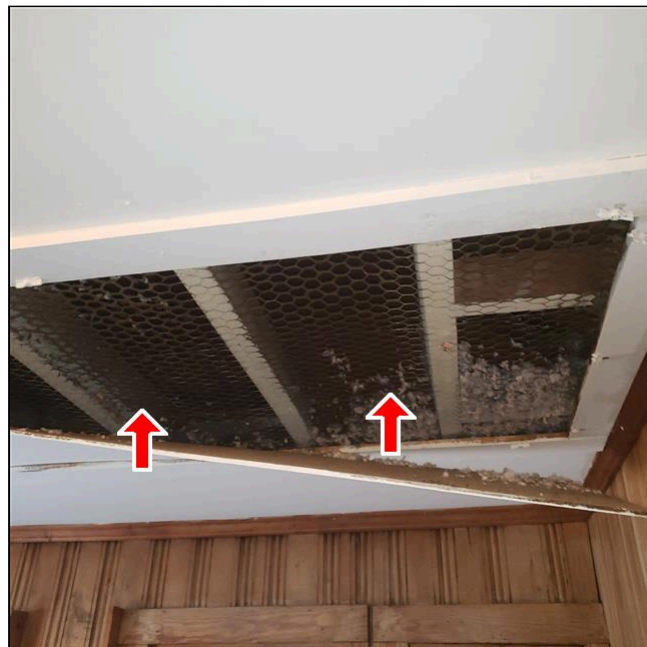
4.4 Item 1 (Picture)

**4.4** (1) There is an abandoned whole house fan above the large BR in the Guest House 2nd Fl apartment. There is no insulation at the access panel. We recommend adding proper insulation at this location.

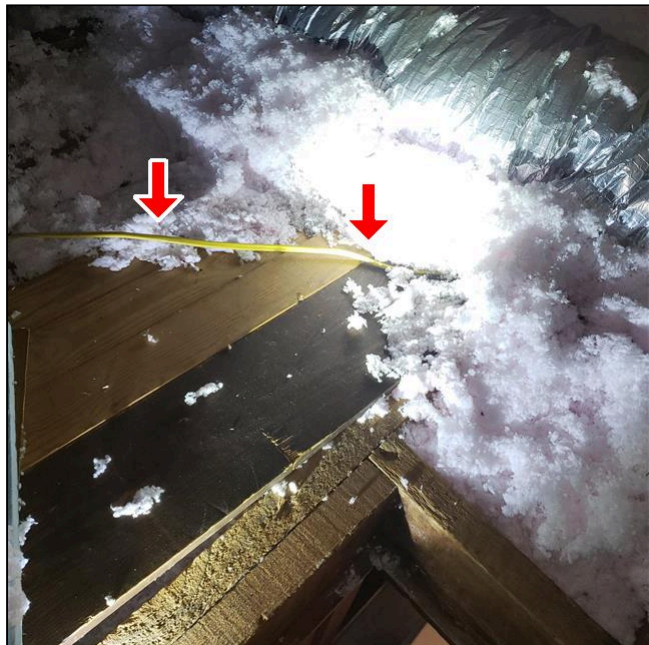
4.8 Item 1 (Picture)

**4.8** Unprotected wiring was observed within 6' of the access to the Guest House attic. Secure/protect as required to reduce the potential for accidental damage.

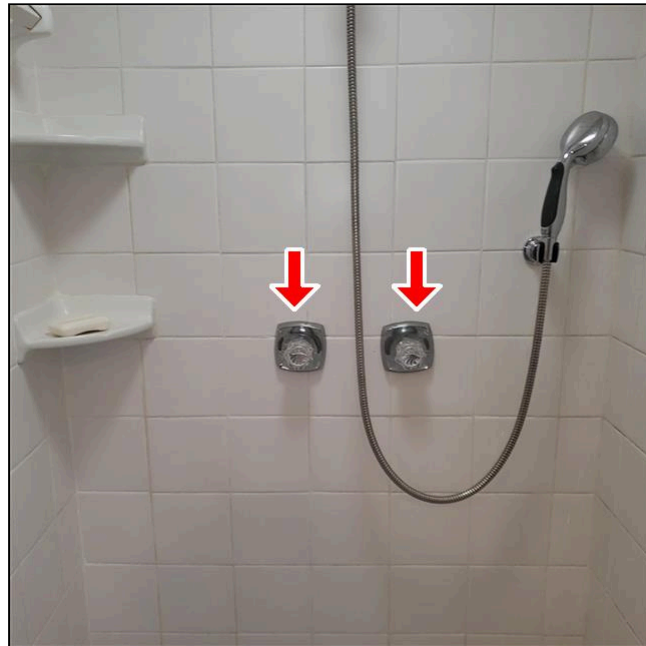
5.4.A Item 2 (Picture)

**5.4.A (3)** Due to the increased potential for scalding, separate hot & cold water valves are no longer permitted, consider installing a faucet with a scald protection feature for improved safety.

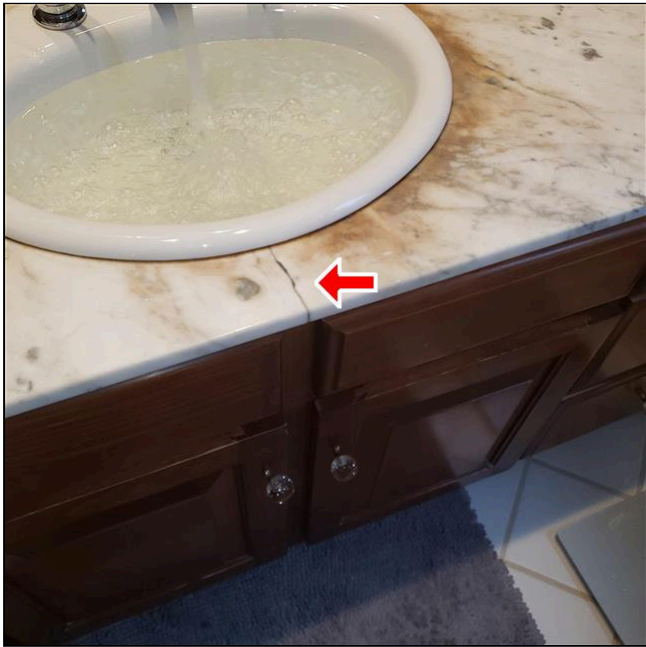
5.0.B Item 1 (Picture)

**5.0.B** (2) The vanity top is cracked at the front edge of the sink, correct as desired.

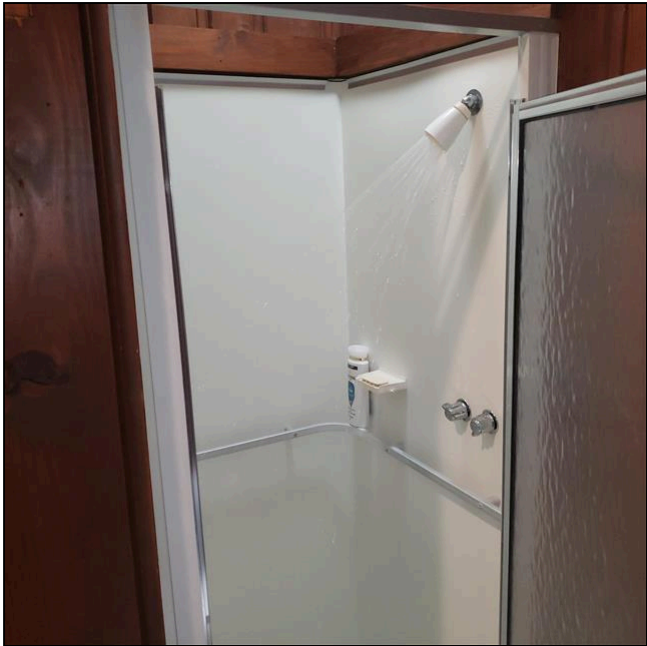
5.4.C Item 1 (Picture)

**5.4.C (1)** The shower stall does not meet current minimum size requirements, consider having the bath reconfigured for improved access and comfort.

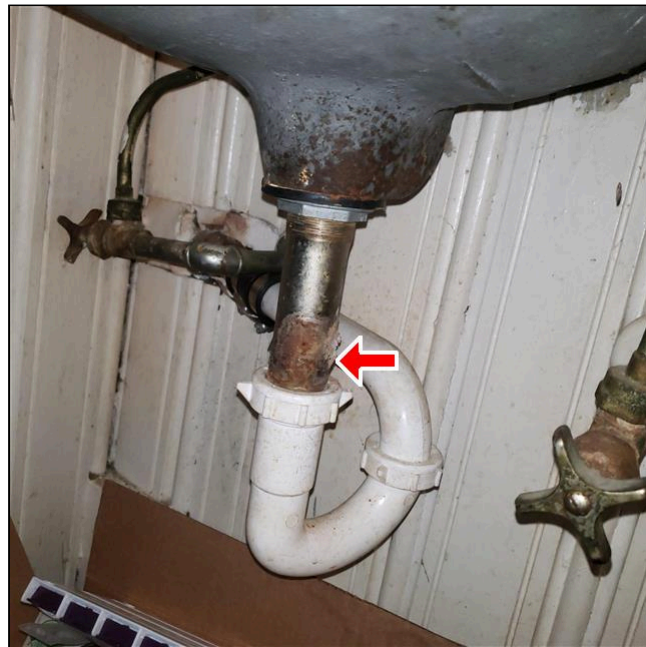
5.0.D Item 1 (Picture)

**5.0.D** (1) The drain connector pipe below the sink is deteriorated, we recommend having checked and corrected as needed by a licensed Plumbing Contractor.

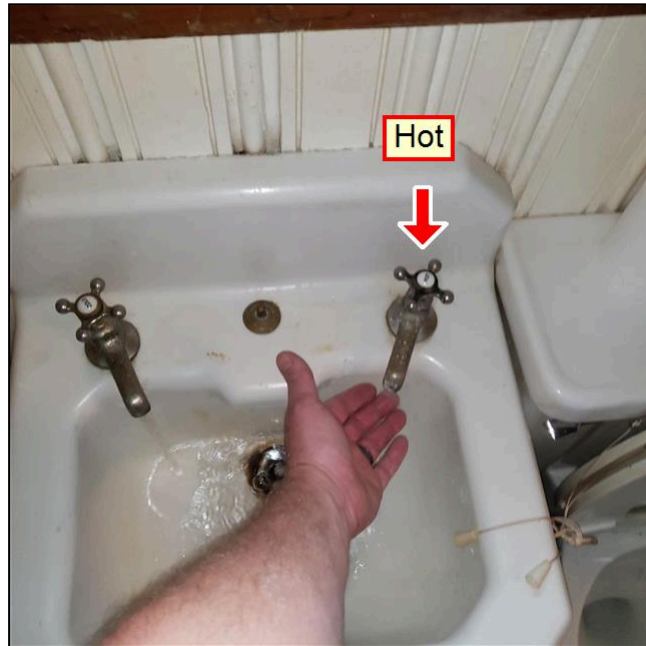
5.0.D Item 2 (Picture)

**5.0.D** (2) The hot & cold valves are reversed, have checked and corrected as needed by a licensed Plumbing Contractor to eliminate a potential scalding hazard.

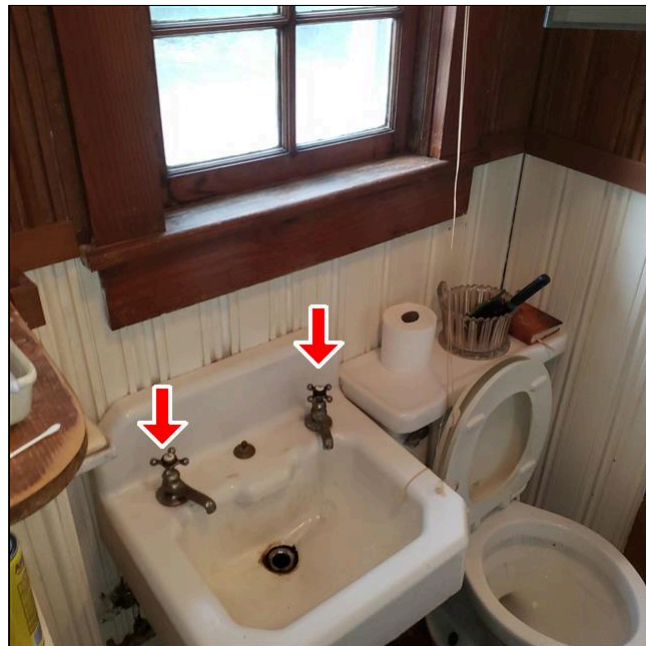
5.0.D Item 3 (Picture)

**5.0.D** (3) Sinks with separate hot and cold faucets have been prohibited for many years due to scalding concerns, consider upgrading.

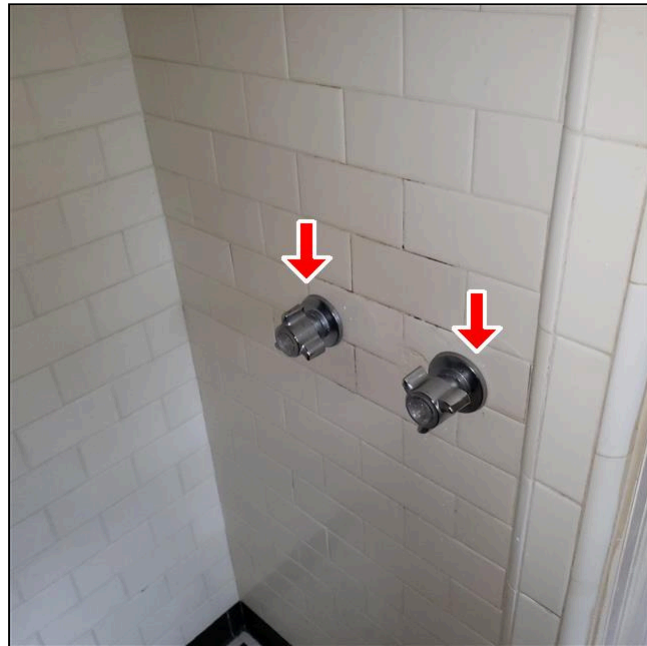
5.4.D Item 2 (Picture)

**5.4.D (2)** Due to the increased potential for scalding, separate hot & cold water valves are no longer permitted, consider installing a faucet with a scald protection feature for improved safety.

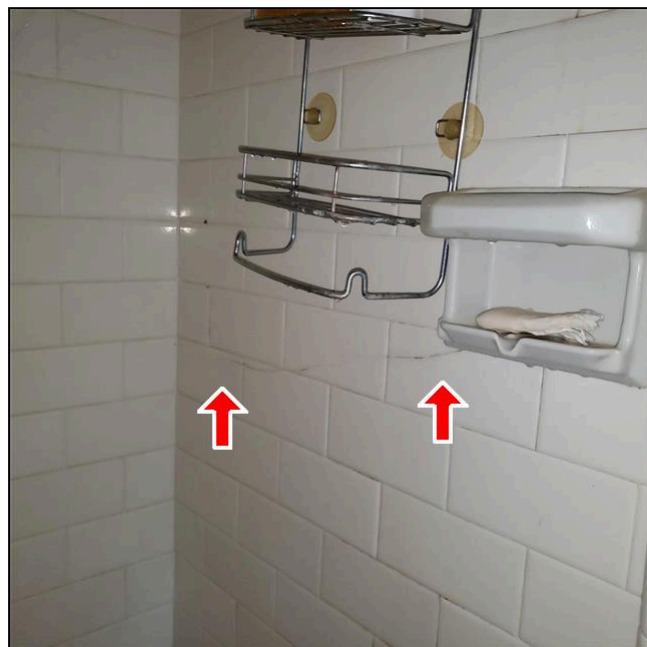
5.6.D Item 1 (Picture)

**5.6.D** .Cracking tiles were noted, correct as desired.

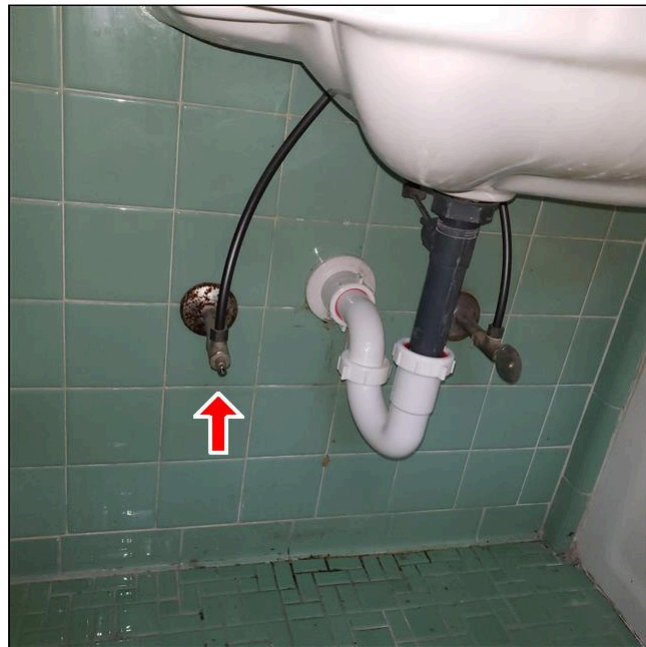
5.0.E Item 1 (Picture)

**5.0.E** (1) The handle is missing from the hot water shutoff valve below the sink, replace as needed.

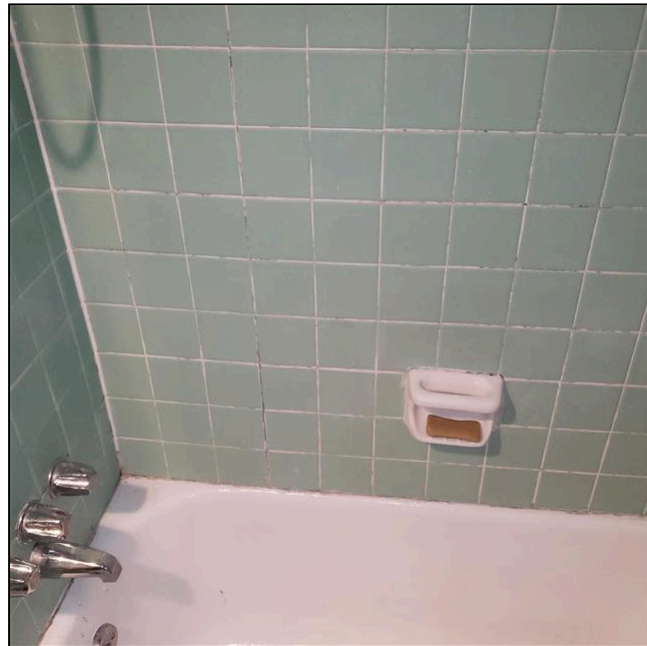
5.6.E Item 1 (Picture)

**5.6.E** Cracking and stained tile grout was noted, correct and maintain as needed / desired.

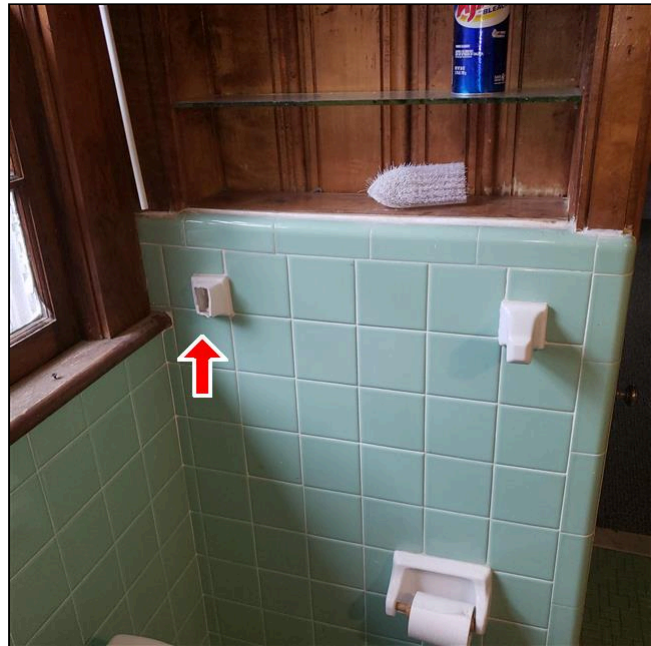
5.7.E Item 1 (Picture)

**5.7.E** A broken towel rod holder tile was noted, replace as needed / desired.

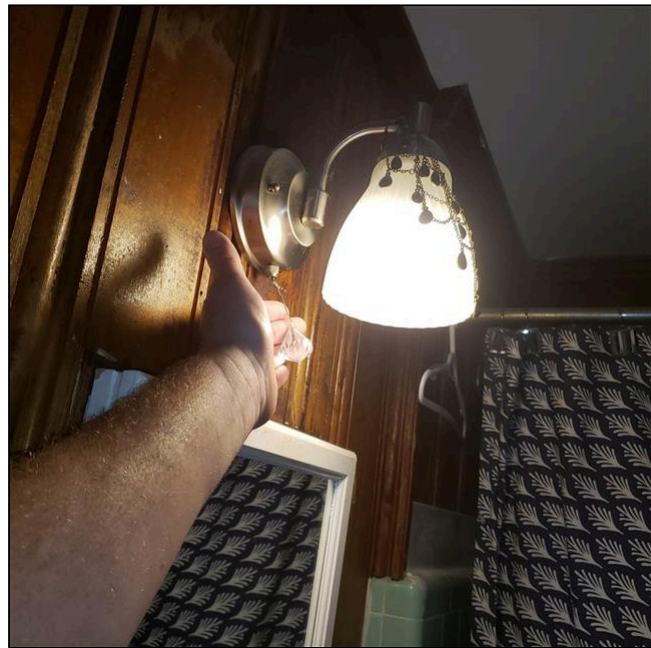
5.10.E Item 1 (Picture)

**5.10.E (1)** Like the Bath on the 1st Fl of the Guest House, the light fixture is controlled by a pull-chain, we recommend having wall switches installed.

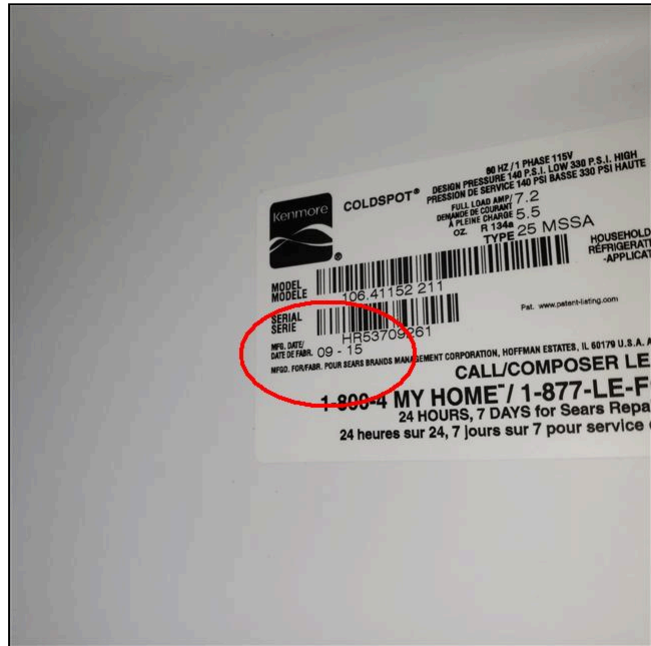
6.8.A Item 1 (Picture)

6.8.A See Dishwasher comment with respect to life expectancy.

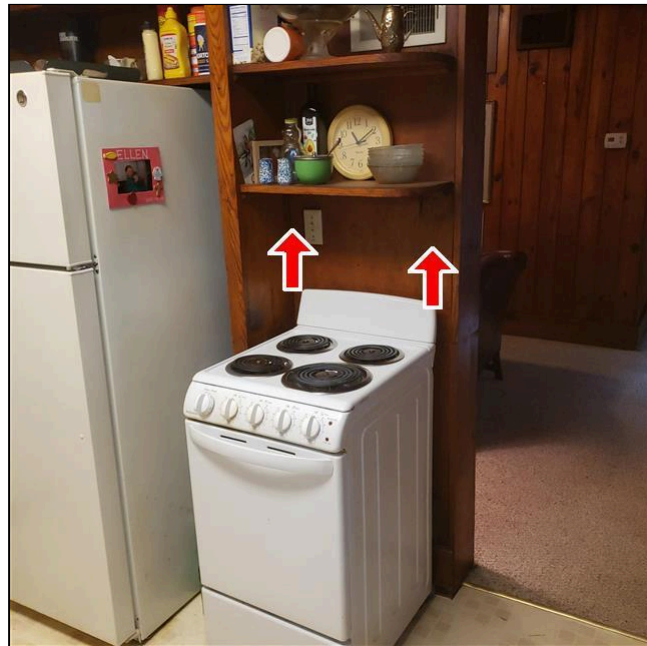
6.5.B Item 1 (Picture)

**6.5.B (1)** The cooktop does not have the required 30" of clearance with the shelves above, correct as needed to eliminate a potential fire hazard.

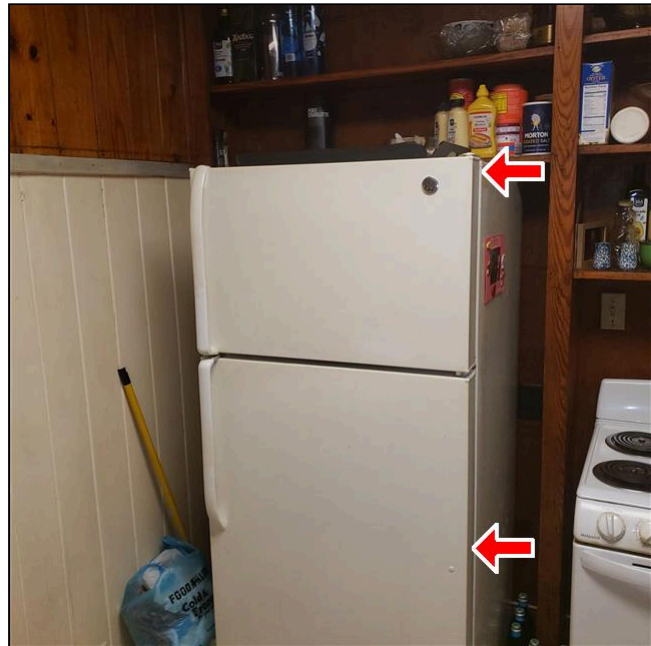
6.8.B Item 1 (Picture)

**6.8.B** The refrigerator doors are hinged on the wrong side for the layout of the Kitchen, but they may be reversible, we recommend having checked and reversed as needed for easier access.

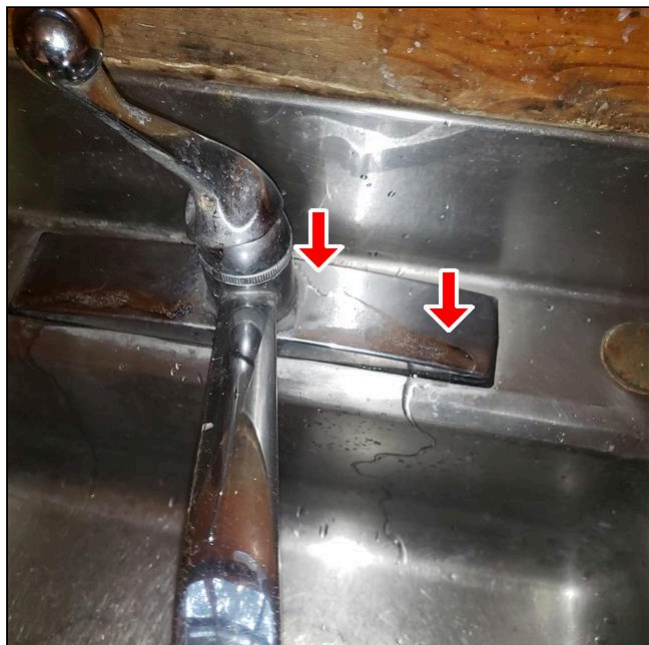
6.0.C Item 1 (Picture)

**6.0.C** (1) Active leakage was observed at the faucet's valve stem, have conditions evaluated further and corrected as needed by a licensed Plumbing Contractor as soon as possible to reduce the potential for moisture related damage to the structure and/or mold growth.

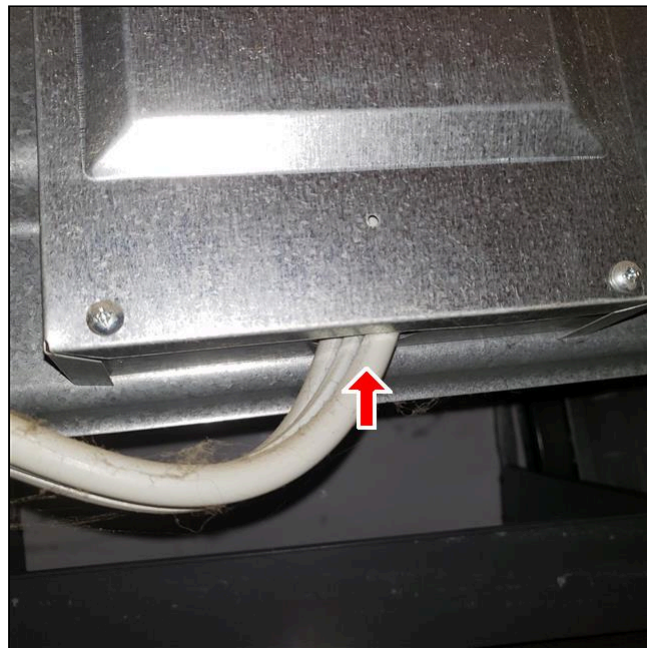
6.5.C Item 1 (Picture)

**6.5.C (1)** The 220v power cord is not properly secured where it enters the unit. Have a proper cable clamp installed as required to prevent wiring from being cut by sharp edges or being pulled loose when unit is pulled out for cleaning.

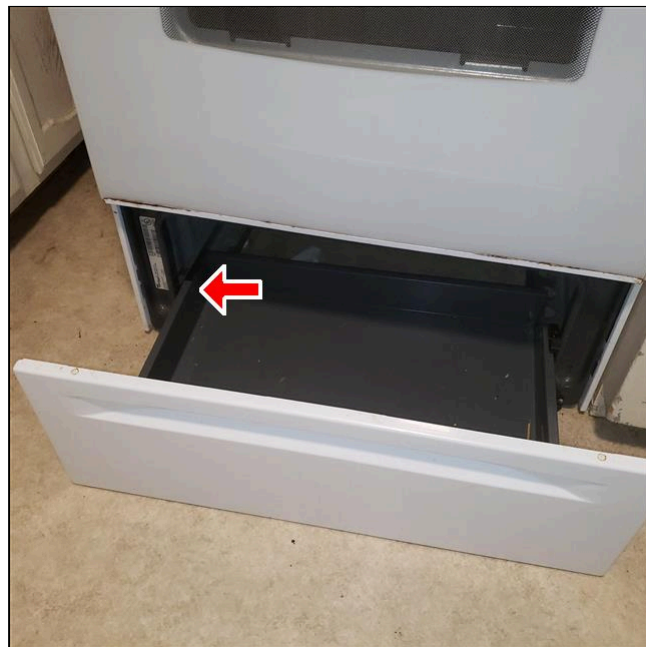
6.5.C Item 4 (Picture)

**6.5.C (3)** Hardware / guides for the storage drawer are damaged or missing, replace as needed.

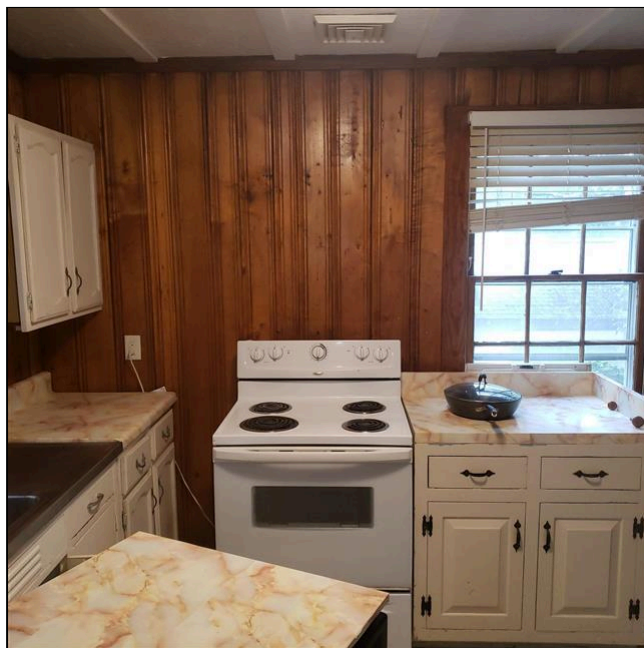
6.7.C Item 1 (Picture)

**6.7.C** No ventilator is present, we recommend installing a proper range hood.

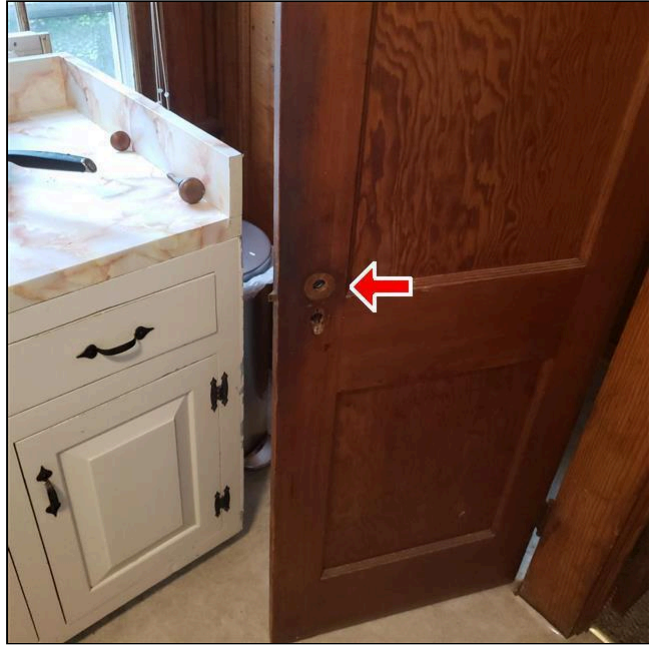
7.6 Item 5 (Picture)

**7.6** (2) As previously noted, missing and defective hardware were found at doors in the Guest House at the 2nd Fl Pantry and 1st Fl Bath, correct and maintain as needed.

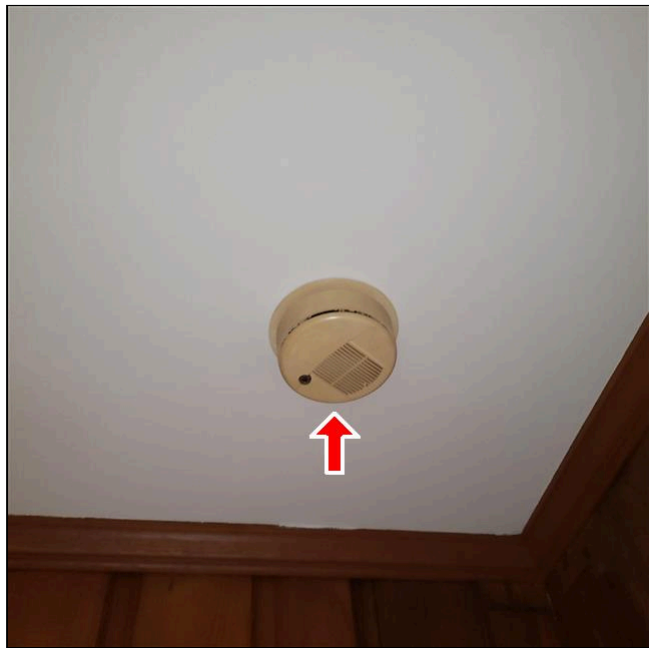
7.7 Item 1 (Picture)

**7.7** Too few smoke inspectors were installed at the time of inspection, and those that were present appear to be beyond their intended service life. Install a smoke alarm on each of the BR's in both buildings, and combination smoke/CO alarms on each floor in each building as well.

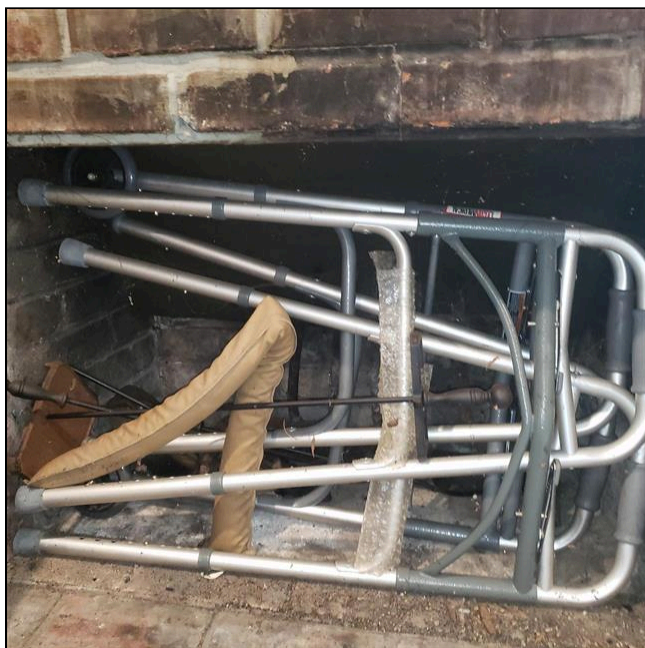
7.8 Item 1 (Picture)

**7.8** Inspection of the fireplace in the Main House 1st Fl Family Rm was limited by the presence of storage and obstructions, requiring further evaluation. The knob to operate its flue damper is missing, requiring repair. As noted in the Roofing Section, there are concerns at both fireplace chimneys, and a Level 2 inspection by a (CSIA) Certified Chimney Sweep is recommended prior to closing.

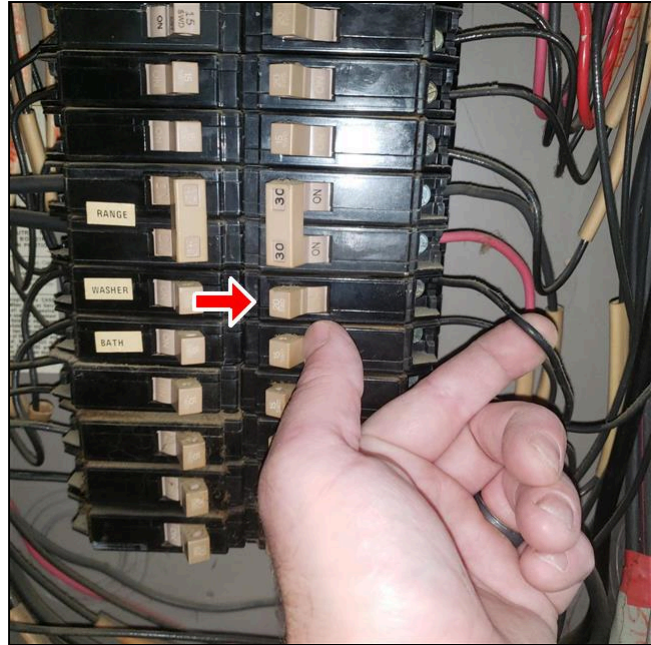
9.3 Item 1 (Picture)

9.3 A 20amp breaker was found in the main house panel that is connected to a 14 gauge wire, which is rated for 15amps. This presents a potentially serious safety concern and risk of fire. Have a licensed Electrical Contractor replace the breaker with a 15amp unit.
