INSPECTION REPORT  
210 81st St  
Virginia Beach VA 23451

INSPECTED BY  
John Burke  
Beacon  
Inspections -  
OBX, LLC

INSPECTION DATE  
📅 9/28/2023  
🕒 09:00 AM

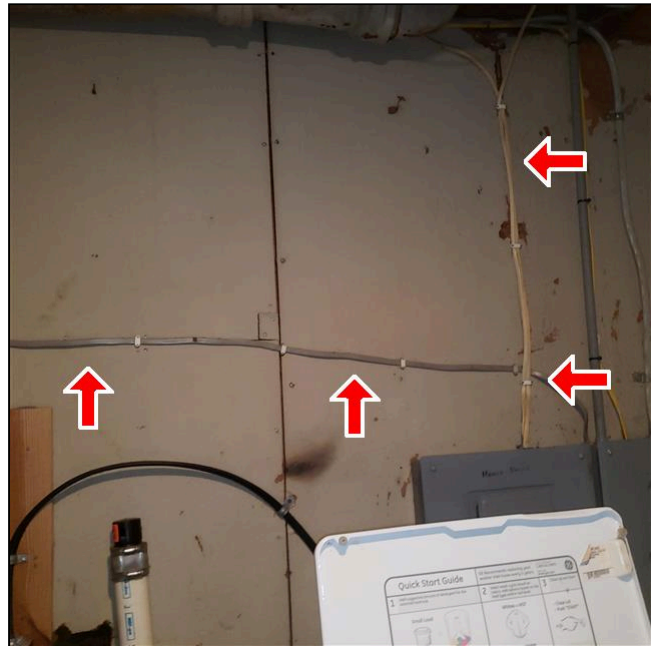
9.5 Item 3 (Picture)

**9.5 (2)** See notes in the Exterior & Attic Sections regarding unprotected wiring on the exterior and in the attic of the Guest House. Exposed wiring was also found in the Guest House Laundry Rm. Have checked and protected, enclosed, or replaced as needed by a licensed Electrical Contractor.

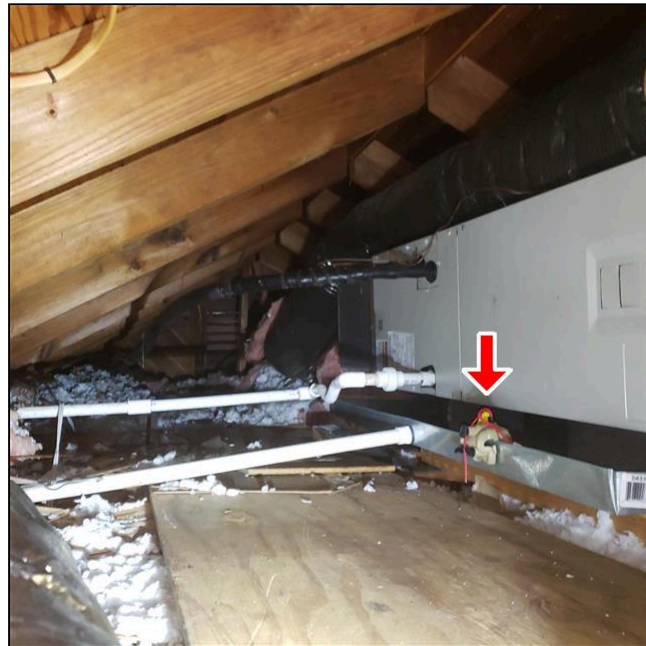
10.7 Item 1 (Picture)

**10.7** Please Note: Most modern systems are equipped with float switches on the overflow pan and/or the drain piping by the air handlers or evaporator coils. These switches are designed to shut off the system if there is a backup in it's primary drain line and/or its overflow pan fills with water. This may cause a system to run in short or erratic cycles during a partial backup in the drain piping as well. We recommend monitoring the condensate discharge on the exterior of the home during cooling mode operation, and to be sure to have drain lines cleaned at time of semi-annual system servicing. If an AC or Heat Pump system stops working during hot weather, it would be advisable to check these float switches and clean the lines as needed prior to contacting an HVAC professional for an emergency service call.

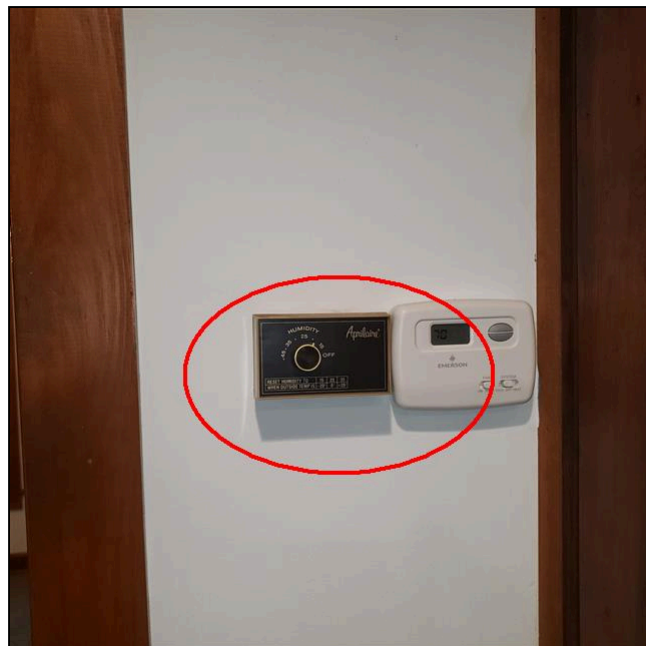
10.10 Item 1 (Picture)

**10.10** A humidistat for a whole-house humidifier was found in the Main House, but a humidifier was not found mounted to the ductwork, replace as needed / desired.

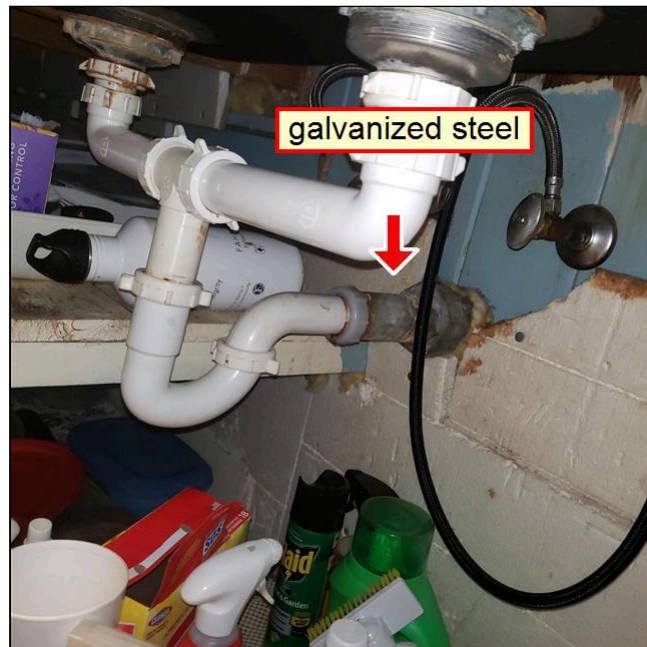
11.2 Item 1 (Picture)

**11.2** Older galvanized steel and cast iron lines are likely to clog with rust and debris over time. Future/ periodic repair or replacement needs should be anticipated. Consider having a video inspection of the larger drain lines performed by a qualified specialist prior to closing as a precaution.
