Home Inspection Report

600 Lotz Dr
Yorktown, VA 23692

Inspected by:
Andy Call
Peninsula Property Inspections Inc

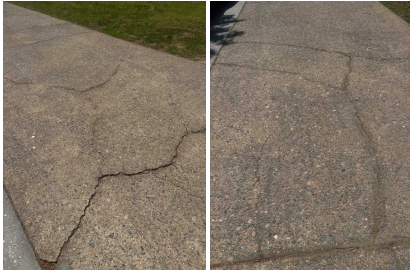
1. Driveway: Concrete - [Cracking noticed, monitor for future settling](#)

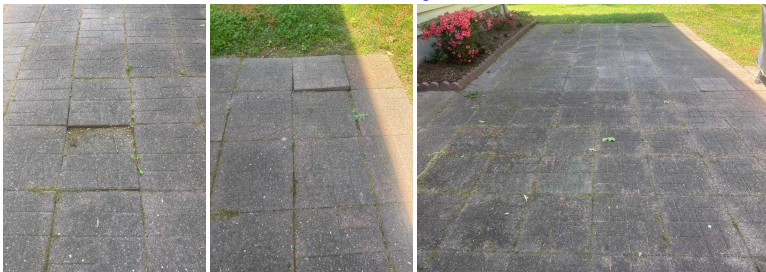
4. Patio: Paver - [Loose and unevenly settled, recommend monitoring condition](#)

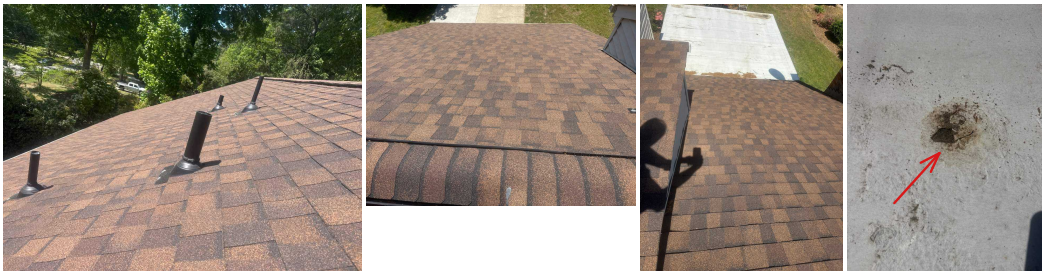
1. Method of Inspection: On roof
2. Unable to Inspect: 10%
3. Material: Asphalt shingle 30 year Architural, Membrane - [Damaged membrane noted, recommend correction](#)

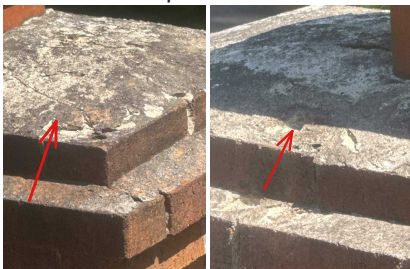
14. Flue/Flue Cap: Mortar - [Crown cracked , Repair chimney mortar crown](#)

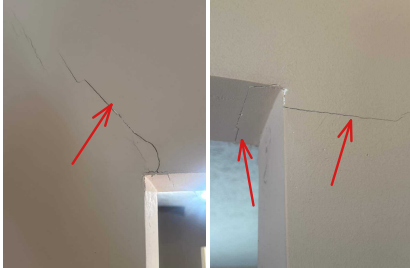
1. Closet: Single
2. Ceiling: Paint
3. Walls: Paint - Cracks present, living room , recommend to monitor for future correction

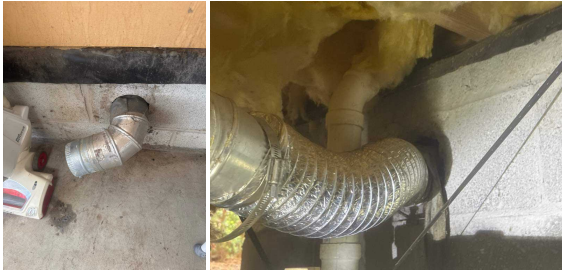
3. Washer and Dryer Electrical: 110-240 VAC
4. Dryer Vent: Rigid metal - Metal flex used under dwelling for dryer vent is unsafe, recommend replacing with ridged metal

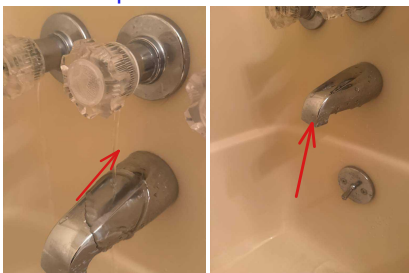
1. Ceiling: Paint
2. Walls: Paint
3. Floor: Tile
4. Doors: Hollow wood
5. Electrical: 110 GFI
6. Counter/Cabinet: Wood
7. Sink/Basin: Molded single bowl
8. Faucets/Traps: Moen fixtures with a PVC trap - [Leaking faucet, at tub/shower valve, and tub fill , a licensed plumber recommended to repair](#)

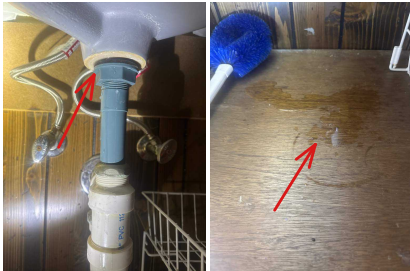
- 26. Ceiling: Paint
- 27. Walls: Paint and paneling
- 28. Floor: Hardwood
- 29. Doors: Hollow wood
- 30. Electrical: 110 GFI
- 31. Counter/Cabinet: Wood
- 32. Sink/Basin: Molded single bowl
- 33. Faucets/Traps: Delta fixtures with a PVC trap - **Leaking trap in 1st floor 1/2 bathroom, recommend correction**

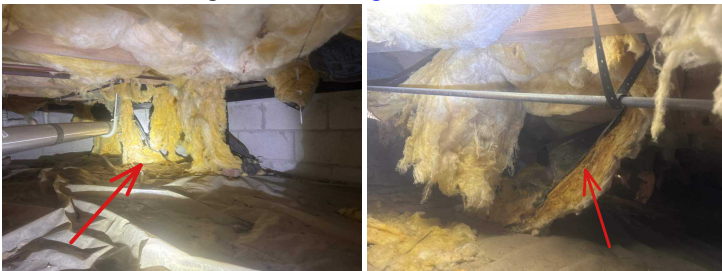
8. Insulation: Fiberglass - [Falling down in areas, recommend correction](#)

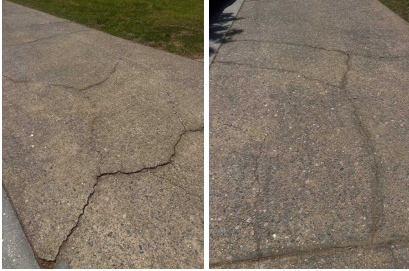
1. Driveway: Concrete - [Cracking noticed, monitor for future settling](#)

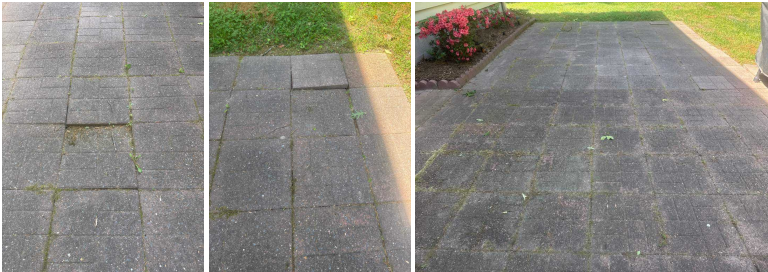
2. Patio: Paver - [Loose and unevenly settled, recommend monitoring condition](#)

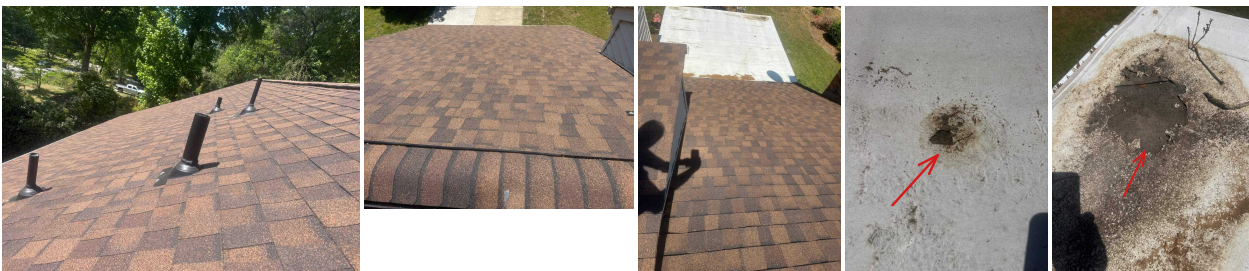
4. Main Roof Surface Material: Asphalt shingle 30 year Architectural, Membrane - [Damaged membrane noted, recommend correction](#)

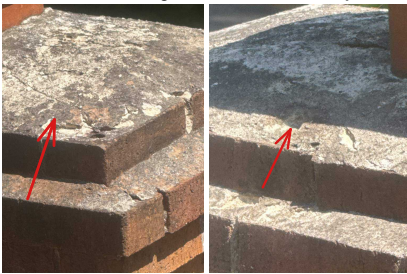
6. East Chimney Flue/Flue Cap: Mortar - [Crown cracked , Repair chimney mortar crown](#)

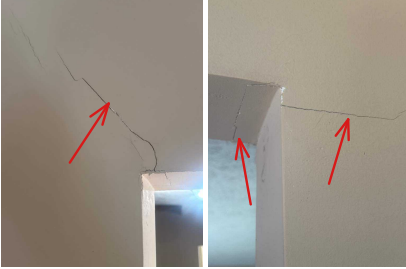
9. Living Room, Dining Room, Family Room, Sun Room Living Space Walls: Paint - [Cracks present, living room , recommend to monitor for future correction](#)

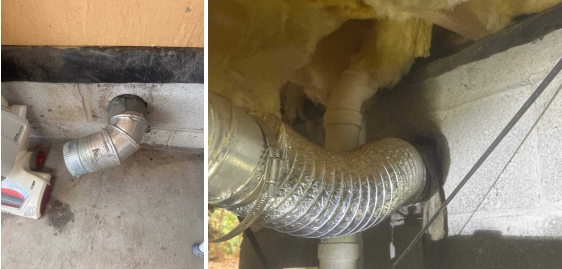
11. Garage Laundry Room/Area Dryer Vent: Rigid metal - [Metal flex used under dwelling for dryer vent is unsafe, recommend replacing with ridged metal](#)

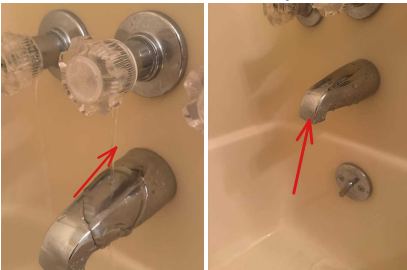
12. 2nd floor main Bathroom Faucets/Traps: Moen fixtures with a PVC trap - [Leaking faucet, at tub/shower valve, and tub fill](#) , [a licensed plumber recommended to repair](#)

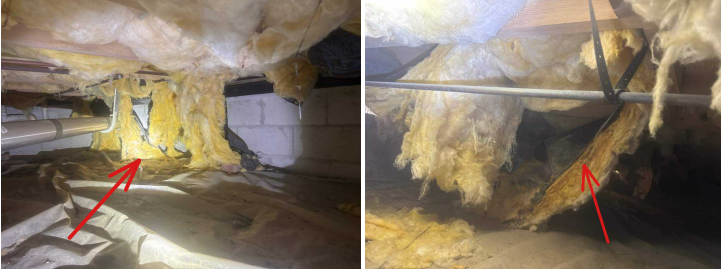
13. Main Crawl Space Insulation: Fiberglass - [Falling down in areas, recommend correction](#)

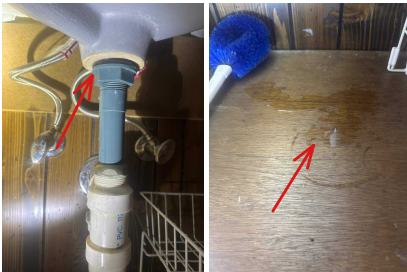
3. 1st floor main Half Bathroom Faucets/Traps: Delta fixtures with a PVC trap - **Leaking trap in 1st floor 1/2 bathroom, recommend correction**
