Soil Evaluation Report

Project number: 06001

"ASHLEYMARIE ESTATES" subd. of {TMP

Lot: 04

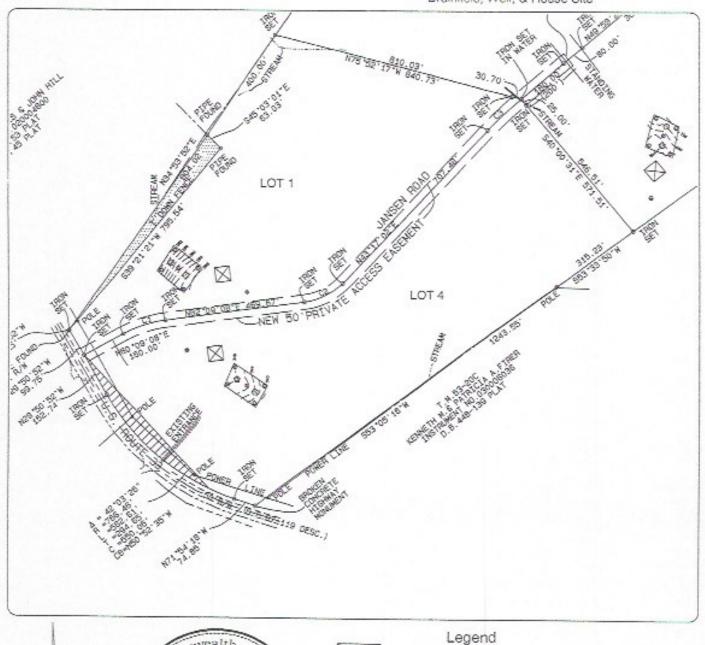
showing proposed

Drainfield, Well, & House Site

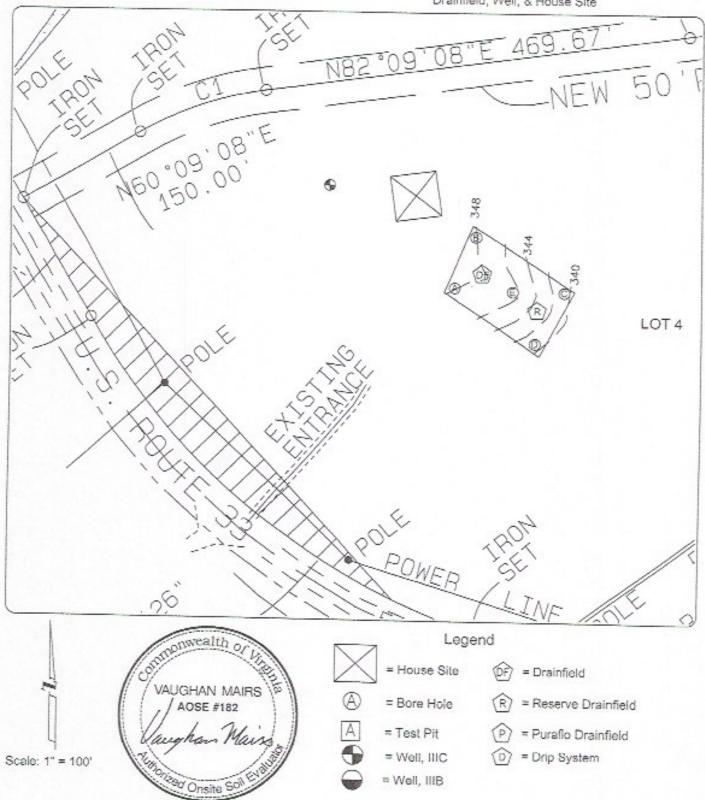
showing proposed Drainfield, Well, & House Site
