# BLUEBONNET REAL ESTATE INSPECTION SERVICE *Commercial & Residential*

## PROPERTY INSPECTION REPORT

**Concerning:** 100 E. Summit, Schulenburg, TX 78956  
(Address or Other Identification of Inspected Property)

**By:** Kevin M Ullrich, Lic #965 07/14/2017  
(Name and License Number of Inspector) (Date)

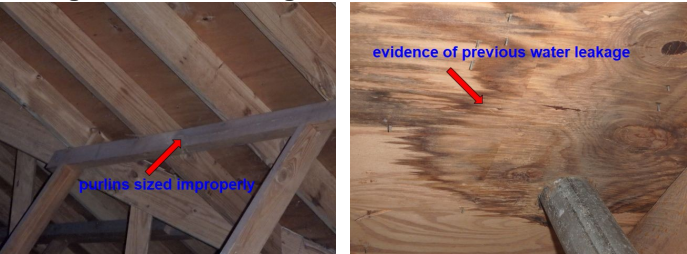
*Comments:* Decking: plywood Structure: stick built Attic Ventilation: soffit vents, ridge vents **Attic drop stairs do not have proper fire-resistance, suggest adding gypsum to exterior of drop stairs. Purlins sized improperly in attic areas on all sides. Purlins should be the same dimension lumber as the rafter. Attic has insufficient ventilation. Current building code states: R806.2 Minimum area. The total net free ventilating area shall not be less than 1/150 of the area of the space ventilated except that reduction of the total area to 1/300 is permitted, provided that at least 50 percent and not more than 80 percent of the required ventilating area is provided by ventilators located in the upper portion of the space to be**

ventilated at least 3 feet (914 mm) above the eave or cornice vents with the balance of the required ventilation provided by eave or cornice vents. As an alternative, the net free cross-ventilation area may be reduced to 1/300 when a vapor barrier having a transmission rate not exceeding 1 perm is installed on the warm-in-winter side of the ceiling. Suggest adding additional ventilation to meet requirements of building code. Evidence of previous water leakage in attic decking areas back, etc.

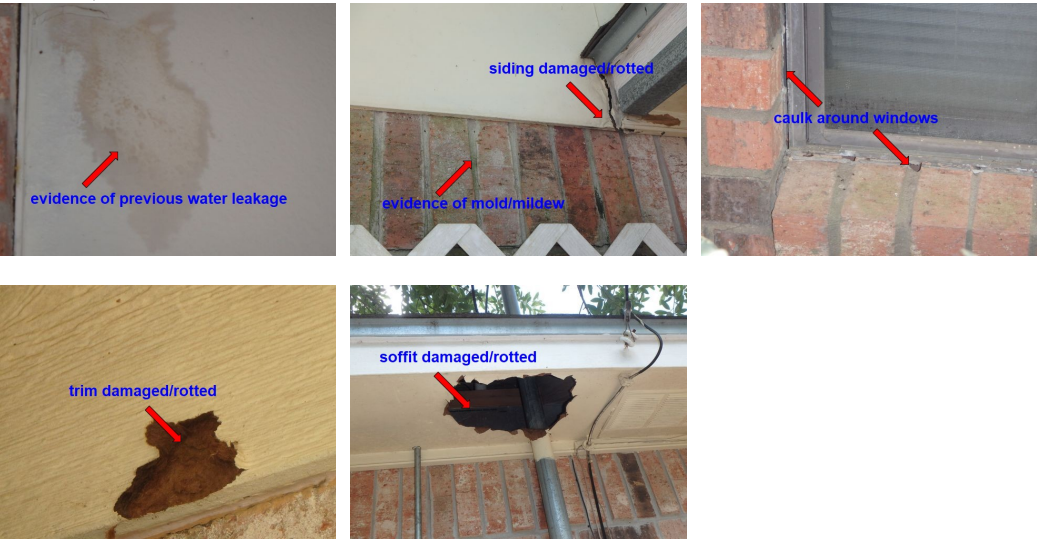
Comments: Exterior Finish: brick/stone veneer, hardboard siding  
Evidence of previous water leakage noted in wall areas of den. Evidence of mold/mildew in exterior siding/soffit/trim/brick/stone areas on all sides. The exterior walls need to be re-sealed around windows to control the intrusion of water/moisture. Siding damaged/rotted various locations. Trim damaged/rotted various locations, etc. Soffit damaged/rotted/holes in back, etc.

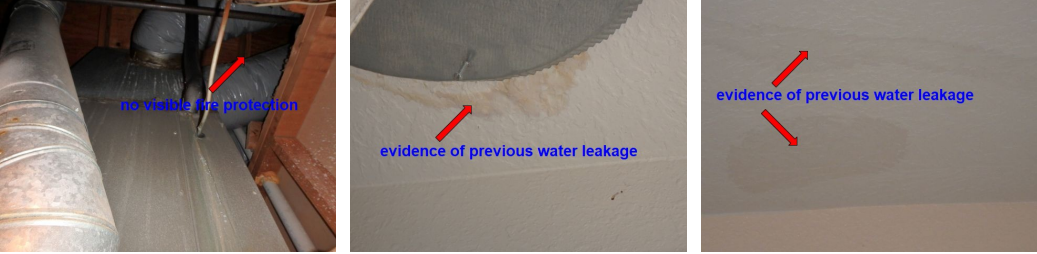
Comments: Fire-resistance missing/incomplete in ceiling areas of furnace closet. Ceiling has evidence of previous water leakage/damage in M-bath, laundry room, etc.

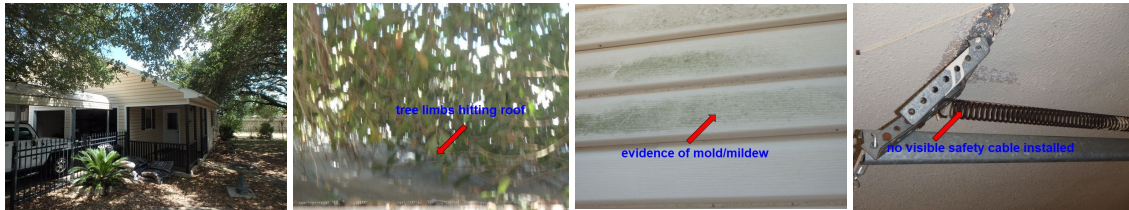
**Evidence of previous foundation repairs, suggest buyer obtain copies of all foundation repair warranties/guarantees, and any engineers reports. Areas for water to pool on right side, back, etc. Gutter nails backing out various locations. Gutters heavily clogged, needs cleaning. Rust spots noted in metal roof areas. Tree limbs need to be trimmed away from roof on right side, back, etc. The stairs/steps in garage do not have a handrail. Current standards require that handrails shall be provided on at least one side of each continuous run of treads or flight with two or more risers. There is no switch accessible from top/bottom of stairs to turn on light for stairwell. Further investigation and repairs needed. There are no GFCI protected plugs installed in outbuilding areas. Evidence of mold/mildew in exterior siding/soffit/trim/brick/stone areas on all sides. There is no visible safety cable installed at overhead garage door springs. Overhead door lock mechanism is not disabled (this is required if door opener is installed). The overhead garage door opener does not reverse properly when the door hits an obstruction. The door should reverse with no more than 5 psi of pressure, needs adjusting.**
