Home Inspection Services By Jove inc
Property Inspection Report

168 Rivoli Ridge Dr, Macon , GA
Inspection prepared for: Ben Hudson
Date of Inspection: 8/9/2024
Age of Home: 1985 Size: 3461 Sq'

Inspector: jove twedde
3014 clairmont Ave, Macon GA, 31204
Phone: 478-737-2978
Email: jovetweddle@bellsouth.net

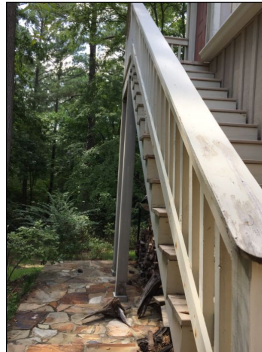
- 1.1. The loose / flimsy railing to the bonus room, should be reinforced and secured.

The loose / flimsy railing to the bonus room, should be reinforced and secured.

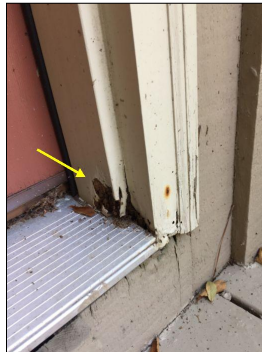
- 2.3. Repair the water damaged door jambs at the rear left exterior door opening and I recommend installing a storm door to prevent future water damage to the jamb & sub-floor below.

Repair the water damaged door jambs at the rear left exterior door opening and I recommend installing a storm door to prevent future water damage to the jamb & sub-floor below.

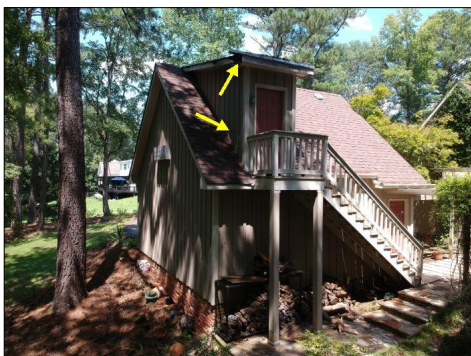
The sub-fascia board & possibly roof decking rot was observed as well as siding rot at the roof level on the upper rear bonus room outset area, replace all as needed.

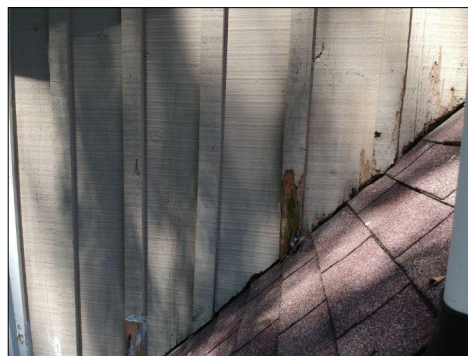
- 3.1. Minor water damage noted to the siding where setting on the roof at the rear left area repair as necessary

Minor water damage noted to the siding where setting on the roof at the rear left area repair as necessary.

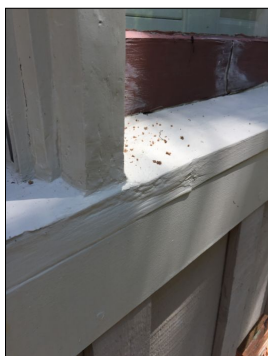
Replace the rotted window sill, sash and mulls at the rear left den triple window unit.

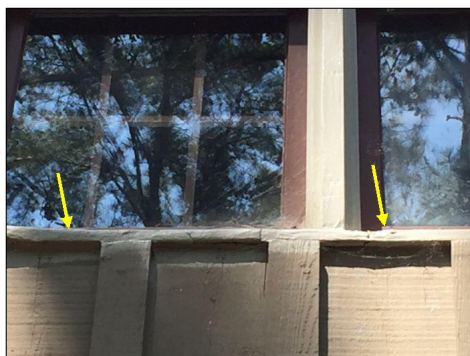
The window sill, sashes and mull are rotted at the upper left side, lower left side and front left side living room window units replace all damaged window componets as necessary.

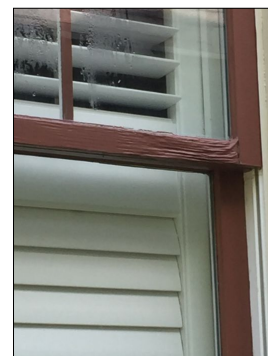
Replace water damaged sashes and window sills on the right side windows of the front middle bedroom.

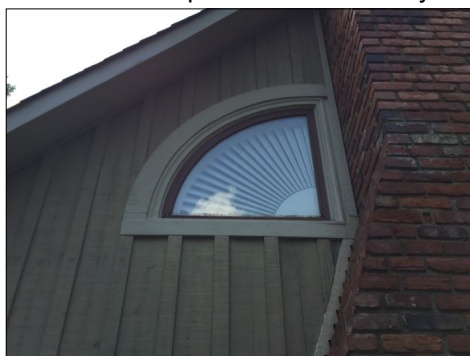
Replace rotted window sills at the front right 1/4 round windows to the left and right of the chimney.

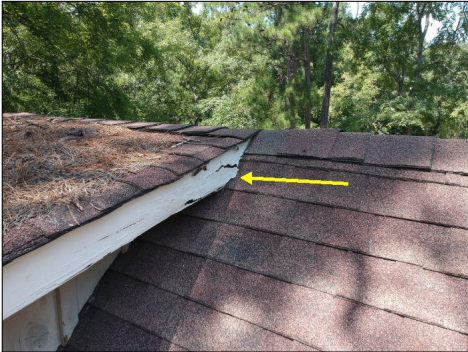
Replace the rotted fascia boards on the front & rear bonus room eaves.

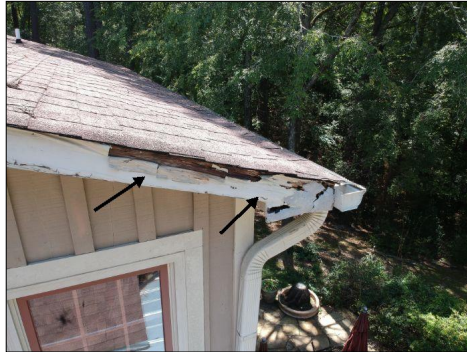
Replace the wood rot at the upper right side & rear eaves.

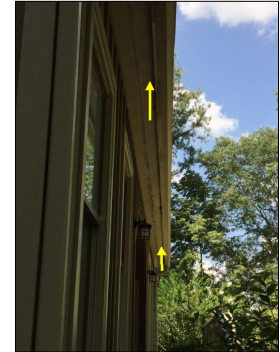
Replace all water damaged soffit and fascia boards as necessary across the front eave.

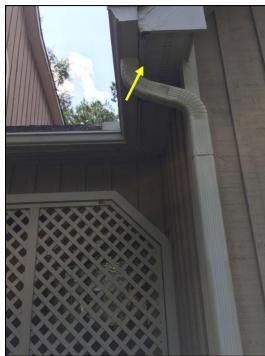
Replace water damaged fascia and soffit at the front left side of the master bedroom

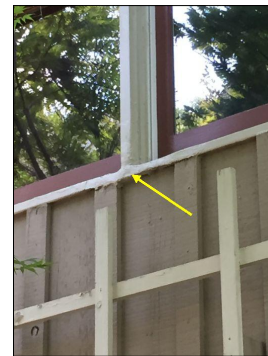
Replace the rotted window sill & mull at the front upper bonus room window.

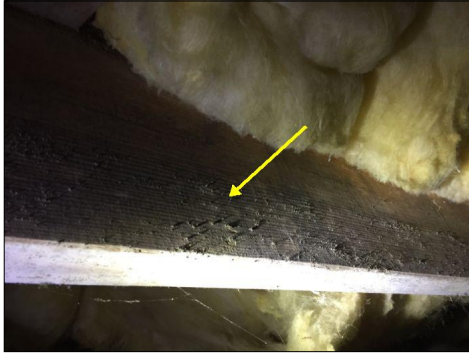
1.1. Areas of wood fungus growth were noted through out the crawl space, from periodic water intrusion during rain fall, extend the down spouts as far from the base of the home as possible and monitor for the need of taking further steps to mitigate moisture level in the crawl space, such as closing off the foundation vents and installing 2 dehumidifiers in the main and master suite crawl space areas.

Areas of wood fungus growth were noted through out the crawl space, from periodic water intrusion during rain fall, extend the down spouts as far from the base of the home as possible and monitor for the need of taking further steps to mitigate moisture level in the crawl space, such as closing off the foundation vents and installing 2 dehumidifiers in the main and master suite crawl space areas.

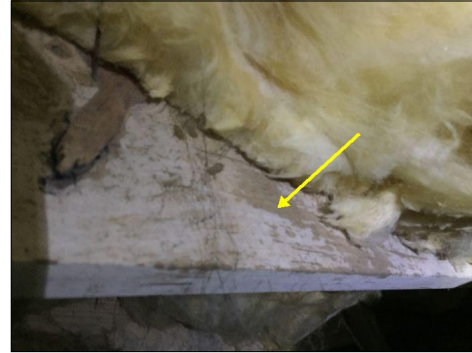
Minor to marginal wood fungus growth noted on the floor system in the crawl space.

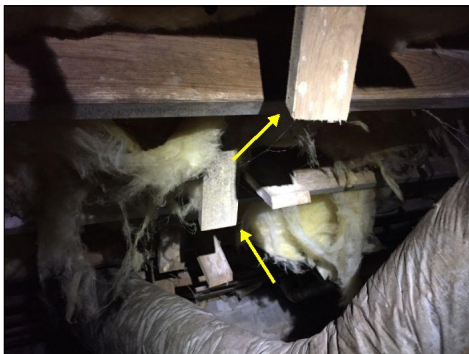
2.1. It should be noted that all of the floor structure bridging was left un-nailed since construction, I recommend having all of the loose bridging properly secured to the floor joists to strengthen the floor structure.

It should be noted that all of the floor structure bridging was left un-nailed since construction, I recommend having all of the loose bridging properly secured to the floor joists to strengthen the floor structure.

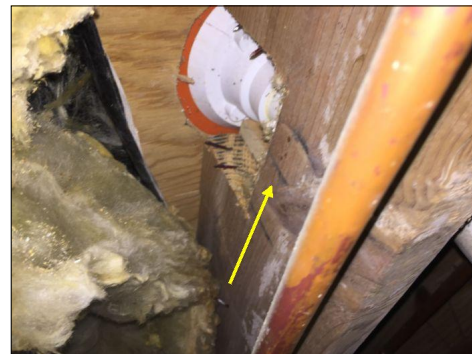
2.2. Reinforce the over notched floor joist below the master shower using a full length 2x8" bearing on both ends or a vertical post setting on a poured concrete footing.

Reinforce the over notched floor joist below the master shower using a full length 2x8" bearing on both ends or a vertical post setting on a poured concrete footing.

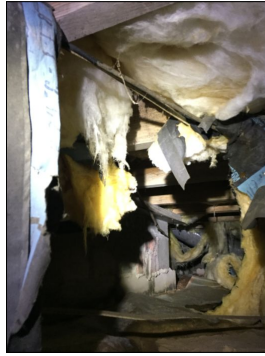
3.1. There were signs of rodent activity in the crawl space mainly in the master suite crawl space where the floor insulation has been pulled down through out the crawl space, call for further evaluation by a pest control company for the need of extermination and replace all damaged & missing floor insulation.

There were signs of rodent activity in the crawl space mainly in the master suite crawl space where the floor insulation has been pulled down throughout the crawl space, call for further evaluation by a pest control company for the need of extermination and replace all damaged & missing floor insulation.

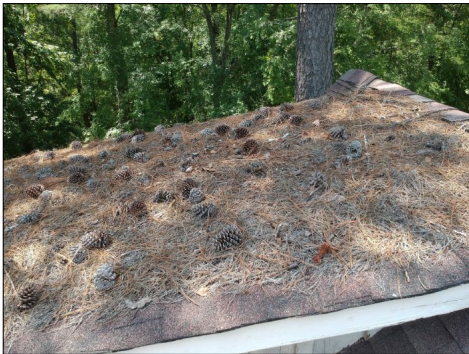
Have the heavy layer of pine straw removed from the bonus room roof & check for possible damage to the decking.

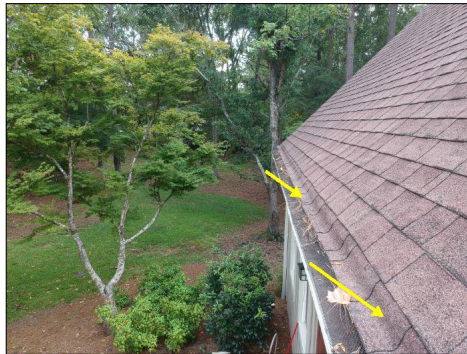
Because of the sharp bend in the shingles where laying on the gutter across the front eve rain water appears to be seeping through the shingles and running behind the gutter, damaging the fascia boards, some type of flashing is recommended to be installed under the shingles at the edge of the roof.

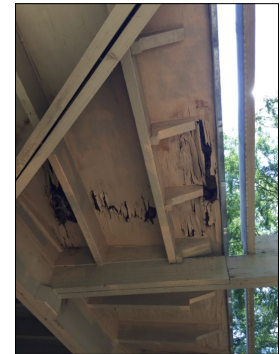
Replace all rotted roof decking and related framing damage at the rear porch roof.

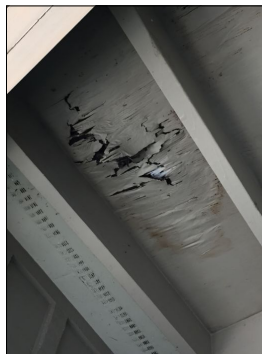
Roof decking rot at the rear porch, replace all.

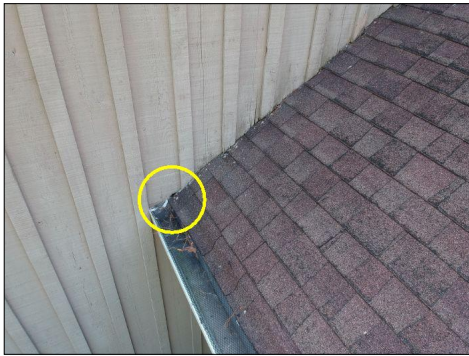
- 2.1. A kick-out flashing should be installed where the front right lower roof eve abuts the master front bedroom exterior wall & check for possible water damage to the substraight in the process.

A kick-out flashing should be installed where the front right lower roof eave abuts the master front bedroom exterior wall & check for possible water damage to the substraight in the process.

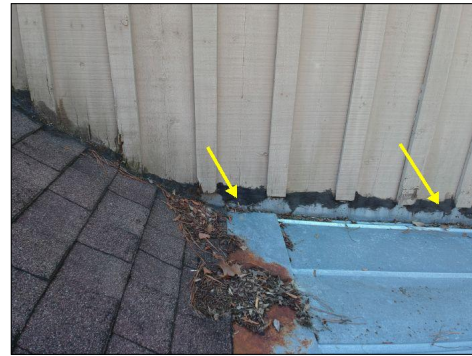
The flashing where the rear porch metal roof abuts the exterior wall appears to be installed on top of the siding and should have been under the siding, call for further evaluation by a roofing contractor for correction.

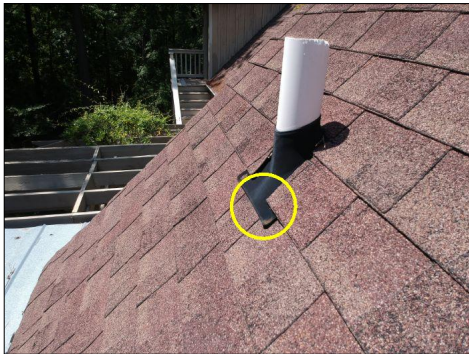
3.1. The plumbing vent boot above the master bath room is deteriorated around the fastener areas and should be replaced.

The plumbing vent boot above the master bath room is deteriorated around the fastener areas and should be replaced.

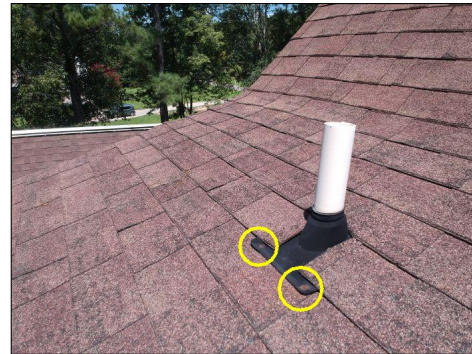
3.2. All of the fasteners in the plumbing vent boot flanges on the roof should be caulked.

All of the fasteners in the plumbing vent boot flanges on the roof should be caulked.

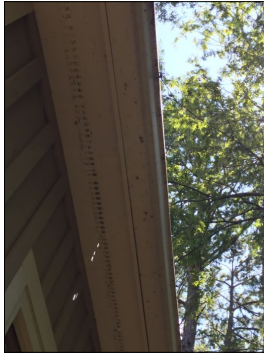
4.1. Replace the rusted out rear left gutter system and any related fascia board damage.

Replace the rusted out rear left gutter system.

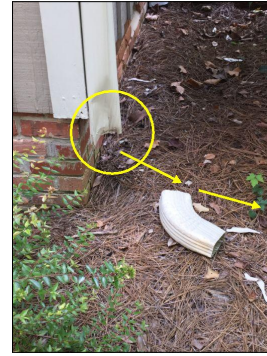
4.2. The front gutter down spouts should be extended to the left and right lower elevations of the lot using drain pipes to reduce water intrusion into the crawl space.

The front gutter down spouts should be extended to the left and right lower elevations of the lot using drain pipes to reduce water intrusion into the crawl space.

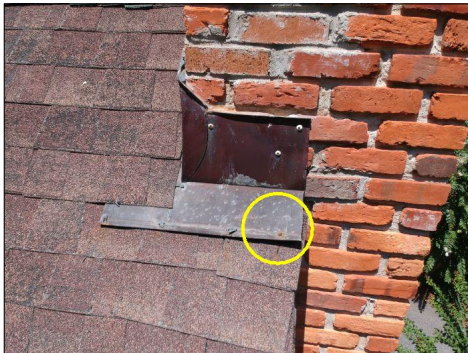
The chimney flashing fasteners should be re-caulked at both chimneys

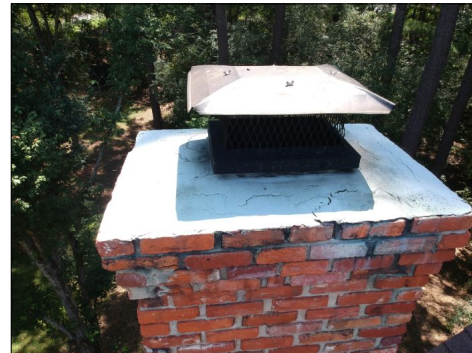
General minor brick deterioration noted on both chimneys which have been point tuckered & seem stable at this point, monitor for the need of further pointing up.

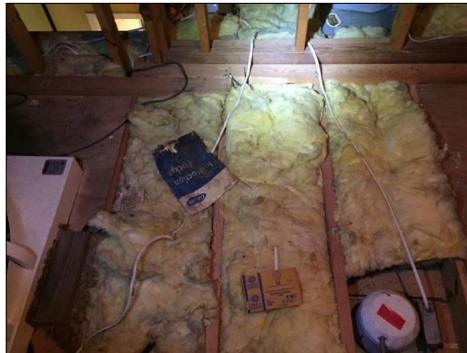
3.1. R-19 fiberglass batt insulation noted, at minimum R-30 insulation is recommended.

R-19 fiberglass batt insulation noted, at minimum R-30 insulation is recommended.

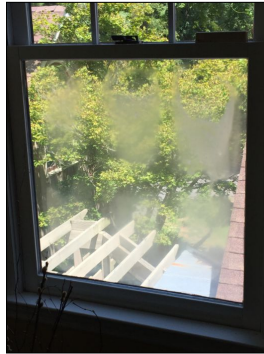
Multiple condensed sashes were noted throughout the home, call for and exact count and cost to replace failed sashes by a window specialist.

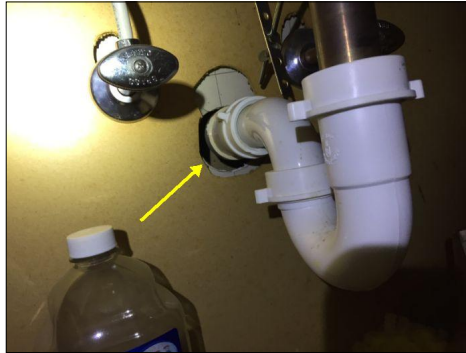
- 2.1. Openings around drain pipes in walls under sinks should be sealed.

Openings around drain pipes in walls under sinks should be sealed.

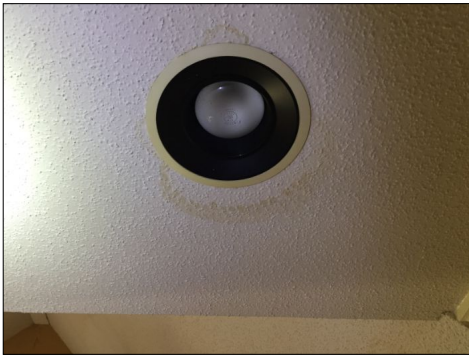
Water stains noted around the recessed light fixture at the left end of the rear hall to the laundry area as well as on the rear den area ceiling from apparent periodic water seepage at the roof above, call for further evaluation for repair.

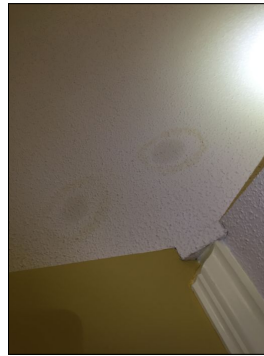
Water stains noted on the rear den area ceiling, from possible roof leaks, call for further evaluation by a roofing contractor.

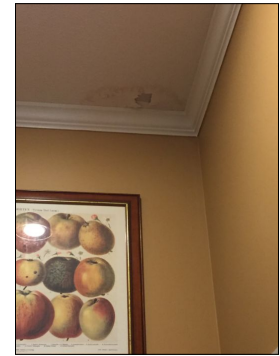
- 3.1. Minor water damage noted on the kitchen area ceiling, check for possible roof leak & repair as necessary.

Minor water damage noted on the kitchen area ceiling, check for possible roof leak & repair as necessary.

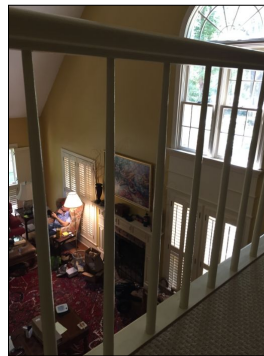
4.1. Be advised the weak railing at the upper rear balcony area should be reinforced and the spindles are over-spaced, gap between the spindles should not exceed 4"

Be advised the weak railing at the upper rear balcony area should be reinforced and the spindles are over-spaced, gap between the spindles should not exceed 4"

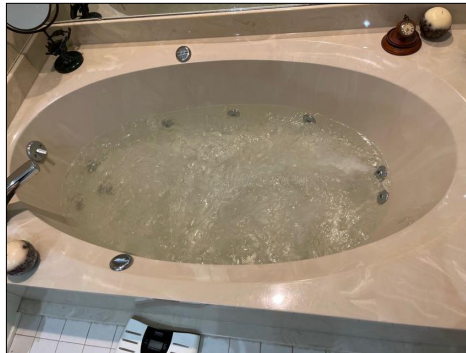
- 4.1. Jetted tub is functioning during the inspection
- 4.2. Jetted tub was functioning during the inspection, however GFCI protection was not confirmed due to access door being sealed shut with duct tape, GFCI protection is required for the jetted tub motor.

Jetted tub was functioning during the inspection, however GFCI protection was not confirmed due to access door being sealed shut with duct tape.

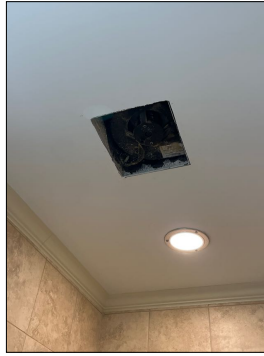
- 6.1. Replace the missing cover on the master bathroom exhaust fan

master bath exhaust fan cover is missing

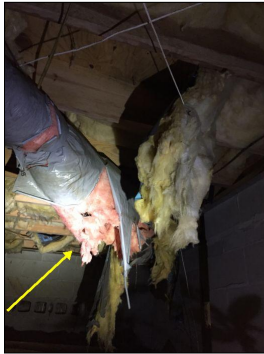
2.1. Replace the damaged branch HVAC duct in the front left crawls space, to the front living room HVAC vent

Replace the damaged branch HVAC duct in the front left crawls space, to the front living room HVAC vent

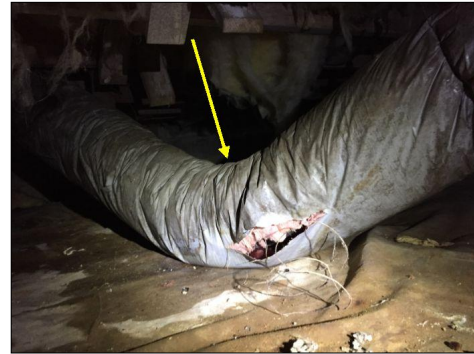
Re-strap the fallen branch duct in the rear right crawl space and repair the torn insulation sleeve.

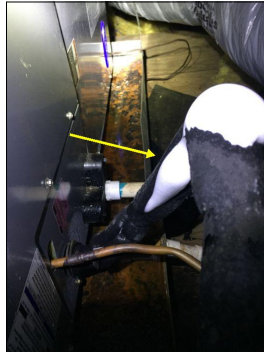
The refrigerant suction line was completely iced over as well as the evaporative coil in the upstairs air handling unit upon arrival to the home, the system may be low on refrigerant, call for repair by a licensed HVAC contractor.

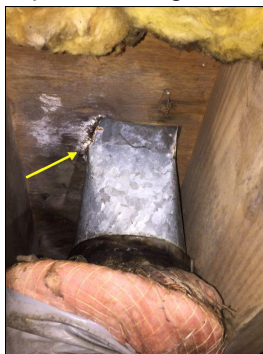
The AC vent boot should be insulated and caulked / sealed to the floor in the master bathroom.

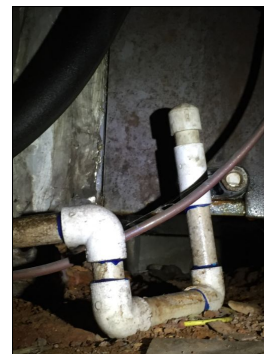
The condensate drain from the air handler in the crawl space was very slow draining, have the line cleaned out by an HVAC contractor and evaluated for the need of installing a condensate pump.

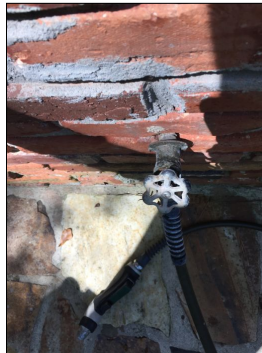
- 3.1. Secure the loose rear left hose spigot to the foundation wall.

Secure the loose rear left hose spigot to the foundation wall.

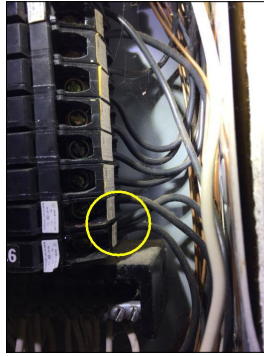
- 4.1. The wires that are doubled up on one breaker should be separated to individual breakers at the bottom right of the sub-panel.

The wires that are doubled up on one breaker should be separated to individual breakers at the bottom right of the sub-panel.
