Following is the Inspection Report Summary from the Home Inspection. The items that are highlighted have been addressed. Contact Steve Slocumb at 478-957-4283 if you have any questions.

REPORT SUMMARY

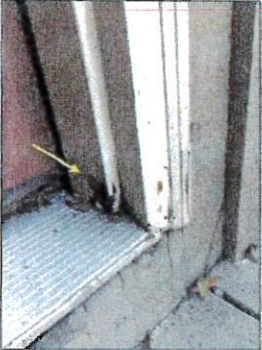
Repair the water damaged door jambs at the rear left exterior door opening and I recommend installing a storm door to prevent future water damage to the jamb & sub-floor below.		
Page 4 Item: 3	Exterior Siding Condition	3.1. Minor water damage noted to the siding where setting on the roof at the rear left area repair as necessary
Page 5 Item: 4	Exterior Windows Condition	4.1. Replace the rotted window sill, sash and mulls at the rear left den triple window unit. 4.2. Replace water damaged sashes and window sills on the right side windows of the front middle bedroom. paint ✓ 4.3. Replace rotted window sills at the front right 1/4 round windows to the left and right of the chimney.
